Sewer Trunk Main Rehabilitation Site Photos

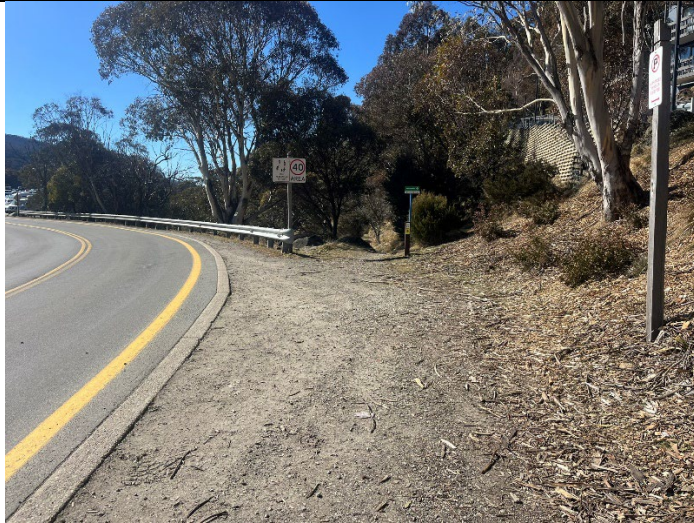
PH1: Machinery will be parked in the pullover bay along Friday Drive when working at the western end of the alignment.

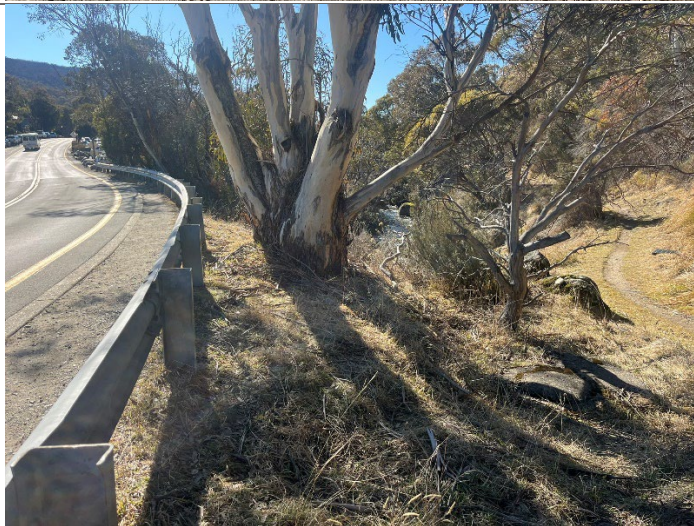
PH2: Sewer manhole at the start of the alignment.

Located within Biodiversity Values Map and waterfront land.

Materials and lining equipment will be carried in on foot from this location.

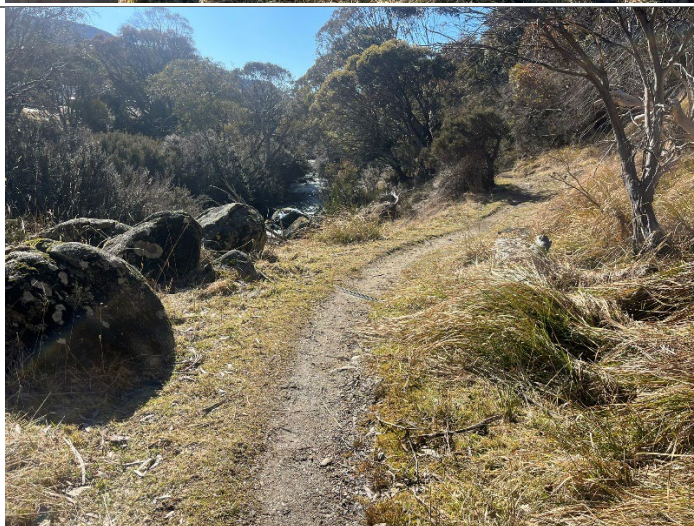
PH3: Start of the alignment facing east.

Alignment located within the Biodiversity Values Map and waterfront land.

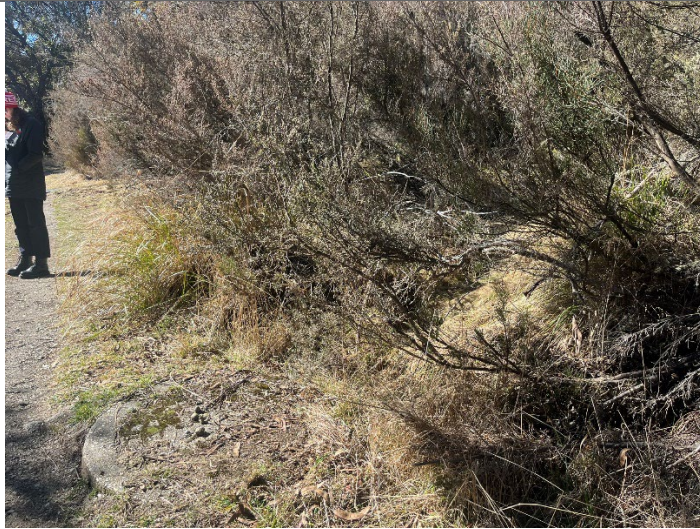
PH4: Manholes located on either side of the existing easement comprising the Pipeline Path shared use trail.

The corridor is heavily disturbed comprising native vegetation either side. In some locations the shrubs and trees are overhanging the manholes.

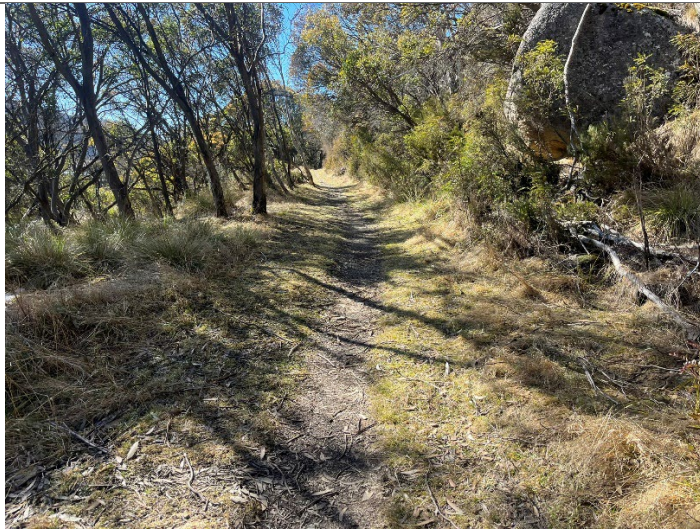
PH5: The pipeline follows the disturbed corridor.

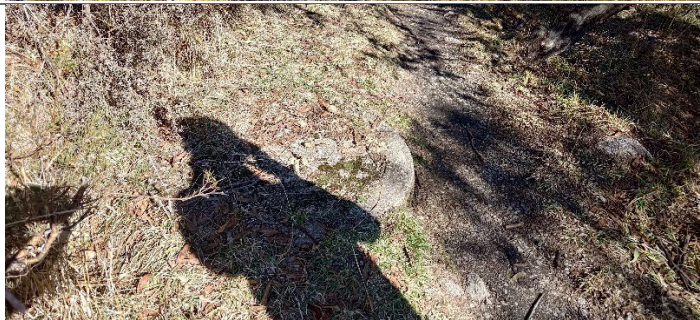
PH6: The sewer manholes are located within the disturbed easement on the edges of either side of the Pipeline Path shared use trail.

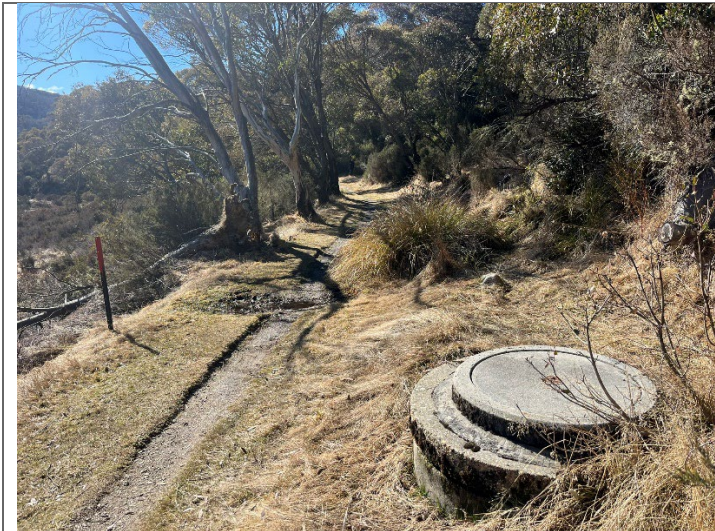
PH7: Start of the approximate 50 m section of pipe to be excavated and replaced with new pipe.

Section located outside of waterfront land.

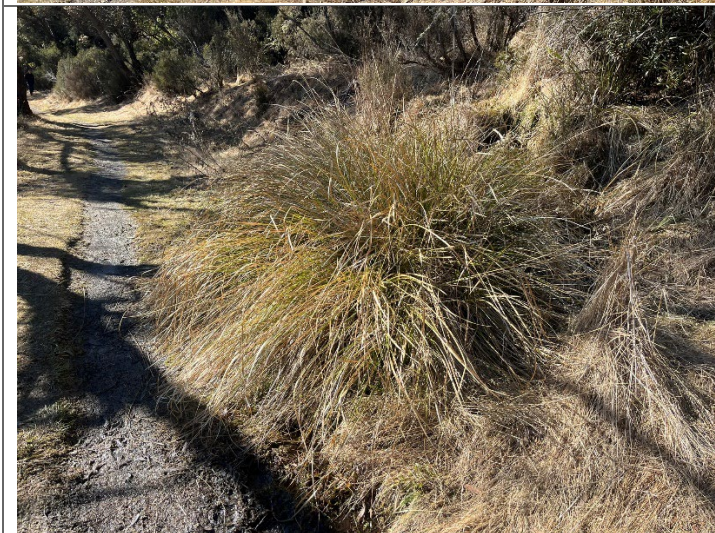
PH8: Shrub to be removed as part of approximate 50 m replacement.

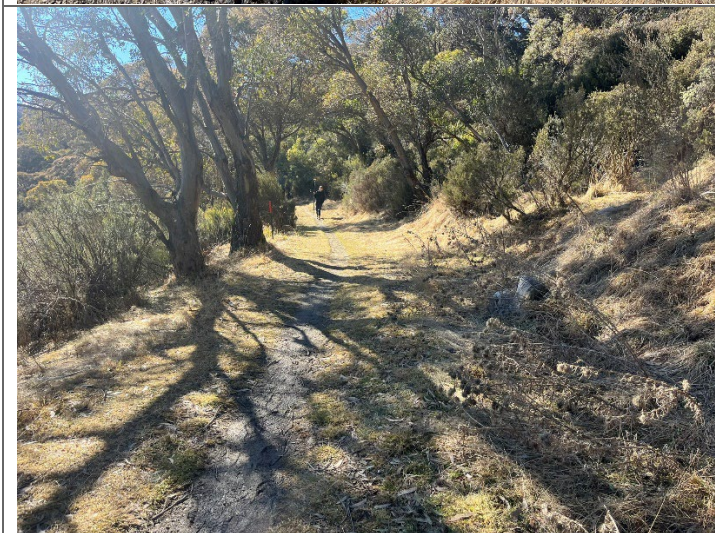
PH9: Alignment of section to be replaced is located within disturbed corridor, dominated by exotic species.

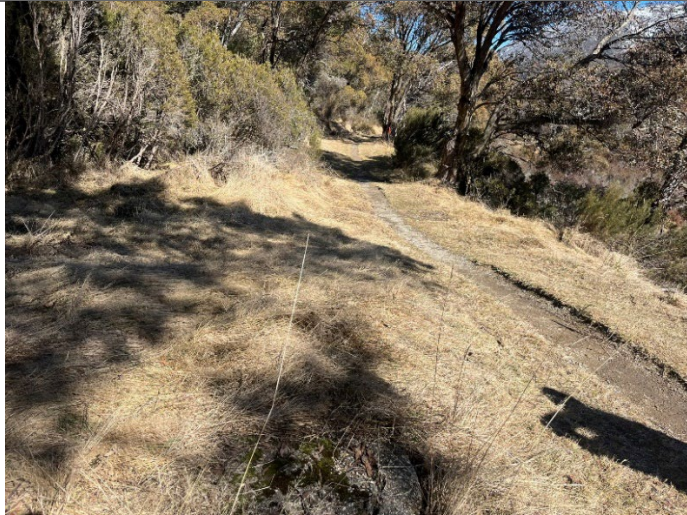
PH10: Standing at end of section to be replaced facing towards the start of the pipeline.

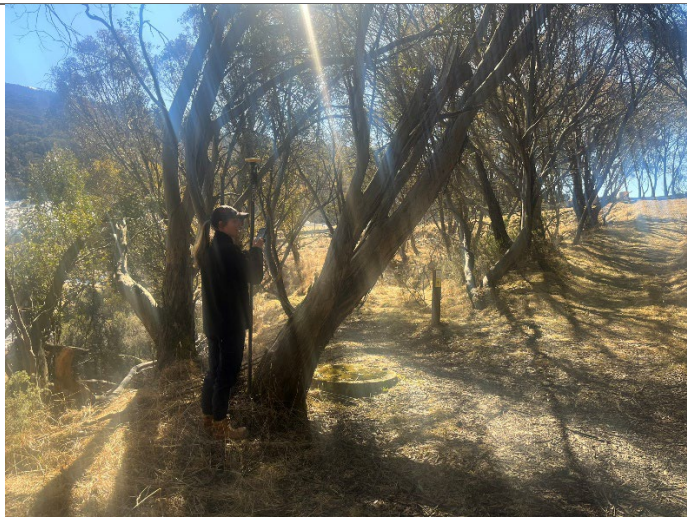
PH11: Sewer manhole toward the north-eastern end of the Pipeline Path.

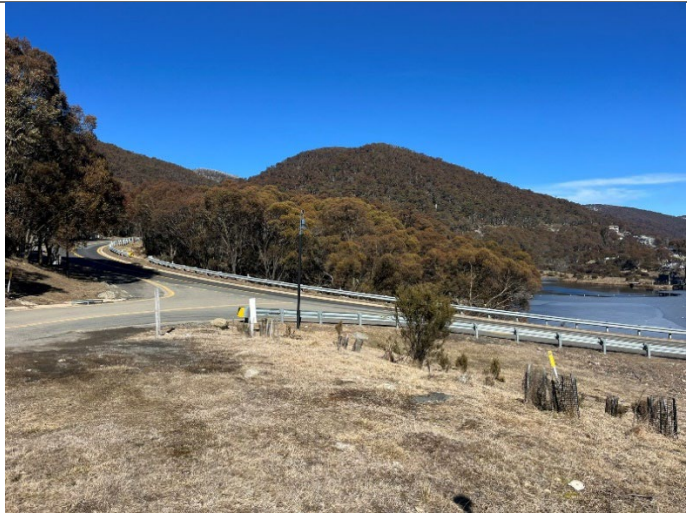
PH12: Pipe traverses below Friday Drive towards the top overflow carpark.

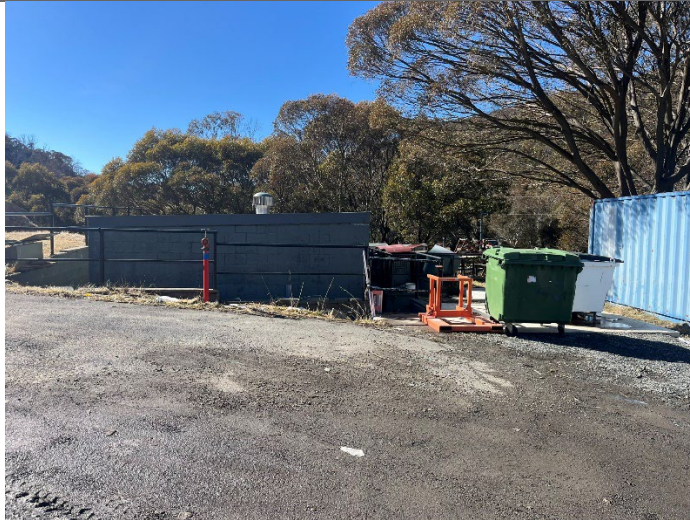
PH13: The pipe traverses below the road and into the Pre-treatment screening shed building.

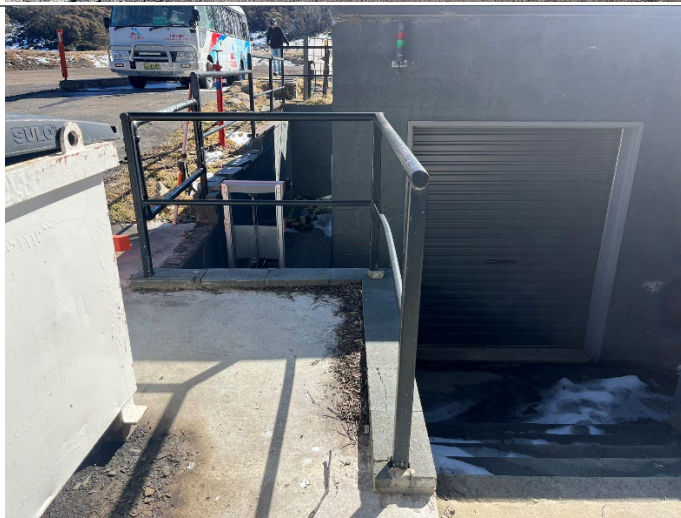
PH14: The pipe connects into the Pre-treatment screening shed. The re-lining works terminates where the pipeline enters this shed.

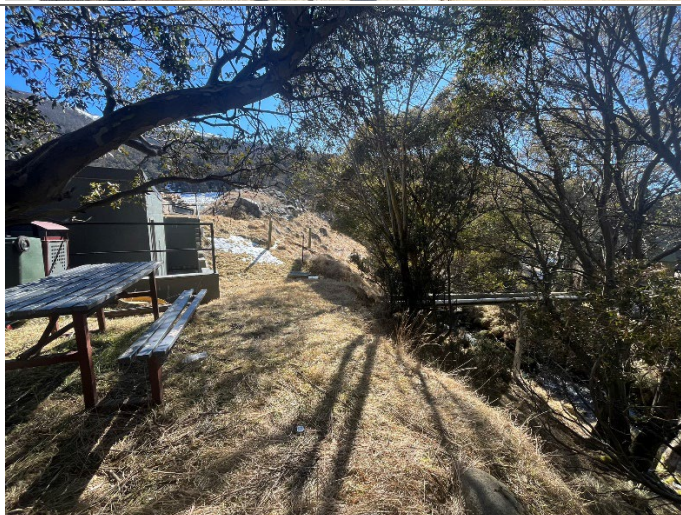
PH15: The pipe exits the building and crosses a watercourse before entering the Sewerage Treatment Plant. This section of pipe will not be relined.
