# Arborist Impact Assessment

Proposed Manufactured Home Estate  
Lot 100 DP1286524 & Lot 11 DP615229  
40-80 & 82 Chapmans Road Tuncurry, NSW

**9 December 2024**

**AEP Ref: 3295**

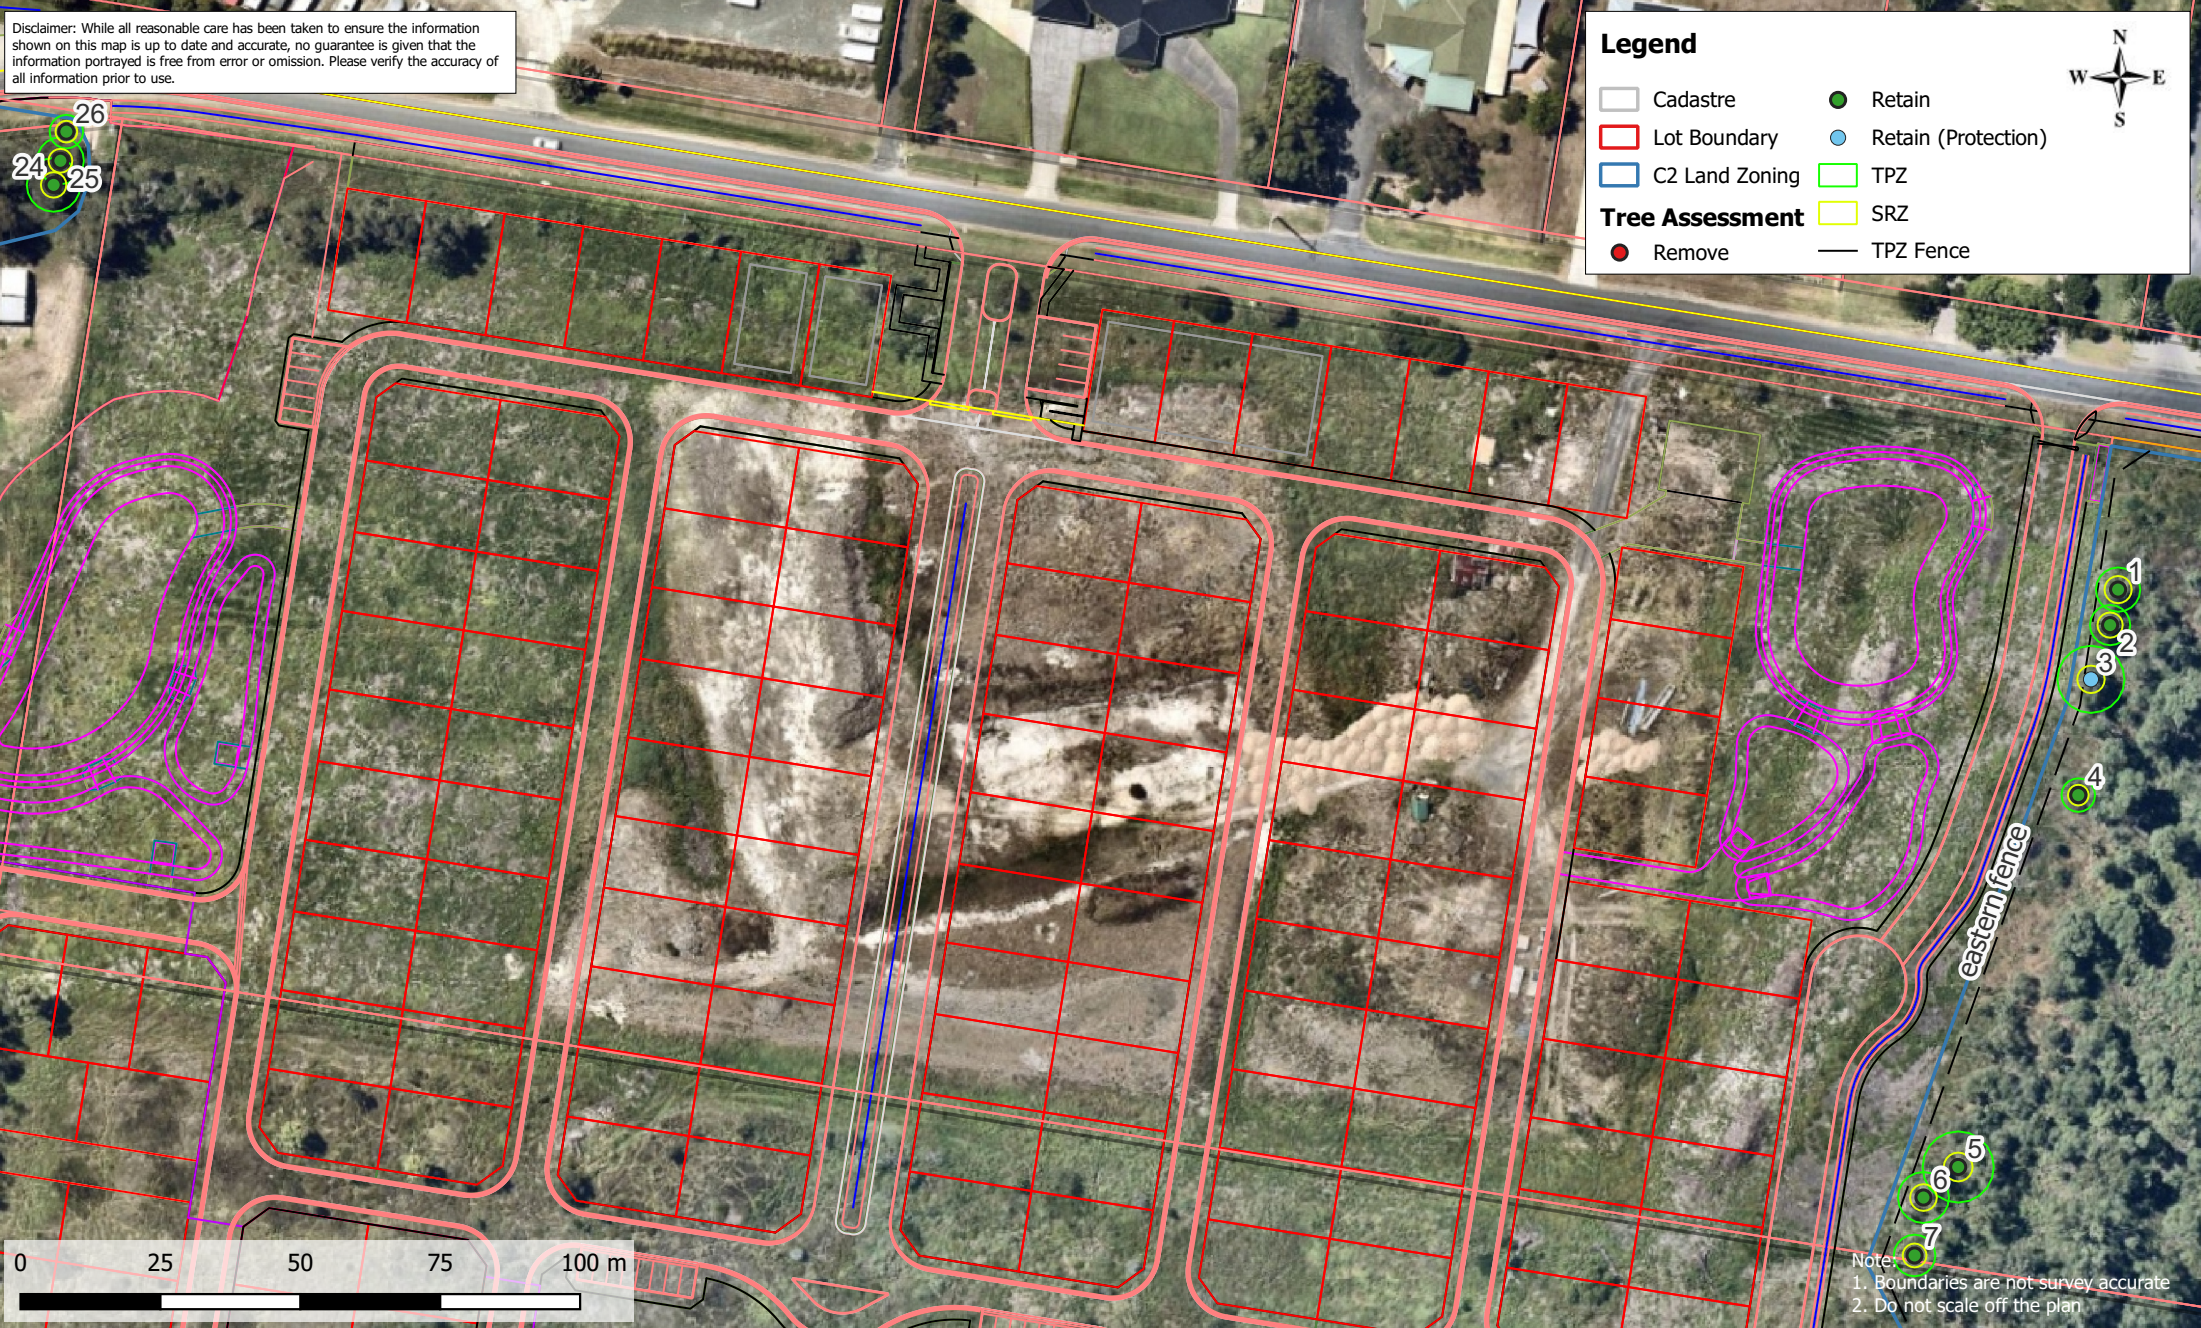
Figure 4 - Tree Assessment (North)

Upon review of the supplied proposal footprint, one assessed tree (Tree 3) has encroachment into the SRZ of this tree by a proposed retaining wall and "fill" area behind the wall. This could be a major impact upon the stability of this tree. The following should be considered within engineering design and construction detail for works within the TPZ of this tree to mitigate these potential impacts;

- Engineering controls such as a pier and bridge footing for the retaining wall should be considered and utilised within the design of the retaining wall for areas within 5m of this tree. Furthermore, placement of piers should be a minimum of 4m from the base of this tree. Retaining wall footings should be on grade within this area where possible. This option would greatly reduce potential impacts;

- If the above cannot be achieved then construction controls during excavation works for the footing should be applied. This should include arborist supervision of retaining wall construction with potential pruning of roots and using "soft" construction techniques (pneumatic/ hydraulic excavation of soils) to excavate within 4m of this tree to establish the footings for the retaining wall;

- Soils that are applied within the "fill" areas that intersect with the tree protection zone of Tree 3 should be a "Structural Filler" soil that complies with the requirements within *AS 4419:2018 Soils for Landscape Use* for this type of soil. The supplier of the soil must provide written certification that the soil provided complies with AS 4419:2018;

- Compaction of existing soil should be limited;
- Soils that are applied should be coarser or more porous than current site soil within these areas; and

- This tree should be monitored at regular periods during and post-construction.

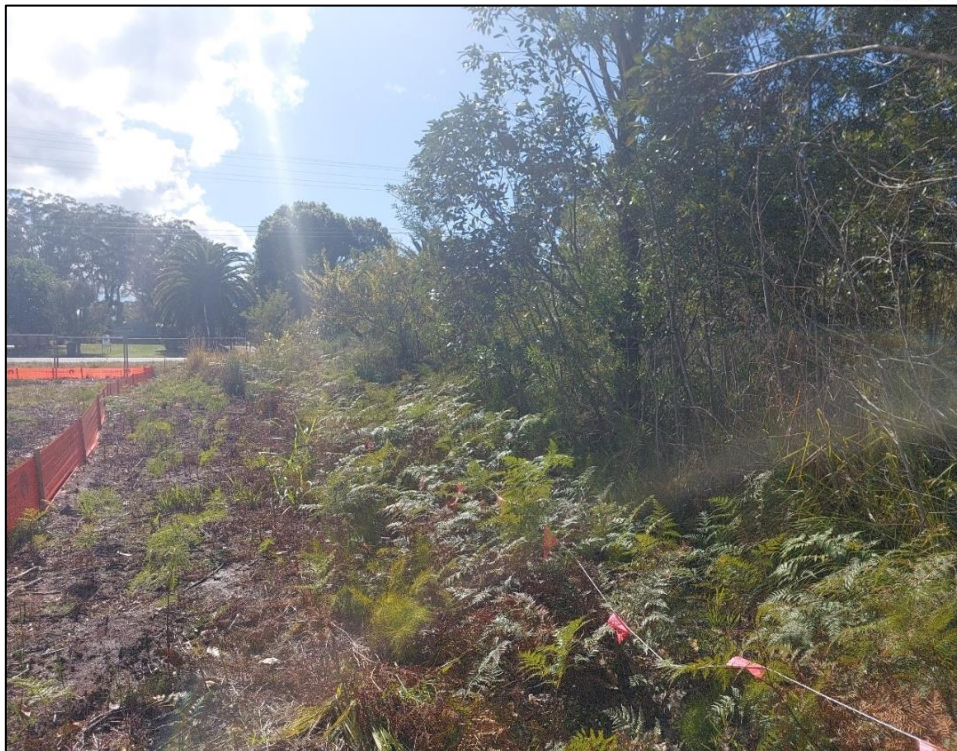
**Plate 1: Looking north along the sediment fence. To the right of the fence, the trees are located in the C2 zone along the eastern boundary of Lot 100. Fencing to protect this zone will be required at the approximate position of the bunting string-line.**

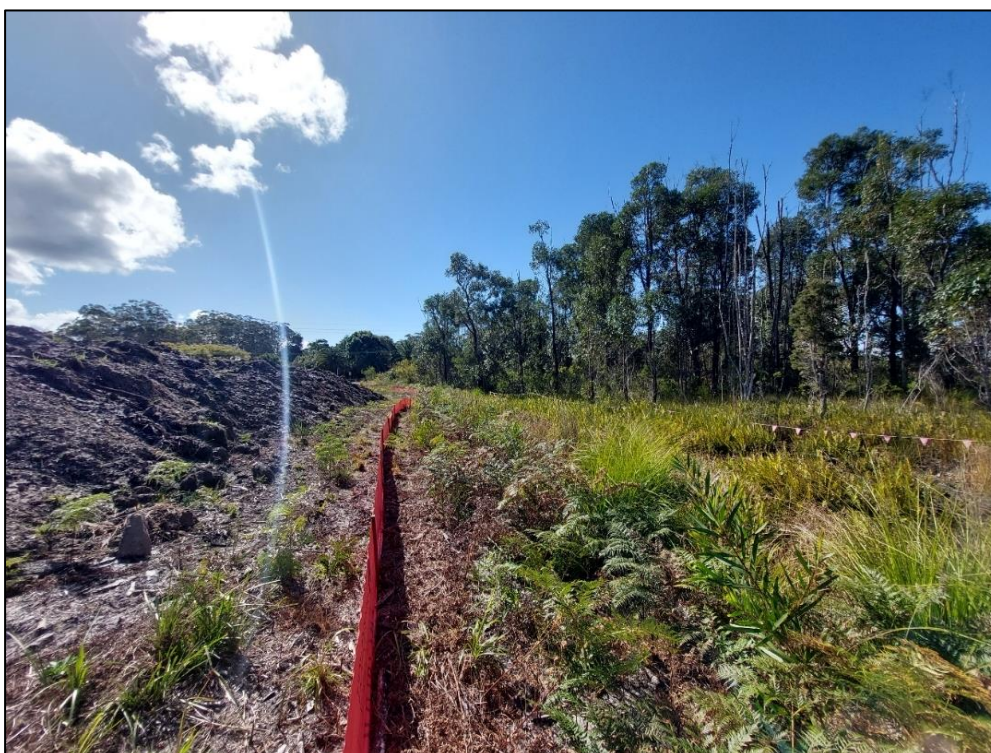
**Plate 2: The view looking North along the approximate edge of the eastern Conservation Zone. A Tree Protection Zone fence is recommended in this area to protect vegetation.**

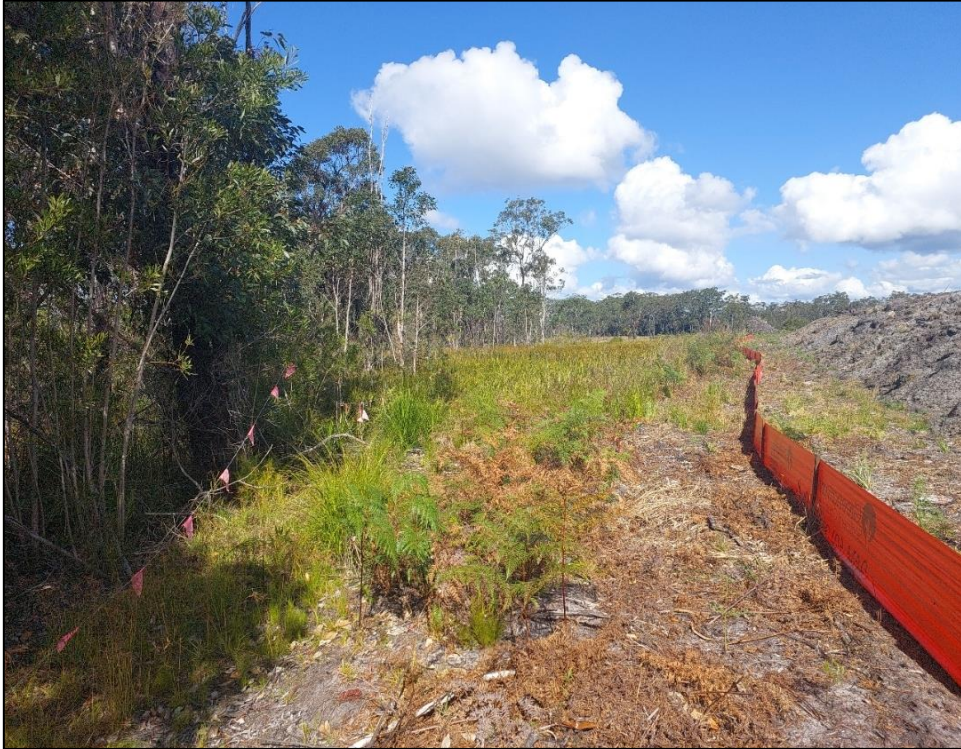
**Plate 3: The view in the opposite direction (south) to Plate 2. Tree protection fencing should be implemented in this area.**

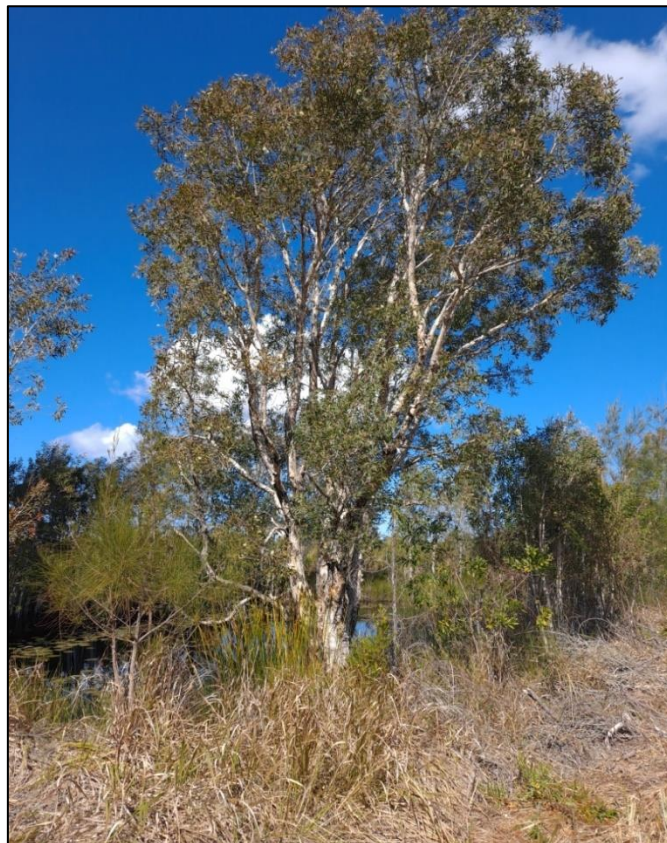
**Plate 4: Tree 7 is located just within the eastern Conservation Zone. On site, the estimated position of the Conservation Zone boundary was approximately 2 – 3 m to the right of this tree.**

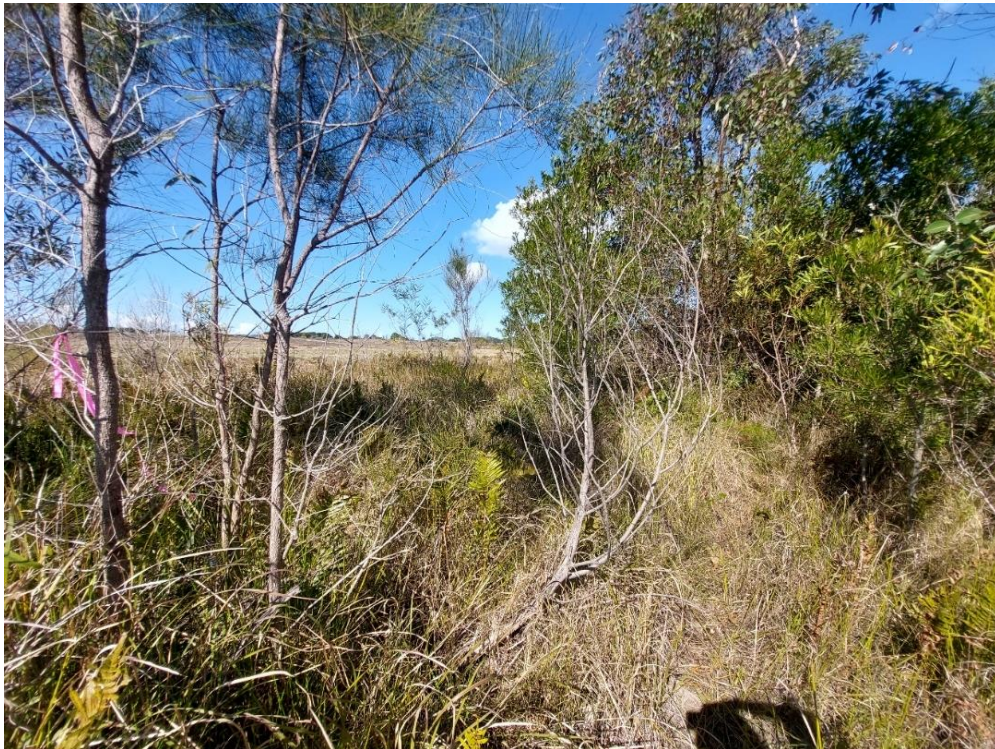
**Plate 5: Tree 12 – *Eucalyptus robusta* in the rear of the image.**

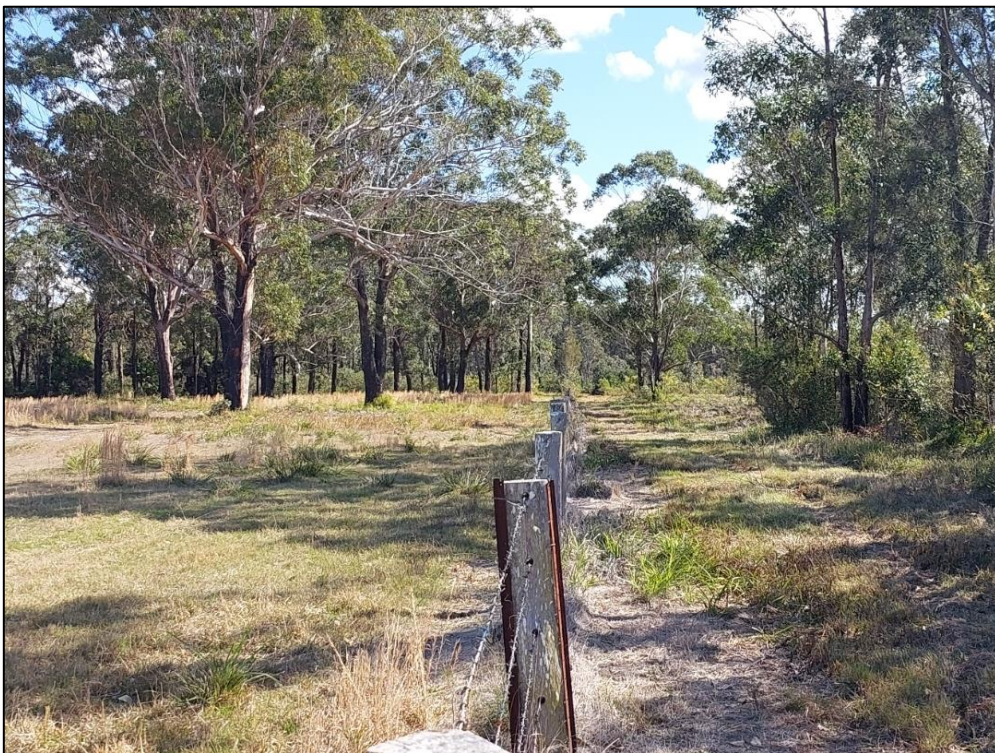
**Plate 6: Looking west along the southern boundary fence. The left side of the fence is an adjoining property.**

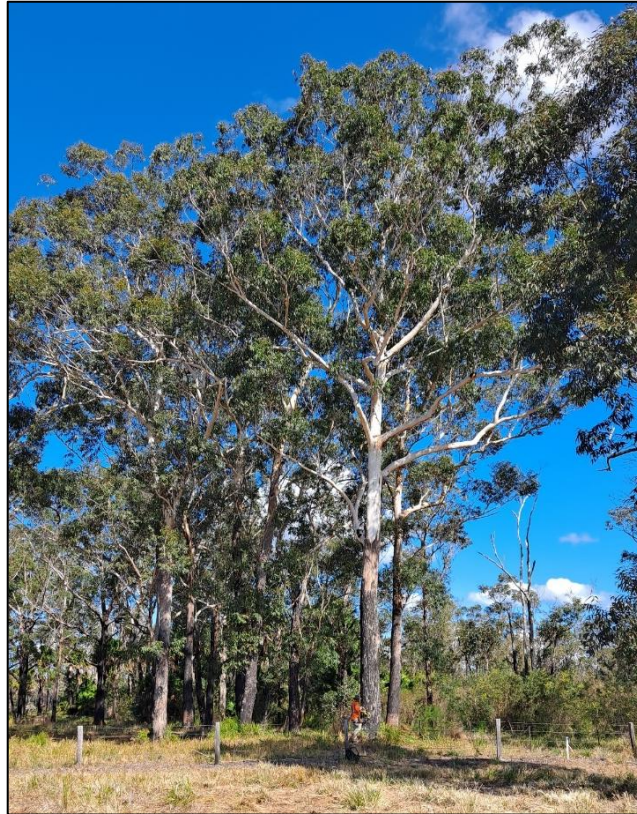
**Plate 7: Tree 14 – *Eucalyptus pilularis* listed as having a very high landscape significance due to its height (29 m), and large canopy area 299 m<sup>2</sup>)**

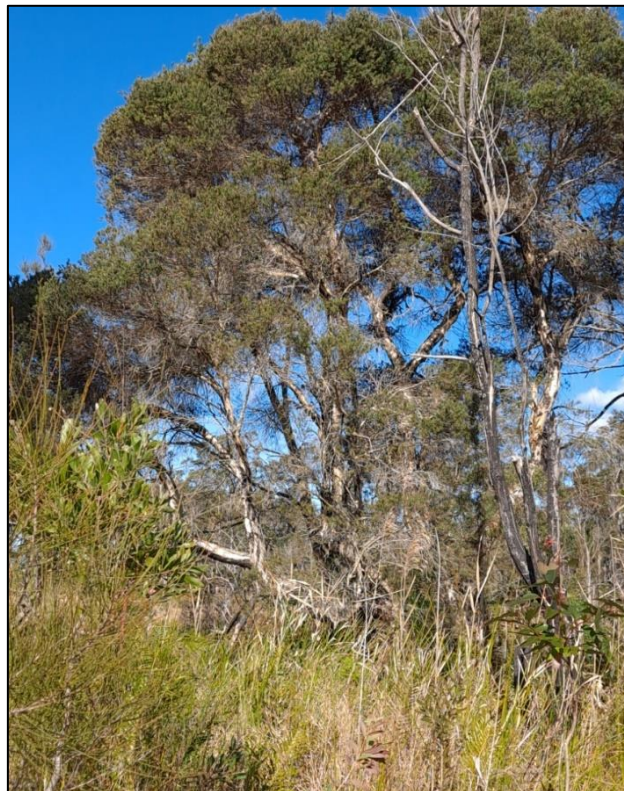
**Plate 8: Tree 21 – *Melaleuca linariifolia* located just on the boundary of the Conservation zone.**

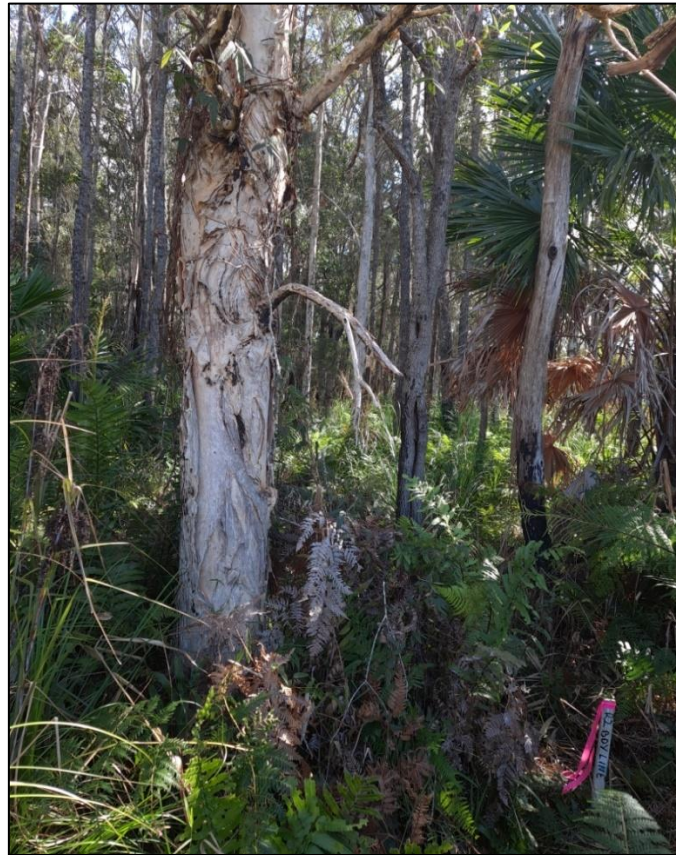
**Plate 9: Tree 18 – *Melaleuca quinquenervia* positioned on the edge of the Conservation Zone and boundary in the south-west of the site. The dense Swamp Mahogany/Paperbark.**

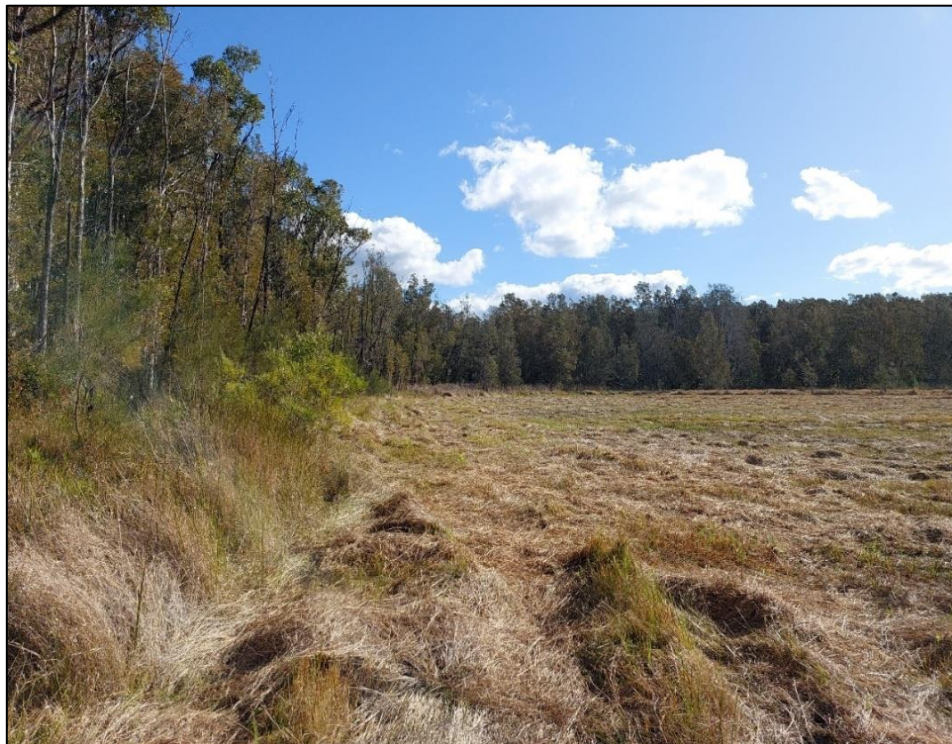
**Plate 10: Looking along the south-west boundary line from Tree 21. The Conservation Zone is on the left and background of the photo.**
