Arboricultural Impact Assessment

Western Sydney University, Milperra Campus
Childcare Centre Alterations and Additions
NSW, 2214
2/-/DP1291984
Job No: 240166
17/12/2024

Temporal Tree Management Pty Ltd.

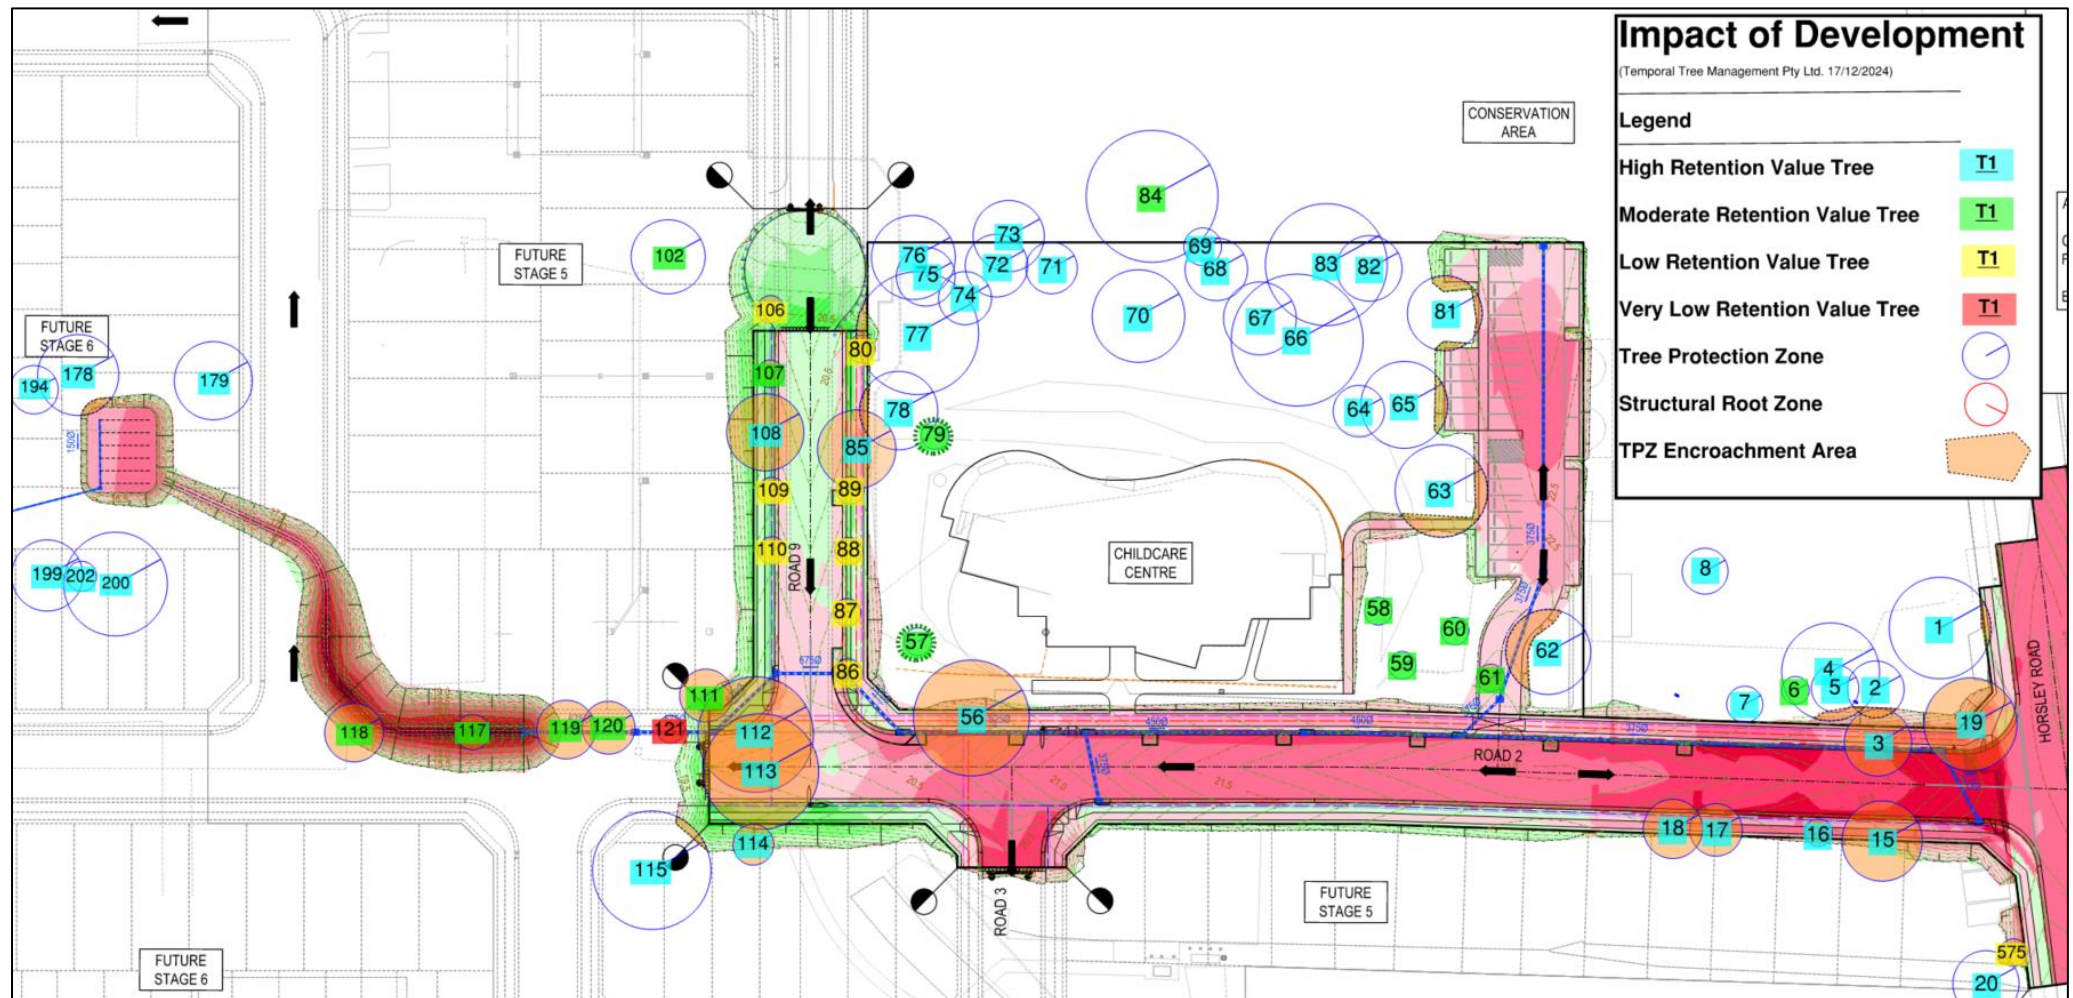
Figure 6. Retention values, TPZs and Encroachments for seventy assessed trees. Proposed development plans. *Bulk Earthworks Plan*, prepared by *Beveridge and Williams*, Project No: 2301879, Ref: 315, Drawing No: 015, Rev: B, drawn: 12/12/24. Annotated by Temporal Tree Management Pty Ltd. (17/12/2024).

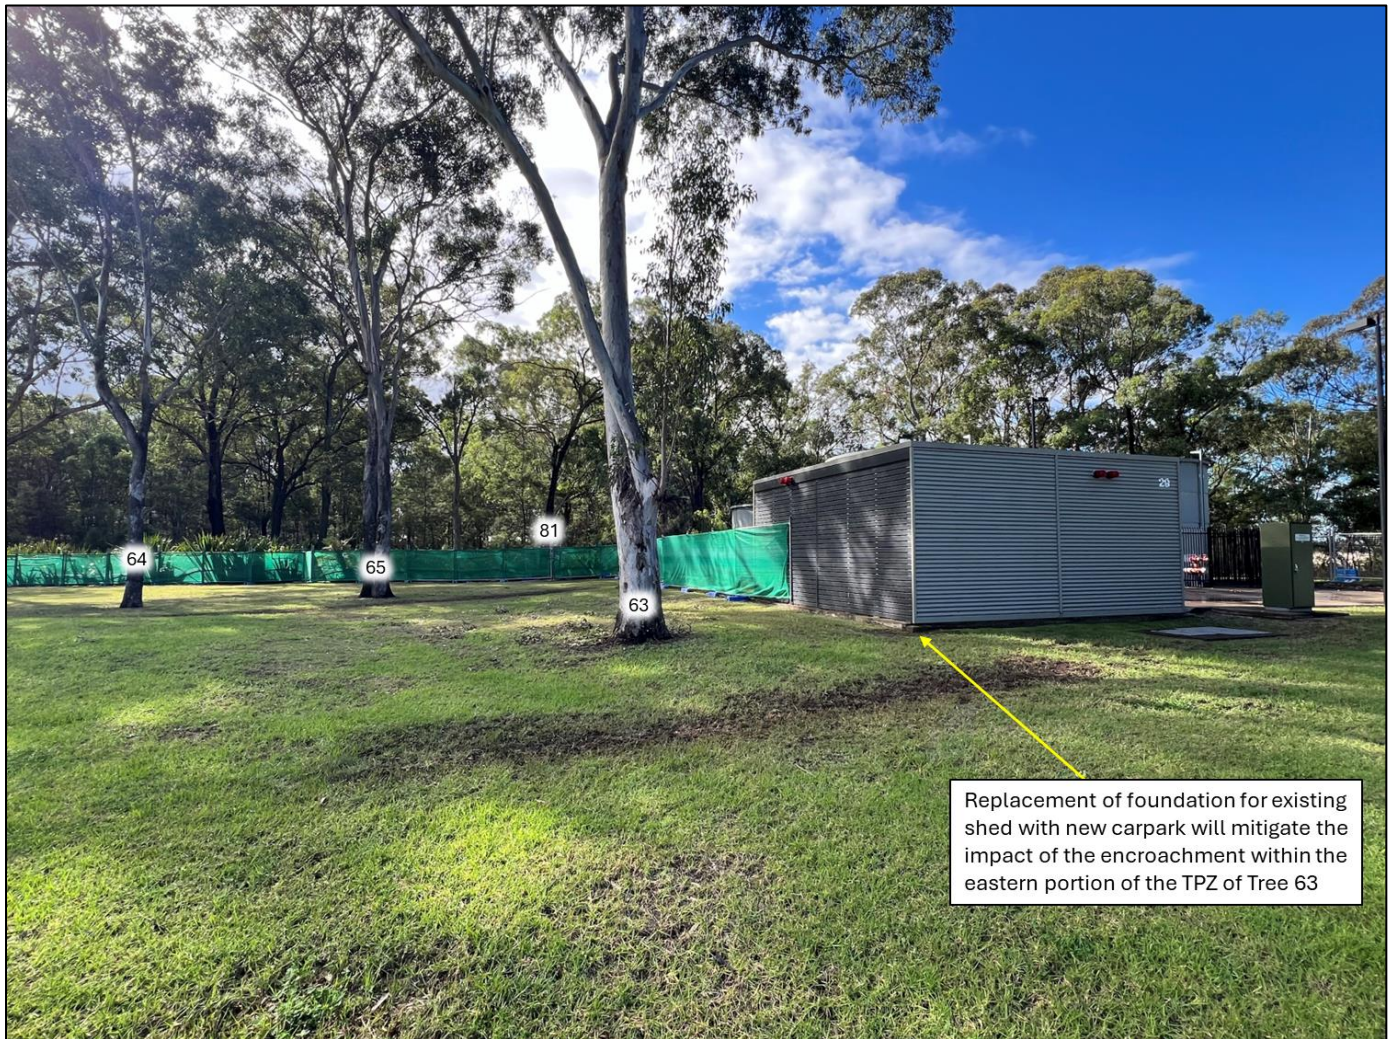
63	No	25	High	Tree will sustain a major encroachment within the southern portion of its TPZ during construction of a new pedestrian pathway and construction of the proposed carpark. The encroachment within the eastern edge of its TPZ will be mitigated by the replacement of the existing shed foundation, which is likely to have restricted eastern root growth from this tree.	Retain. Undertake Root Mapping Assessment in accordance with Section 3.3.4 of AS4970 (2009). Install tree protection measures compliant with Section 4 of AS4970 (2009).
64	N/A	0	N/A	Tree will not be directly impacted by proposed development.	Retain. Install tree protection measures compliant with Section 4 of AS4970 (2009).
65	No	8	Low	Tree will sustain a minor encroachment within the eastern portion of its TPZ during the construction of the proposed carpark. The tree's good health suggests it will tolerate encroachment within its TPZ. The encroachment within the eastern edge of its TPZ will be mitigated by the replacement of the existing shed foundation, which is likely to have restricted eastern root growth from this tree.	Retain. Install tree protection measures compliant with Section 4 of AS4970 (2009).

Figure 7. Mitigating factor within the eastern portion of the TPZ of Tree 63.

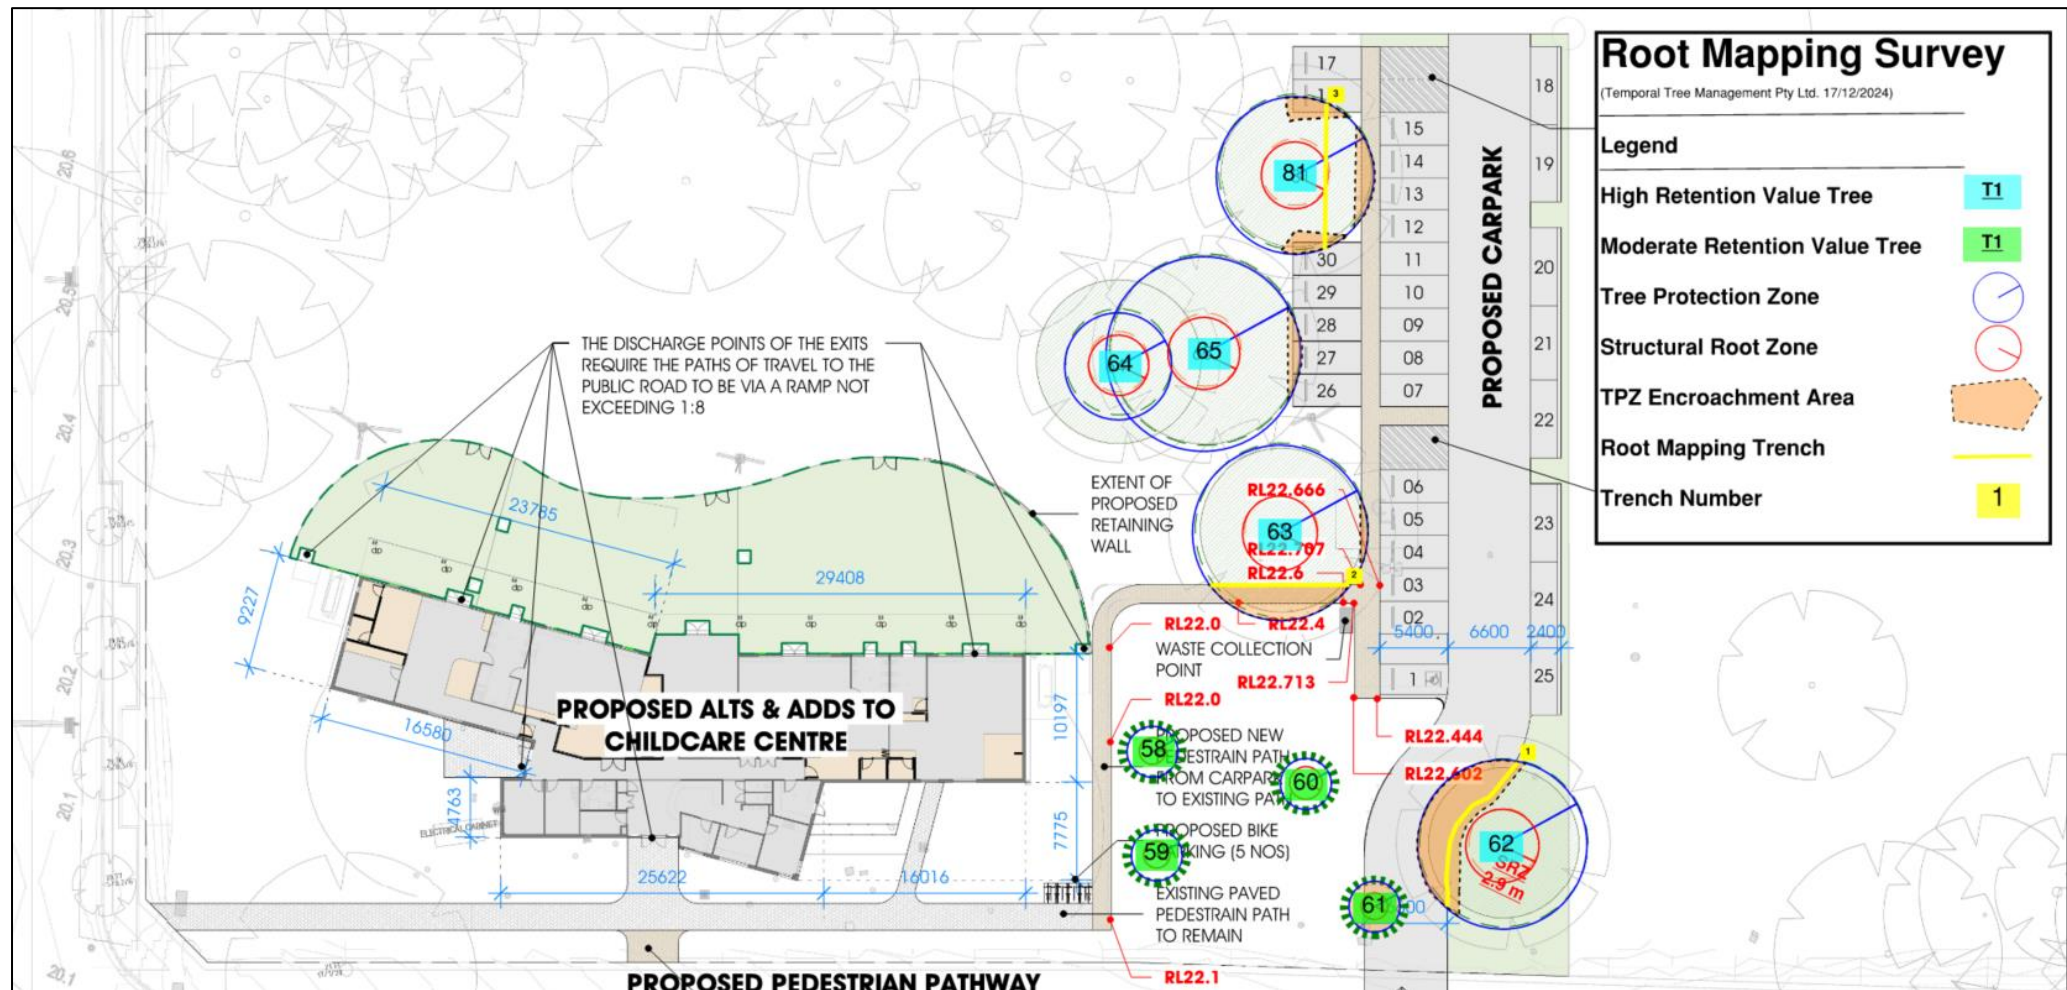
Survey Trench 1 was excavated along the portion of the eastern edge of the proposed driveway that is within the TPZ of Tree 62 (Figure 8). Survey Trench 2 was excavated along the portion of the northern edge of the proposed pedestrian walkway that is within the TPZ of Tree 63 (Figure 8). Survey Trench 3 was excavated along the portion of the eastern edge of the proposed carpark that is within the TPZ of Tree 81 (Figure 9). Excavation to a depth of up to 400mm will be required for the construction of the proposed driveway, pedestrian walkway and carpark. Survey Trenches 1-3 were therefore excavated to a depth of 400mm (Figure 9).

Figure 8. Position of three survey trenches that was non-destructively excavated within the TPZs of Trees 62, 63 and 81. *Proposed Site Plan*, prepared by Envision Group Pty Ltd. (Project No: 194, Drawing No: DA-06, Rev: I, drawn: 11/12/2024). Annotated by Temporal Tree Management Pty Ltd. (17/12/2024).

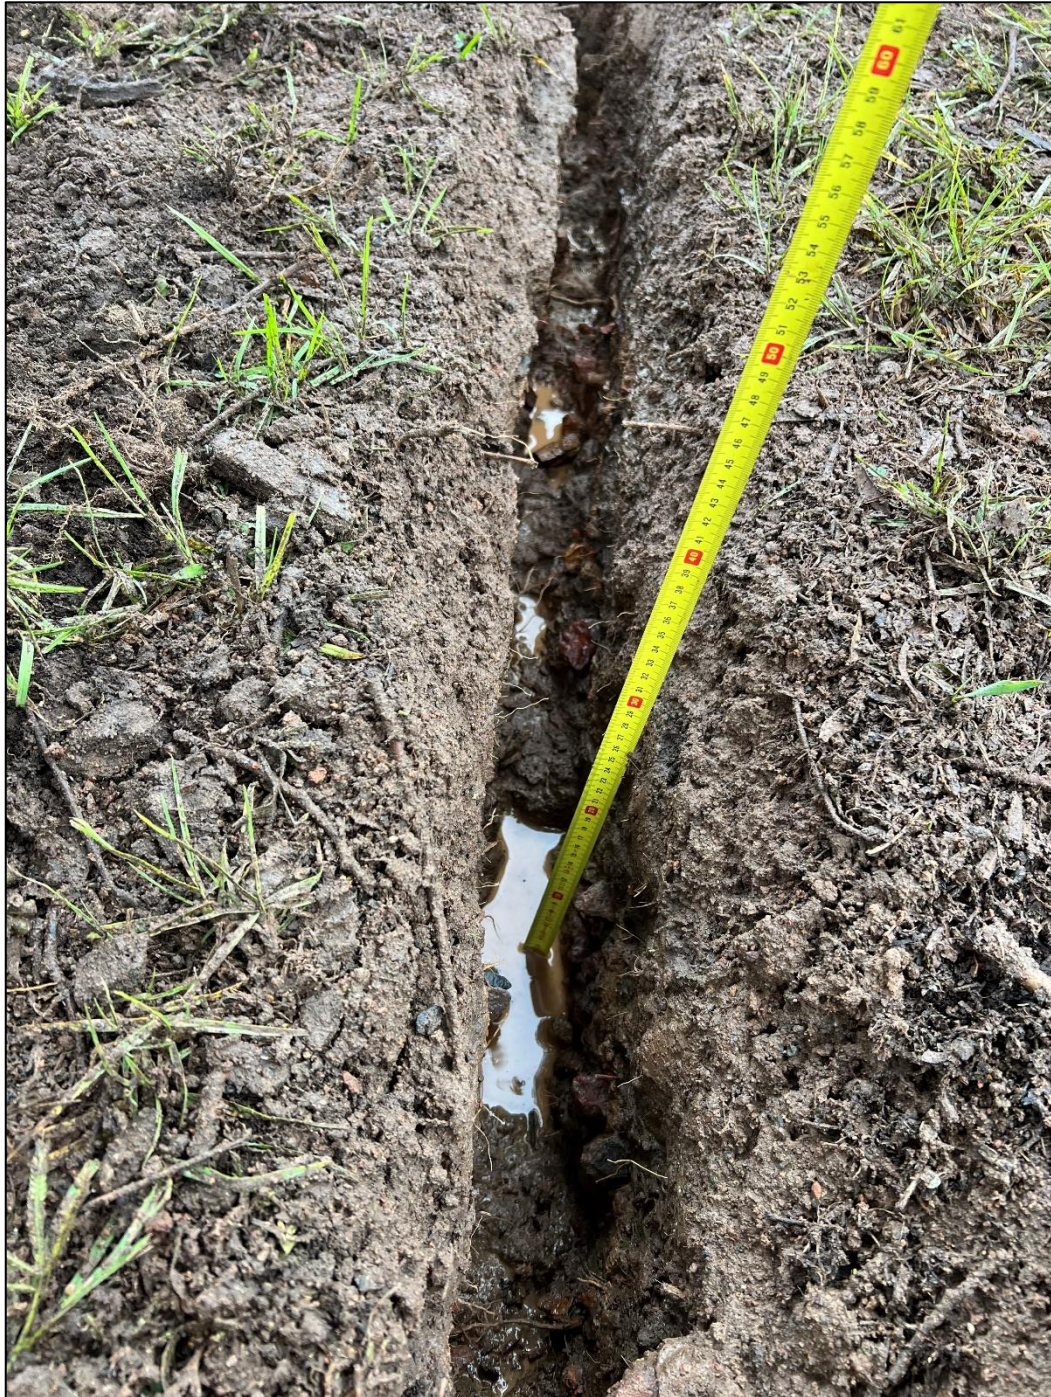
Figure 9. Survey Trenches 1-3 were excavated to 400mm depth in accordance with *Section 3.3.4 of AS4970 (2009)*.

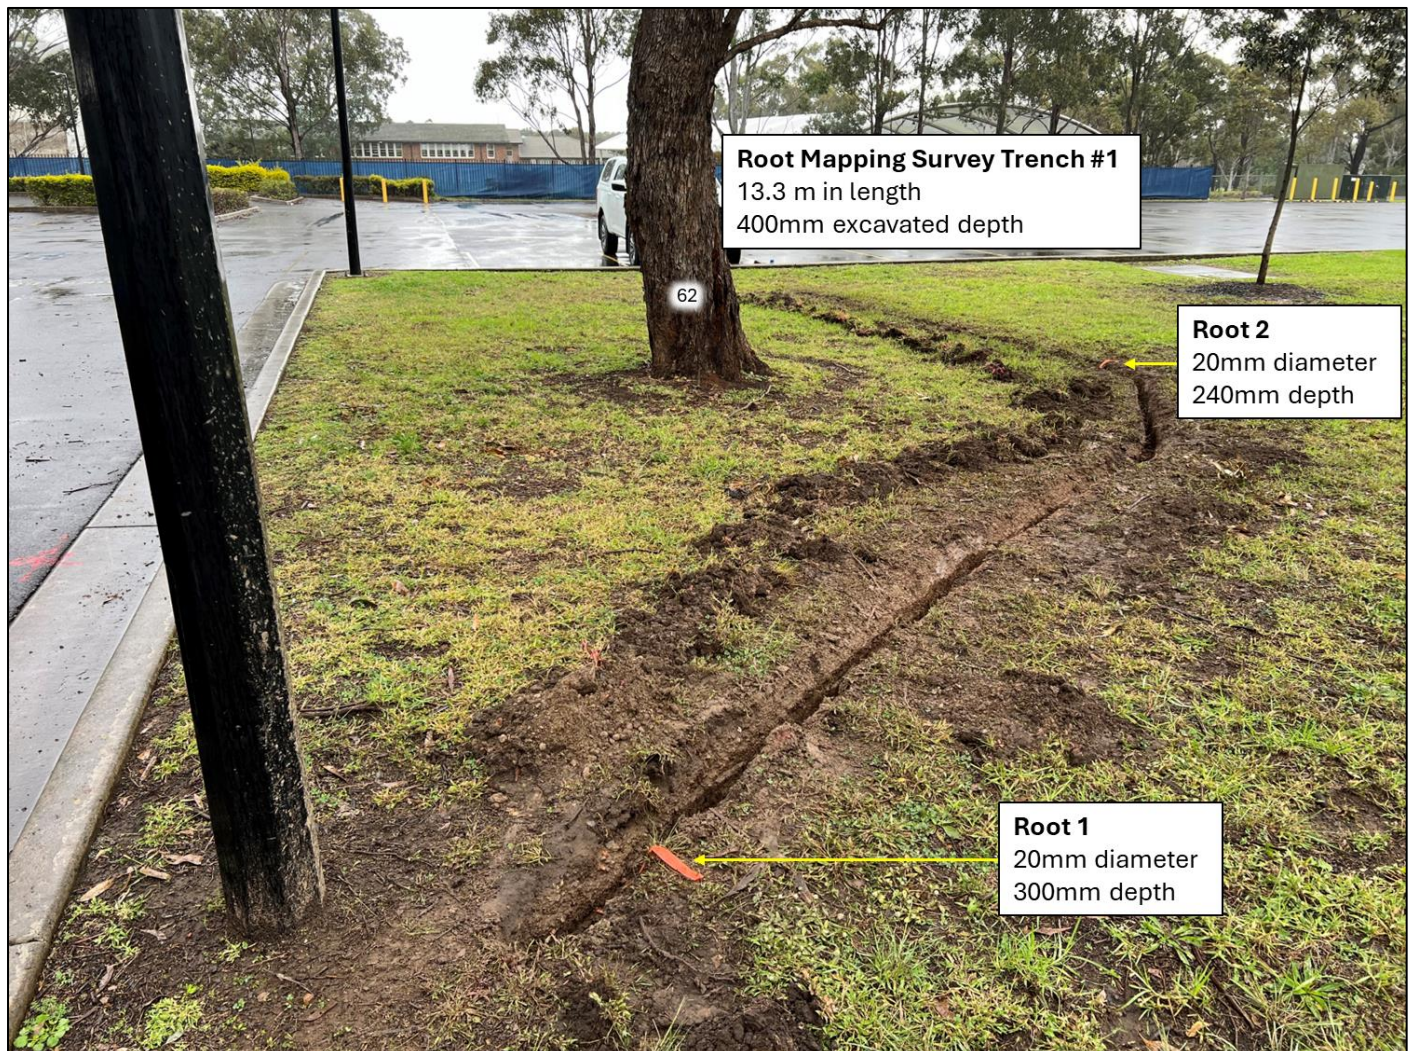
Root	Distance from Northern edge of trench (m)	Diameter of root (mm)	Depth of root [mm]	Comments
1	0.4	20	300	Minor root crossing trench laterally. Orientation and root bark suggest root is from Tree 62.
2	7.6	20	240	Minor root crossing trench diagonally. Orientation and root bark suggest root is from Tree 62.

Figure 10. Position of Roots 1 and 2 within Survey Trench 1.

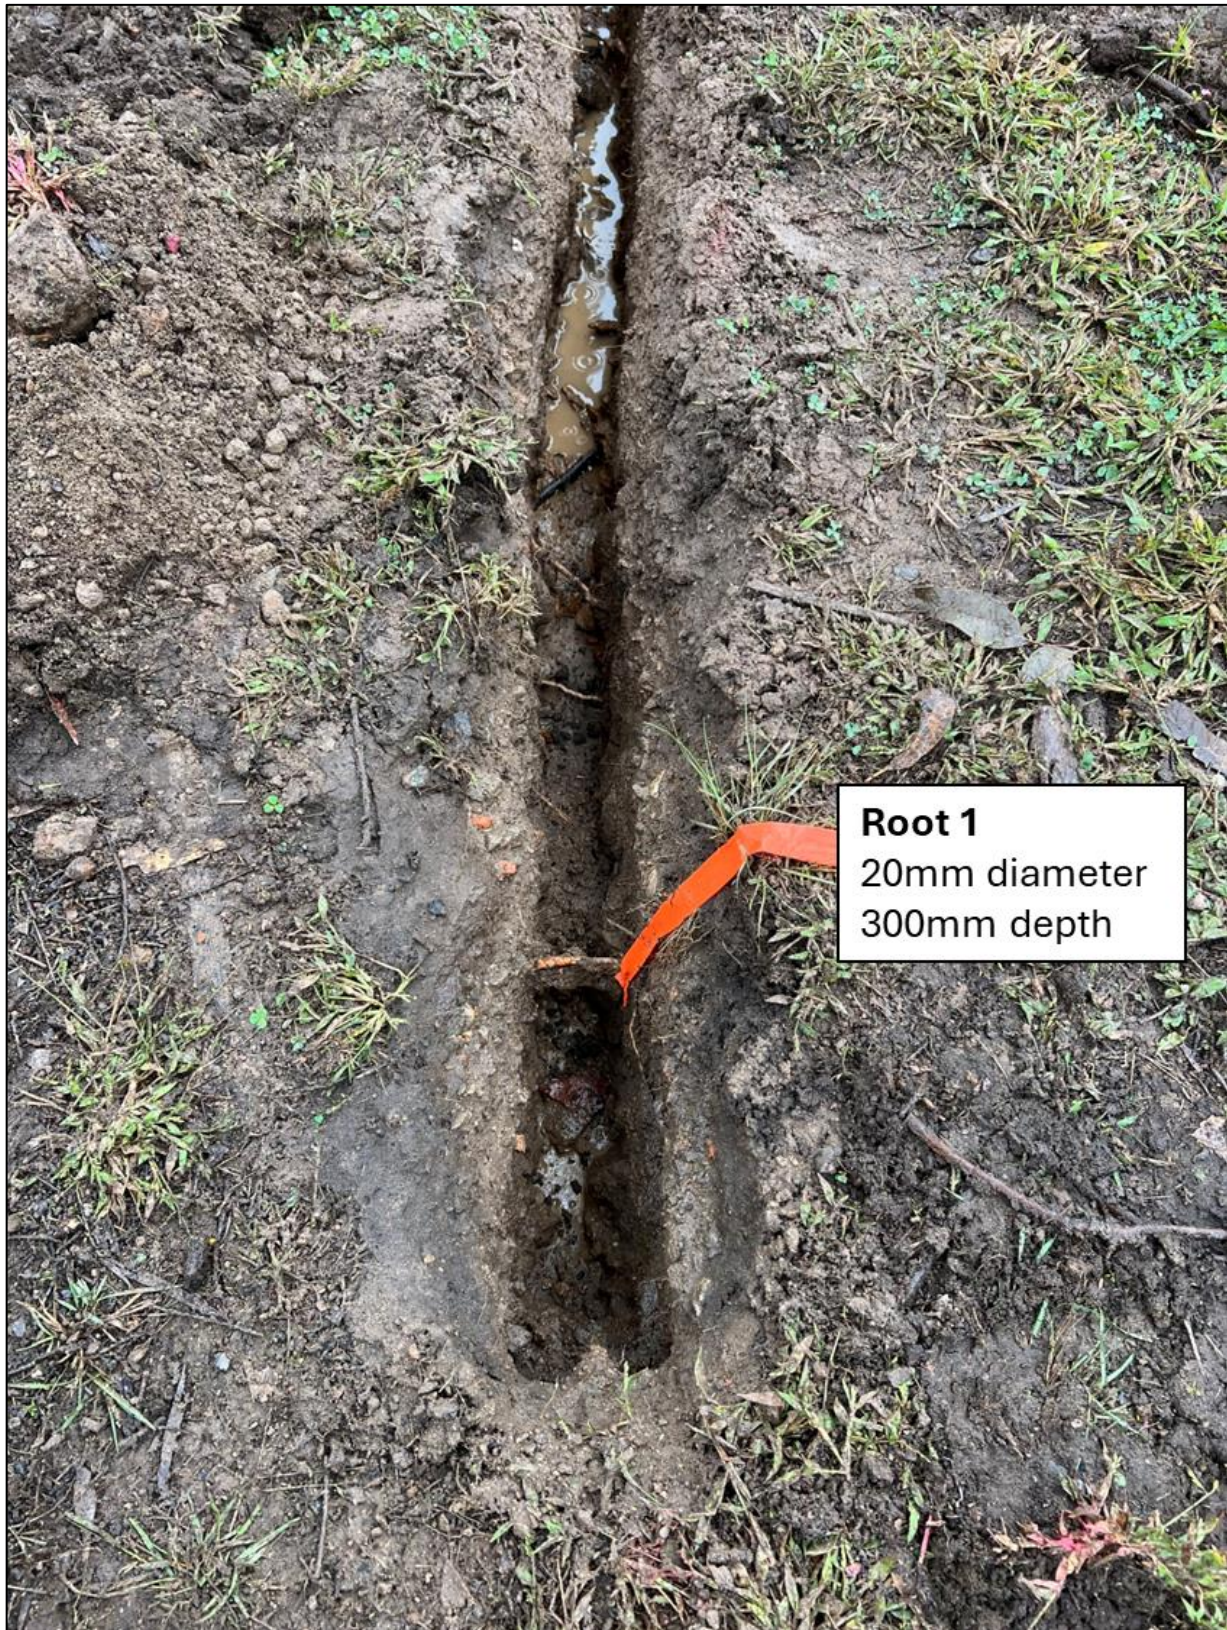
Figure 11. Position of Root 1 within the northern portion of Survey Trench 1.

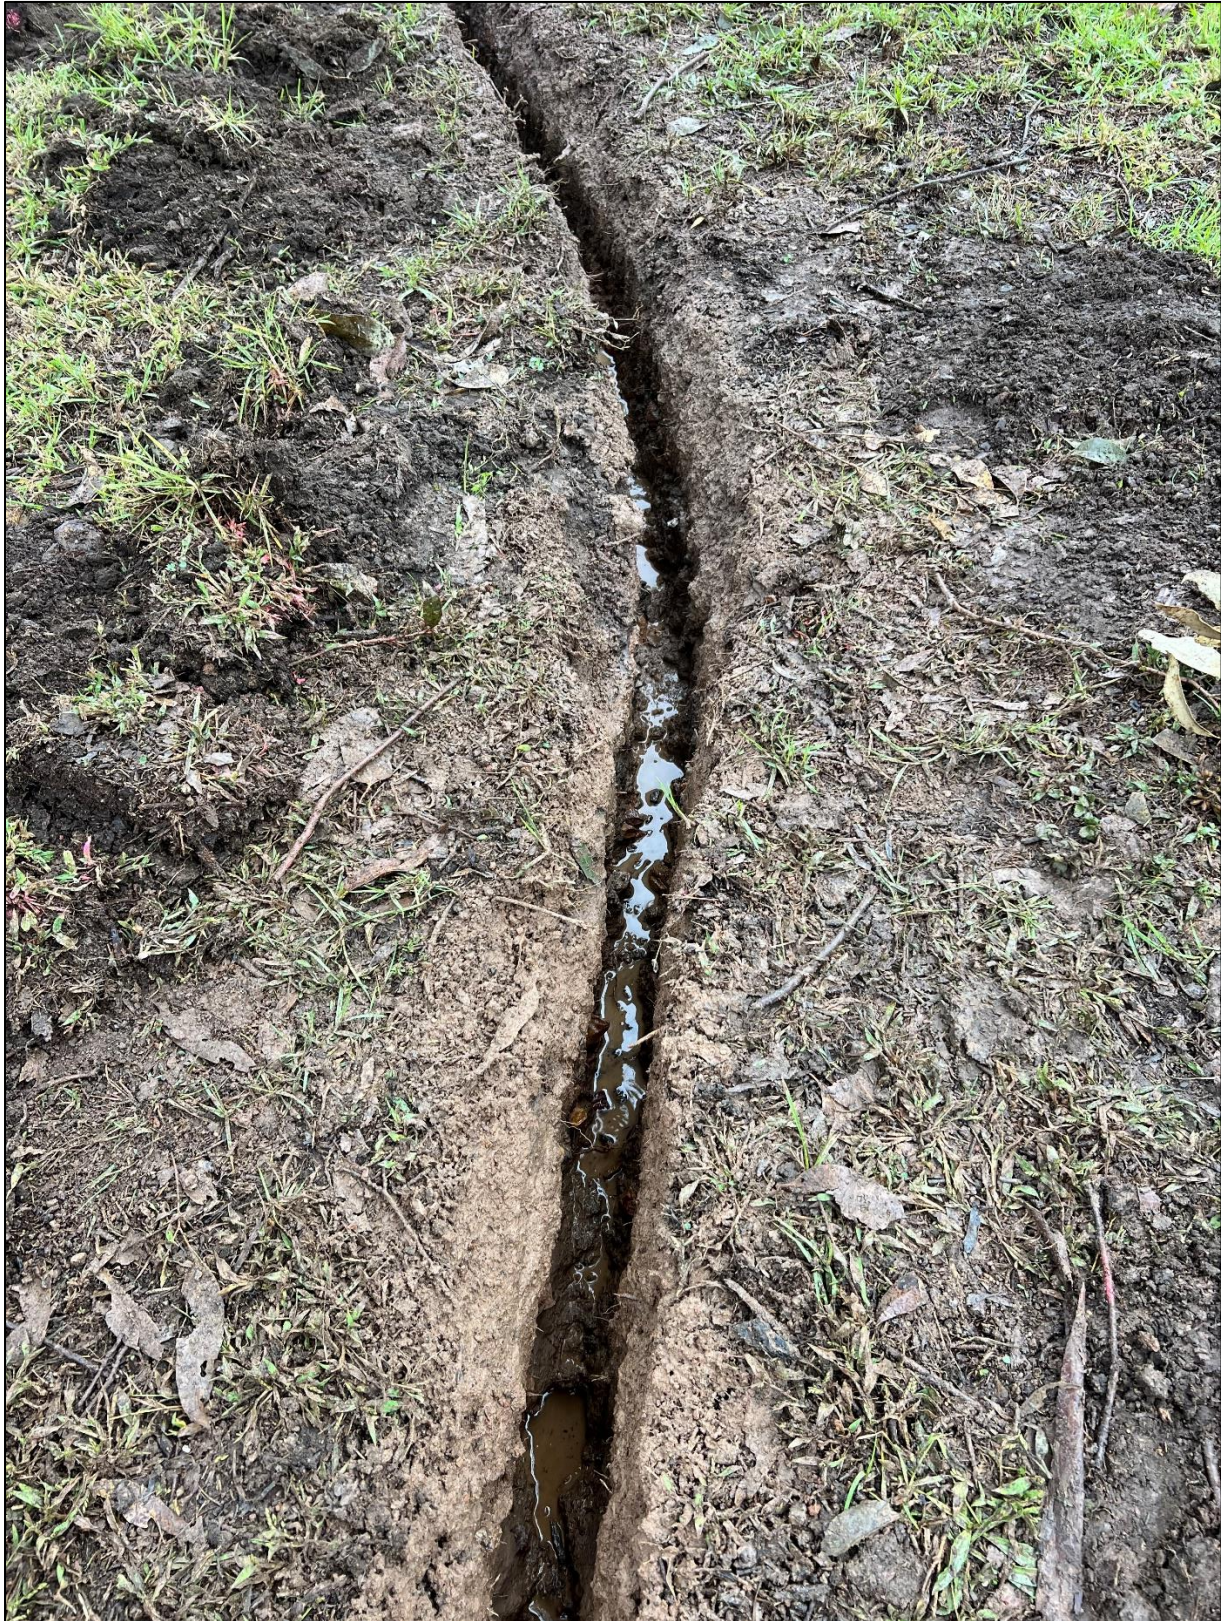
Figure 12. No tree roots observed within the central portion of Survey Trench 1.

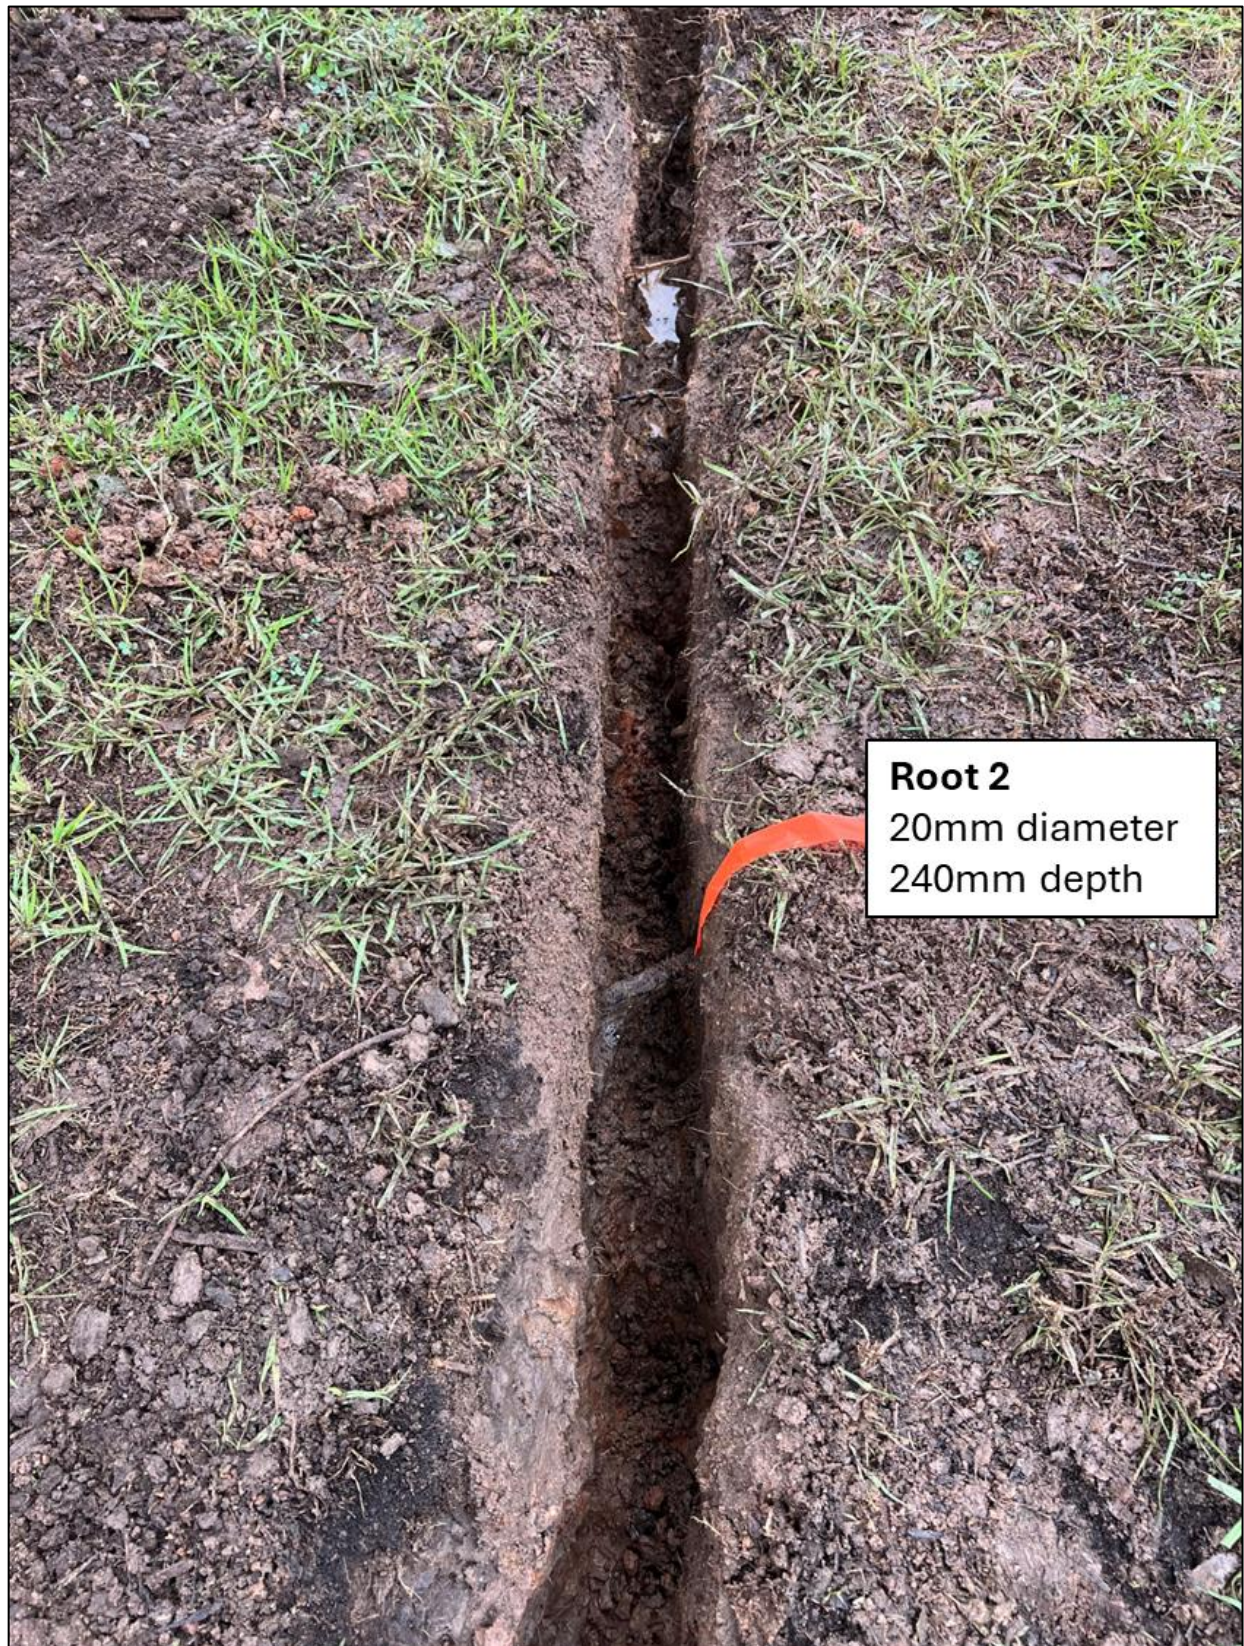
Figure 13. Position of Roots 9-15 within the northern portion and northern edge of Survey Trench 1.

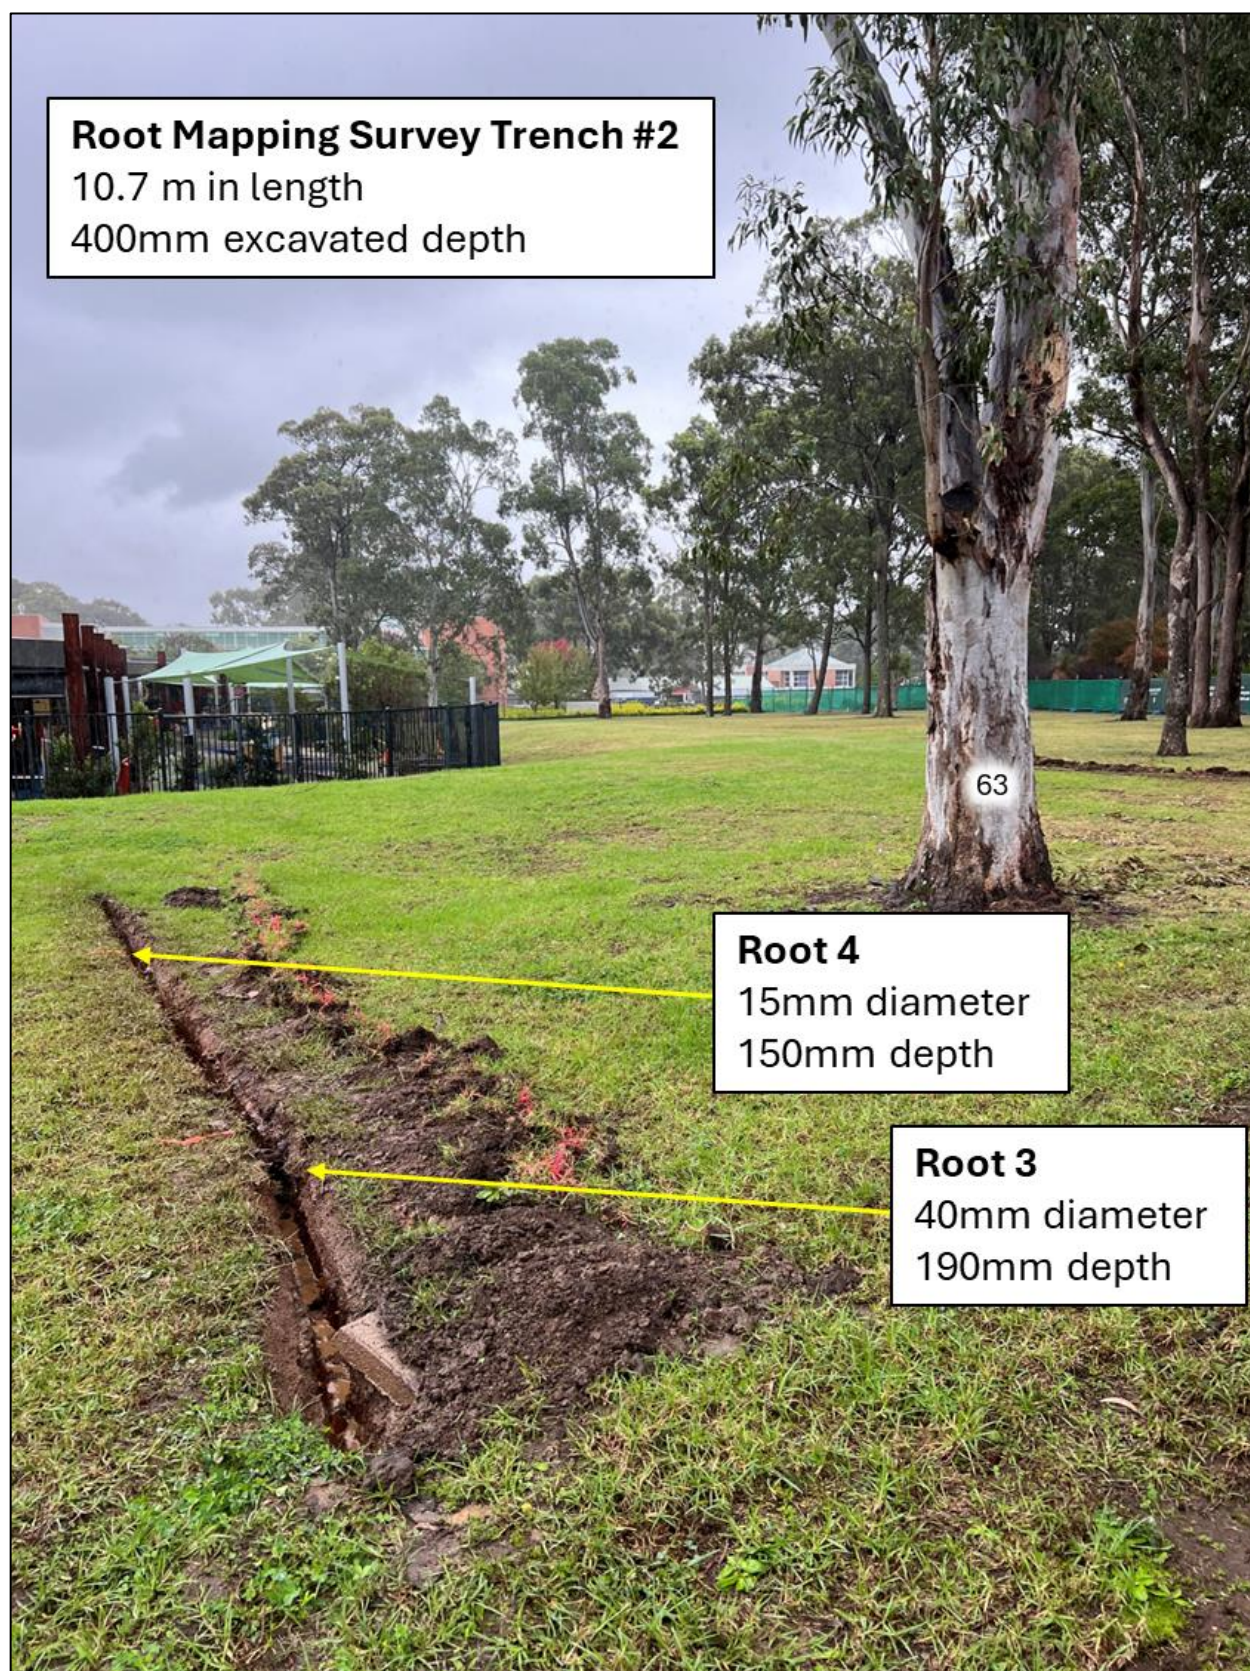
Root	Distance from Eastern edge of trench (m)	Diameter of root (mm)	Depth of root [mm]	Comments
3	3.1	40	190	Major root crossing trench diagonally. Orientation and position suggests root is from Tree 63. Tree with extensive tissue necrosis and signs of decay, suggesting root has died.
4	6.8	15	150	Minor root crossing trench laterally. Orientation and root bark suggest root is from Tree 63.

Figure 14 Position of Roots 3 and 4 within Survey Trench 2.

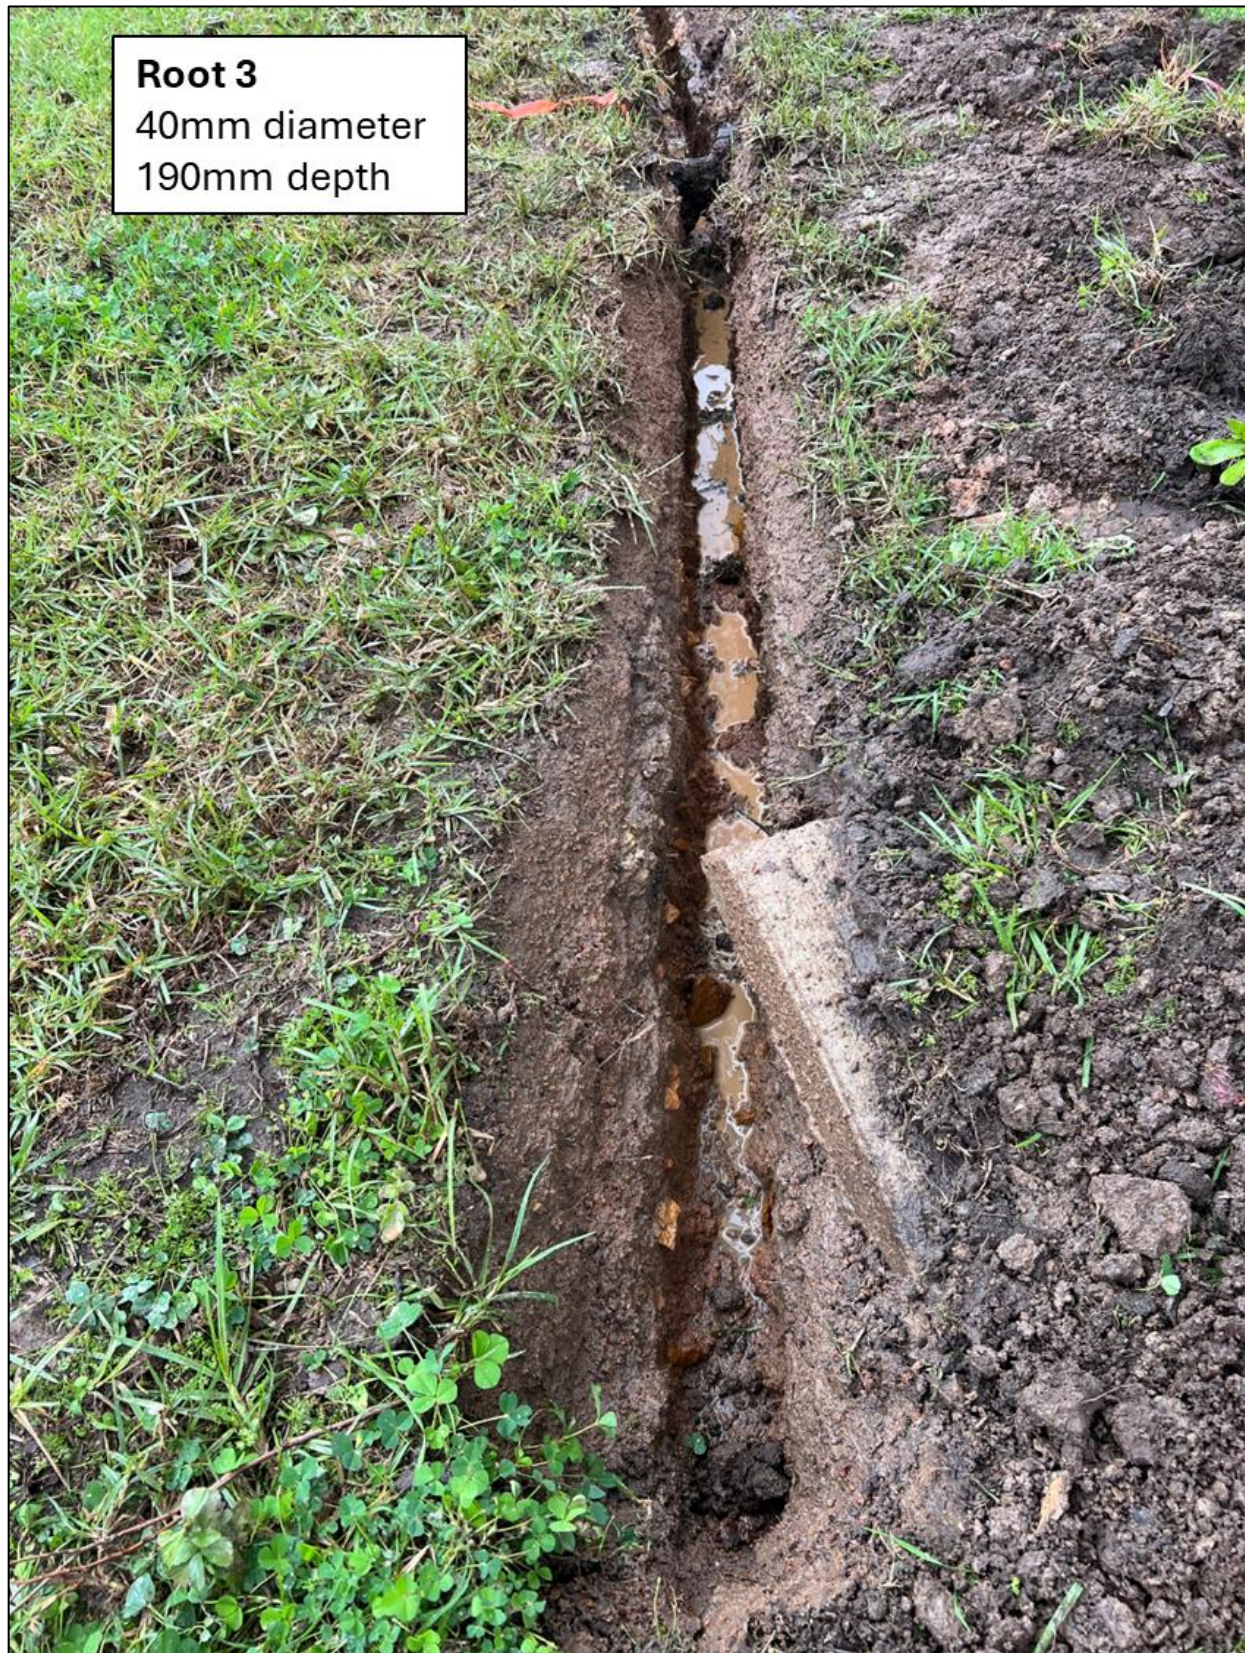
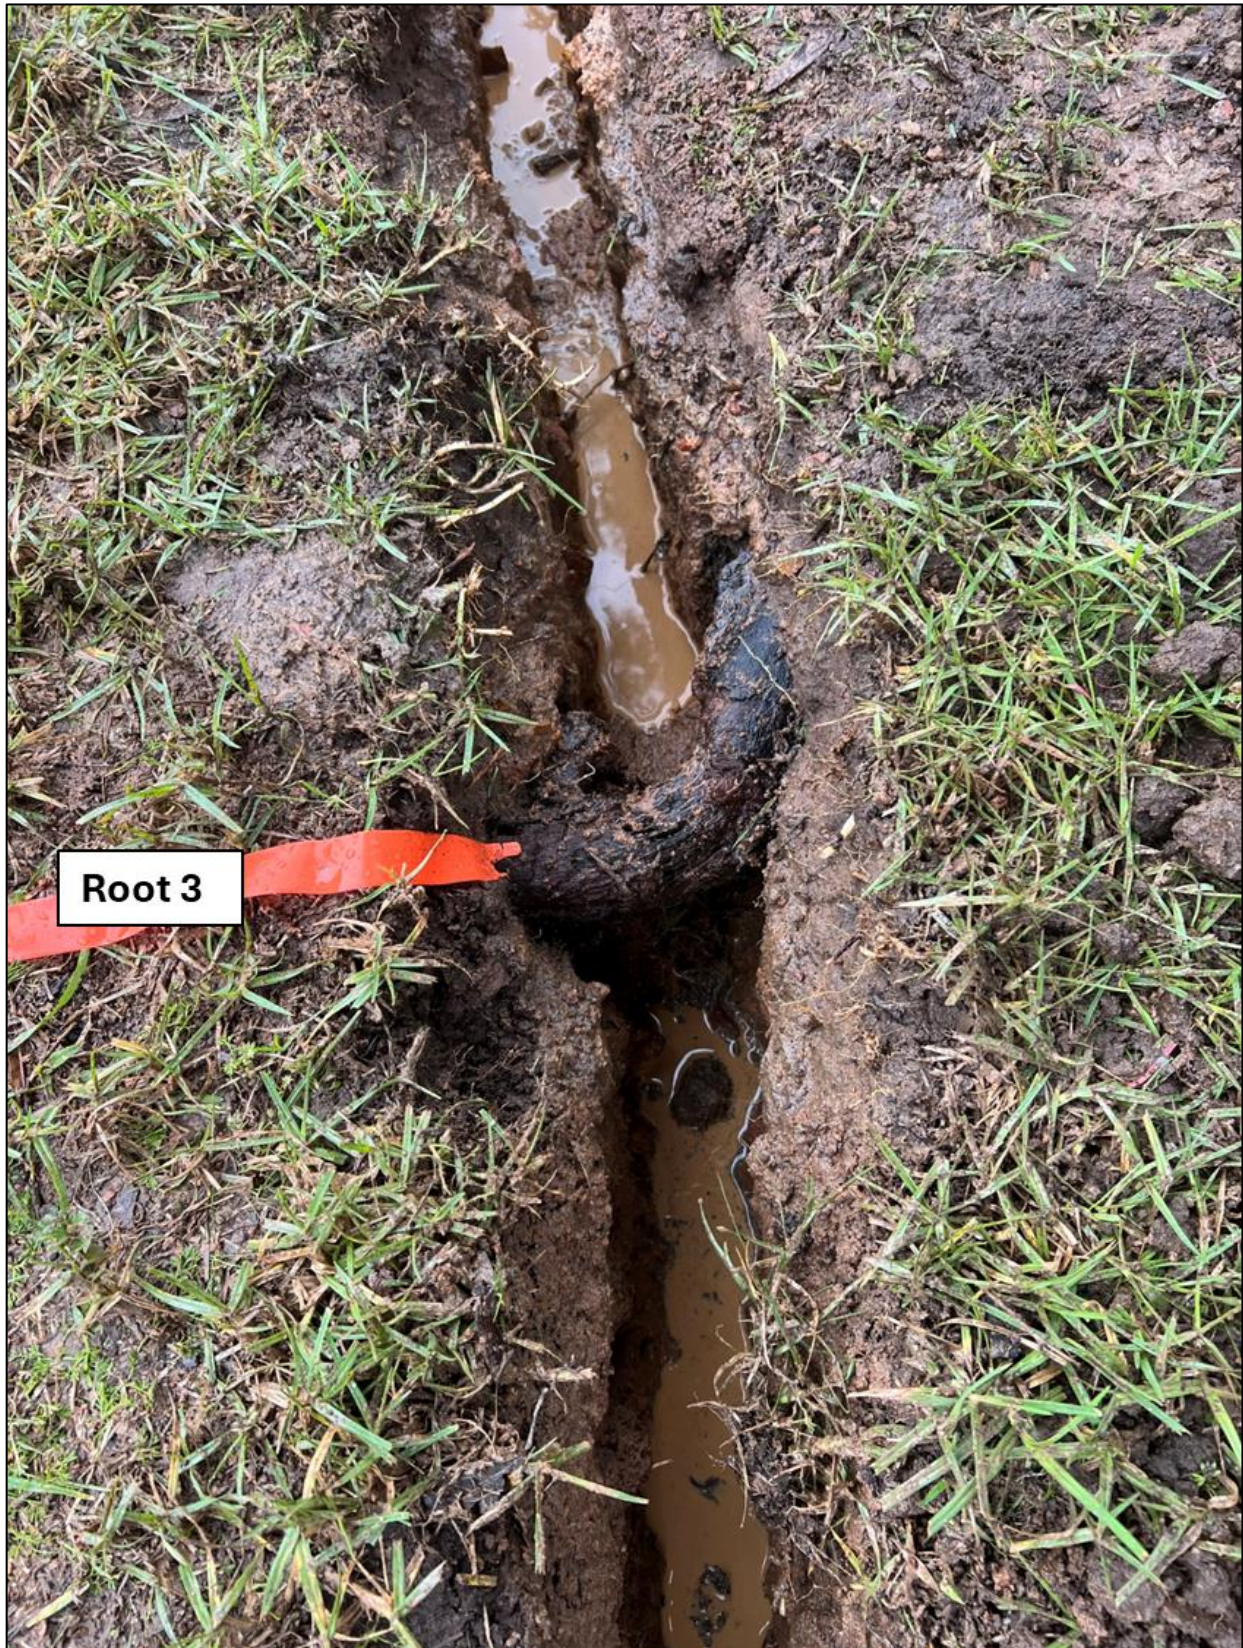
Root 3 is a small major root with a measured diameter of 40mm. This major root has extensive tissue necrosis and decay. Close observation of this root suggests that it has died / ceased to function (Figure 17). This major root is unlikely to be contributing to the health or structural integrity of Tree 63. Root 4 is a small minor root.

Figure 15. Position of Root 3 within Survey Trench 2.

Figure 16. Root 3 within Survey Trench 2.
