Arboricultural Impact Assessment

Western Sydney University, Milperra Campus
Childcare Centre Alterations and Additions
NSW, 2214
2/-/DP1291984
Job No: 240166
17/12/2024

Temporal Tree Management Pty Ltd.

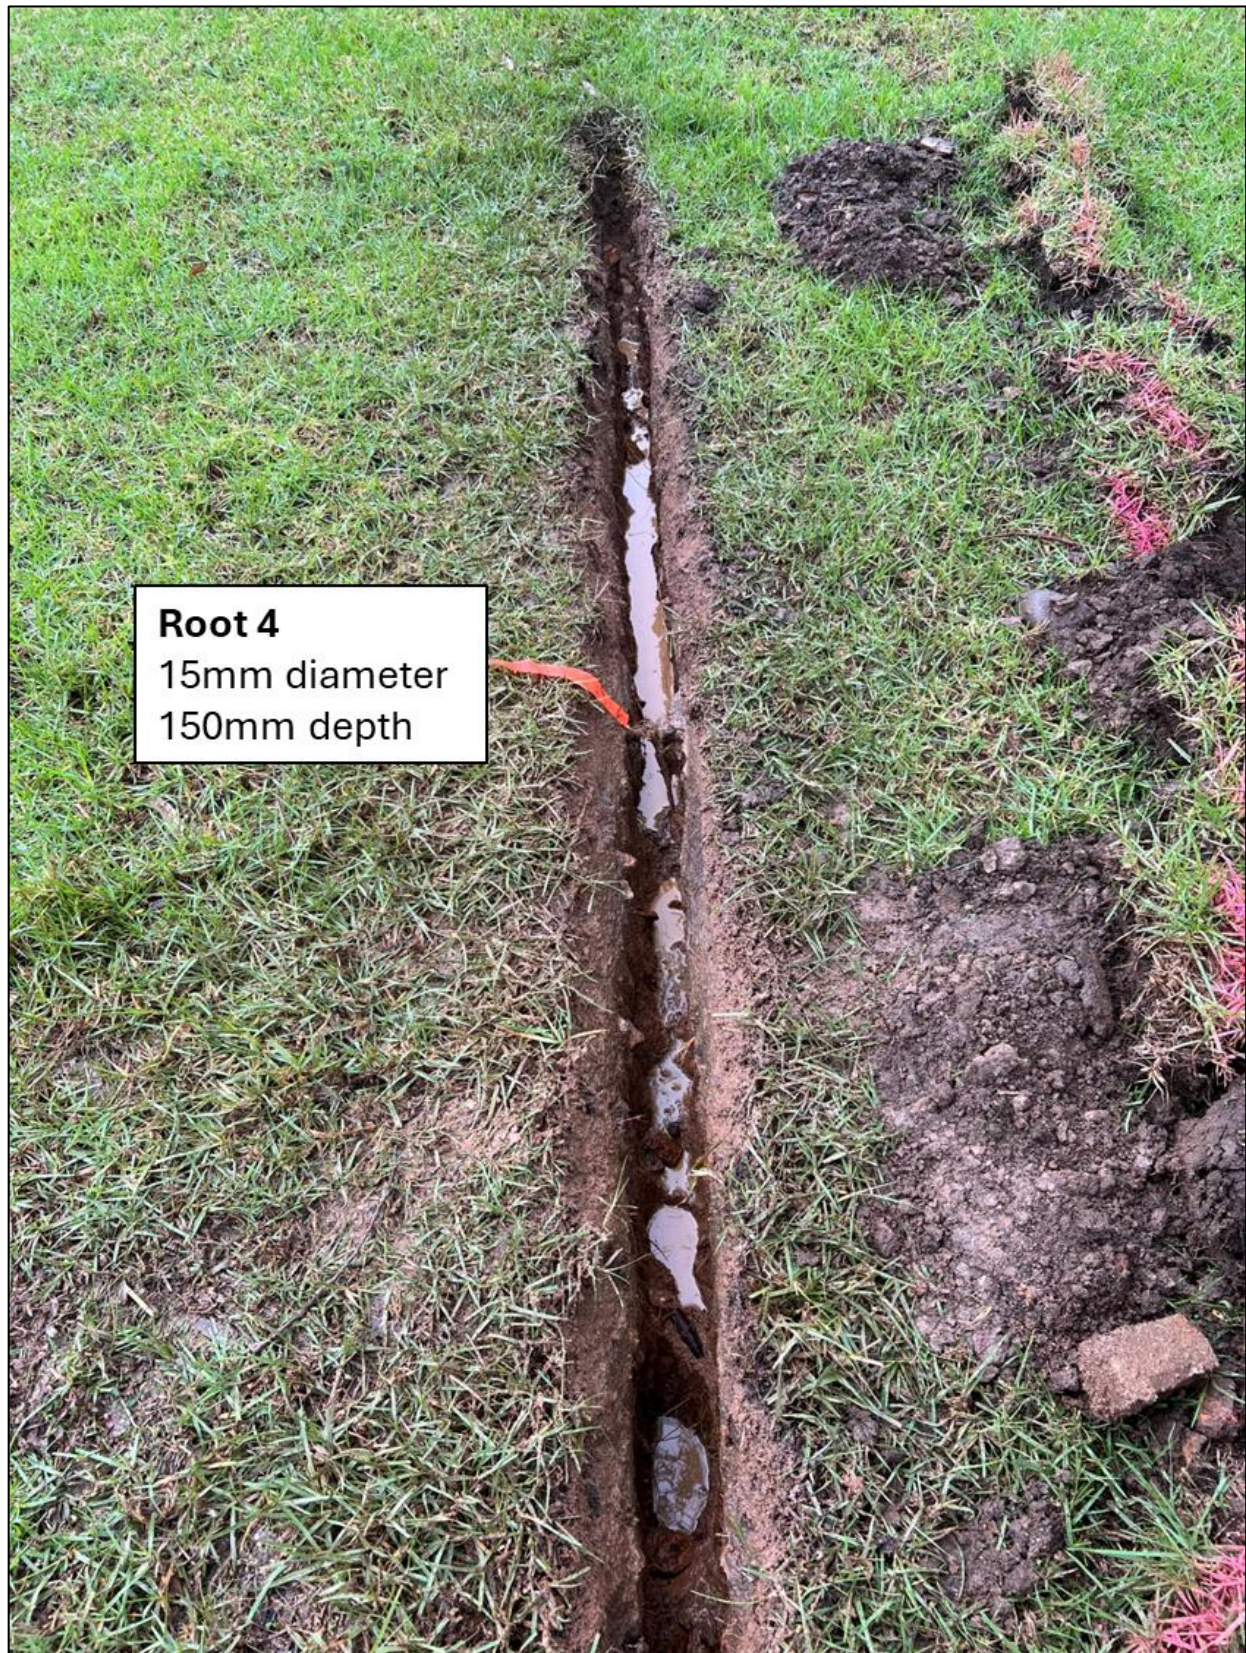
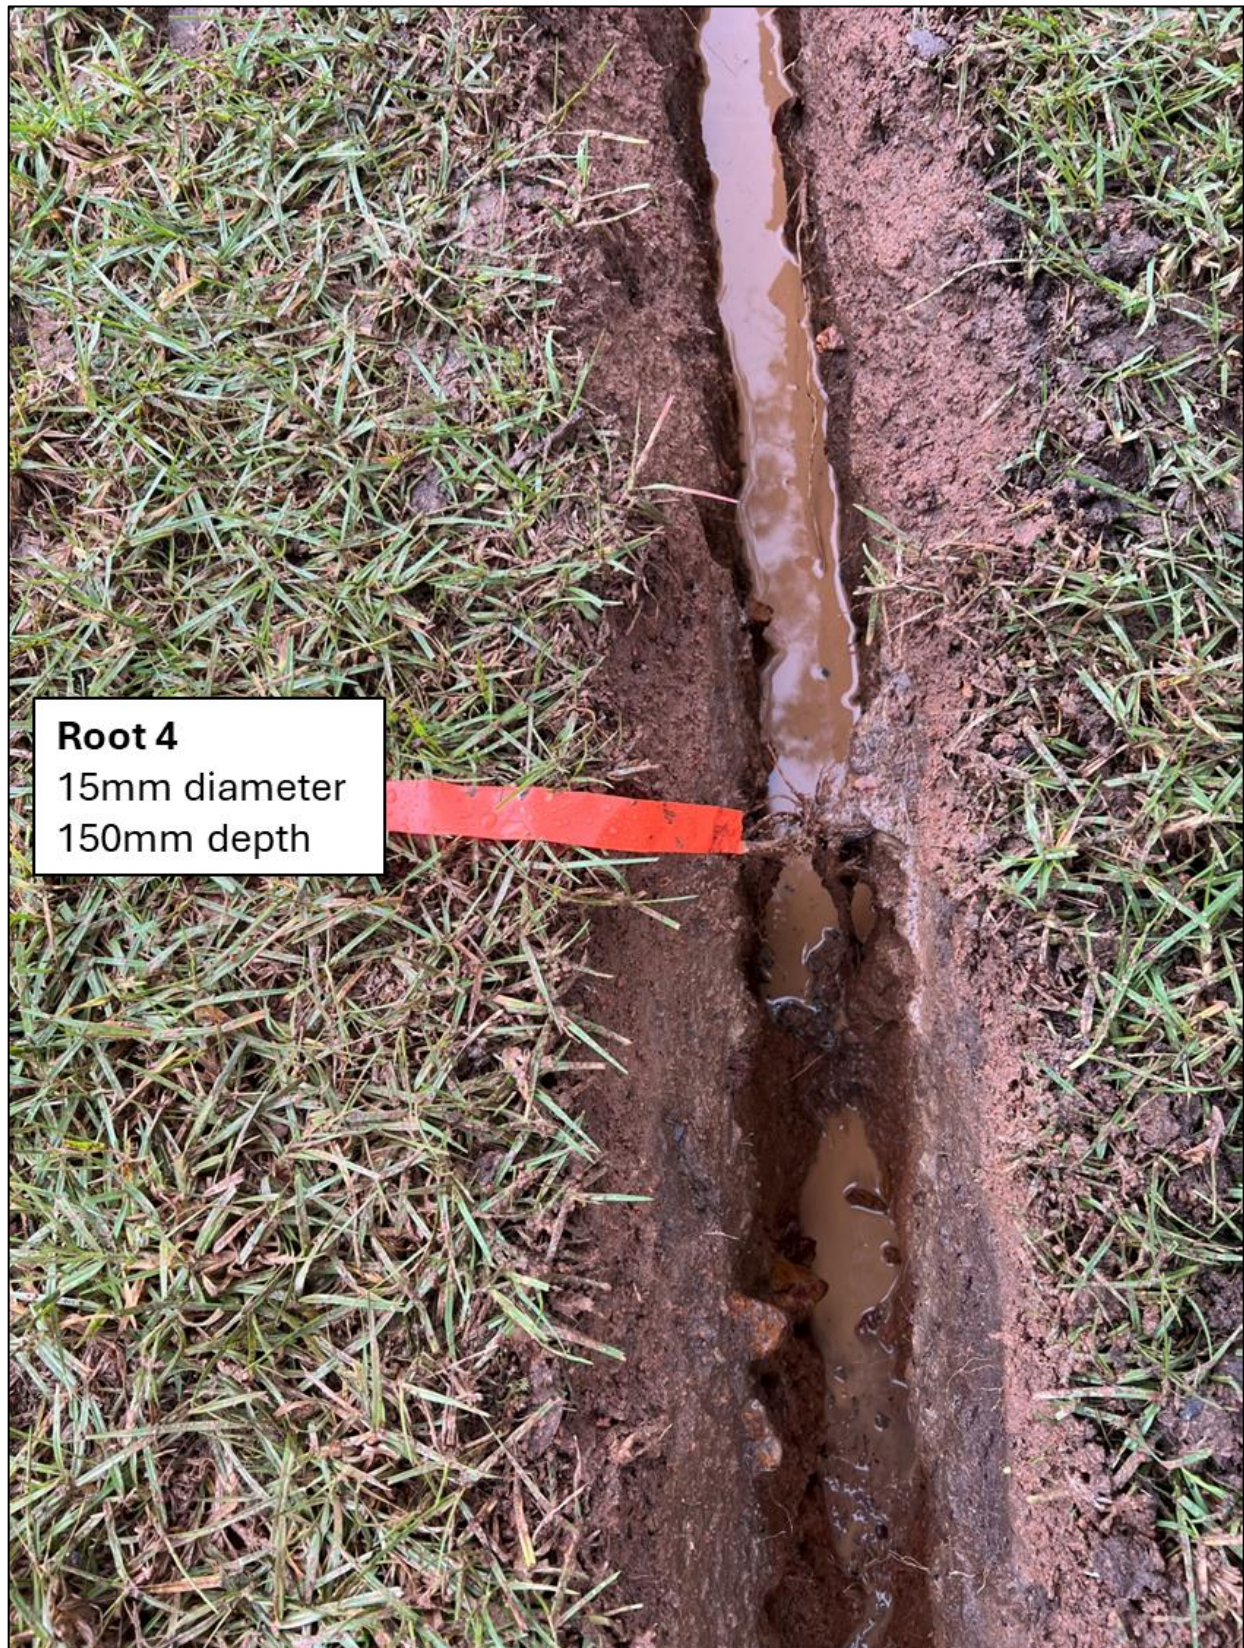
Figure 17. Position of Root 4 within Survey Trench 2.

Figure 18. Root 4 within Survey Trench 2.

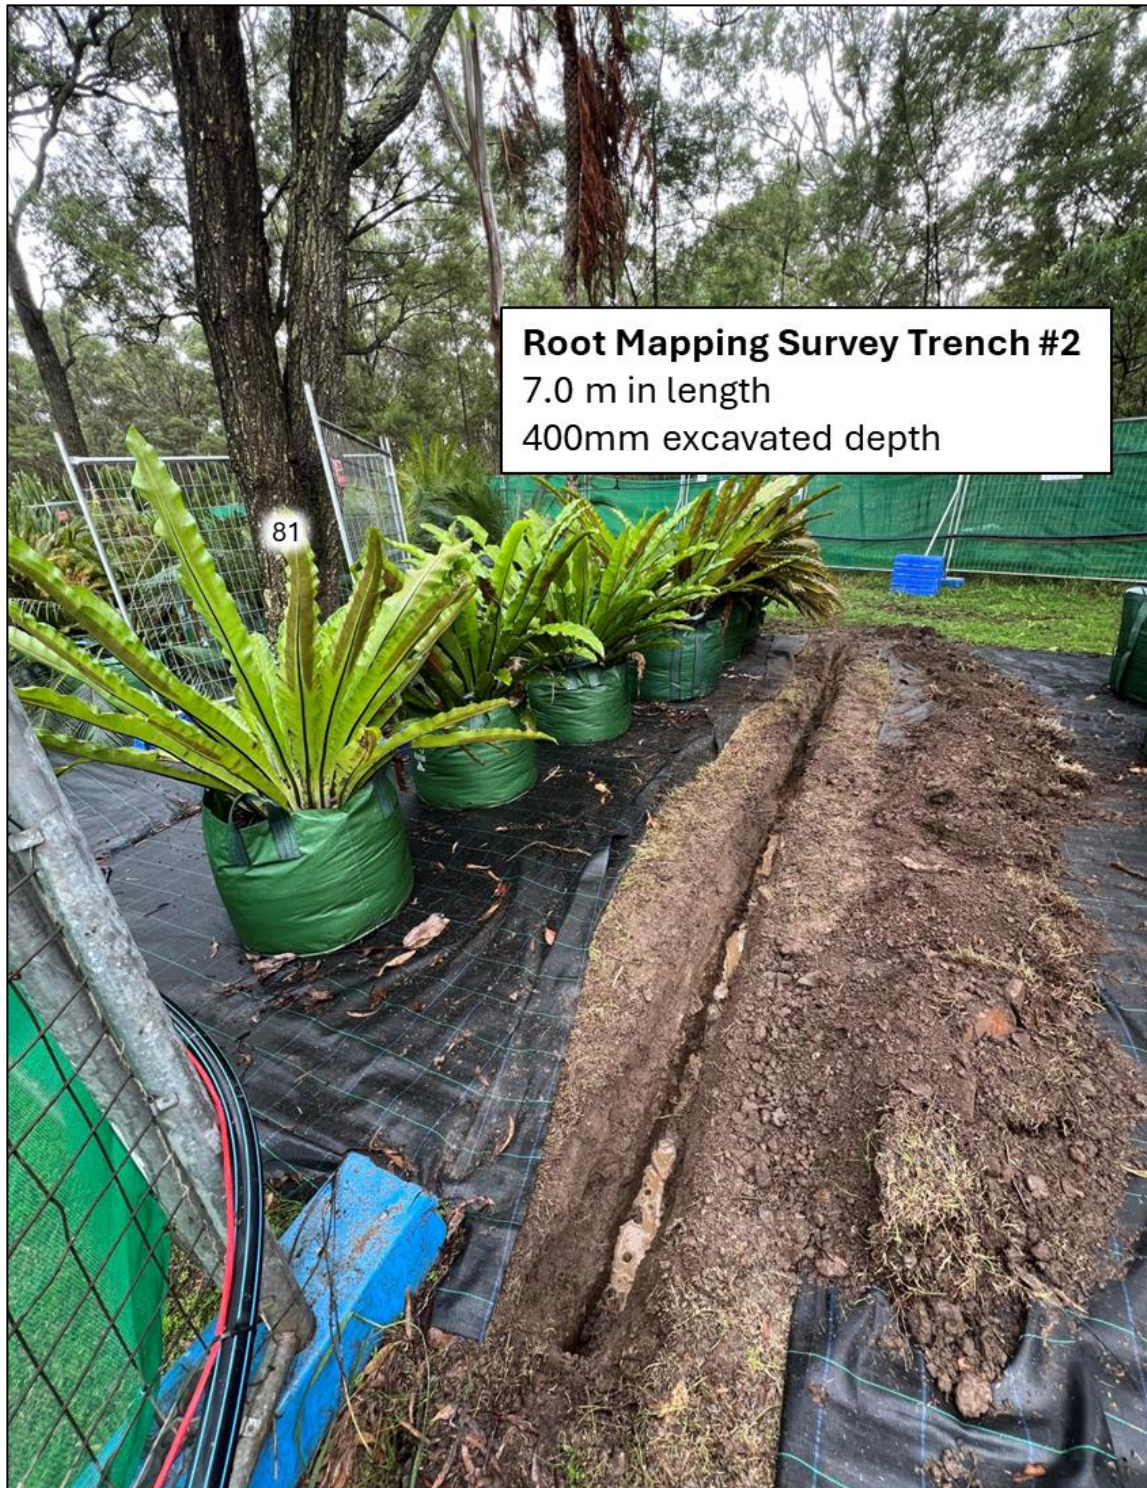
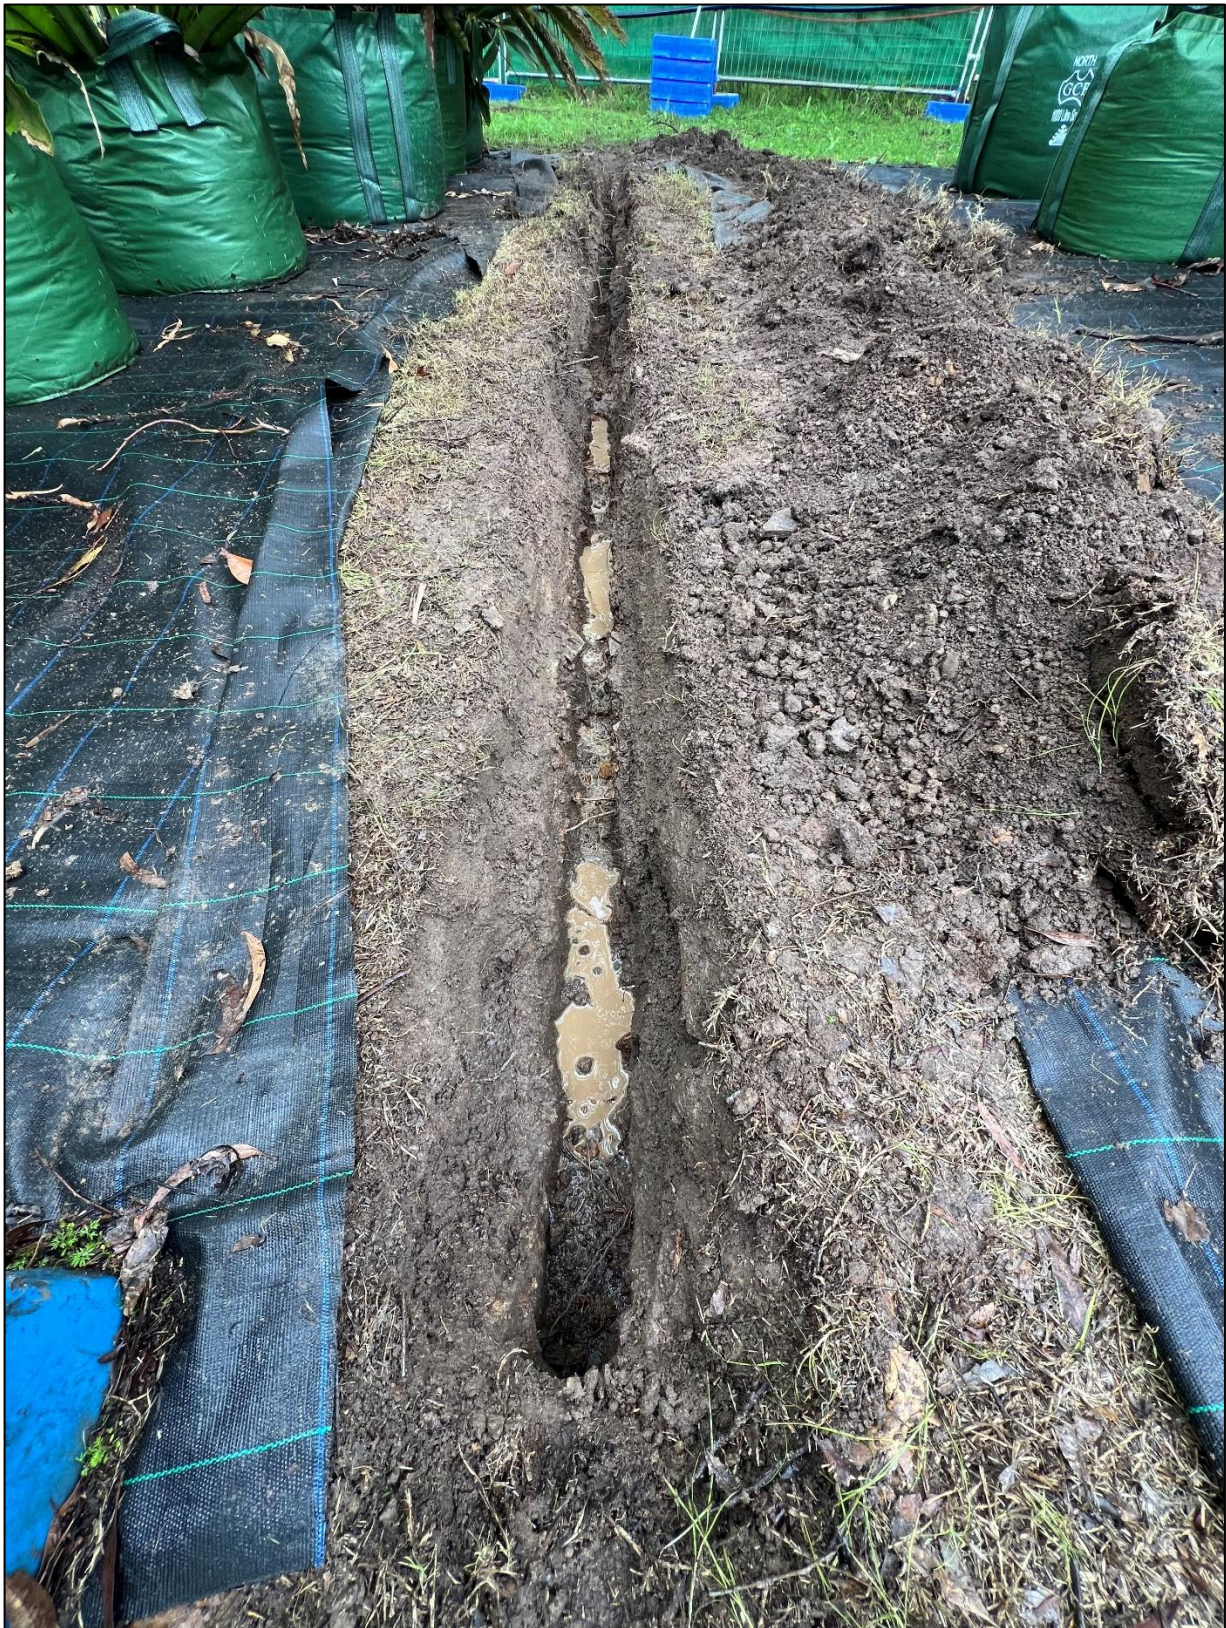
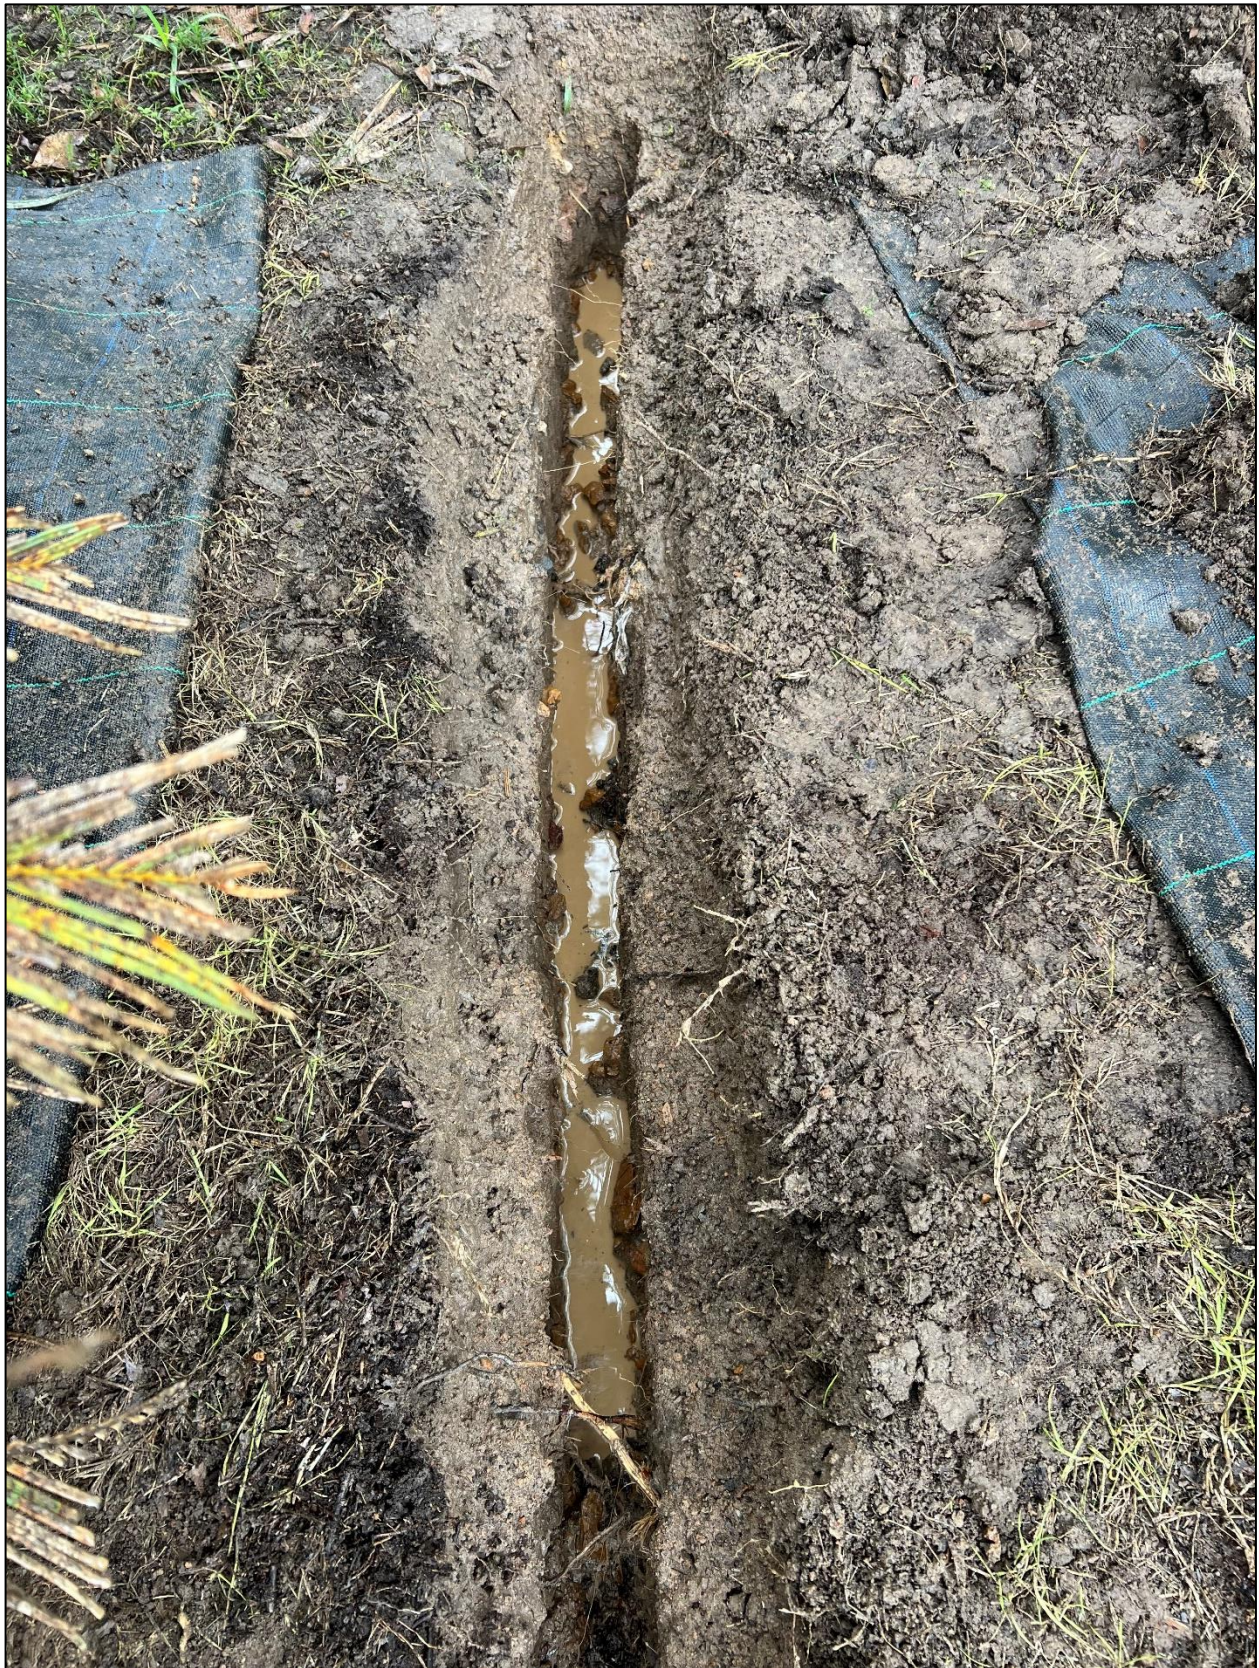
No tree roots were encountered in Survey Trench 3 (Figure 19 - Figure 21). The heavy clay soil encountered within Survey Trench 3 is also likely to have encouraged deep root growth from Tree 81, which may explain the absence of encountered roots (Gilman 1990, Day et al. 2010). The findings from Survey Trench 3 demonstrate that the construction of the new carpark will not impact Tree 81.

Figure 19. No tree roots with a diameter of greater than 15mm were encountered within Survey Trench 3.

Figure 20. No tree roots with a diameter of greater than 15mm were encountered within the southern and central portion of Survey Trench 3.

Figure 21. No tree roots with a diameter of greater than 15mm were encountered within the northern portion of Survey Trench 3.

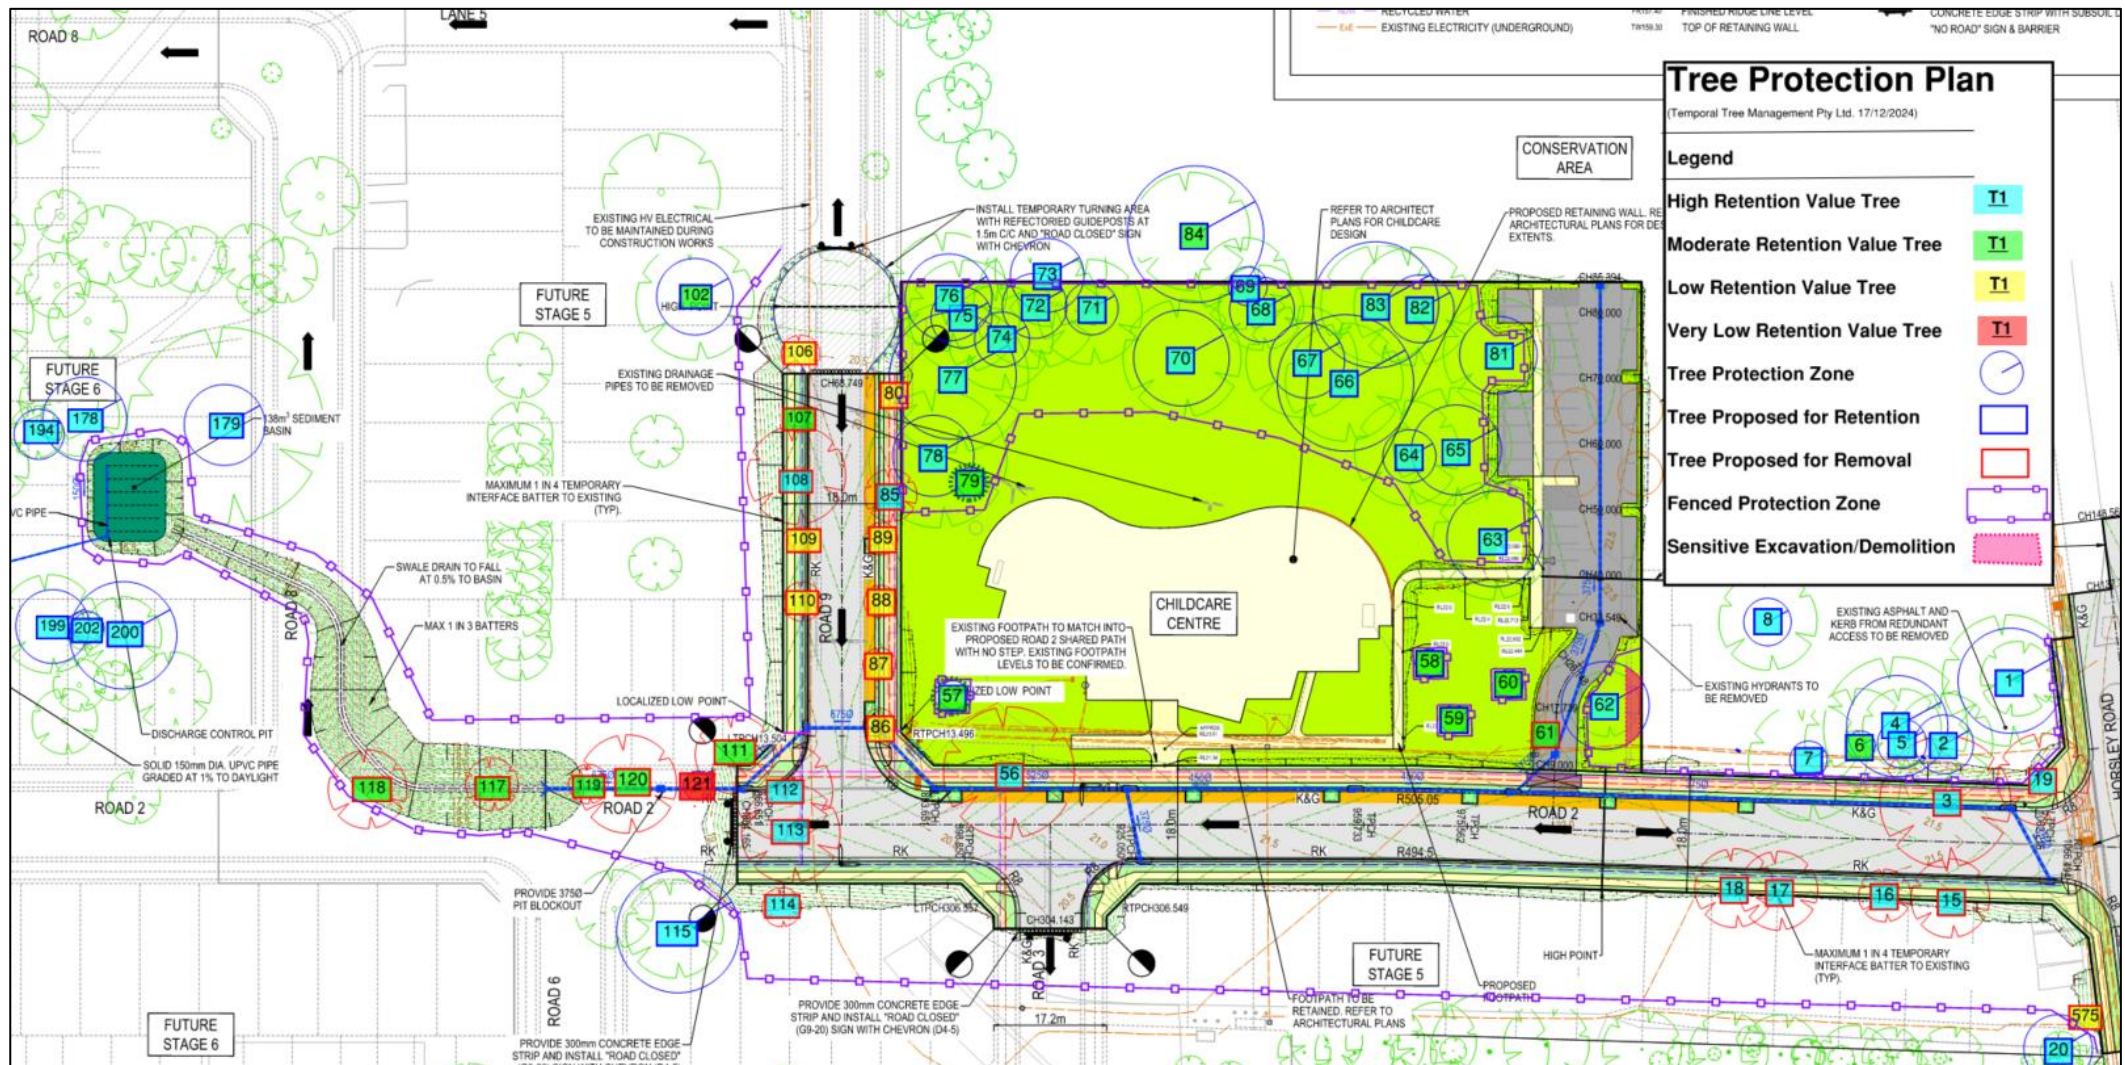
Figure 23. Tree Protection / Removal Plan for the proposed development. *Functional Layout Plan*, prepared by Beveridge and Williams, Project No: 2301879, Drawing No: 910, Rev: P4, drawn: 23/09/24. Annotated by Temporal Tree Management Pty Ltd. (17/12/2024).
