STRUCTURAL

Engineering Report

34 Lostock School Road, Lostock

25 October 2024

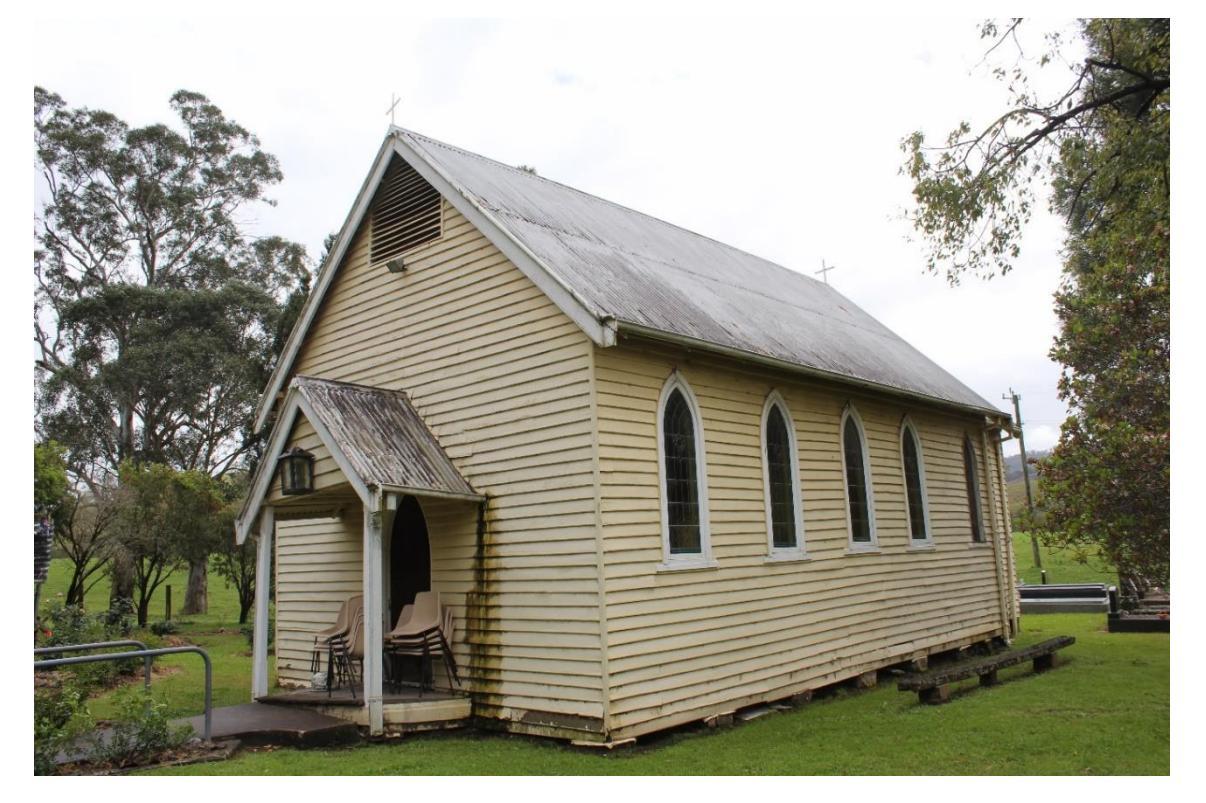
Figure 3

Many of the piers were unable to be inspected due to limited subfloor space, however the condition of those able to be viewed appeared poor with cracking to the timber and general degradation. The piers appear to have sunk up to 300mm in varying locations across the site (refer Figures 10 and 36).

- Settlement Issues: Limited survey data was available indoors, but external observations indicated uneven settlement of the piers, and deterioration of the timber piers. It is likely they have degraded significantly causing the differential floor subsidence internally. The ground externally was notably soddened underfoot.

Foundations/piers would need to be replaced, which would require lifting of the structure and installation of a new termite management system and tie-down. It is likely the floor system and bracing system would require upgrading to resist current design loads for the new building occupancy.

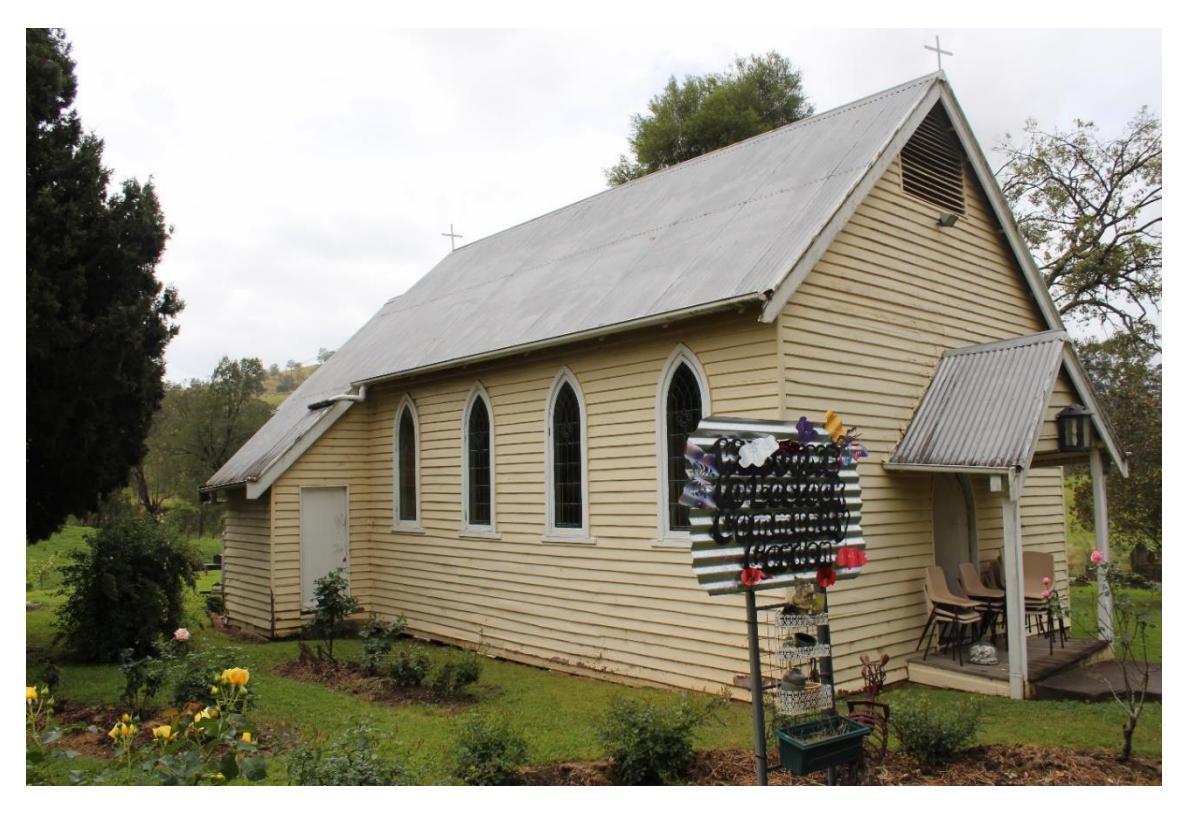
Figure 4

- **Subfloor ventilation:** The settlement of the piers has resulted in the weather boards being in contact with the ground (see photos 4 and 36). This has reduced any subfloor ventilation, evidenced by the damp noted. Damp subfloor we know is likely to result in mould and mildew growth, pest infestation and wood rot to the structure. See photos (14, 15, 16, 26 and 29) for evidence of water ingress.
