Geotechnical Investigation Report

Site Address: "Olympic Park Grandstand" 3 Wilkinson Avenue,
Muswellbrook NSW

25 March 2025

Our Reference: 44840-GR01_A

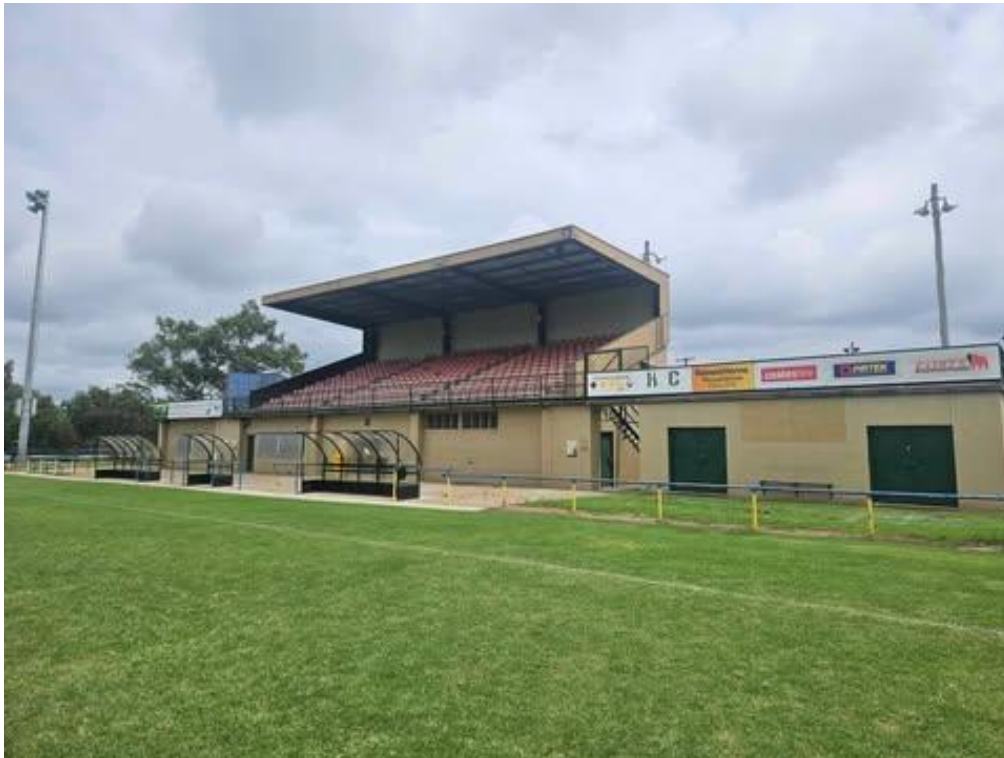
Plate 2 – General view of site facing west.

The site is relatively flat. There are existing sheds, building and grandstands in the immediate vicinity.
