Report: SC2144
D & M Calgaro Pty Ltd
327 Burraneer Road
Coomba Park NSW 2428

RE: GEOTECHNICAL ASSESSMENT RESULTS FOR SITE CLASSIFICATION.

APPENDIX A Site Plan

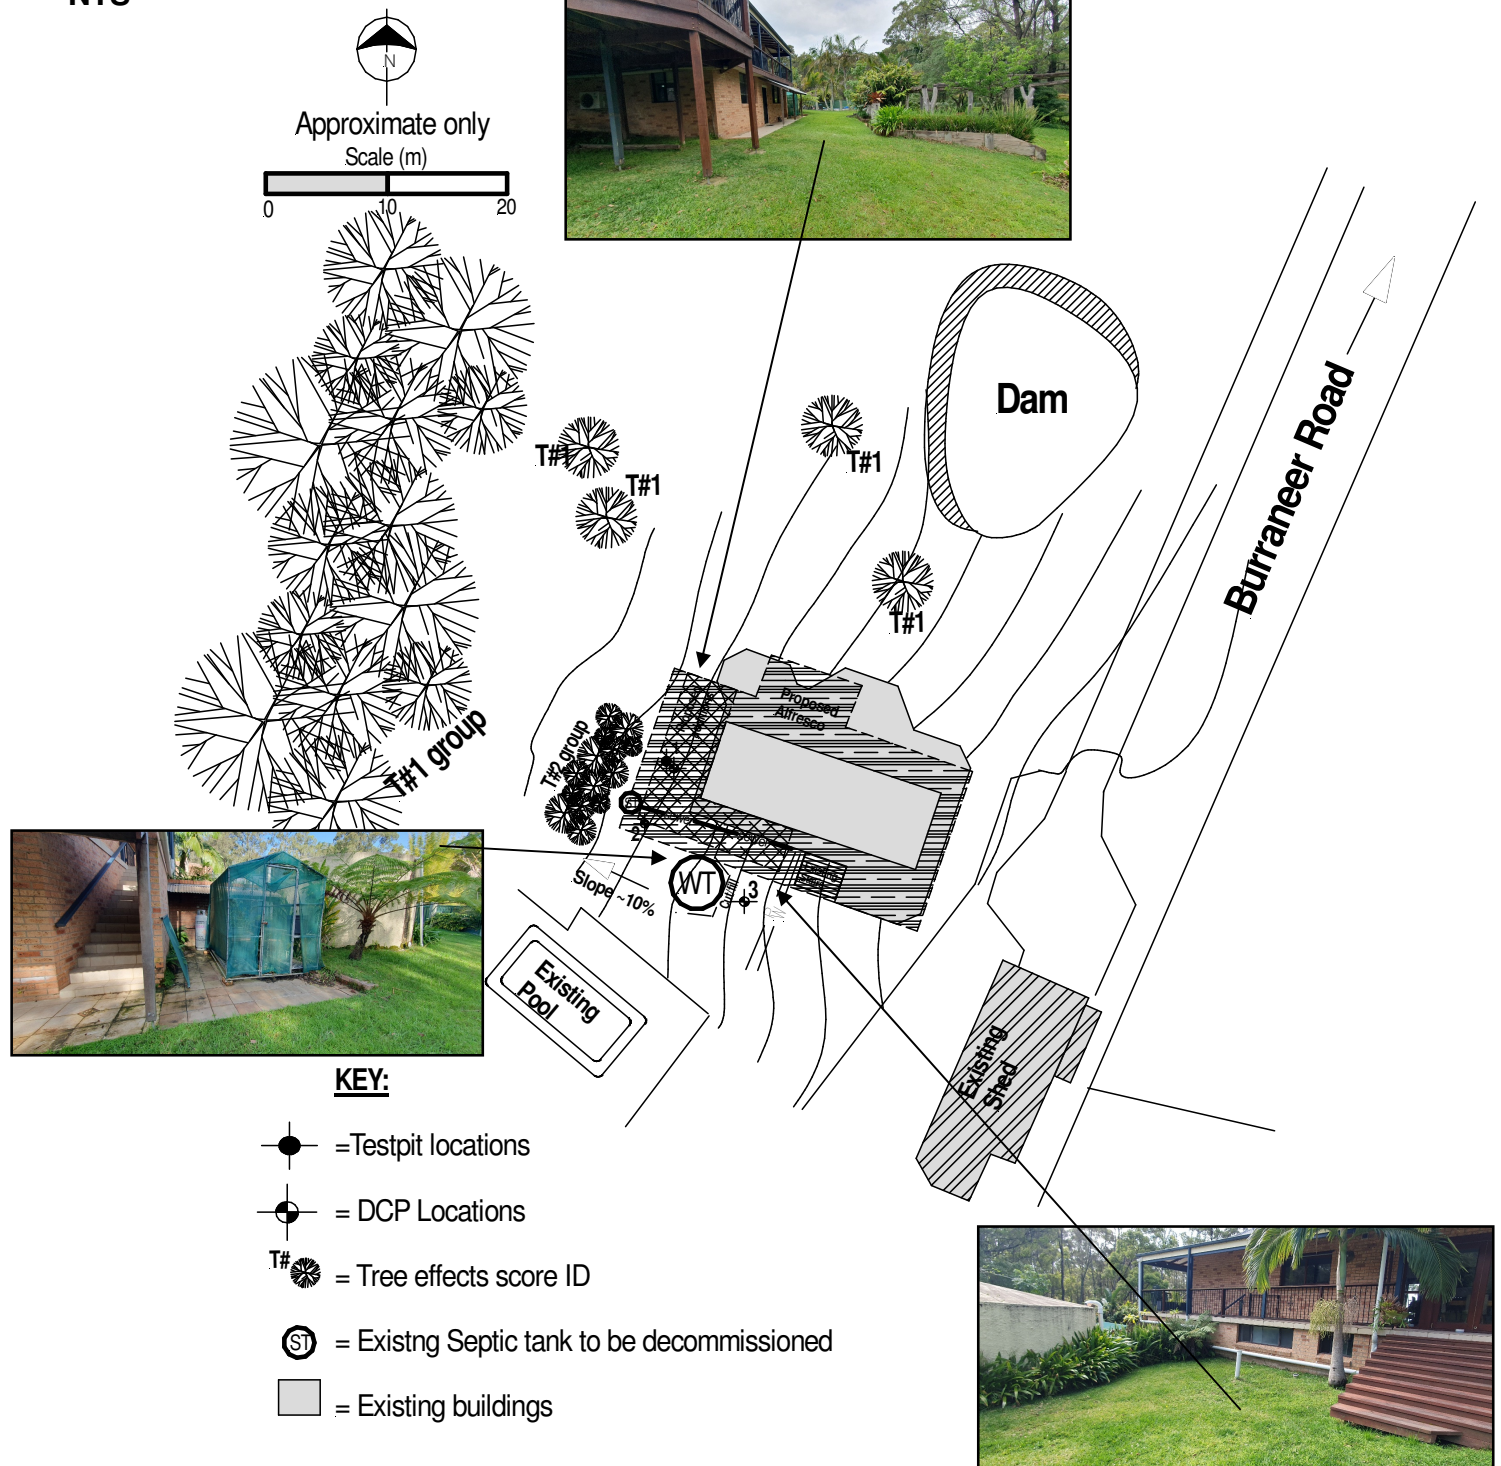
- **Equipment refusal:** Tungsten Carbide V-bit auger refusal from a trailer-mounted Drill rig was encountered at 1000mm (BH1) due to rock. DCP refusal was recorded at 950mm (DCP1), 300mm (DCP2) and 1400mm (DCP3) due to rock. Rock bed not determined.

- **Bearing Capacities:** The site displayed low bearing capacities (ie <100kPa) in DCP1 (300-600mm), DCP2 (0-800mm) potentially due to water tank overflow and upslope seepage above test site and DCP3 (0-300mm) due to fill and plumbing pipes present.
