Services completed for this site☒ Lot Classifications☐ Contamination Report☐ Wastewater Management Report**LOT CLASSIFICATION REPORT**

Prepared for: MELLROSS HOMES
LOT 24 DP 1066526 26 STEPHENS STREET
Site Address: BINALONG NSW 2584

Revision: 01/07/2021
Site Test: 22/08/2024
Lab Test: 03/09/2024
Customer Job: 4575
Job Number: 24113
Technician: JM

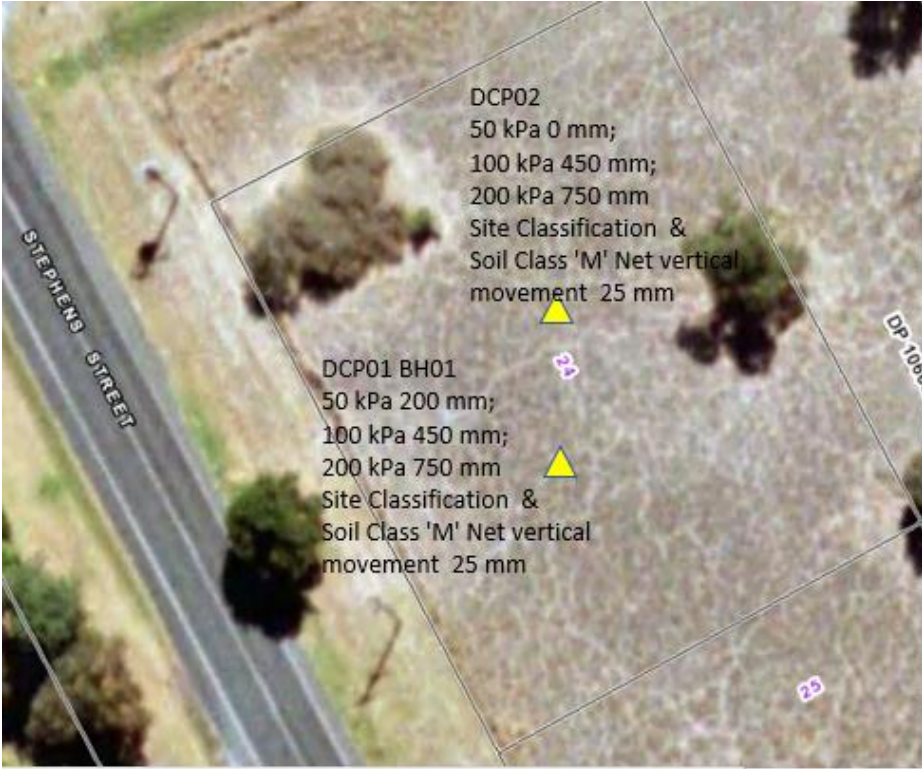
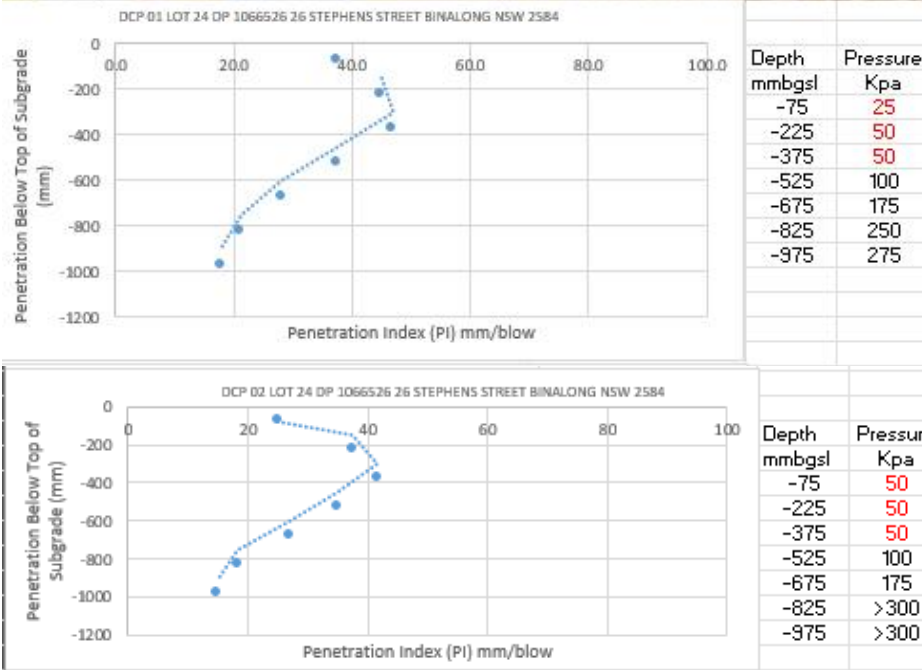
6.0 LOCATION SKETCH

3.1	Site status - platform slope is: Slope: 6% Fall direction: NE	
3.2	Slope stability assessment recommended (> 11 Degrees)	No
3.3	Are there any Retaining Walls supporting this site? (if yes, see attached plan drawing 6.0)	No

Site classification is 'M' with a net vertical movement of 25 mm. Topsoil can be cut and or plate compacted with or without gypsum amendment.
