Site Classification Report 7 Harry Sullivan Avenue Moree NSW 2400

Site Classification Report

7 Harry Sullivan Avenue, Moree 2400

Project Number: 24-80

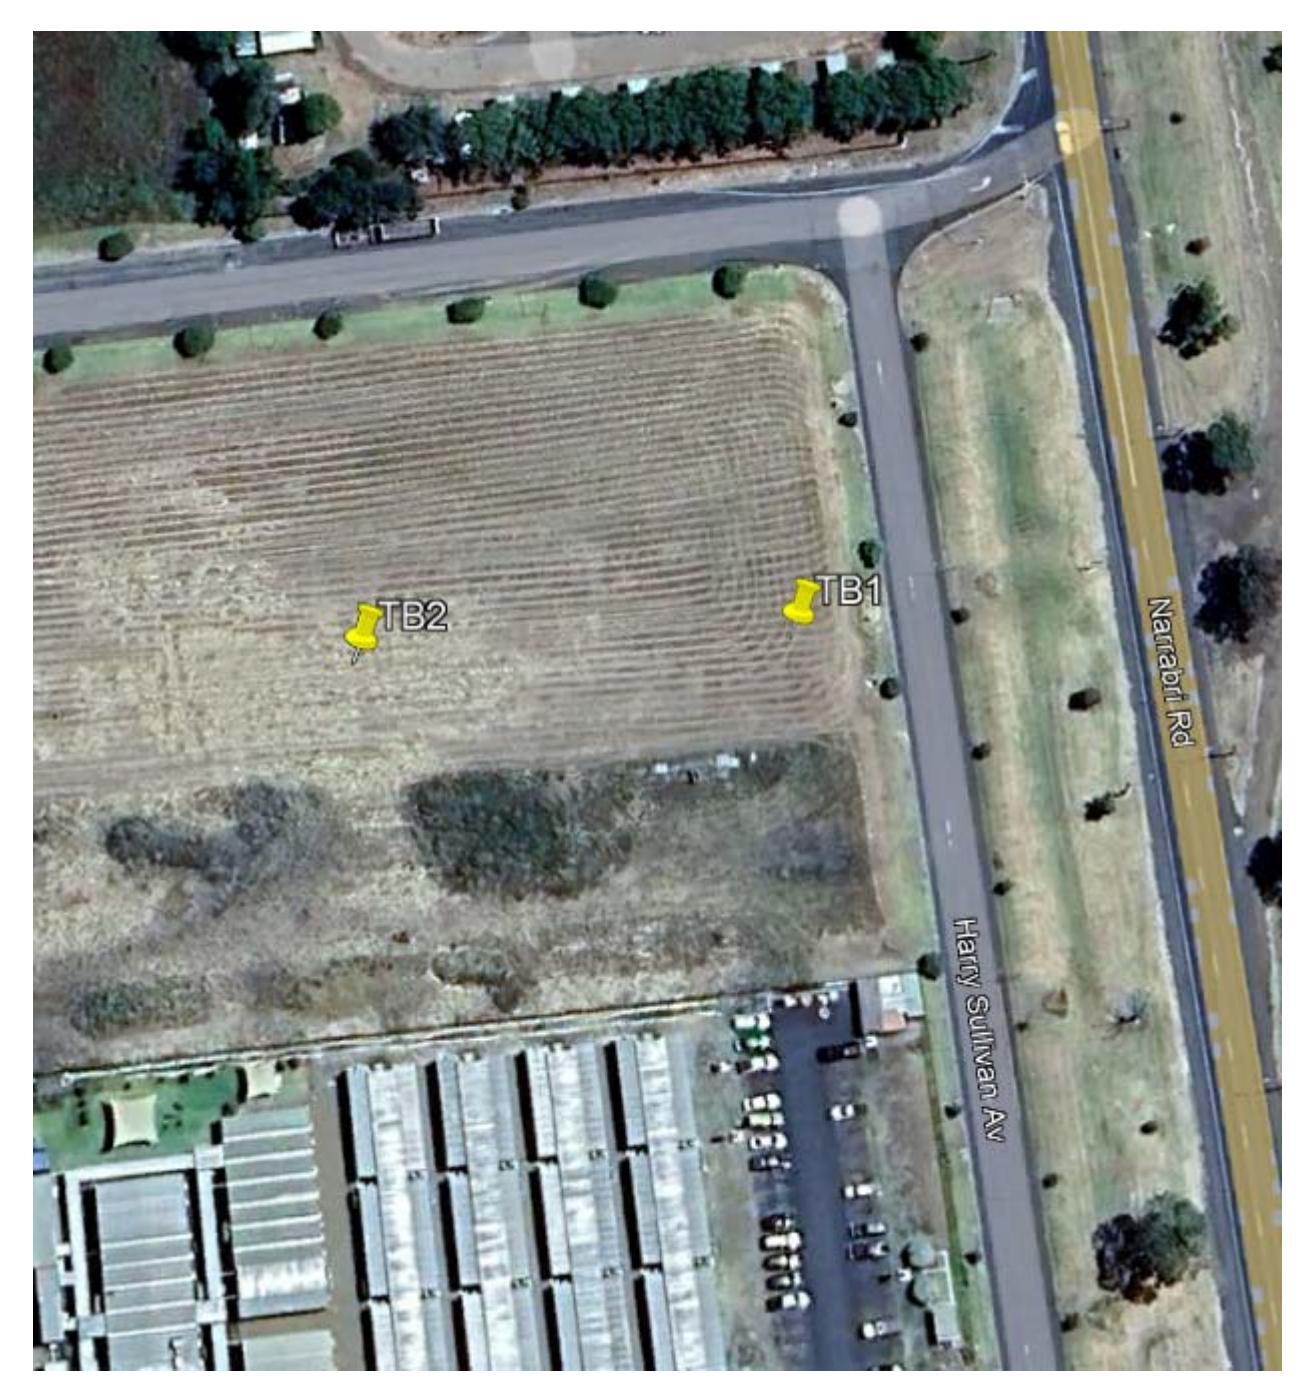
Appendix 3 TEST PIT LOCATIONS

Two test bores were excavated and logged to depths shown on the bore logs in Appendix 2. Bores were positioned to provide a representation of the soil profile across the proposed build site. Soil horizons encountered were varied between bore holes. A heavy clay material being prominent throughout 0-3m in TB1 and in TB2 a heavy clay material 0-1m increasing to silty sand with gravel 1-3m with clay increasing with depth from 2-3m. Bearing capacity is considered to be adequate as per AS2870. Dynamic Cone Penetrometer testing was conducted at each test bore and results can be found in Appendix 5. Allowable bearing capacity was >100Kpa throughout the full depth of investigation. DCP test was terminated once clay became too stiff.
