**RE: Proposed Dwelling**  
**16B The Saddle, Tallwoods Village (Lot 2 DP1279242)**  
**Geotechnical Assessment**

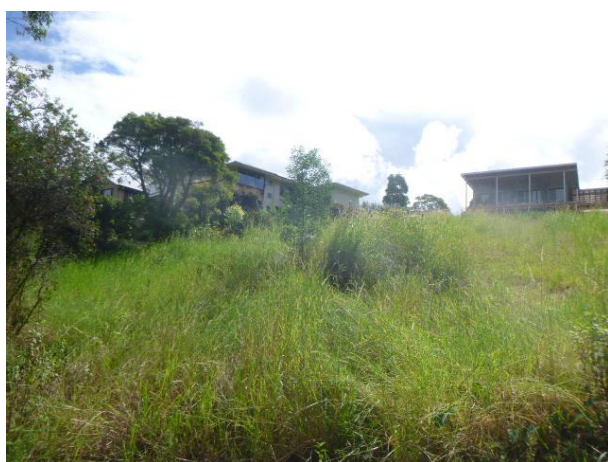
Looking upslope to the west showing long grass and steeply sloping site.

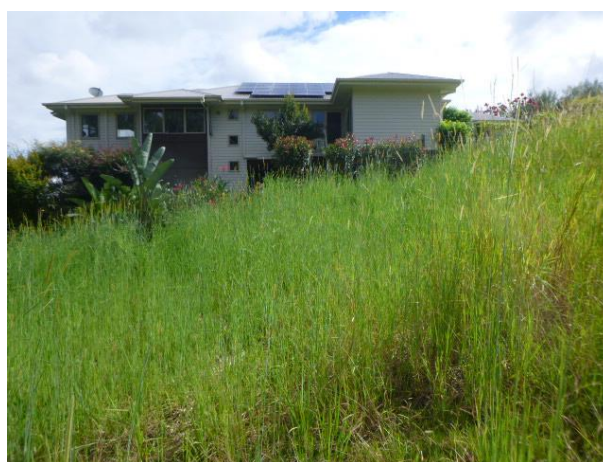
Looking south showing typical slope angles, grass cover and neighbouring dwelling at rear.

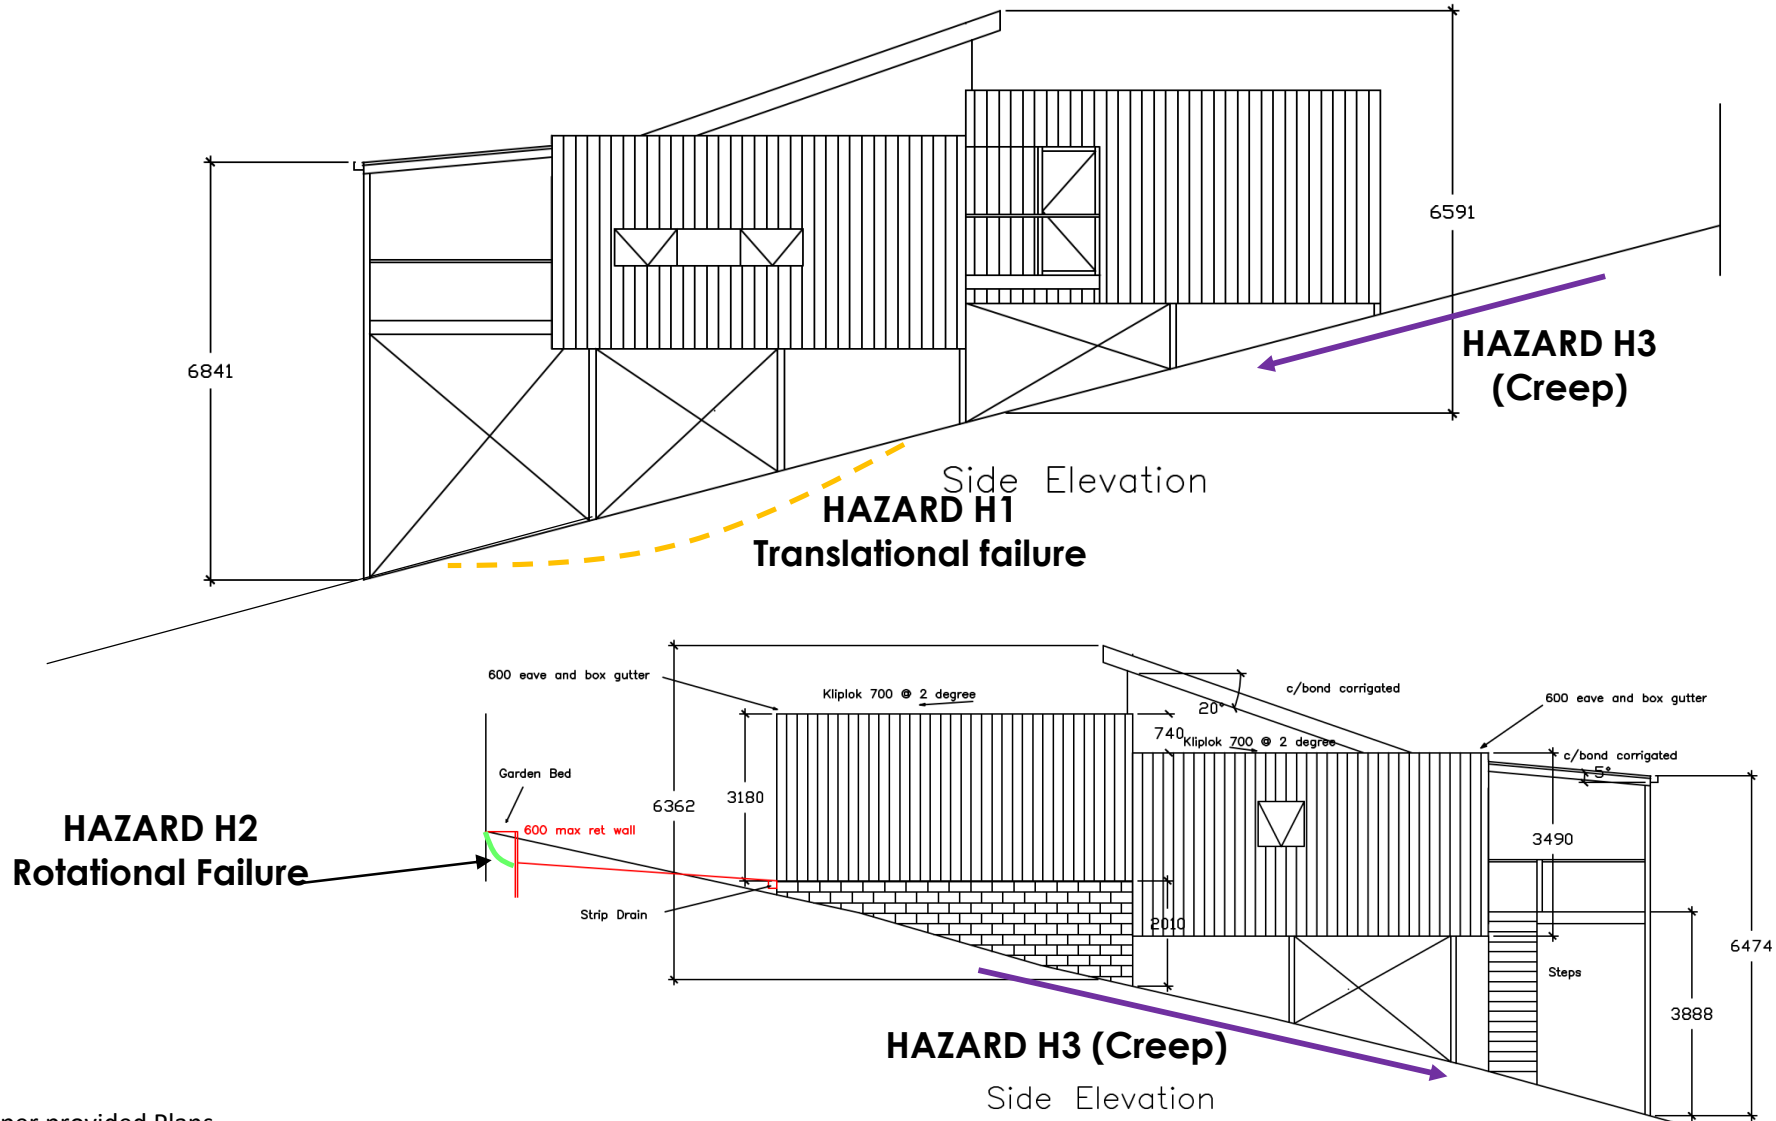
<b>REGIONAL GEOTECHNICAL SOLUTIONS</b>	<b>Client:</b>	Jason McKinley	Job No.	RGS03697.1
	<b>Project:</b>	Proposed Dwelling	Drawn By:	JD
		16B The Saddle, Tallwoods Village	Scale:	NTS
	<b>Title:</b>	Cross section with examples of identified hazards	Date:	1-Apr-25
			Drawing No.	<b>Figure 2</b>

- Hazard 1 –** Translational failure caused by sliding of the soil or rock profile over a plane of weakness such as a clay seam, zone of water concentration within the exposed rock mass, or on the soil-rock interface. Should such a failure occur it could potentially cause moderate structural damage.

- Hazard 2 –** Rotational failure or toppling failure within unsupported excavations or fill batters. If such a failure was to occur it could potentially cause moderate structural damage to a structure. It is noted that no cut or fill is proposed within the proposed building footprint. A small cut approximately 0.6m depth is proposed upslope of the dwelling nearby the western property boundary.

- Hazard 3 –** Soil creep. Creep is an imperceptibly slow movement that takes place on sloping soil sites. It is an ongoing, natural slope process involving the progressive downslope migration of soils over the underlying rock profile.

The identified hazards are shown in Figure 2.

<b>Risk</b>	Low	High	Low
<b>Risk assessment with management as proposed</b>			
<b>Proposed treatment</b>	Employ good hillside construction practice	All cut and fill support to be engineer designed for the slope conditions. Appropriate drainage measures.	No specific treatment proposed – minimise disturbance to existing slope and employ good hillside construction practice
<b>Estimated annual probability</b>	$10^{-5}$	$10^{-5}$	$10^{-1}$
<b>Likelihood</b>	Rare	Rare	Almost certain
<b>Consequence</b>	Medium	Medium	Insignificant
<b>Risk</b>	Low	Low	Low

The assessment presented in Table 2 indicates that there is a **Low** risk of slope instability for the site provided the development is undertaken in accordance with general good hillside practice (refer to attachment) and by adopting the recommendations of this report regarding maximum unsupported cut heights, batter angles, and retaining wall design.
