Murray River Adventure Trail  
Arboricultural impact assessment report

23037 mrat0524\_AIA

19 July 2024

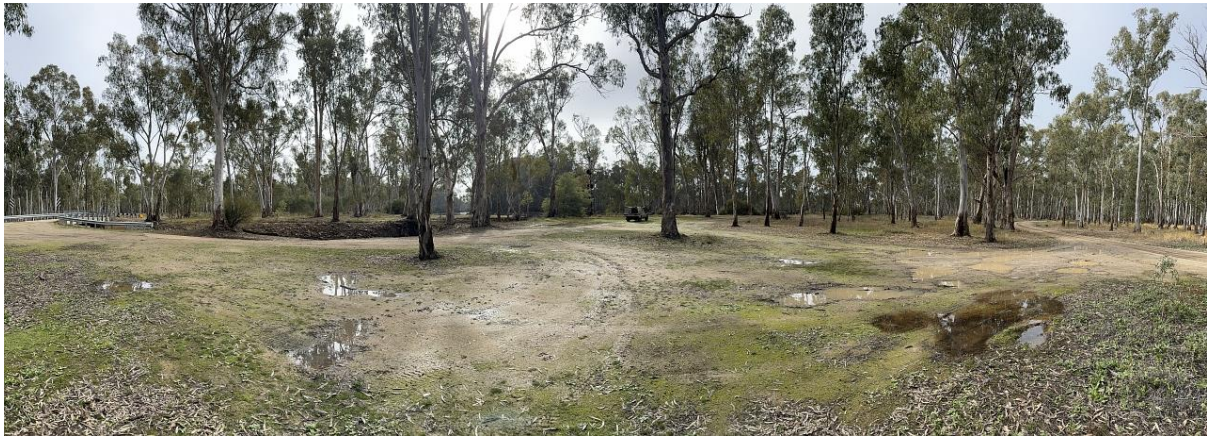
Yarran Creek campground is located next to an existing bridge as well as a concrete boat ramp. The area is already compacted from vehicle traffic. There are several large, mature river red gums within the area, all in fair-good health. The largest tree in the area has an estimated DBH of around 120cm and is located adjacent to the existing boat ramp.

The proposed trailer parking area is quite close to a single tree which is already in fair-poor condition. However, given the already compacted nature of the campground, there is no expected reduction in health or useful life expectancy of this tree. Providing a mulched circle around trees which are close to parking areas will potentially mitigate some of the additional compaction possible with establishing parking.

*Plate 1: Panorama of Yarran Campground; bridge to the left of image, proposed trailer parking in the foreground.*

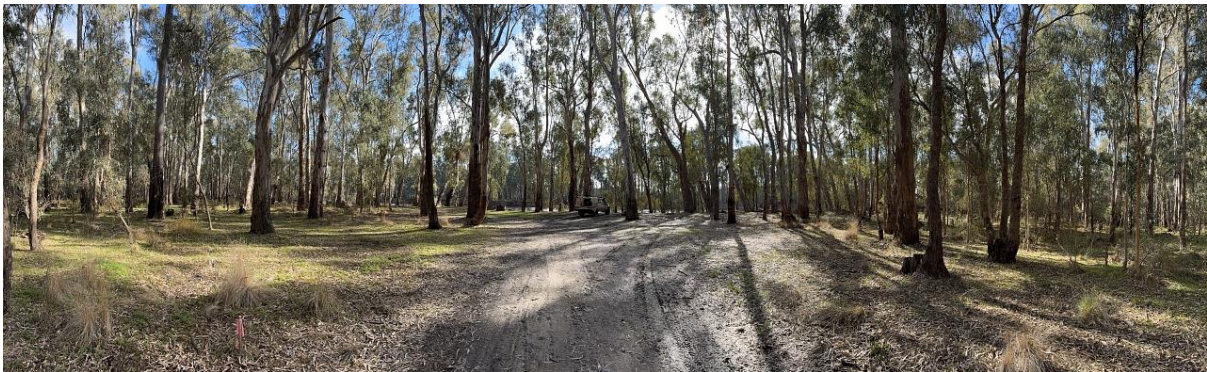
The proposed toilet facility and turn around area is located in a small natural clearing and should have limited impact on adjacent trees.

The proposed camping areas are again located in areas which are already heavily utilised for camping with existing compaction.

*Plate 2: Panorama of Nursery Bend; proposed turn around and toilet facility to the left of image.*

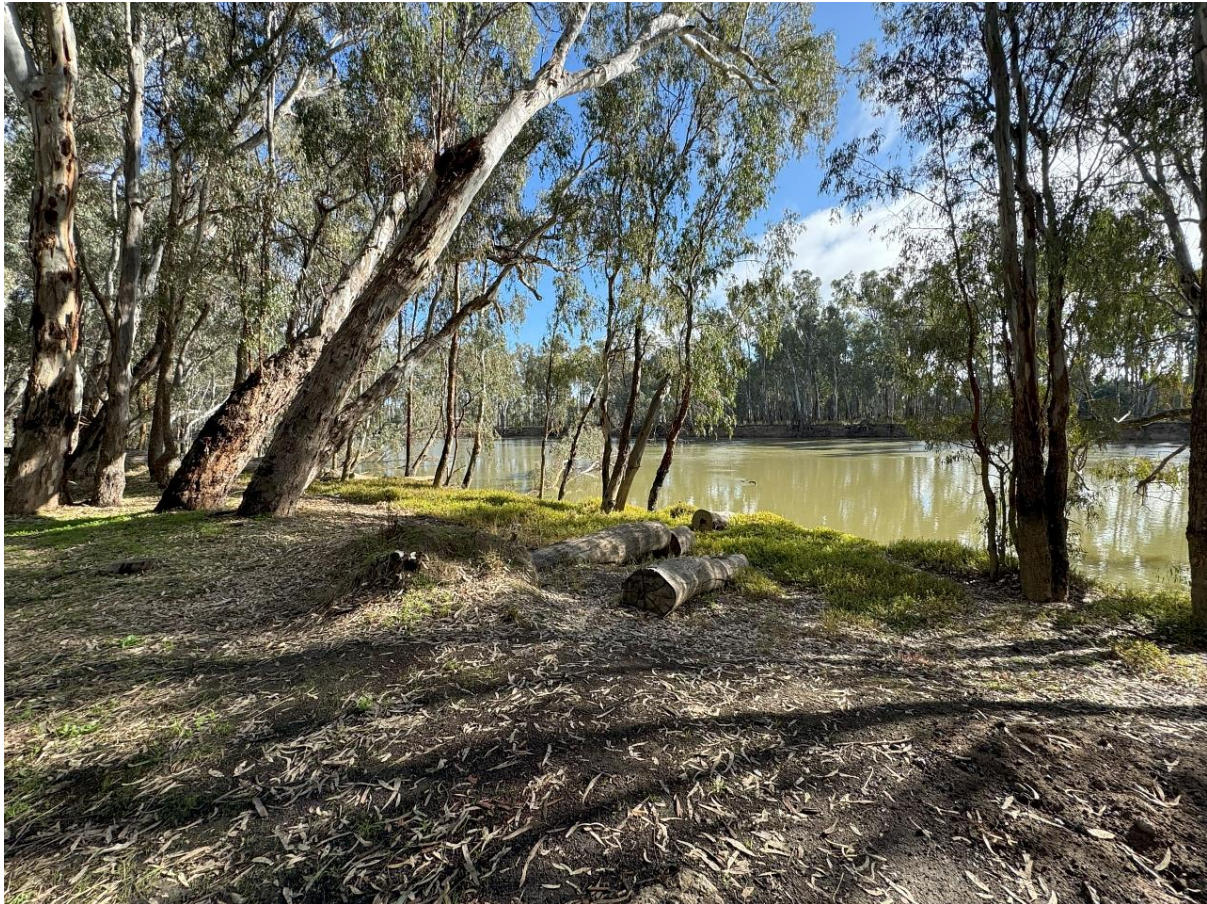
The location for the stepped canoe launch will need to be carefully considered as it will likely require excavation into the bank. However, there should be ample space between some of the larger trees with the possible removal of some small self-seeded trees.

*Plate 3: Stepped canoe launch could be situated where these fallen logs are.*

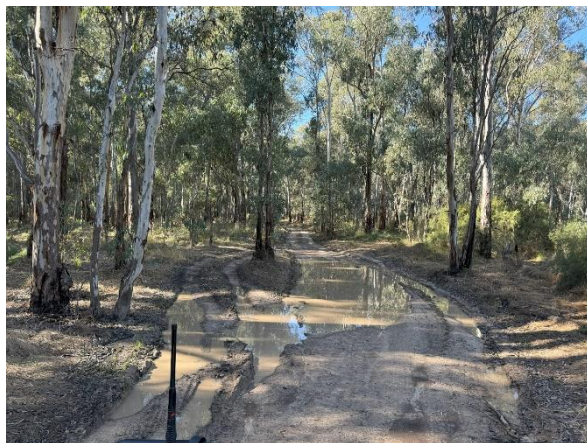
The track leading into Broken River was very boggy in places with evidence of vehicle use off track to avoid the worst sections. The likely entrance into the campground passes beneath a low, leaning tree.

*Plate 5: Boggy track leading to Broken River.*

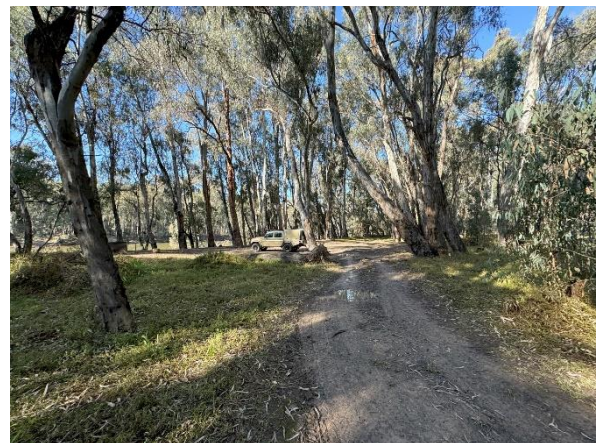
*Plate 4: Low leaning tree at entrance.*

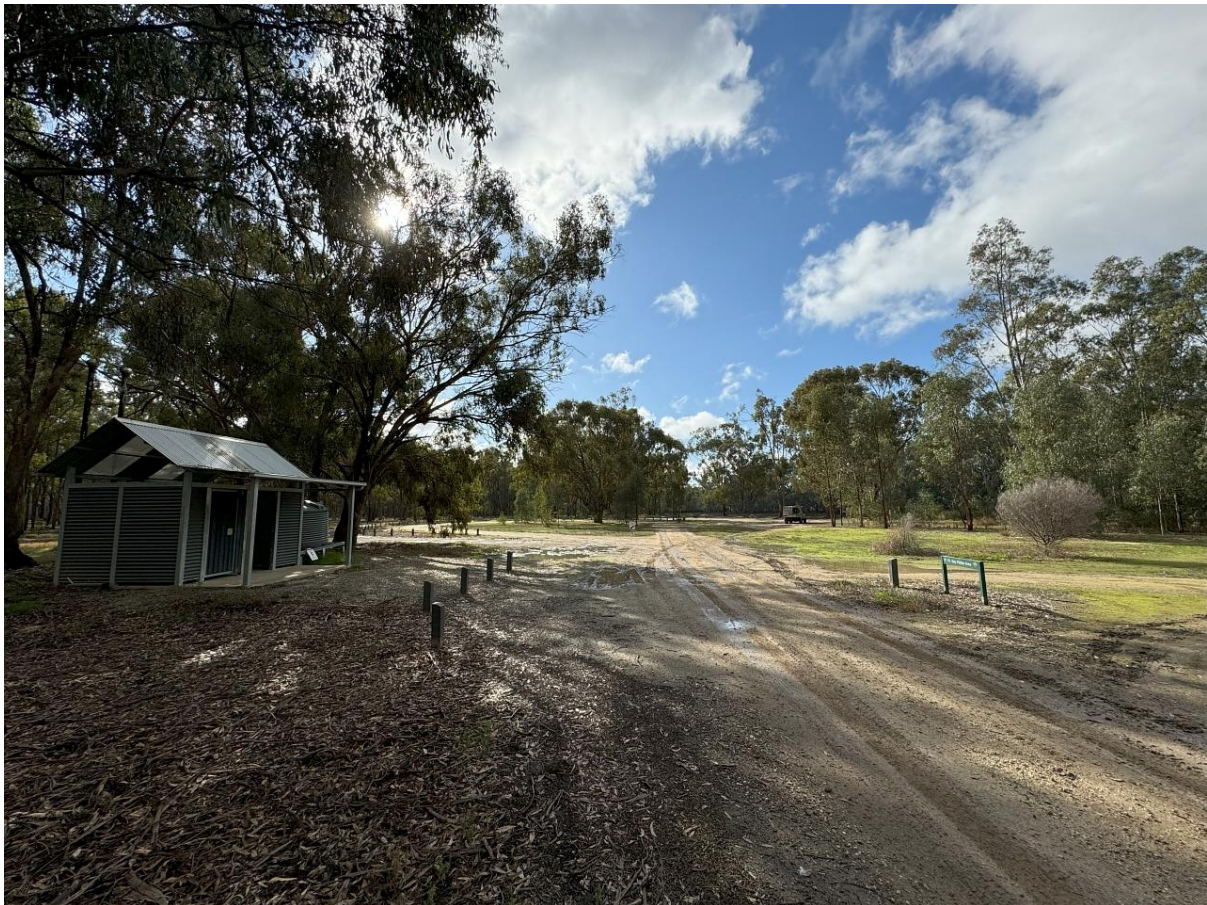
Masters Landing is already a well-established campground with existing toilet facilities and a service road loop. Camping areas are already utilised and well compacted. Delineating camp sites will have no further impact on adjacent trees.

*Plate 6: Entrance to Masters Landing.*

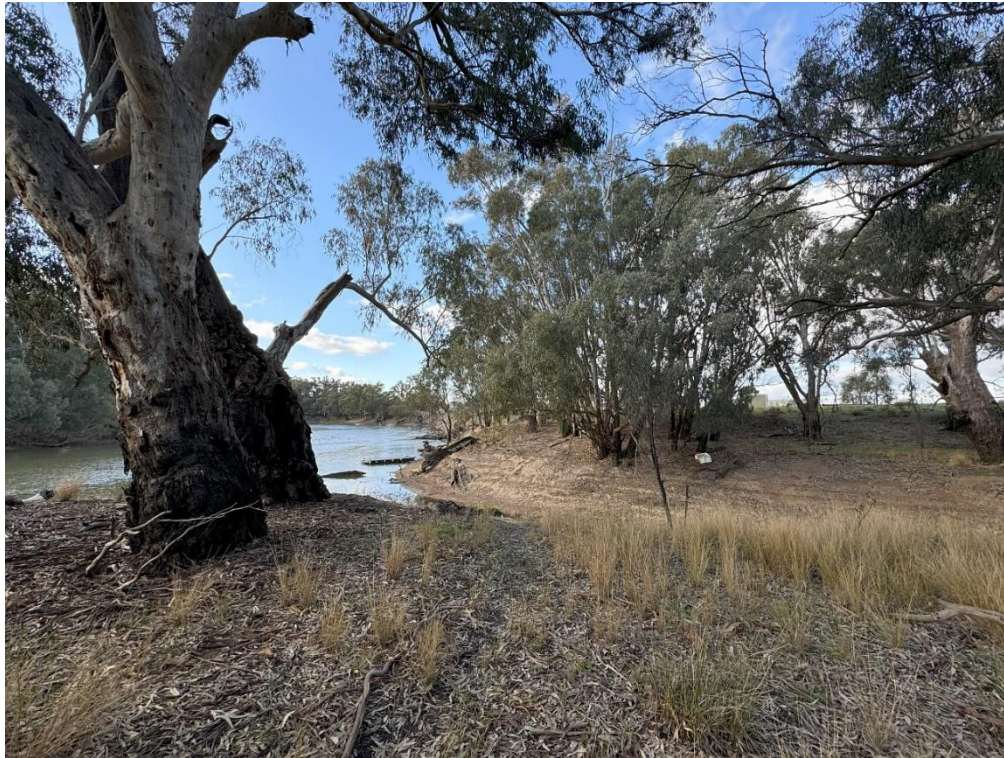
No designs have been seen for this site, however, it is currently proposed to be a culvert crossing. The banks on either side of Mullers Creek are steep and densely vegetated with river red gums.

*Plate 7: Proposed location for Mullers Creek crossing.*

Any proposal will need to consider; access with heavy machinery to place culverts, fill material around the culverts, or possible screw piles and above grade track construction.

Excavation should be avoided, especially within the tree protection zone (TPZ) or structural root zone (SRZ) of retained trees.

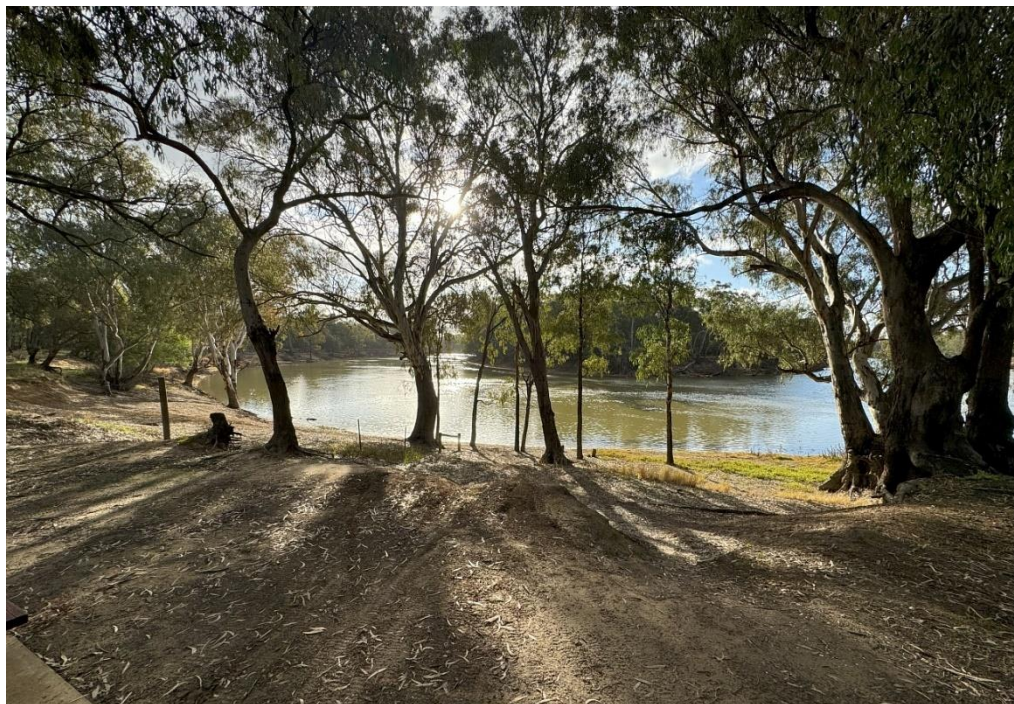
There is ample space between large trees to achieve this without a detrimental impact to tree health or useful life expectancy.

*Plate 8: Braund Bend river access*

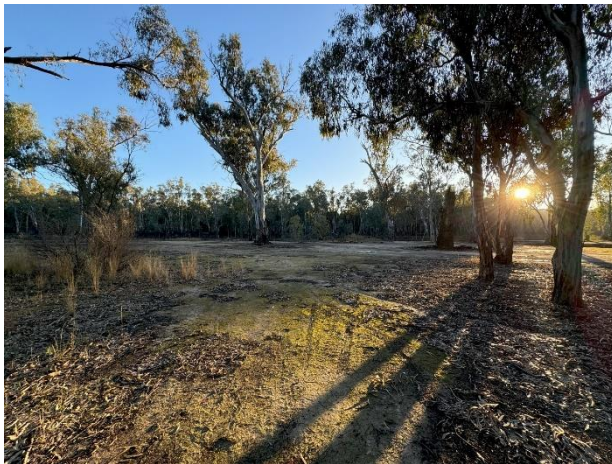
The campground itself was heavily compacted and appeared to have been impacted by storm events with evidence of many broken limbs and branches in the surrounding trees. Tree health and condition was reduced compared to the previous campgrounds, with a higher percentage of deadwood present in the tree canopies.

Given the compacted condition of this camping area, there are no further impacts to trees expected from the construction of camping and parking areas. Provided that the location of the toilet is outside TPZs and SRZs of large trees to be retained, there will be no further impacts.

Plate 10: Kiln Bend compacted campground.

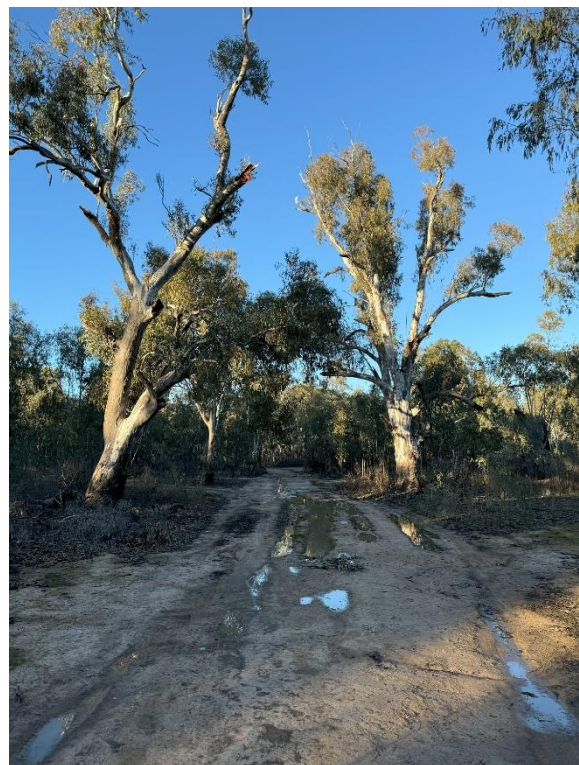
The track in to Kiln Bend was very rough and very muddy. Due to this there were dozens of alternate routes and it was difficult to determine which was the primary route. Improving the access track will significantly reduce compaction from vehicles attempting to find alternative routes in.

Plate 9: Kiln Bend poor track in and evidence of storm damage to trees.

The condition of the trees may necessitate pruning be undertaken to reduce the likelihood of failure over higher use areas such as parking, and campsites. All pruning should be undertaken by an AQF 3 qualified arborist and in accordance with natural target pruning as per AS4373 *Pruning amenity trees*, unless internodal pruning allows the retention of habitat hollows.

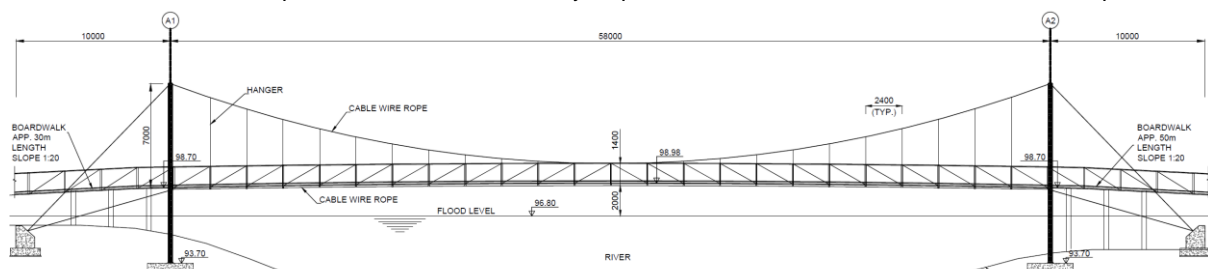
The crossing is deep and very wide and will require a substantial bridge to be constructed. Early construction drawings depict substantial concrete footings ~3mx3m by 600mm high, to be excavated into the bank. A further large concrete anchor footing is also required on each end. Given the substantially more vegetated northern bank, some losses are expected, and some trees may require removal to facilitate the construction footprint.

Plate 11: Murray River adventure trail section 09 Deep Creek Bridge – Bridge design. Drawing No. – JJR-4211023D-9-BR001. Issue – A. Dated – 03.05.2022. Drafted by – R. ABBASI. JJ Ryan Consulting Pty Ltd.

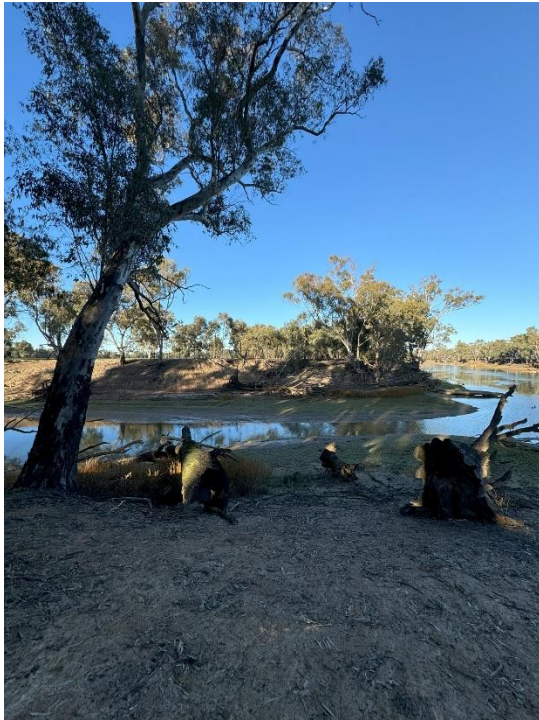
Deep Creek is densely vegetated on the northern bank, with much sparser vegetation on the southern bank.

*Plate 13: Deep Creek - Looking south.*

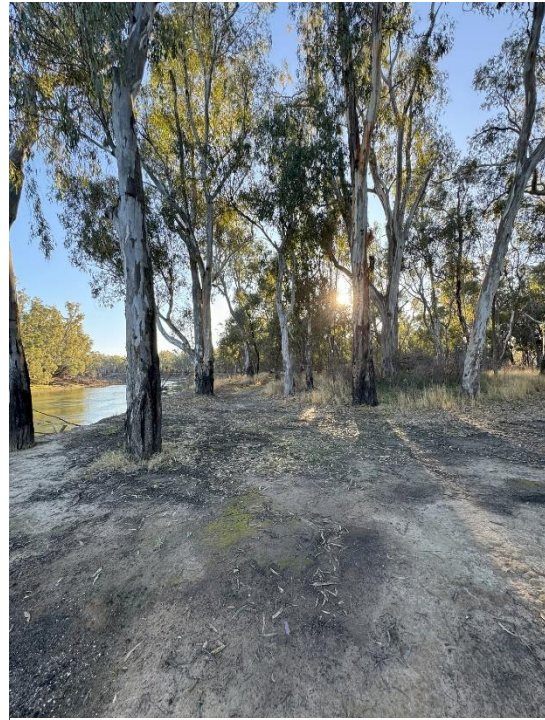
*Plate 12: Same location as plate 12 - looking north*

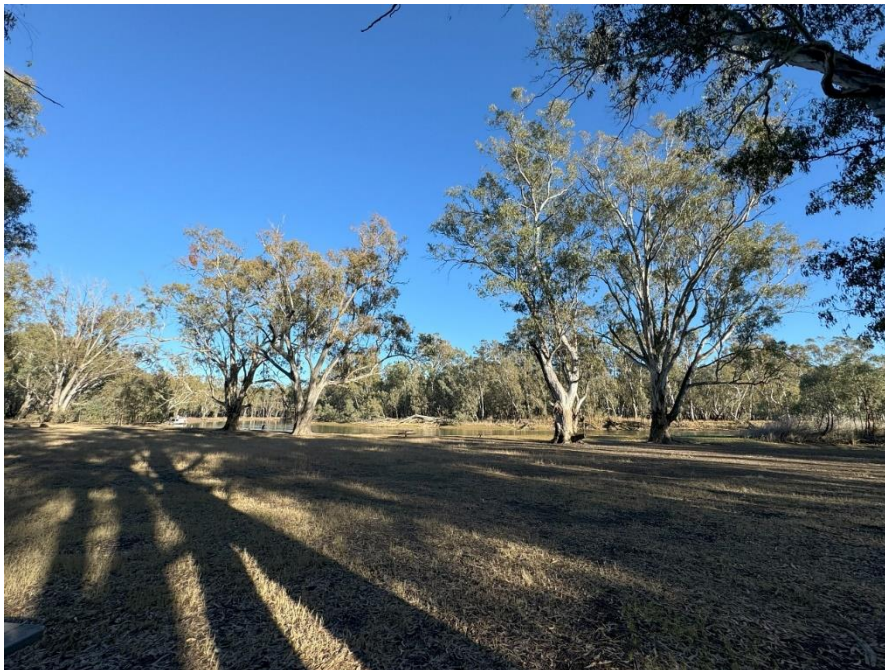
Preliminary designs indicate pile driven piers, which, provided they are outside structural root zones, should not adversely impact the health or useful life expectancy of retained trees.

*Plate 14: Possible proposed location of canoe launch, centrally located between trees.*

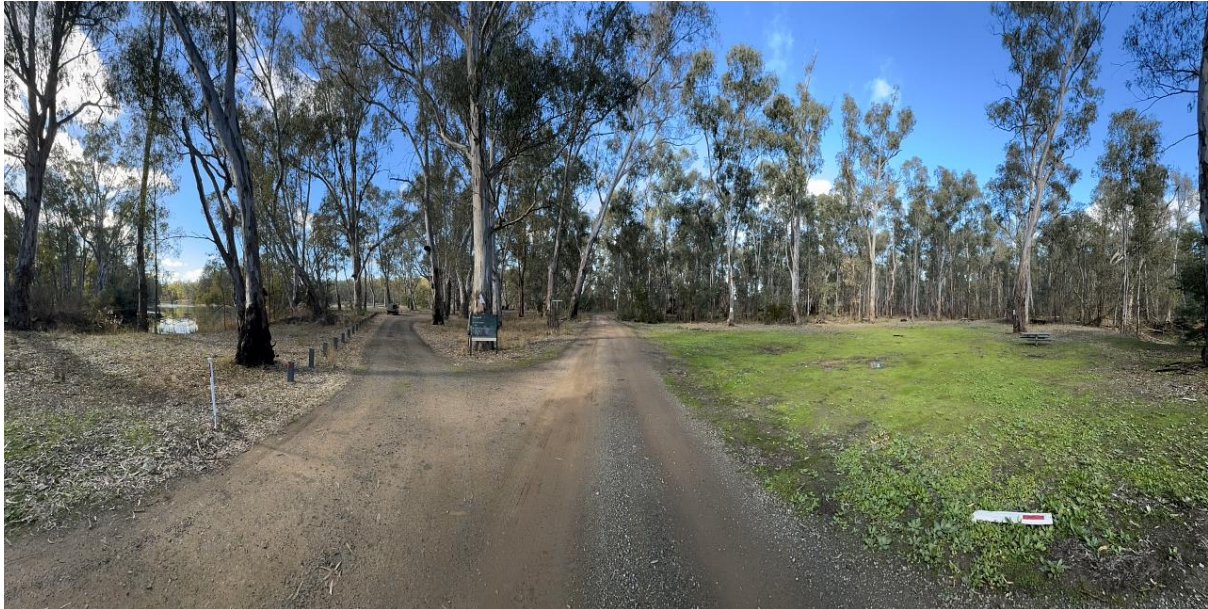
*Plate 15: Panorama of the Gulf site, with camping to the right of image, and day visitor area to the left.*

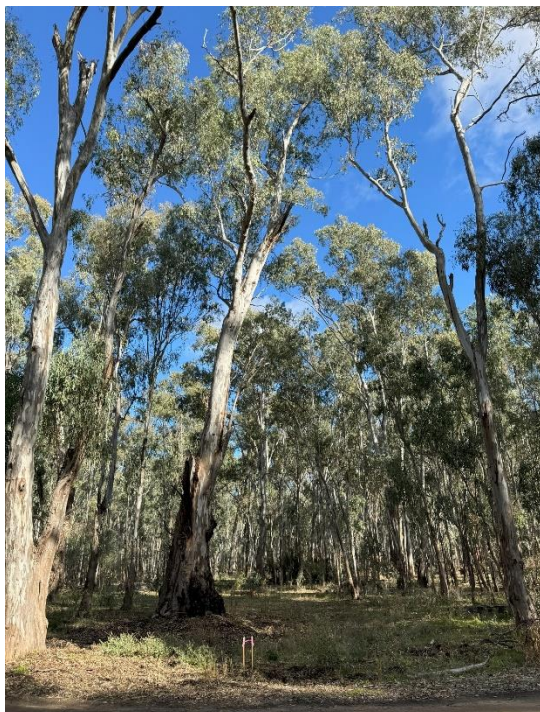
The proposed toilet facility should be located outside of the tree protection zone of the large river red gum adjacent. Some impacts to trees are anticipated, mostly small patch trees, given the density of surrounding trees.

*Plate 16: Possible toilet facility location, with large veteran tree behind.*

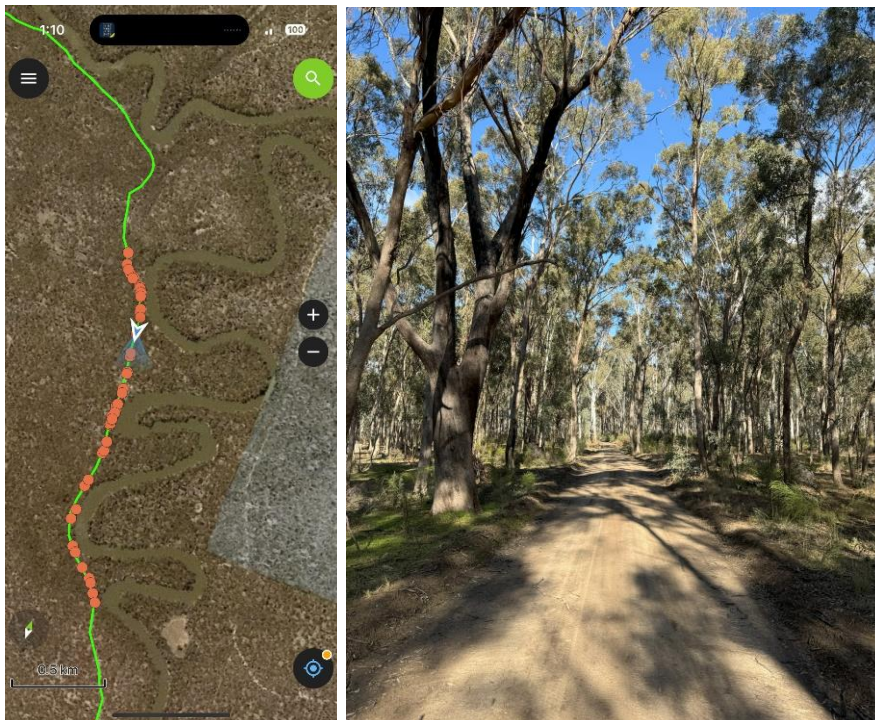
The most significant intervention required to rehabilitate the track will be in areas which have already been significantly impacted by compaction. Whilst accessing some campgrounds, such as Kiln Bend, it was observed that some wheel ruts were already at depths of up to approx. 500mm below grade. In such cases, the treatment required to rehabilitate the road is unlikely to have a greater impact than that already created by wheel ruts.

Much of the track into, and the existing campground areas, is also heavily compacted from current use. Soil compaction occurs more readily when soil conditions are wet, which is a regular occurrence along the Murray River. Delineating campgrounds with bollards and improving track conditions will reduce vehicle compaction in areas other than those designated for use.

Plate 17: Example of track conditions west of Masters Landing.
