# ARBORICULTURAL IMPACT ASSESSMENT AND TREE MANAGEMENT PLAN

**PROPOSED DRIVEWAY  
DEVELOPMENT APPLICATION**

**2H BILOELA STREET  
VILLAWOOD, NSW**

15th May 2025 – Version 2

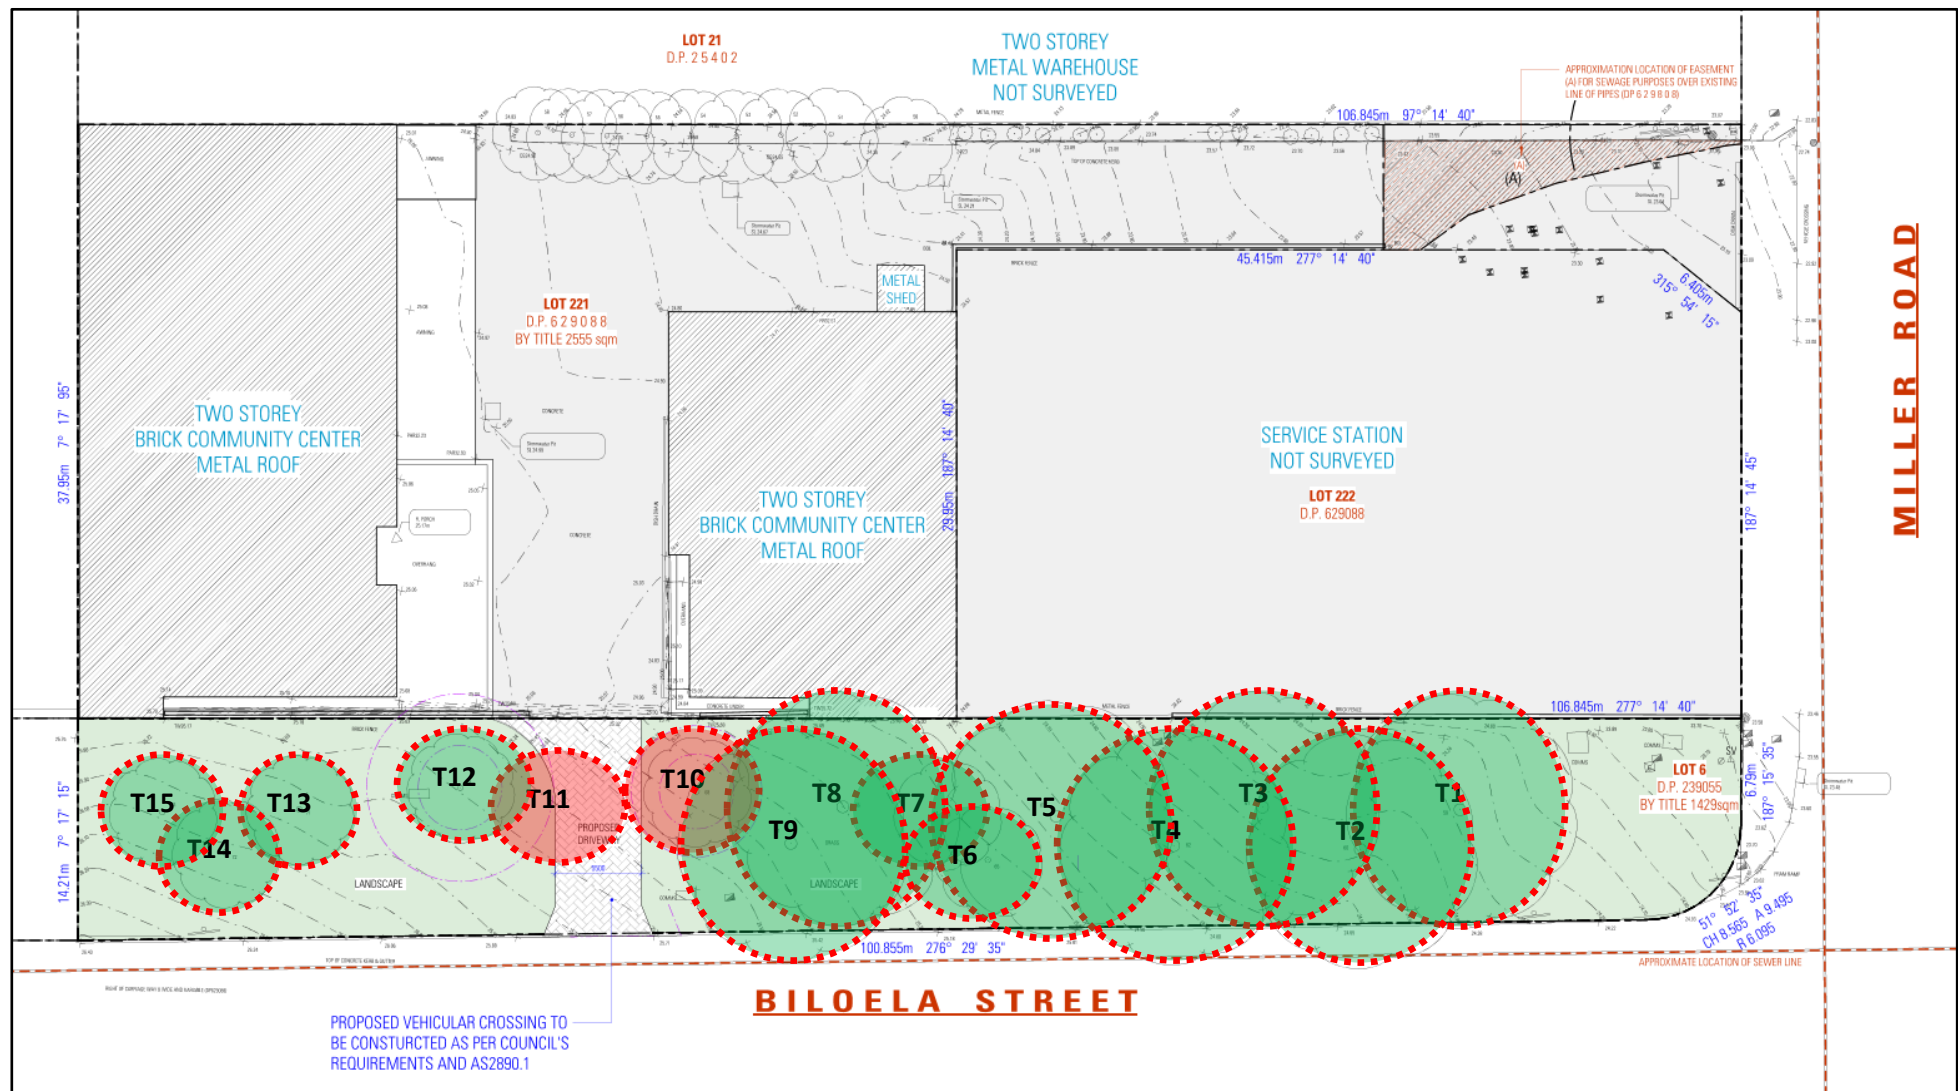
Figure 4 Shows the site trees in red proposed to be removed based on the driveway development layout.

Furthermore, these trees are both in poor declining health and individual poor structural condition from previous mechanical damage, lightning damage and soil compaction from hardstand parking area, hence their removal is required.

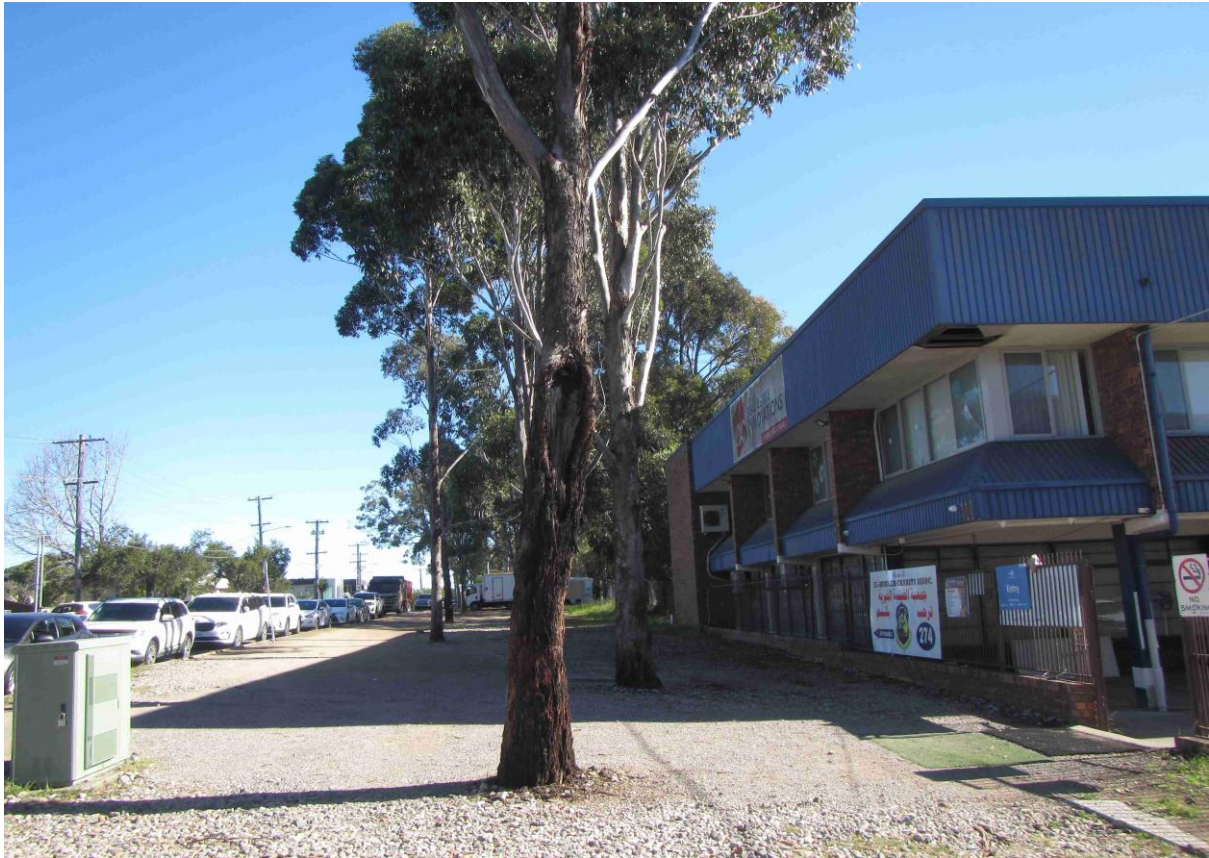
**Figure 8 Shows Tree 11 within the proposed new driveway entrance with open wound that is required to be removed for the new driveway entrance.**

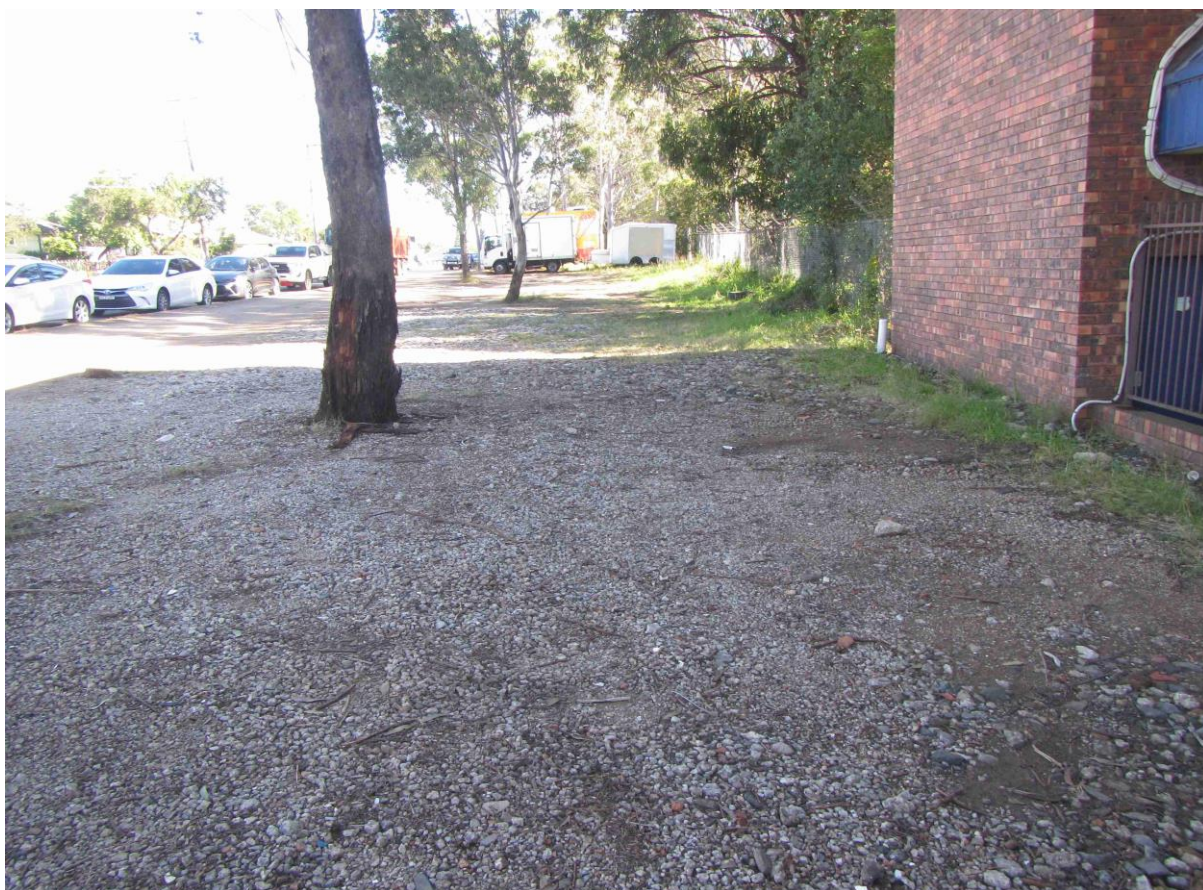
**Figure 10 Shows road base/gravel used for the hard standing parking area compacting the existing soil profile.**

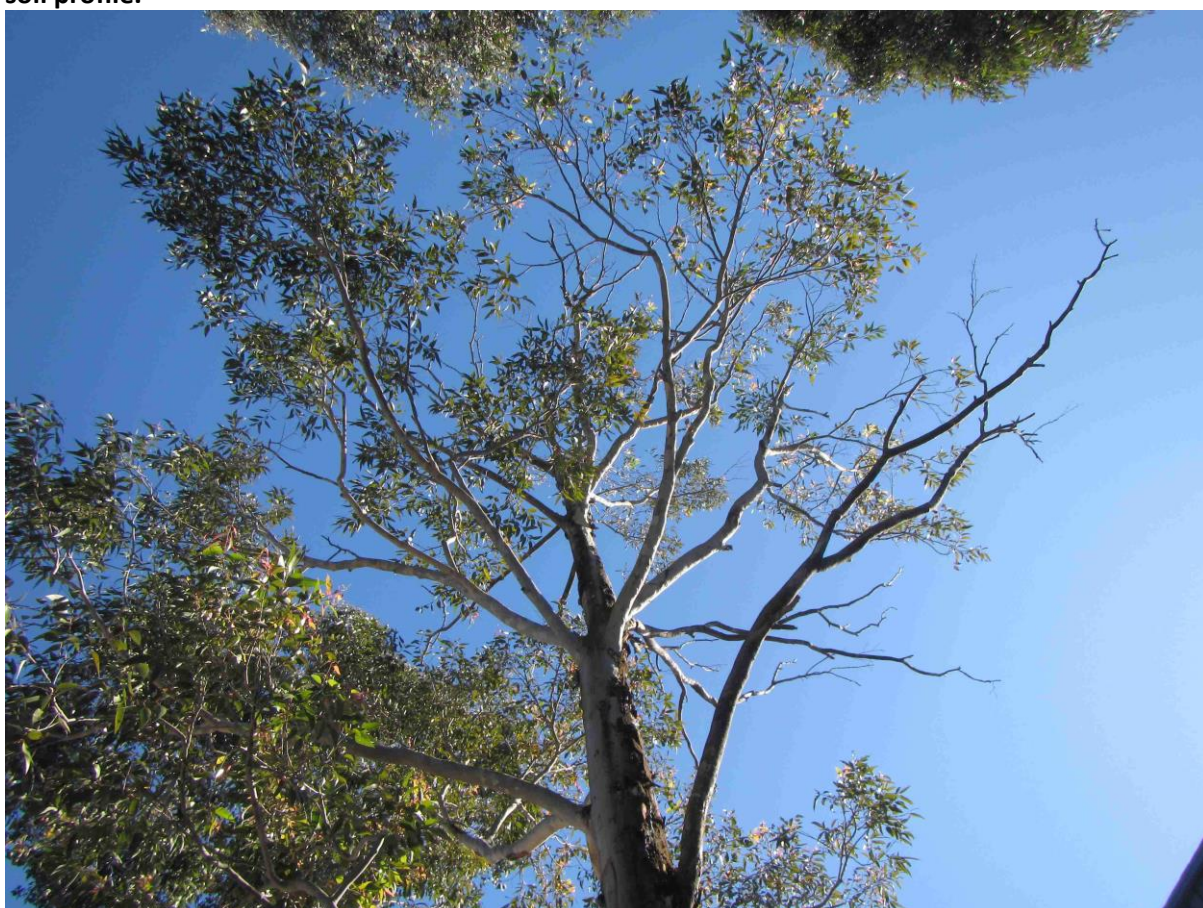
10	Spotted Gum <i>Corymbia maculata</i>	12	350	460	N/A	N/A	Mature	Fair to Poor	Poor	4C	Nil	Low	Nil	No
	<p><b>Comments:</b> This tree is in poor declining health and structural condition, based on its limited canopy foliage, large open mechanical wounds, previous lightning strike and gravel hard stand parking that would have resulted in additional soil compact, which supports its removal. No roosting or habitat hollows were observed, and in summary, this tree is required to be removed.</p> <p>It is recommended this tree will be replaced in the landscape upon completion of the driveway works with an advanced canopy trees in 75lt and planted in a location that can support and accommodate its further growth.</p>													
11	Grey Box <i>Eucalyptus moluccana</i>	15	530	680	N/A	N/A	Mature	Fair	Fair to Poor	4	Nil	Low	Nil	No
	<p>This tree is in fair declining health and poor structural condition, based on its canopy foliage percentage, large open mechanical wounds, previous limb failure from storm damage and gravel hard stand parking that would have resulted in additional soil compact, which supports its removal. No roosting or habitat hollows were observed, and in summary, this tree is required to be removed.</p> <p>It is recommended this tree will be replaced in the landscape upon completion of the driveway works with an advanced canopy trees in 75lt and planted in a location that can support and accommodate its further growth.</p>

**Figure 11 Shows Tree 10 with declining canopy, deadwood and lightening strike damage.**

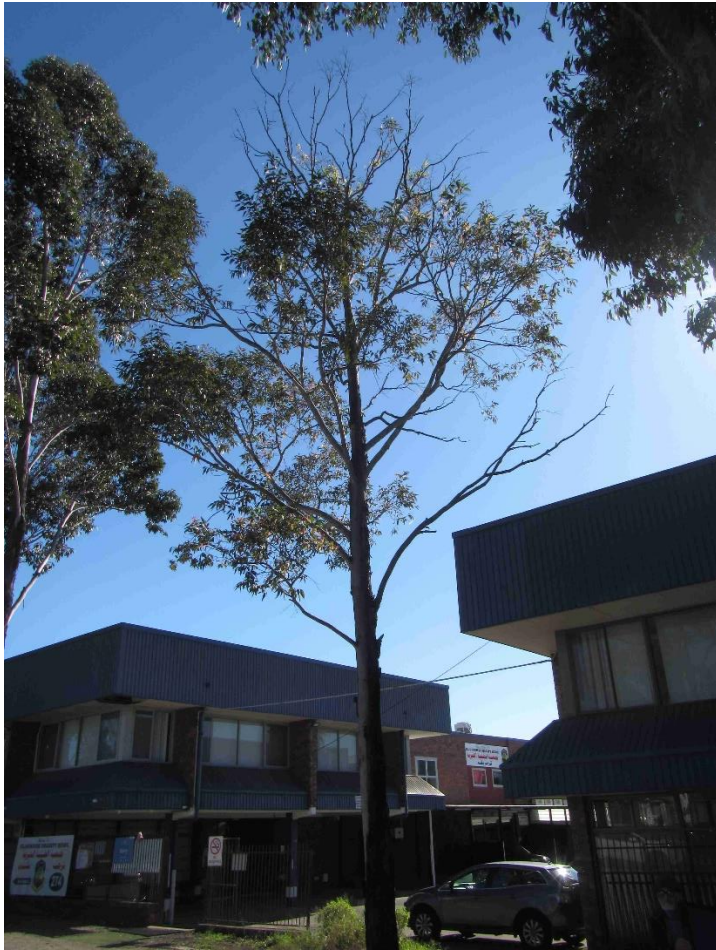
**Figure 12 Shows again Tree 10 in poor health, condition and density, hence removal.**

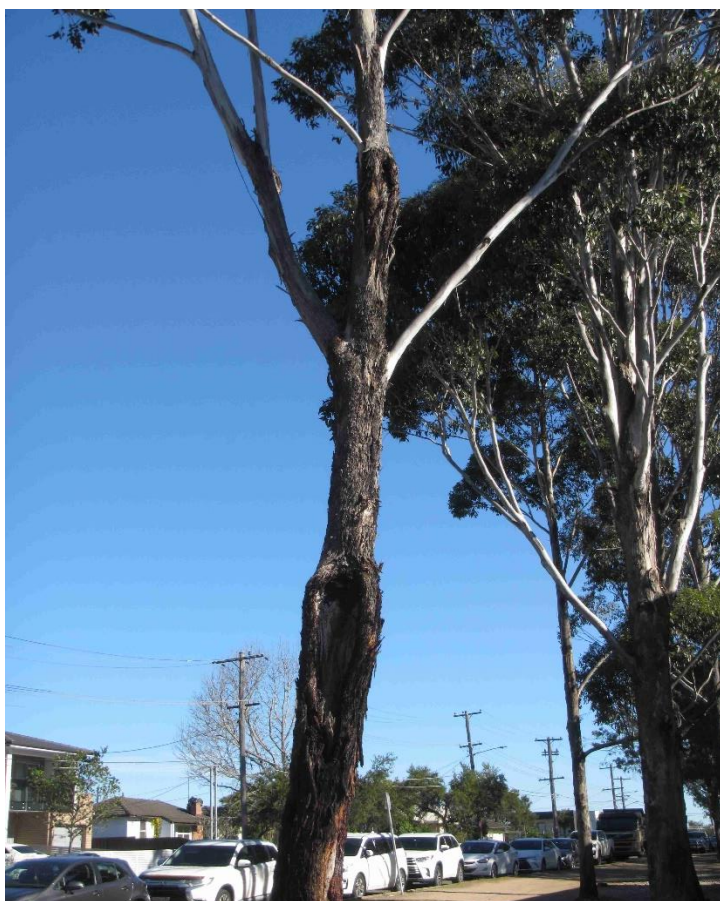
**Figure 14 Shows again Tree 11 with previous failed scaffold limbs resulting in large open wounds.**

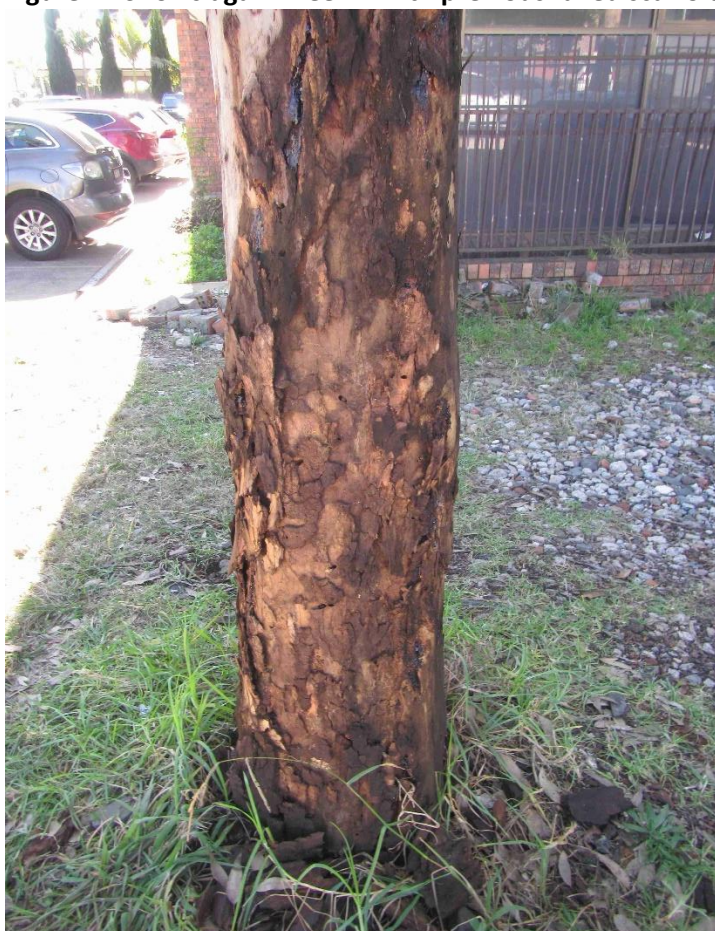
**Figure 15 Shows lightning damage and dead cambium on Tree 10.**

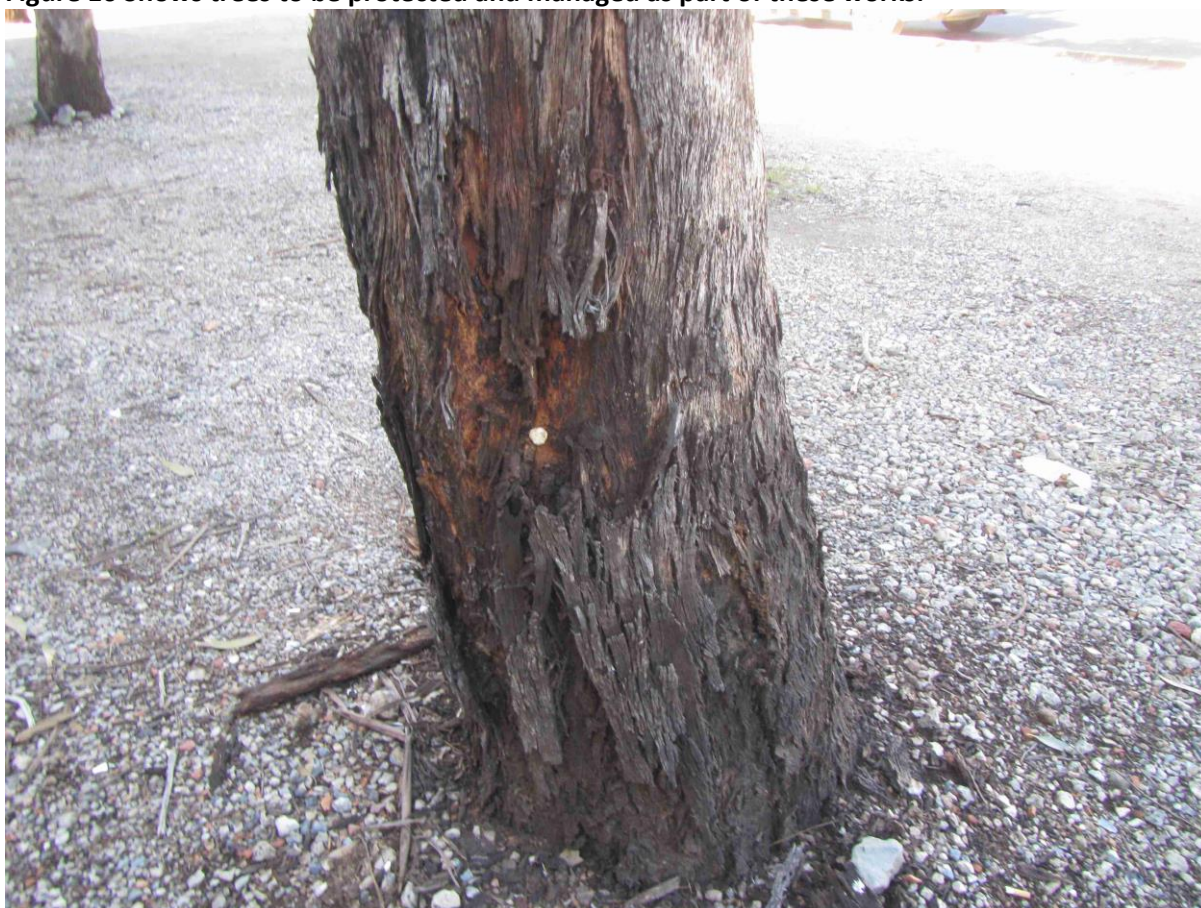
**Figure 17 Shows again crushed road base etc compacting the existing soil profile.**
