## ARBORICULTURAL IMPACT ASSESSMENT

98 Mackenzie Street,  
Revesby  
NSW

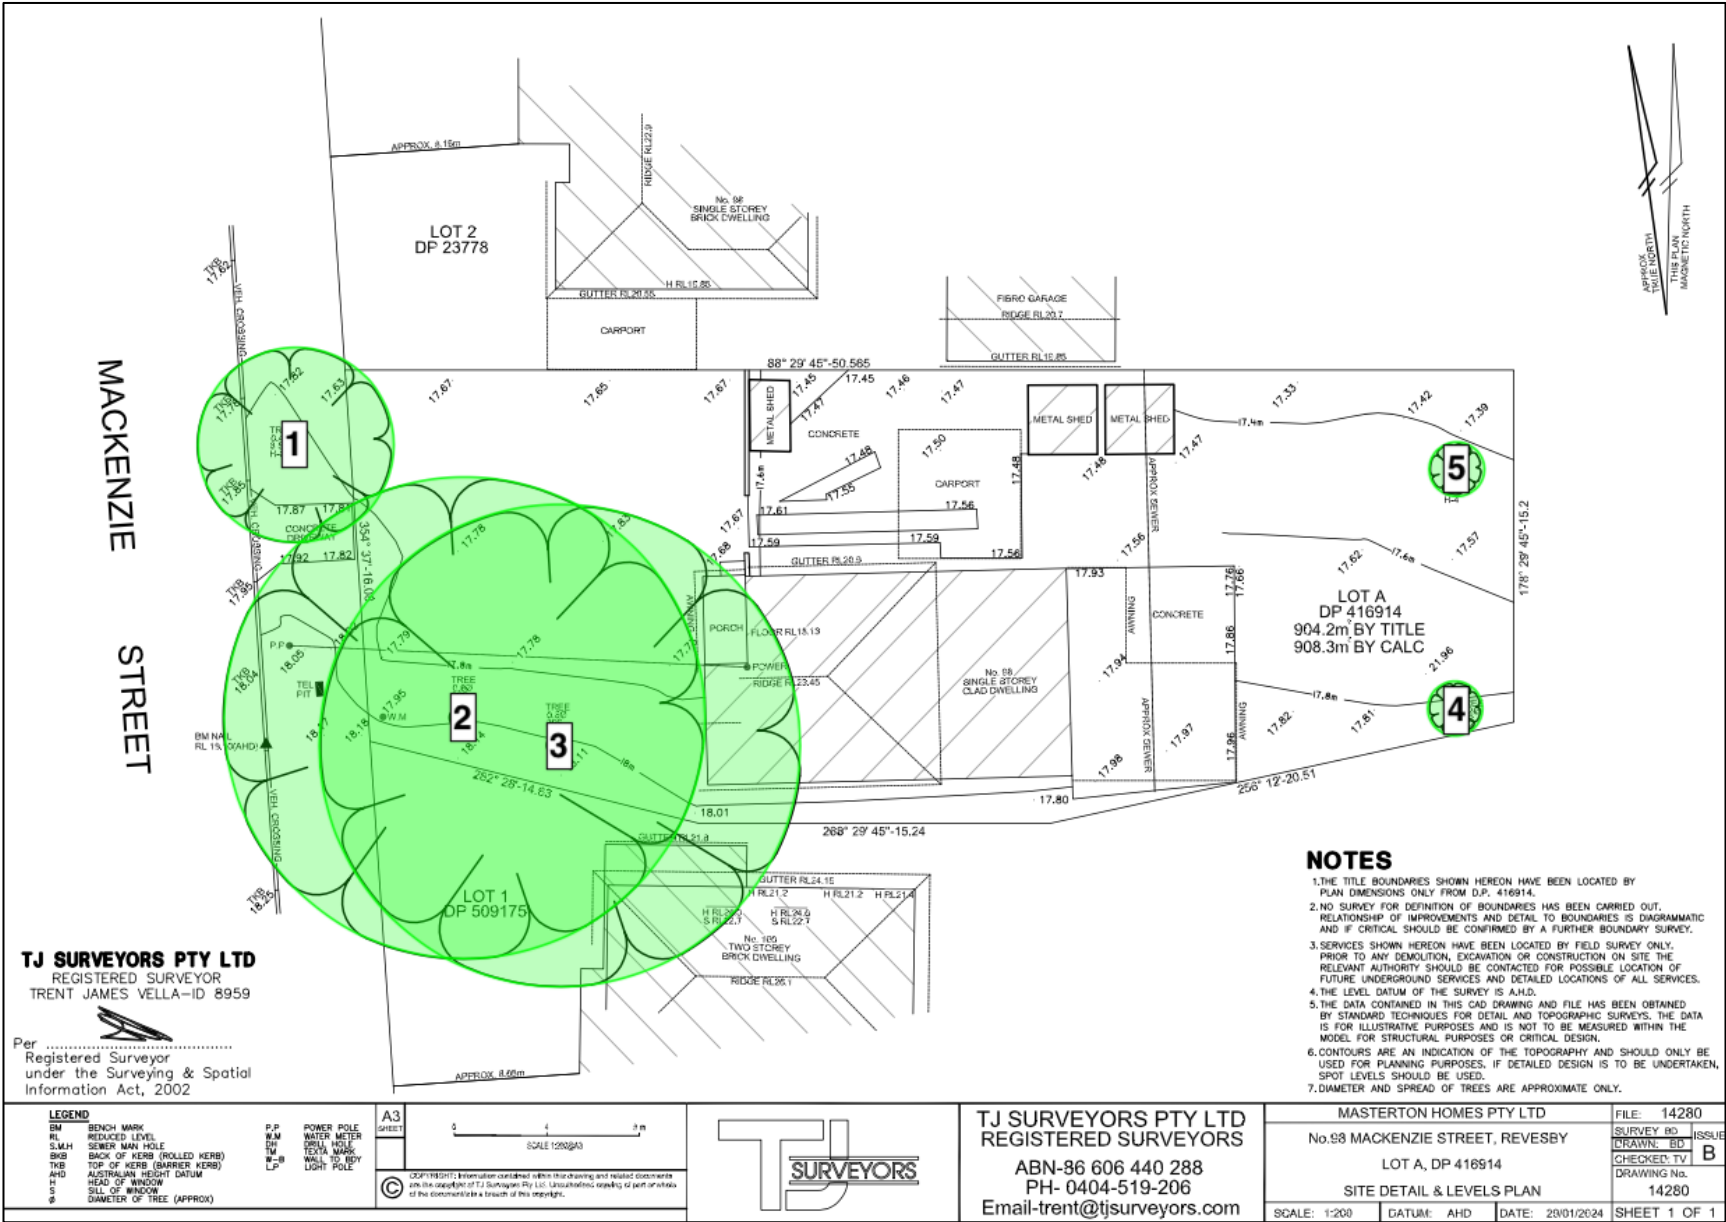
PLAN 1: Site Survey indicating tree location (Plan supplied by client May 2024).

Tree 2 can expect possible TPZ encroachments from the proposed demolition of existing structures. Refer to Appendix 11 for specific details.

Tree 3 can expect TPZ encroachments from the proposed demolition of existing structures. Refer to Appendix 11 for specific details.

To avoid any unnecessary root compaction it is imperative that no heavy machinery being used in the demolition process of the existing dwelling enter into Tree 2's calculated TPZ.

To avoid any unnecessary root compaction it is imperative that no heavy machinery being used in the demolition process of the existing dwelling enter into Tree 3's calculated TPZ.

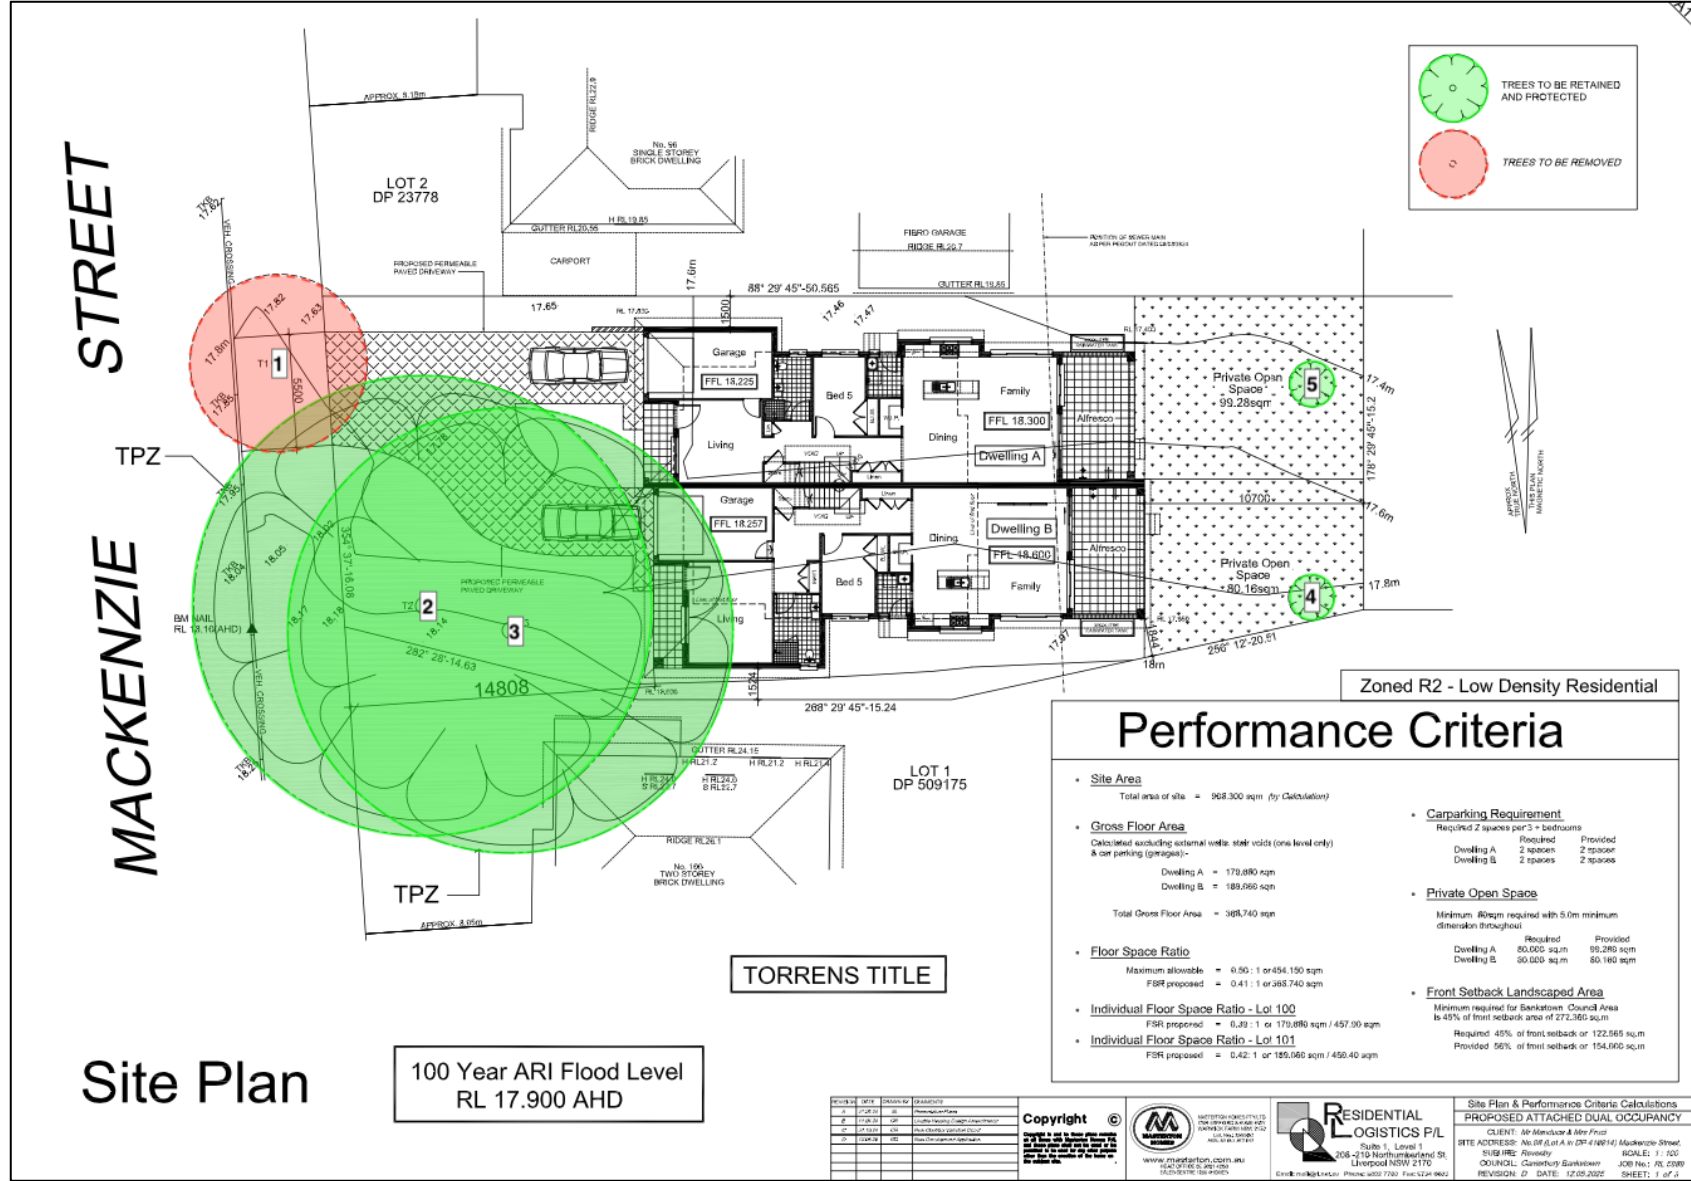
**PLAN 2: Site Plan indicating proposed tree removal (Plan supplied by client May 2025).**

Tree 1 has been proposed for removal to facilitate the proposed 'Driveway Design'.

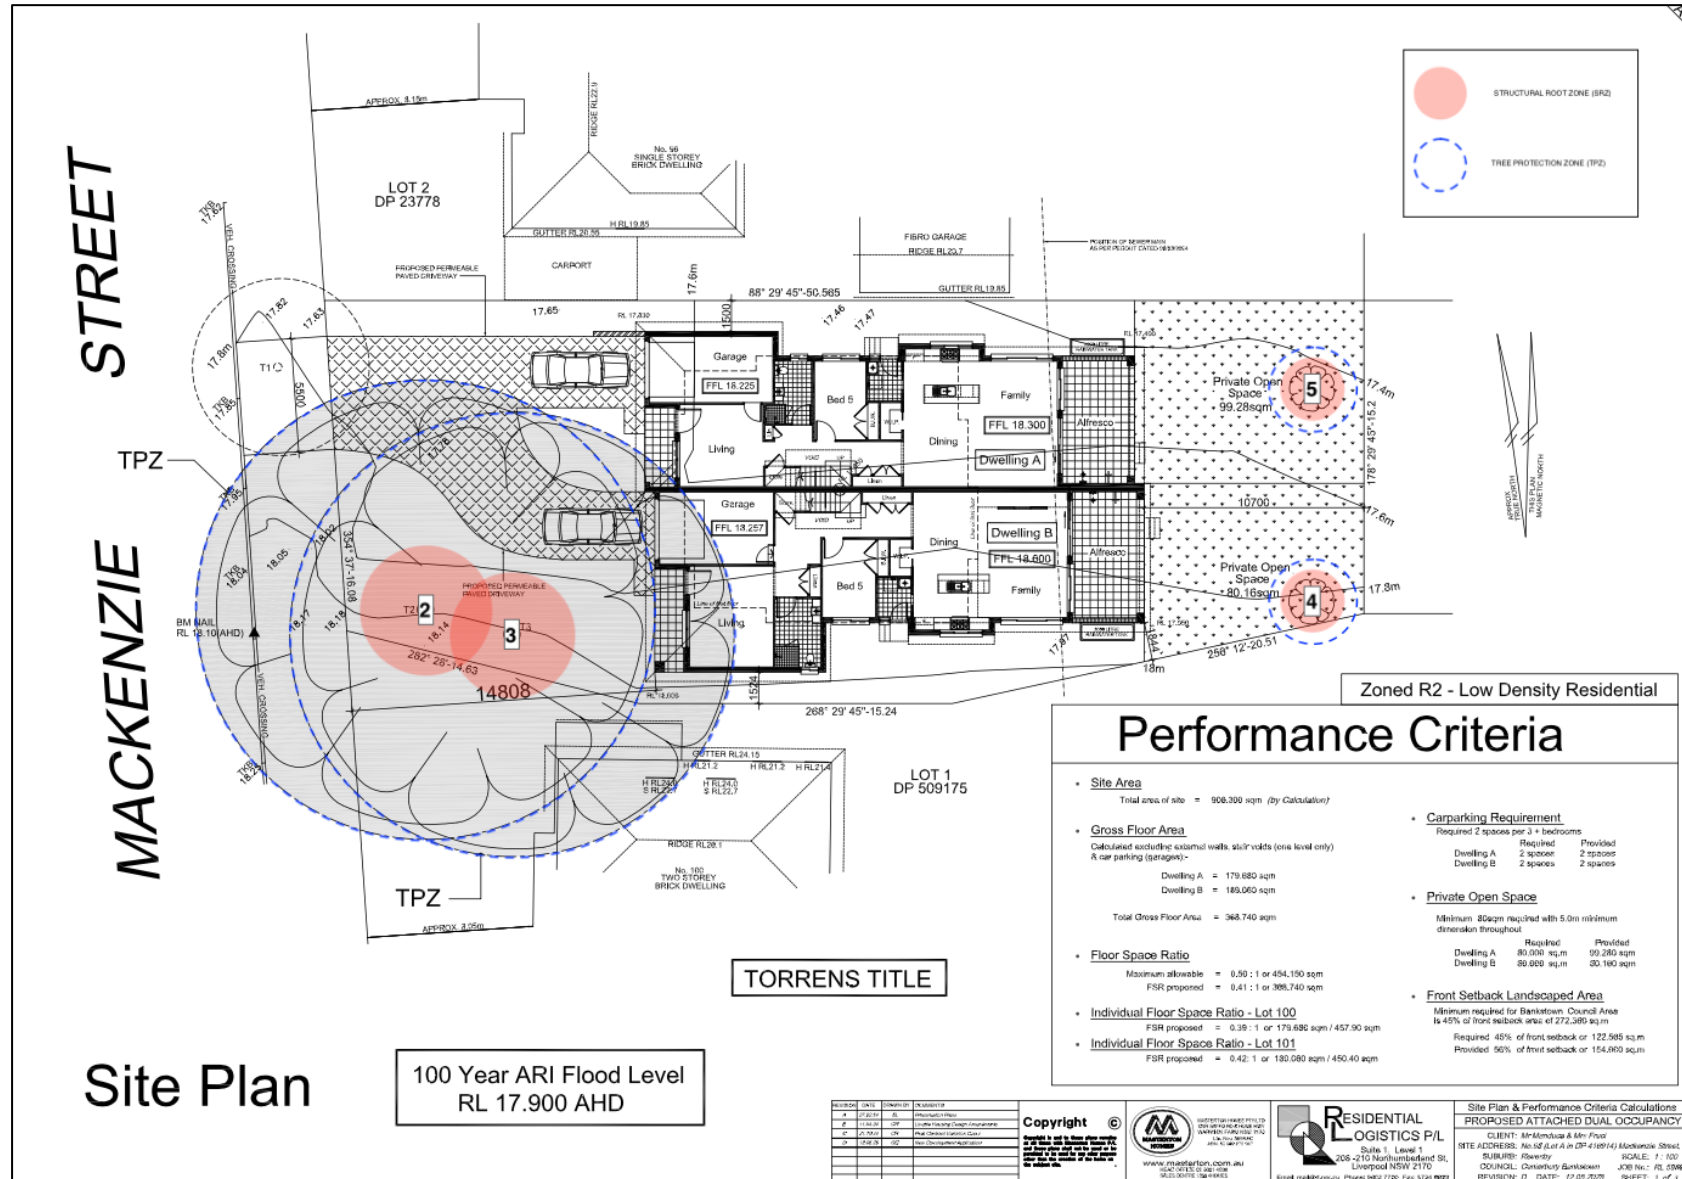
PLAN 3: Site Plan - Calculated SRZ & TP for retained trees (Plan supplied by client May 2025).

Tree 2 can also expect TPZ encroachments from the new 'Driveway Construction' and excavation for new 'Stormwater Infrastructure'. Refer to Appendix 13 and Appendix 14 for specific details.

The total area of TPZ encroachment (footprint) for these works is greater than 10% of the calculated TPZ and considered significant.

Tree 3 can expect TPZ encroachments from foundations of 'Dwelling B'. These encroachments have been calculated as less than 10% of Tree 3's TPZ and are considered acceptable using AS:4970-2009 as a guide for reference.

Tree 3 can also expect TPZ encroachments from the new 'Driveway Construction' and excavation for 'Stormwater Infrastructure'. Refer to Appendix 13 and Appendix 14 for specific details.

The machinery used for any excavation within the TPZ, must be light in nature and performed under strict arborist supervision.

It is recommended that the new driveway be constructed as close to the existing grade as possible using permeable materials. It is recommended that any excavation works within Tree 2's TPZ be performed using hand tools.

It is recommended that the new driveway be constructed as close to the existing grade as possible using permeable materials. It is recommended that any excavation works within Tree 3's TPZ be performed using hand tools.

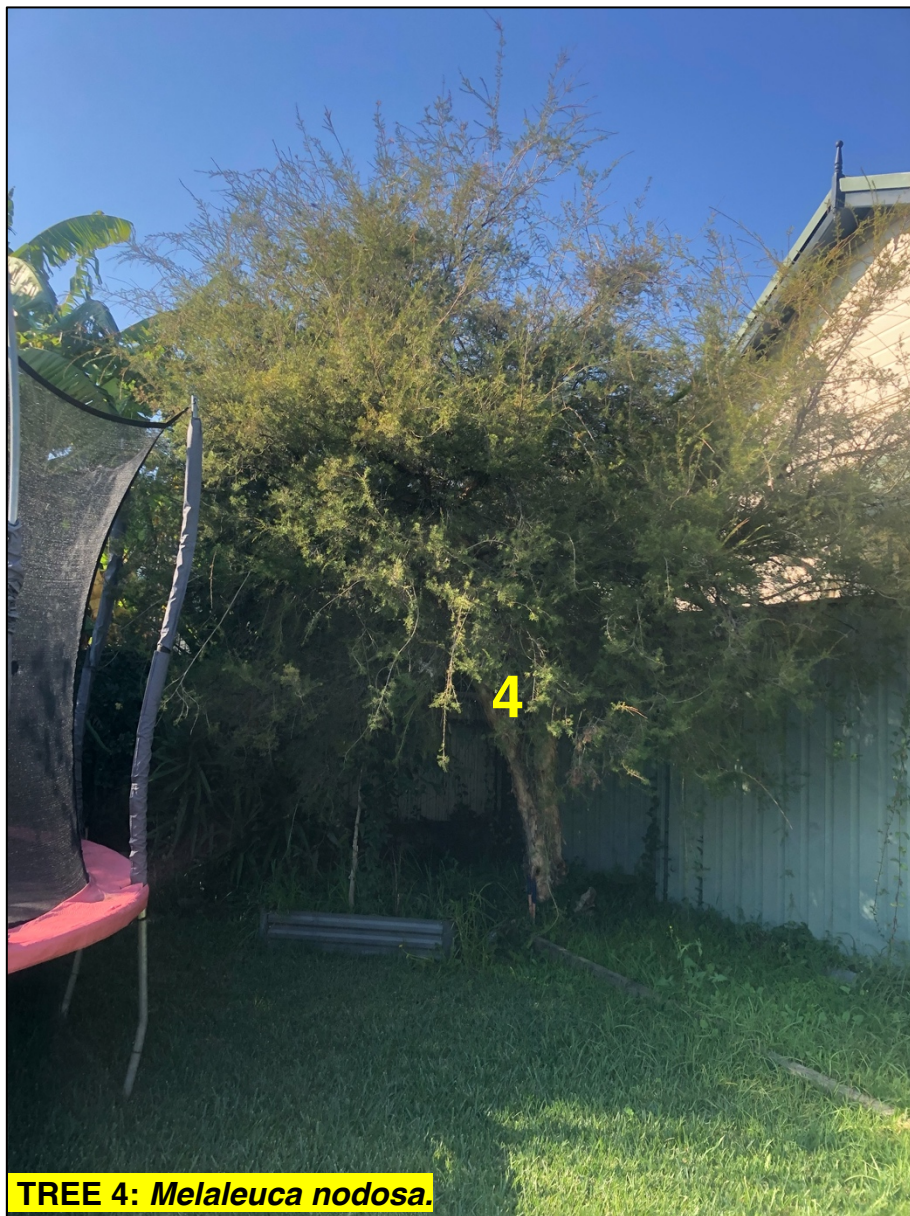
**TREE 4: *Melaleuca nodosa*.**

Tree 4 is a semi-mature site tree growing in the south-east corner of the subject sites rear yard.

Tree 4 has been proposed for retention. TPZ fencing complying with AS:4970-2009 will be required to ensure physical protection to the subject tree. Fencing is to be installed before demolition and is to remain in place throughout the duration of the project.

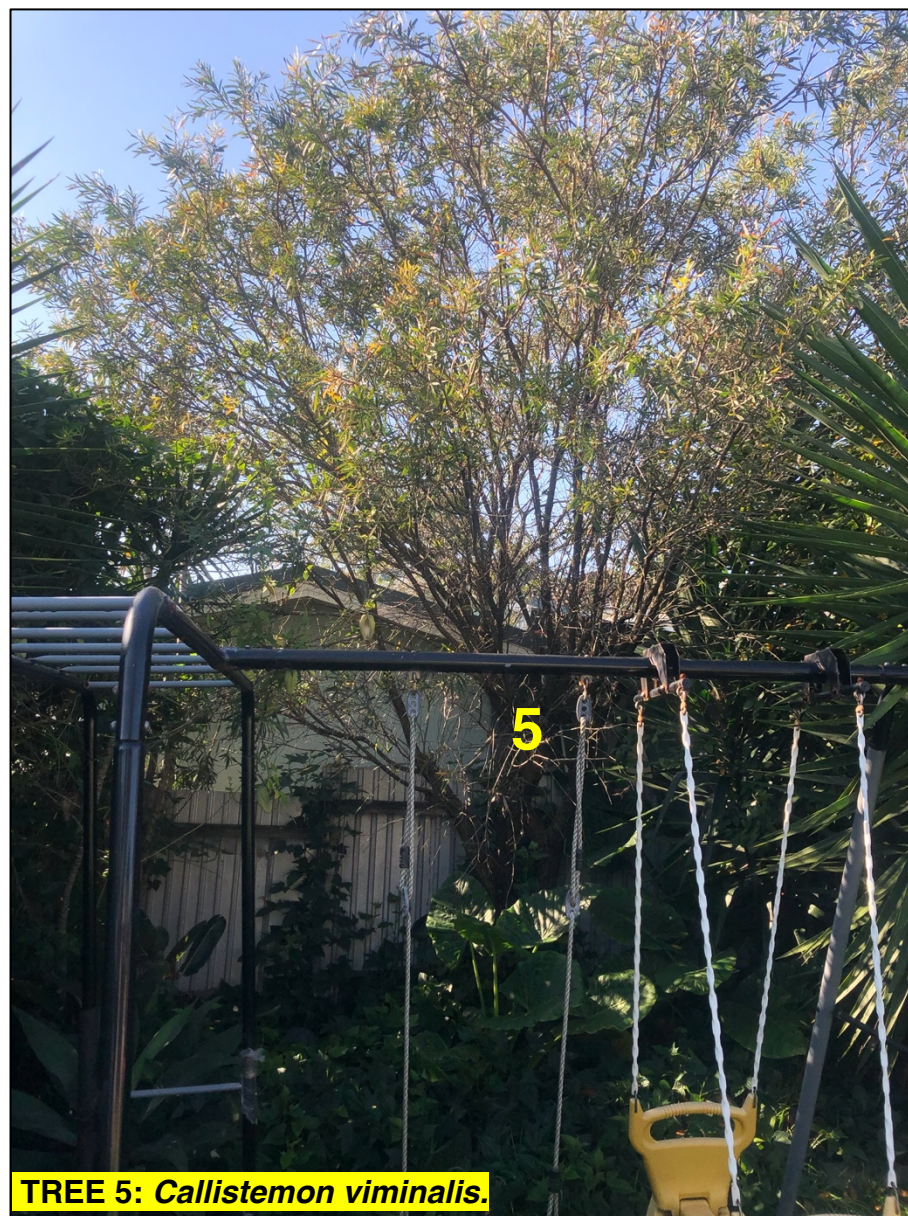
**TREE 5: *Callistemon viminalis*.**

Tree 5 is a semi-mature site tree growing in the south-east corner of the subject sites rear yard.
