## Geotechnical Assessment

# Proposed Residential Development 460 Kolodong Road, Taree NSW

Report Ref: G1246-SCFP-001-Rev0

10 September 2025

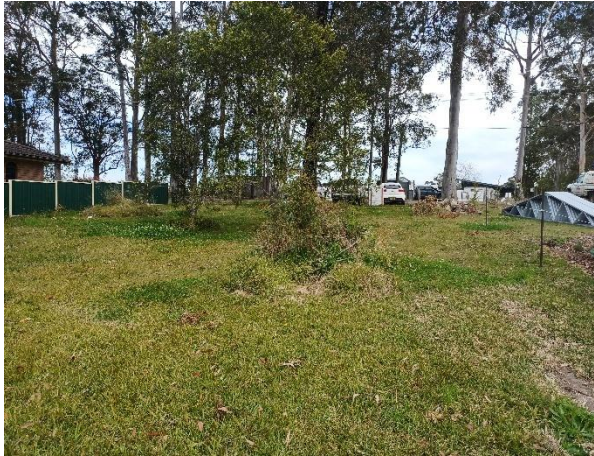
Figure 2: Looking west towards Kolodong Drive, showing a 3° slope to the southeast

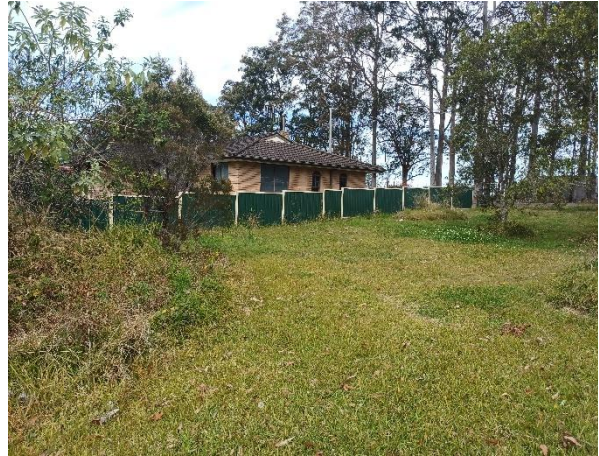
Figure 3: Looking across the southwest boundary showing the existing dwelling

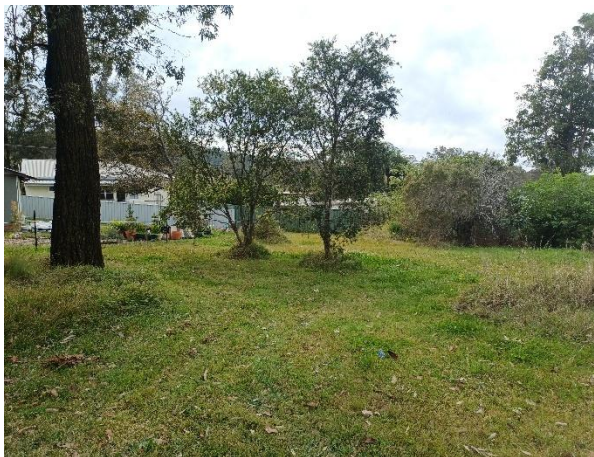
Figure 4: looking to the rear of the site, showing multiple scrubs and smaller immature trees

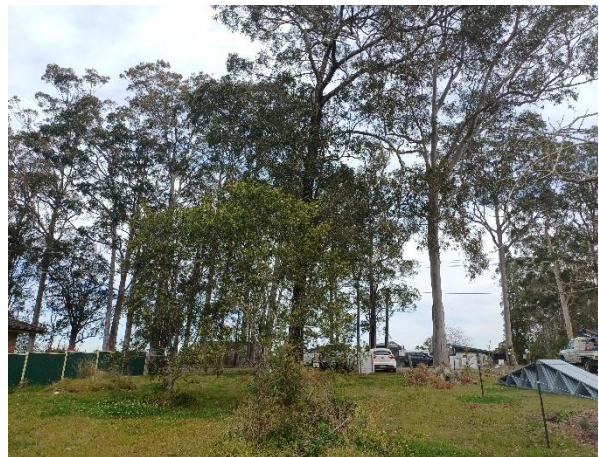
Figure 5: Looking towards the front of the development, showing large mature trees within influence of the proposed building footprint

The proposed building area is located within the influence distance of mature native trees. Potential surface movements must take into account the potential drying effects of trees and be calculated in accordance with the methodology outlined in AS2870-2011 (Appendix H). In accordance with AS2870, the site is classified as **Class P**, due to the abnormal moisture conditions influenced by the drought resistant trees.

The site should take into account the tree score effect in accordance with and designed to AS2870-2011. The site was found to have a “high” tree score effect and been taken into consideration in the characteristic surface movement calculation.
