### **1 PACKARD AVENUE CASTLE HILL, NSW**

### **DEVELOPMENT PROPOSAL**

## **ARBORICULTURAL IMPACT ASSESSMENT REPORT**

Report Ref No- 2322

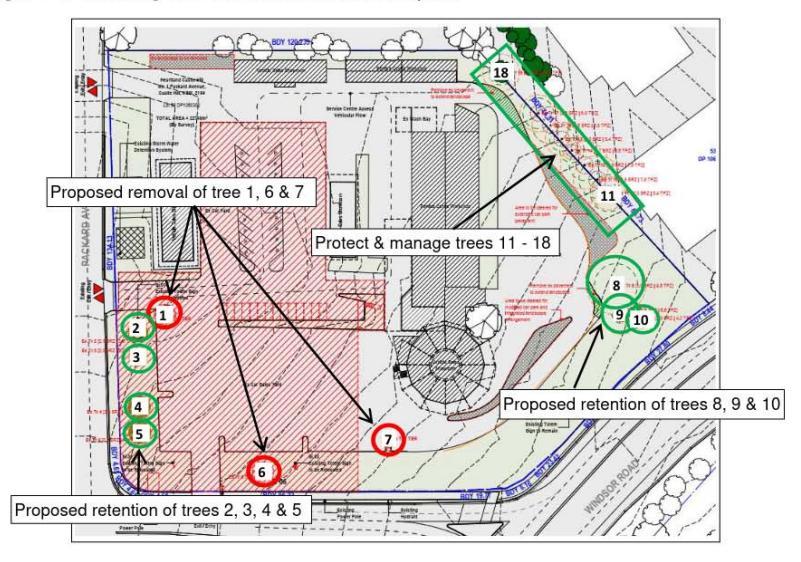
1.4.1 Based on the design footprint trees 1 & 6 fall within the proposed building footprint, or where basement excavations are proposed that require tree removal to accommodate design.

2.1.1 With the consent of Council the removal of two (2) prescribed trees T1 & 6 are required or recommended to accommodate the design proposal. The removal and/or management of exempt palm tree T7 and smaller trees & shrubs <5m in height is permitted without the Council consent.</p>

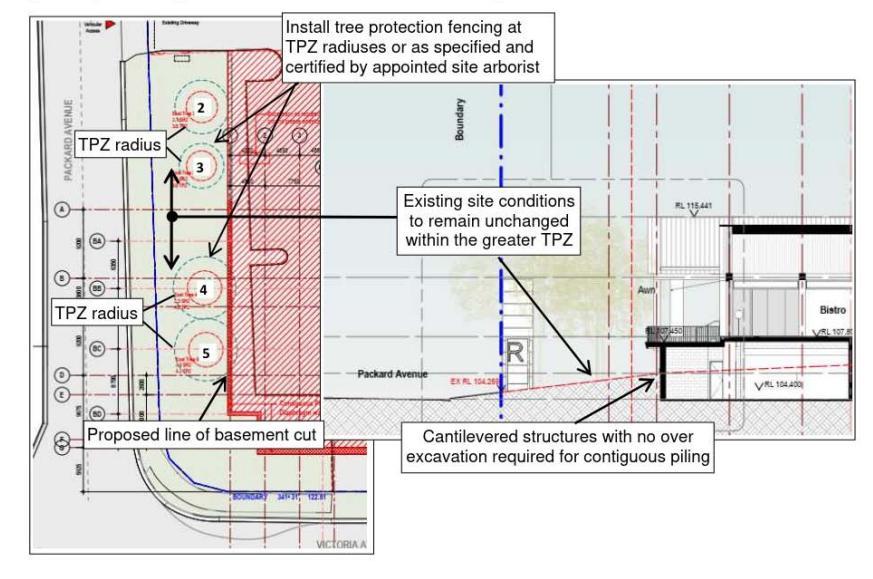
- 1.4.3 One (1) tree T5 receives Major encroachments within the TPZ with no works located within SRZ setback.
- 1.4.4 Tree 5: The proposed basement cut is considered as having a Moderate to Low (10-15%) TPZ occupancy of at or near 10.2%. The TPZ occupancy is considered a low-level impact where the tree can be suitably protected under the general guidelines specified within Section 2.3 *General tree protection requirements*.

- a) Within the tree protection zone there is to be no over excavation beyond the proposed contiguous piling as shown within Site Plan Dwg No: DA0401 and Figure 2 below.
- b) Prior to works tree protection fencing shall be installed, and certified by an appointed site arborist to allow for construction site access and tree protection as indicated within Appendix- B *Tree protection detail* items [A], [B] & [C].
- c) To allow for works within the TPZ ground & root protection mats should be considered opposite the building footprint where scaffolding within the TPZ is to ensure protection of extending canopies.
- d) There shall be no access, soil disruption or modification of levels within the greater TPZ or within 2m of the extending canopy.
