ARBORICULTURAL IMPACT ASSESSMENT AND TREE MANAGEMENT PLAN

PROPOSED RESIDENTIAL BUILDING AND ALTERATIONS DEVELOPMENT APPLICATION

**65 BERESFORD ROAD
BELLEVUE HILL, NSW**

23rd November 2020
Amended 23rd August 2021

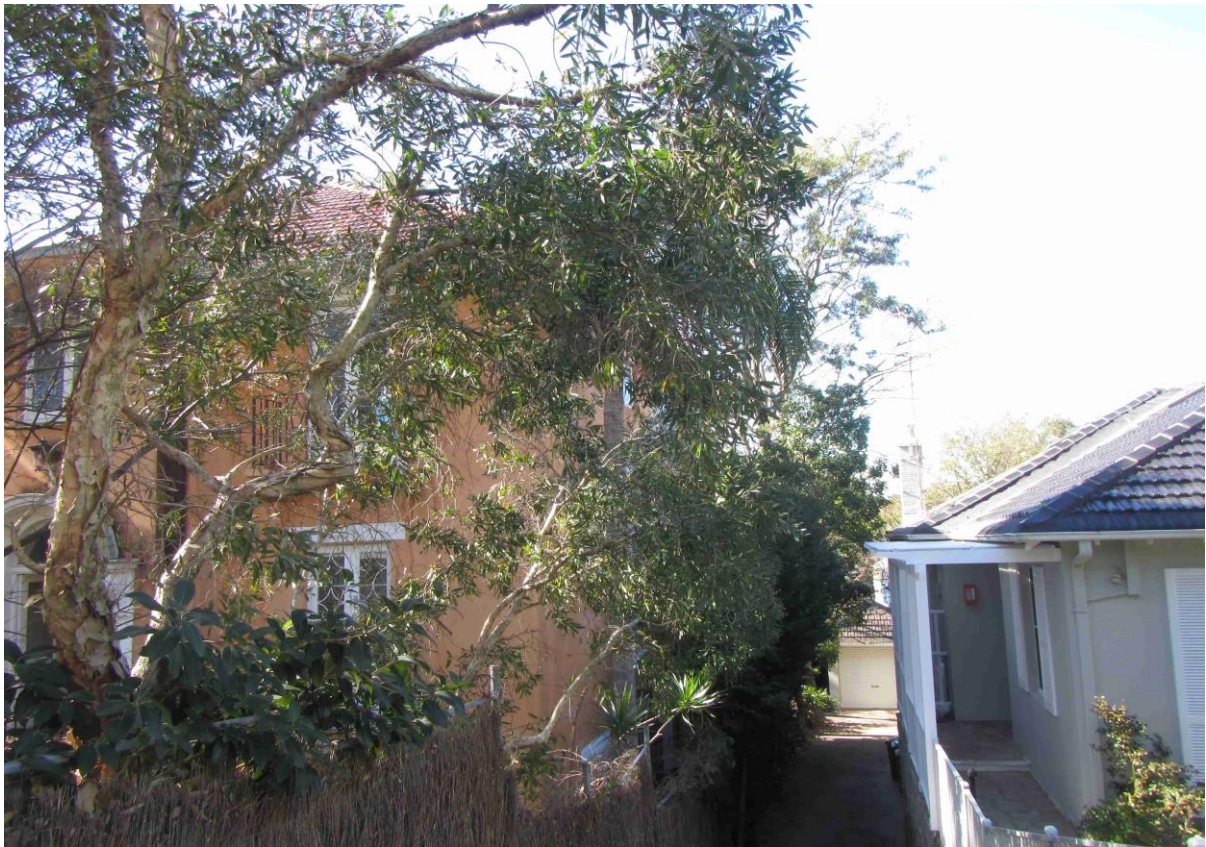
Figure 12 Shows an adjoining Paperbark tree which may require minor branch removal/pruning of limbs around 40mm for delivery access.

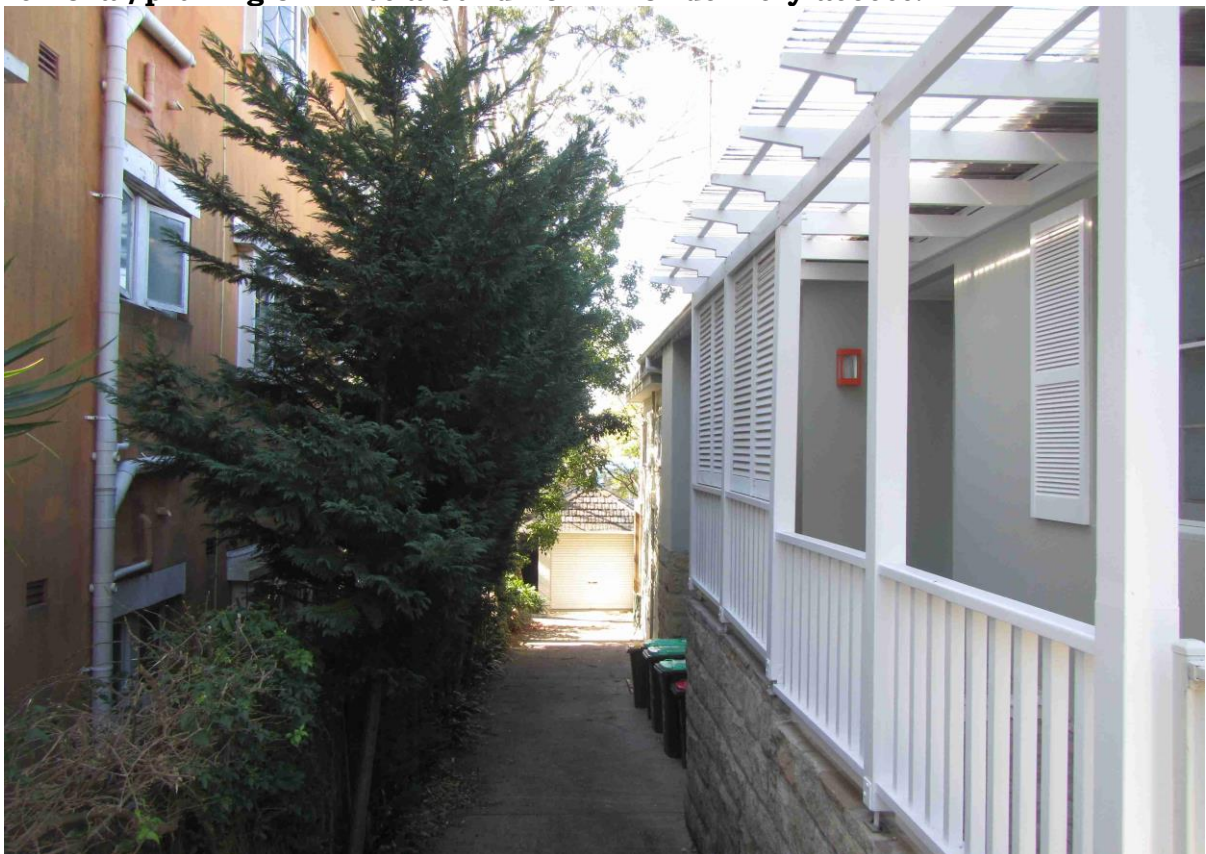
Figure 13 Shows Leylandii Conifers, that are TPO Exempt species that are recommended to be removed and replaced with an appropriate species.

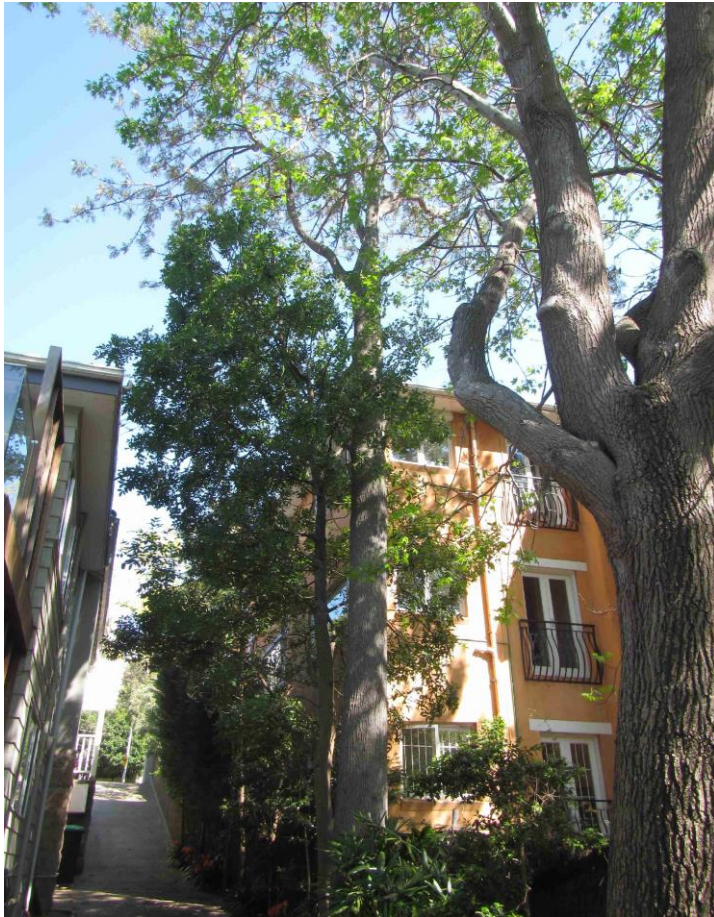
Figure 14 Shows Trees 1, 2 and 3 not impacted from the proposed works.

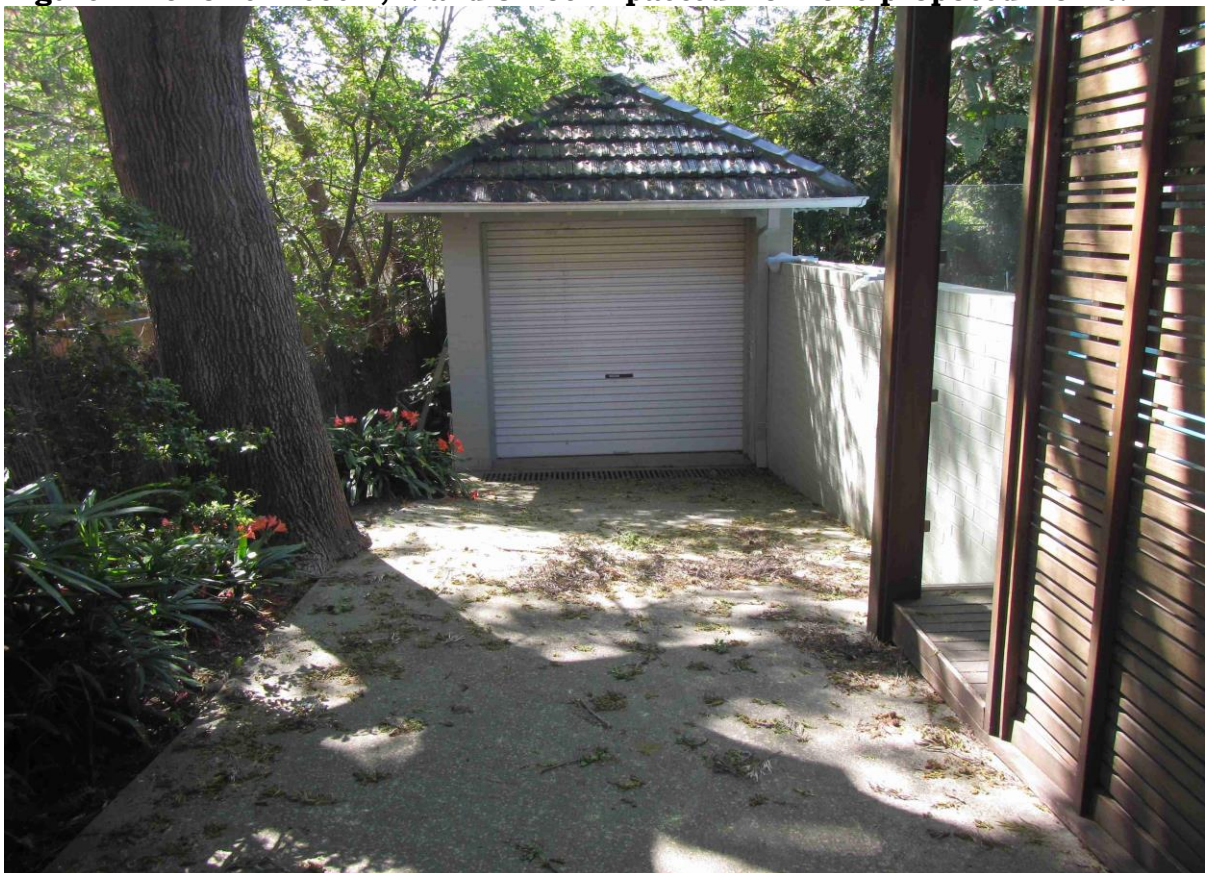
Figure 15 Shows Tree 3 and existing concrete slab levels to remain unchanged and In Situ with the exempt for minor stormwater drainage line installations.

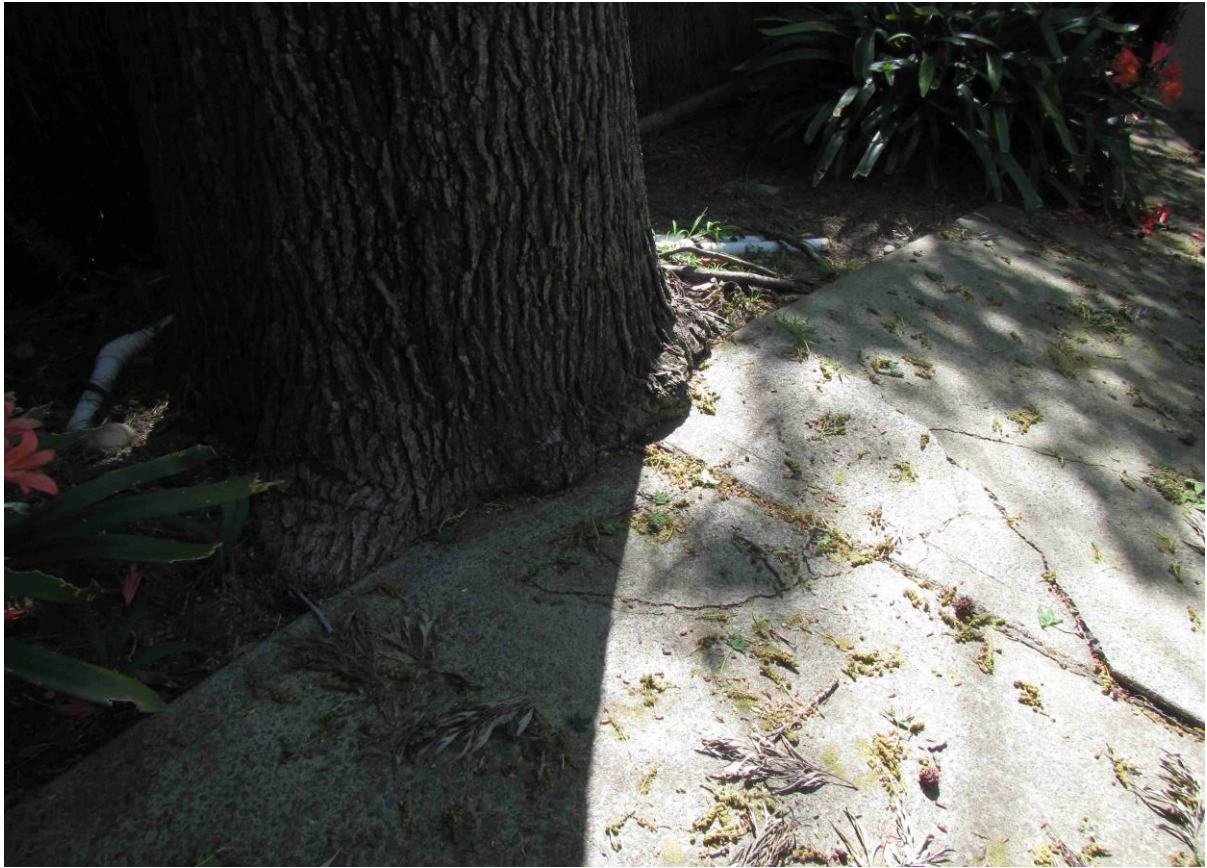
Figure 16 Shows Tree 3 with the existing driveway that is recommended to be removed from around the base of the tree to allow for future growth.

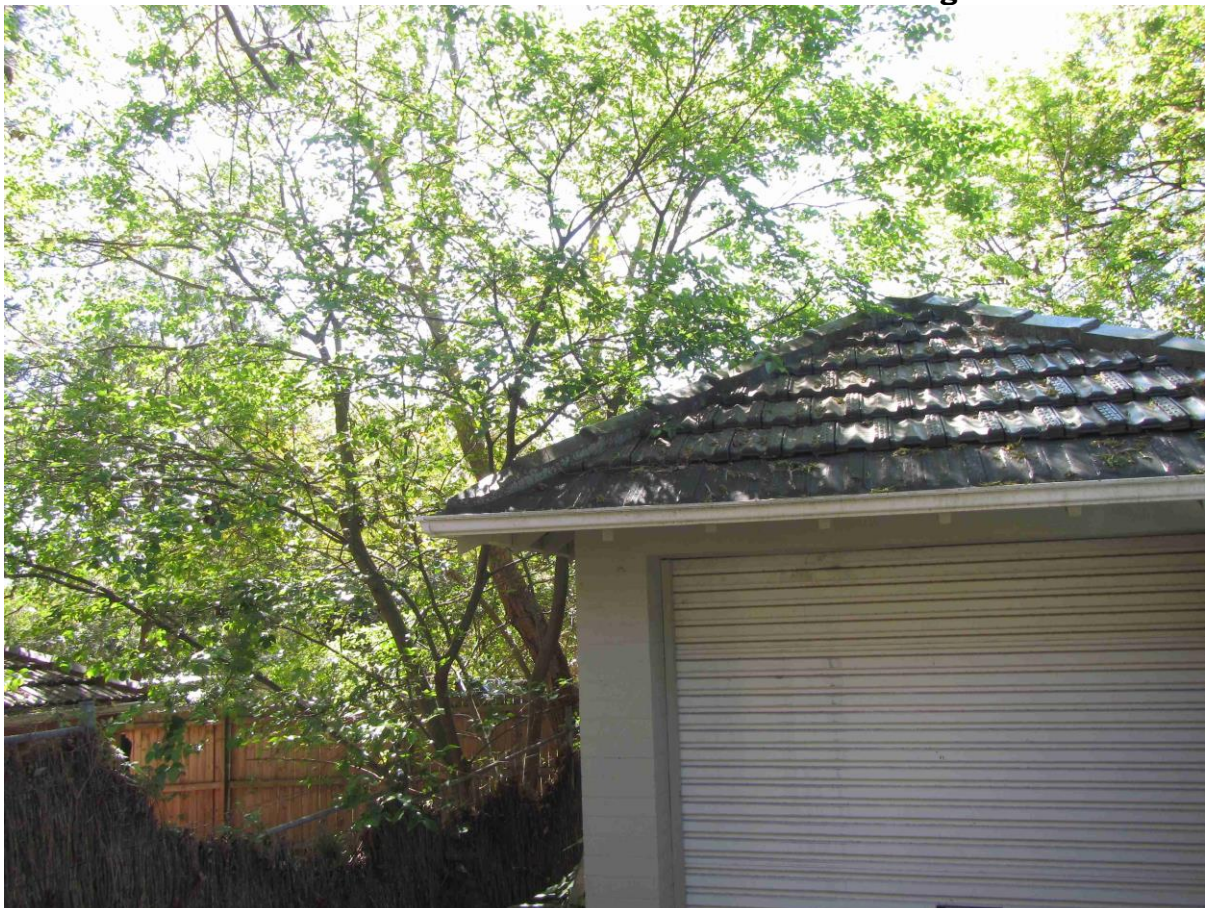
Figure 17 Shows adjoining Trees 4 and 4a being self-seeded Hackberry and Jacaranda trees within the existing retaining wall.

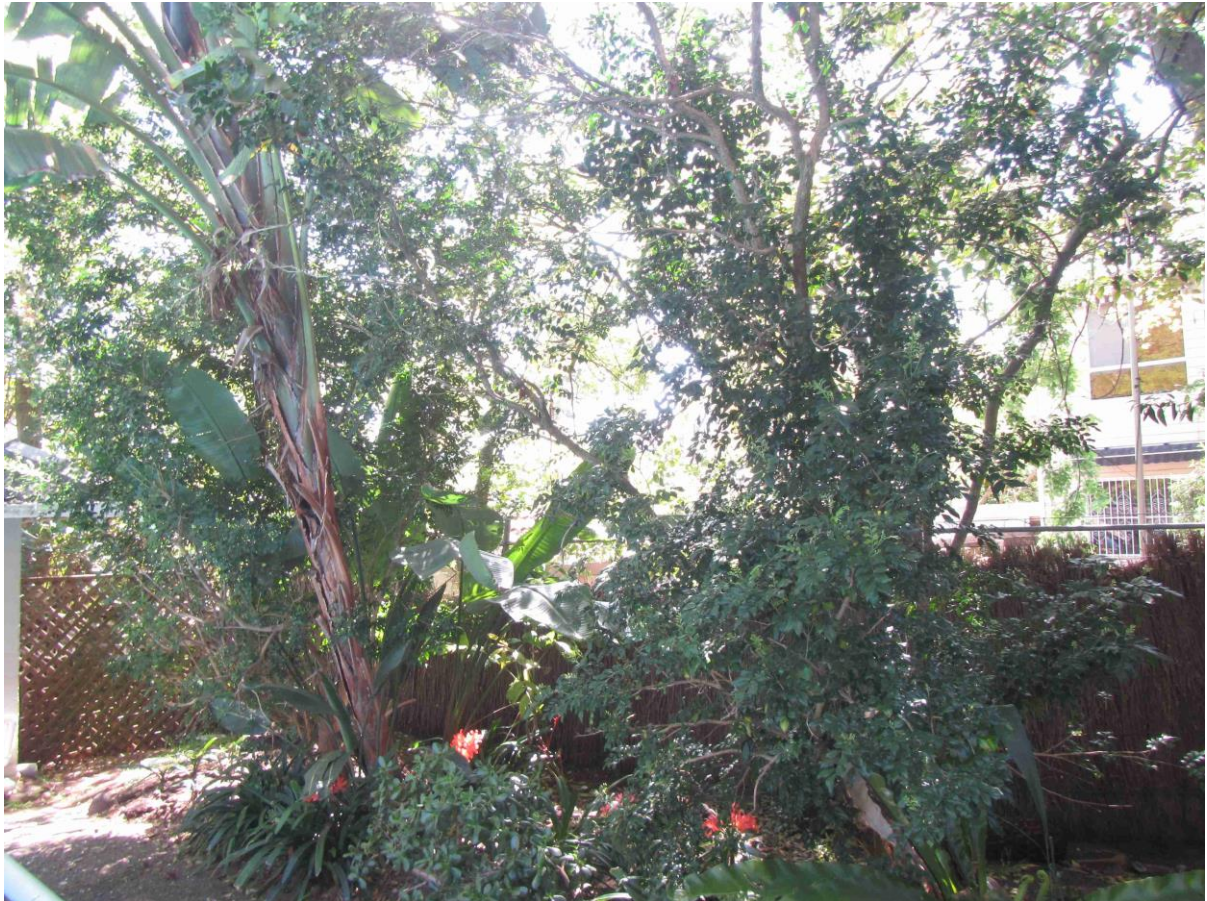
Figure 18 Shows Tree 5 being minor Mock Orange and Bird of Paradise.

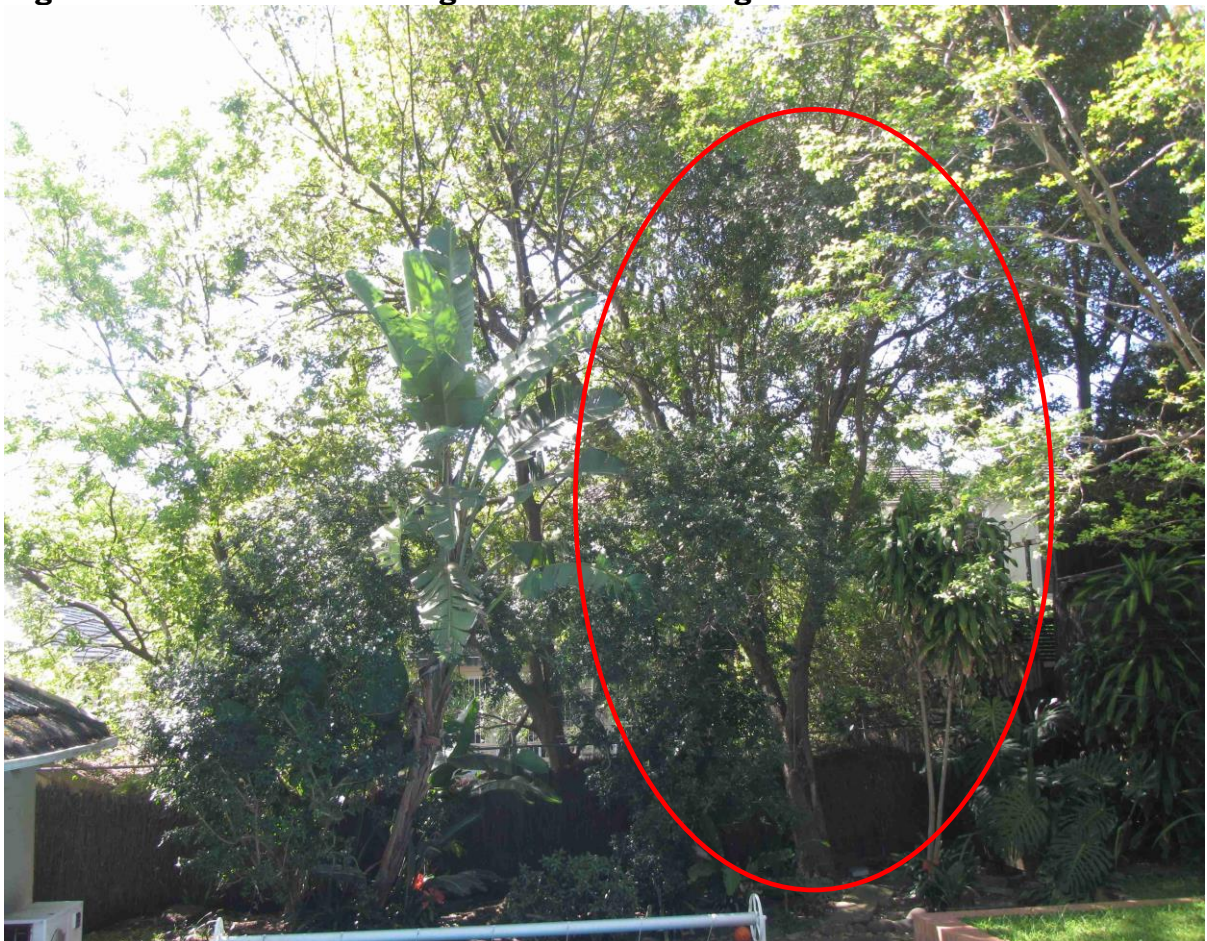
Figure 19 Shows the rear Tree 6 being an Exempt African olive to be removed.

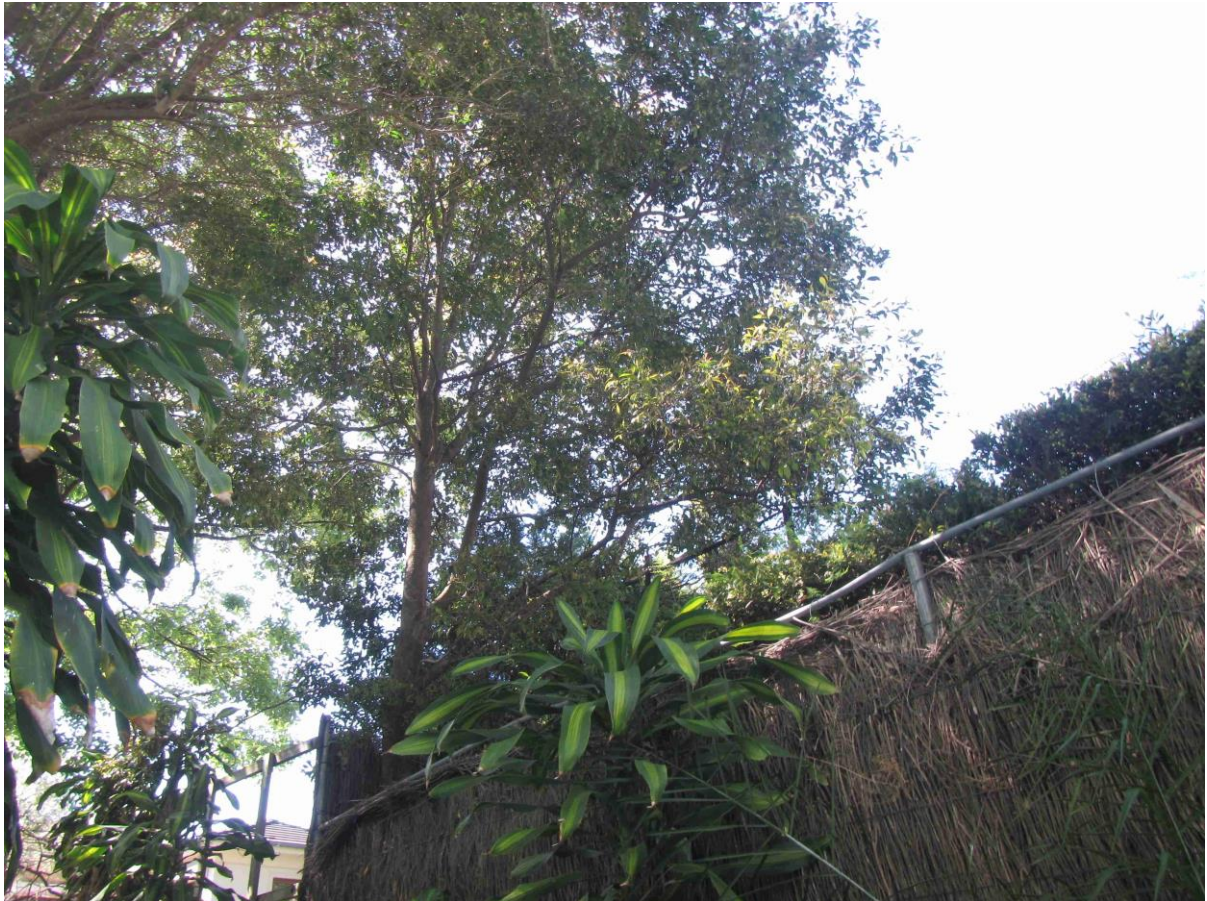
Figure 20 Shows Tree 7 located on the high side of an existing retaining wall

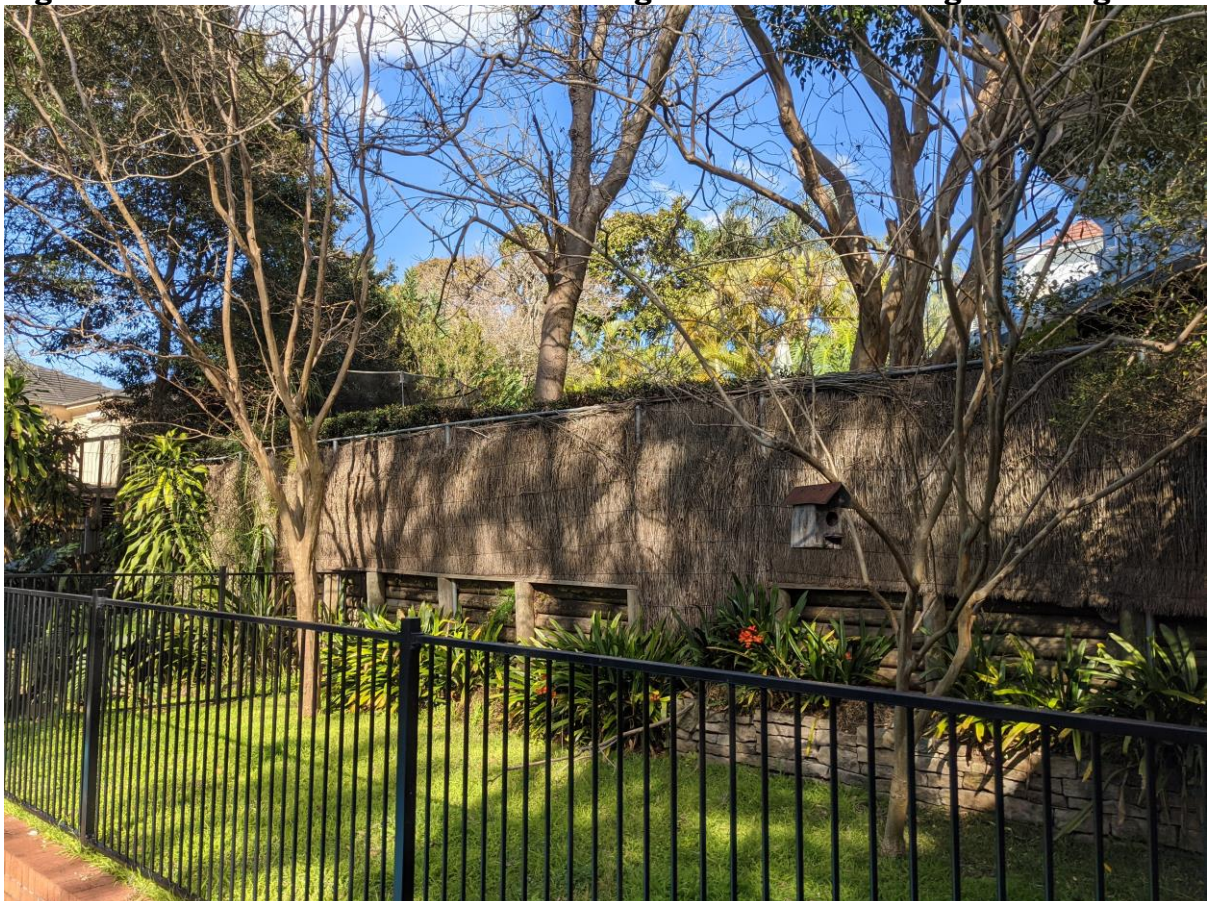
Figure 21 Shows minor Trees 8 and 9 that may be removed and replaced.

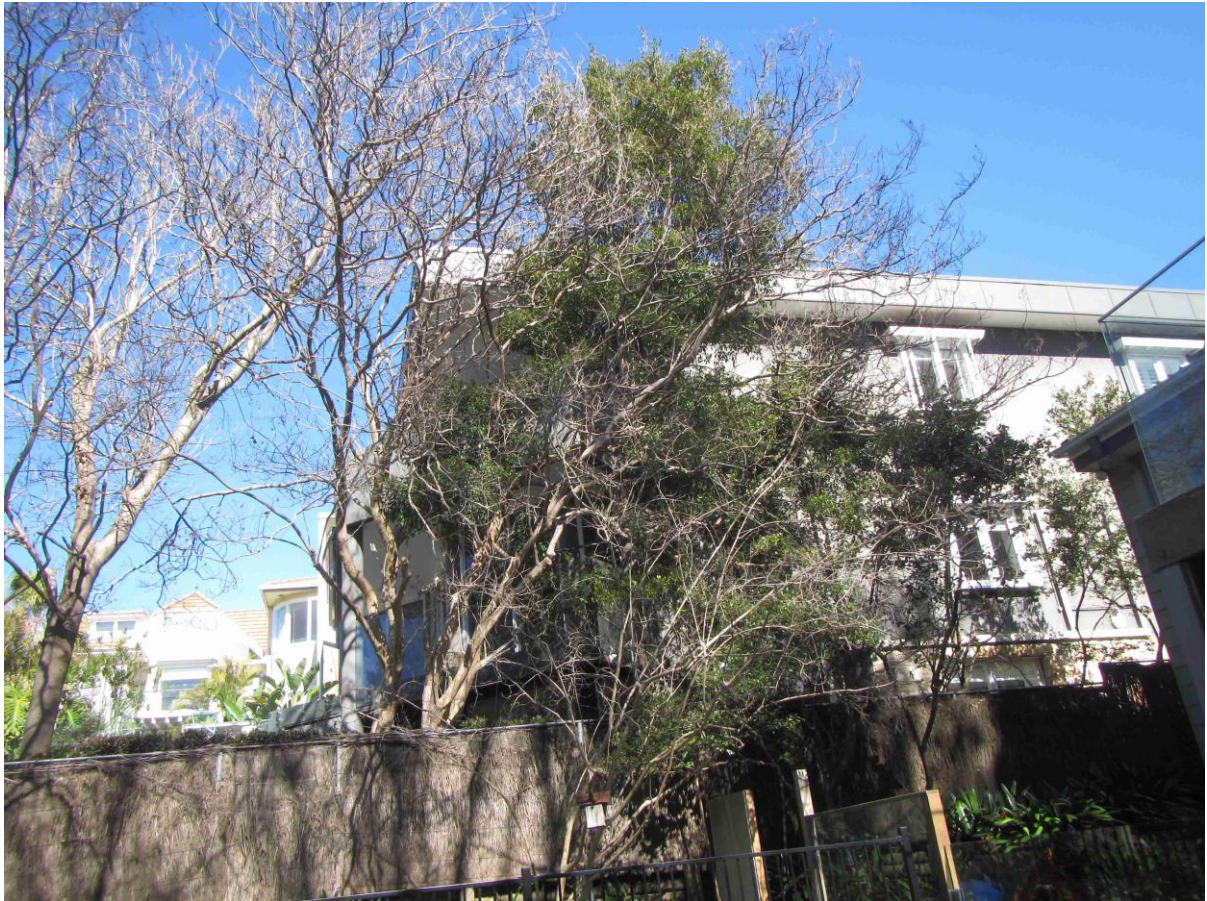
Figure 22 Shows adjoining Trees 10, 11 and 12 sufficiently distanced to be retained and protected being on the high side of the retaining wall, thus in impacts to the trees SRZ is proposed and anticipated.

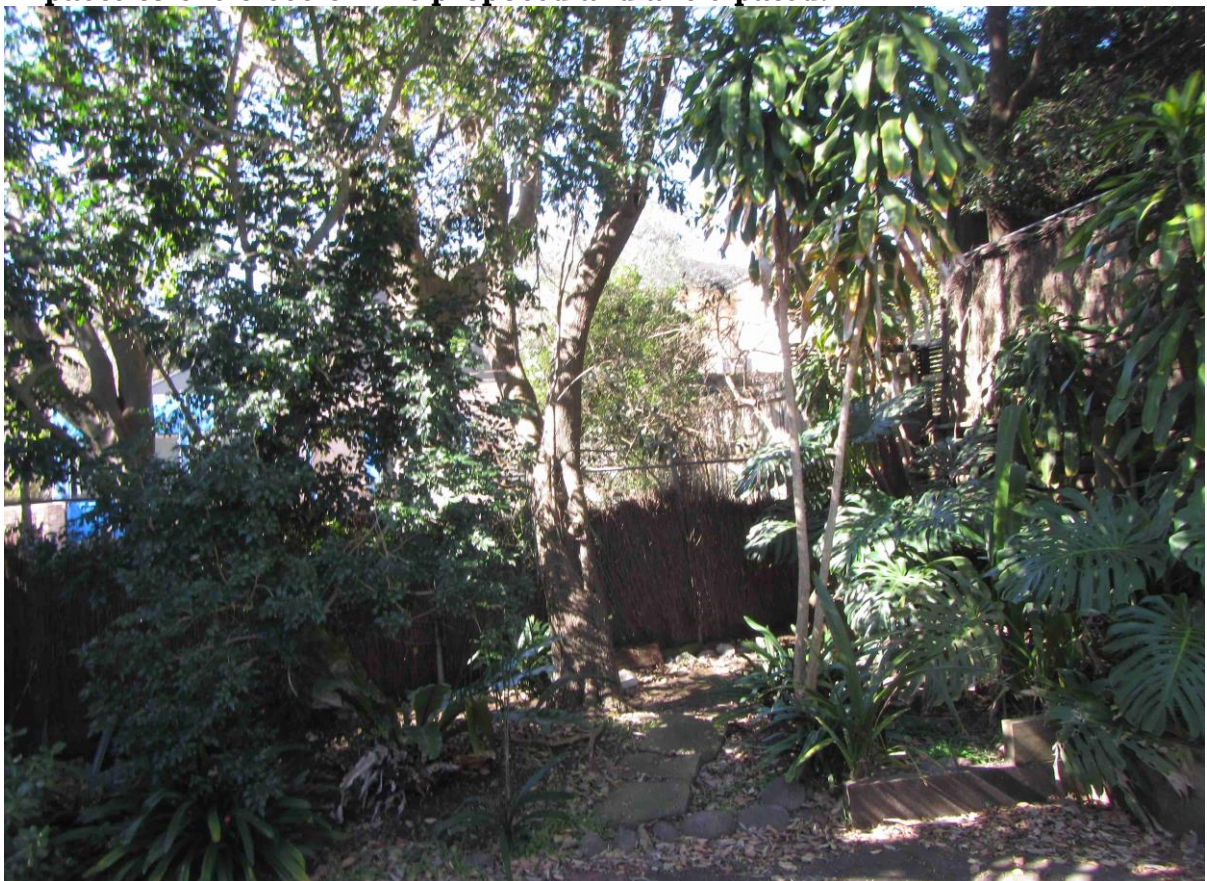
Figure 23 Shows again Tree 6 with minor trees to be removed.

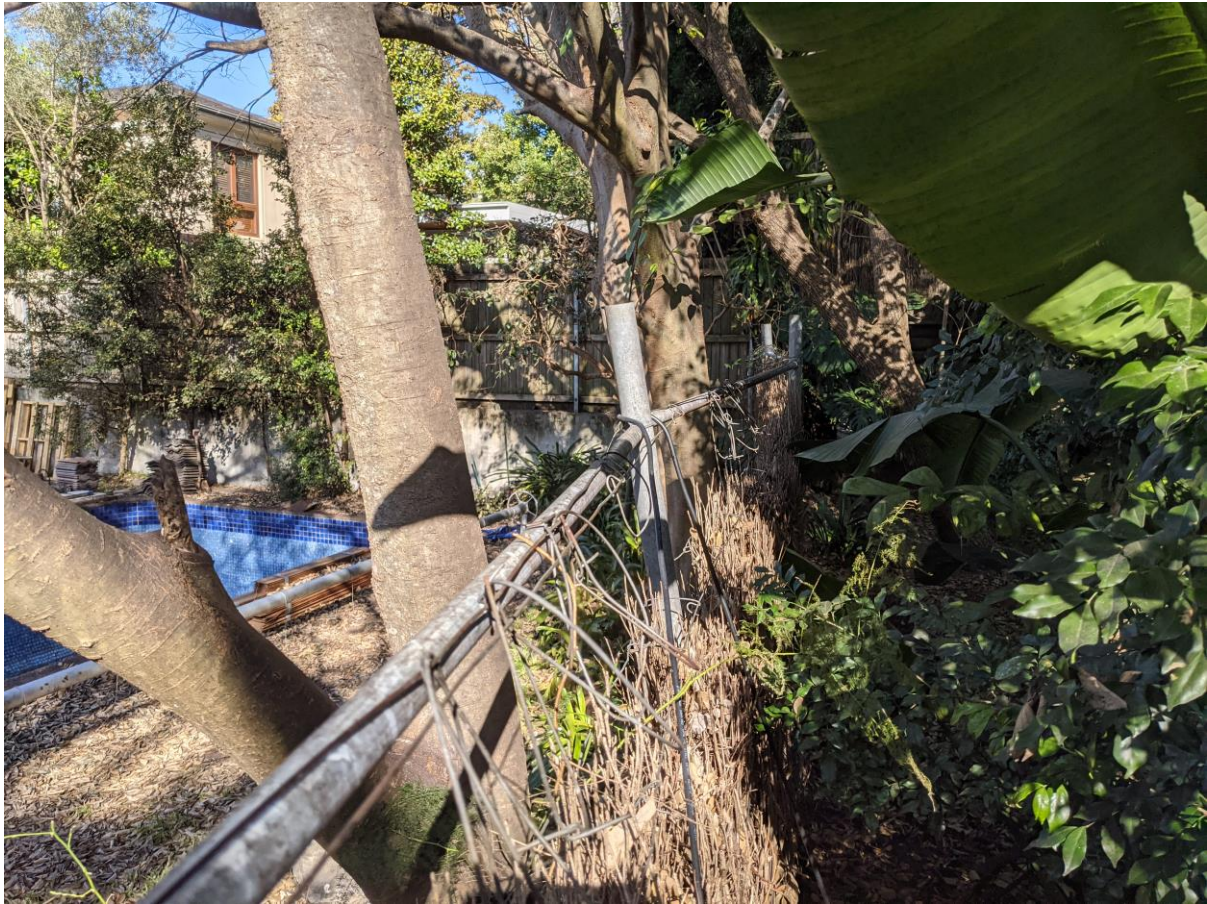
Figure 24 Shows adjoining Celtis, sufficiently distanced and unimpacted.

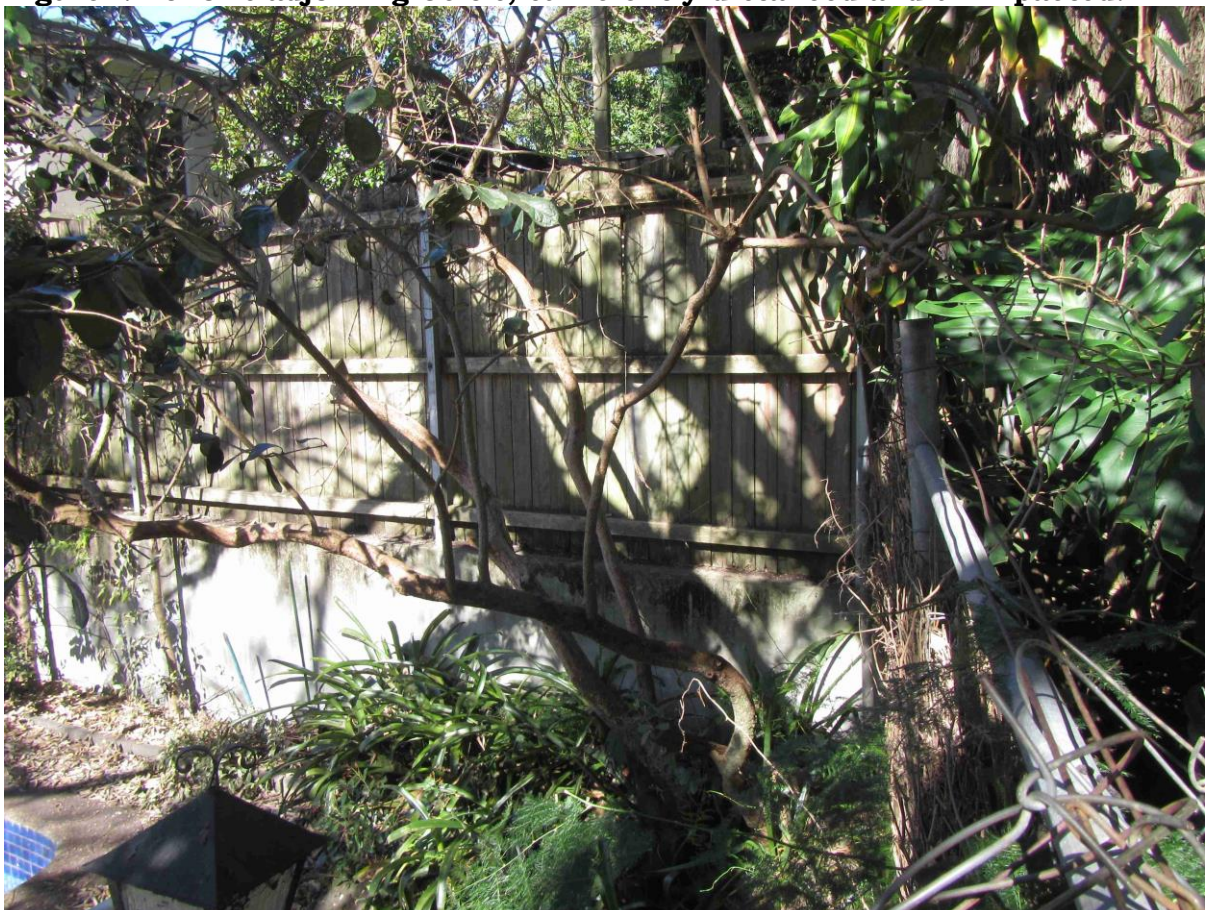
Figure 25 Shows Tree 16 a minor fruit tree, sufficiently distanced to be unaffected by these works.
