Arboricultural Impact Assessment

Prepared for Stephen Thompson
Site Address: 27 Bellevue Avenue Avalon

3rd September 2020, 30th September 2021 Revision G

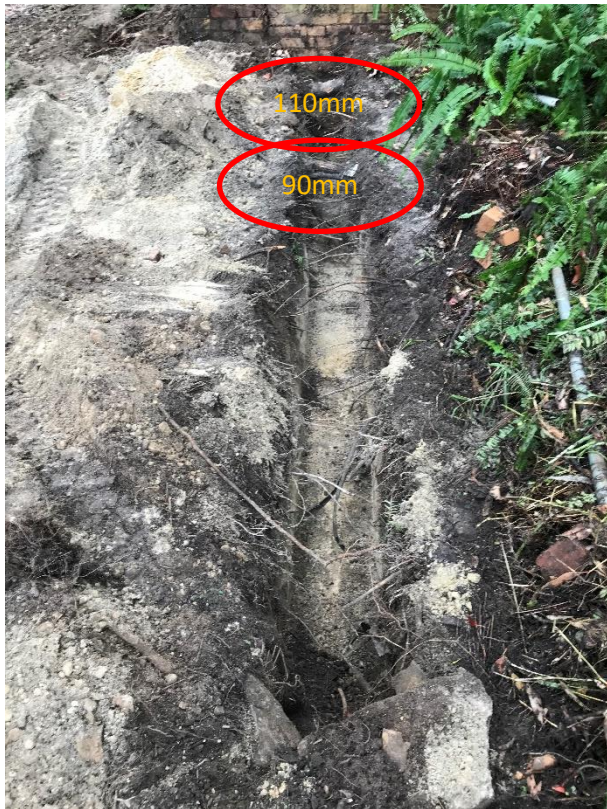
Of the remaining 37 trees, trees 37, 42 and 43 are in the neighbouring property of 29 Bellevue Avenue Avalon. There is no impact projected for trees 42 and 43. The encroachment as calculated from AS 4970-2007 for tree 37 is 23%. To provide an indication of the potential tree roots severed for this development a trench 700mm deep was excavated beside tree 37. Three tree roots 40mm, 90mm and 110mm were located. See section 6.2 for a plan of excavation. Due to the size of these tree roots, the impact if these were to be removed is closer to 10% compared to the calculated 23% incursion. The hardy nature of this tree species is well known and was shown to be one of the top performing trees planted in Hong Kong during forest rehabilitation programs (Corlett, 1999). Proposed works within the TPZ of tree 37 comply with AS 4970-2009. See figures 2 and 3 below.

Figure 3 Trench looking west 2 tree roots

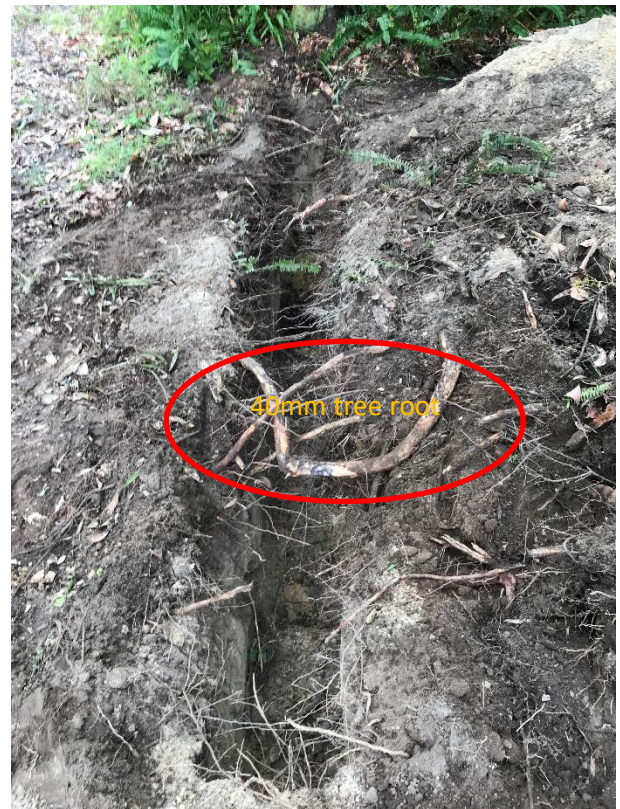
Figure 2 40mm tree root located within trench

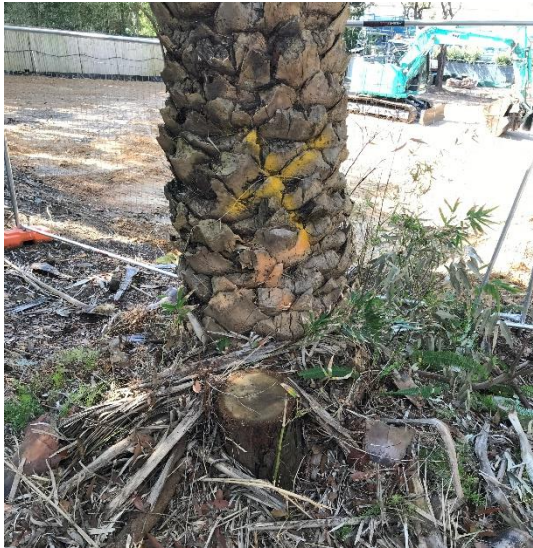
Of the remaining 34 trees, trees 1, 2, 3, 4, 5, 6, 7, 8, 9, 10, 11, 12, 13, 14, 15, 21, 24, 27, 28 and 29 are located on council property. It is proposed that all these trees are retained and protected. Projected impact to the TPZ has been included in table 5 page 7 and figures 5 and 6 below. No incursion is greater than 10%. The TPZ incursion for the construction of the tandem carpark for trees 7 and 13 is less than 9% and 8% respectively. This is in accordance with AS 4970-2009. Trees 11 and 15 have been removed by council. See figure 4 below.

Figure 4 Tree 11 has been removed, stump remains

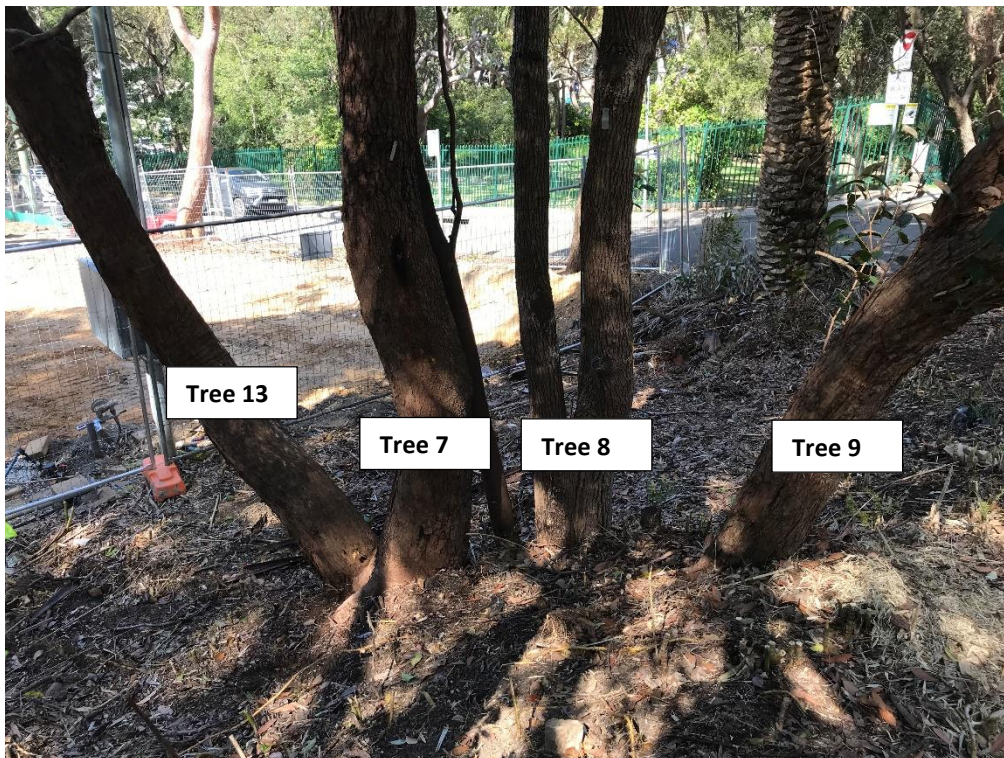
Figure 5 Trees 7, 8, 9 and 13

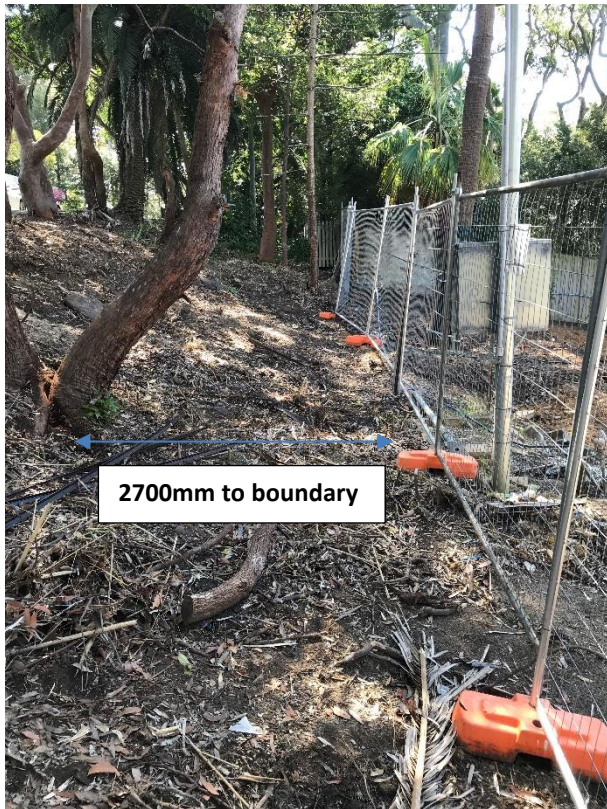
Figure 6 Distance of tree 13 from boundary, 2700mm.

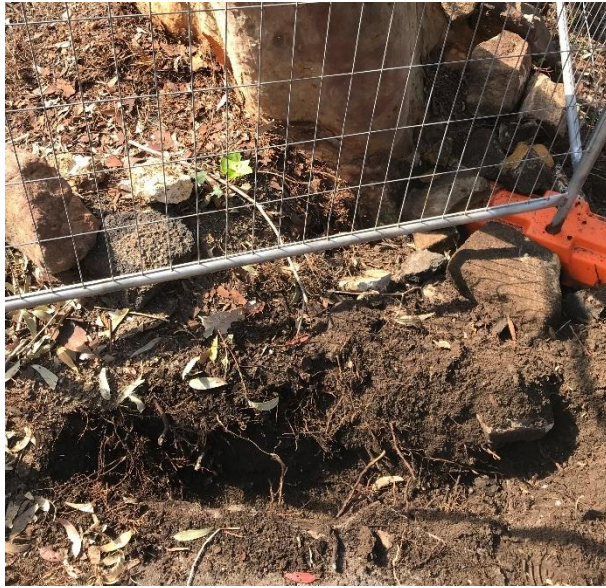
Figure 8 Up hill western trench 200mm deep, no tree roots from tree 21

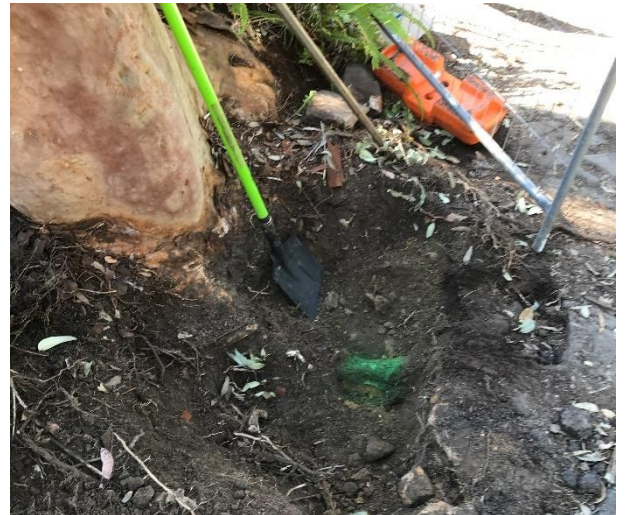
One 40mm tree root at a depth of 200mm below existing grade was located. This tree root is deeper than the proposed excavation and will be retained. See figure 7 below.

Figure 7 Middle trench, excavation between the road and tree 21. One 40mm tree root located 200mm below ground level

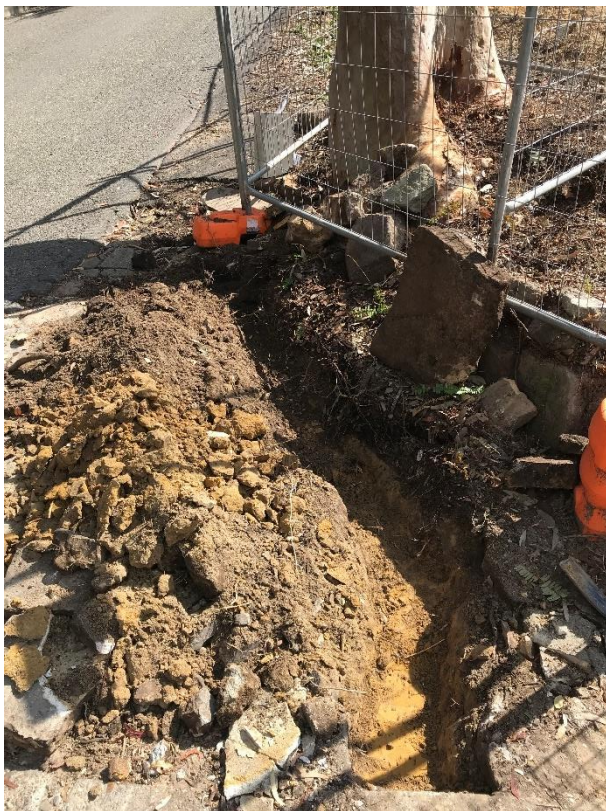
Figure 9 Lower trench 200mm deep no tree roots from tree 21

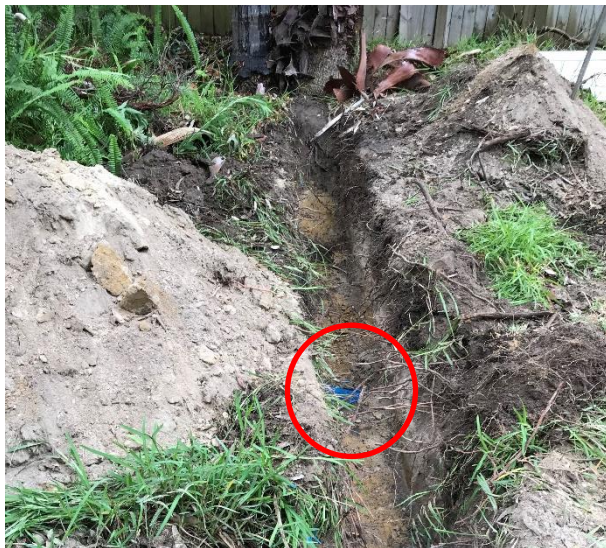
Figure 12 Tree root 110mm found 4 metres from tree 21

The proposed stormwater has been reduced in length, part of it remains within the TPZ. The pit is required to drain any overland flows and the drainage grate is required for any excess water from the driveway. The position of the pit within the TPZ can be repositioned if required so as not to impact any tree roots. Excavation to install the pit and pipes must be hand excavated under the supervision of the project arborist. Any tree roots greater than 30mm must be retained.

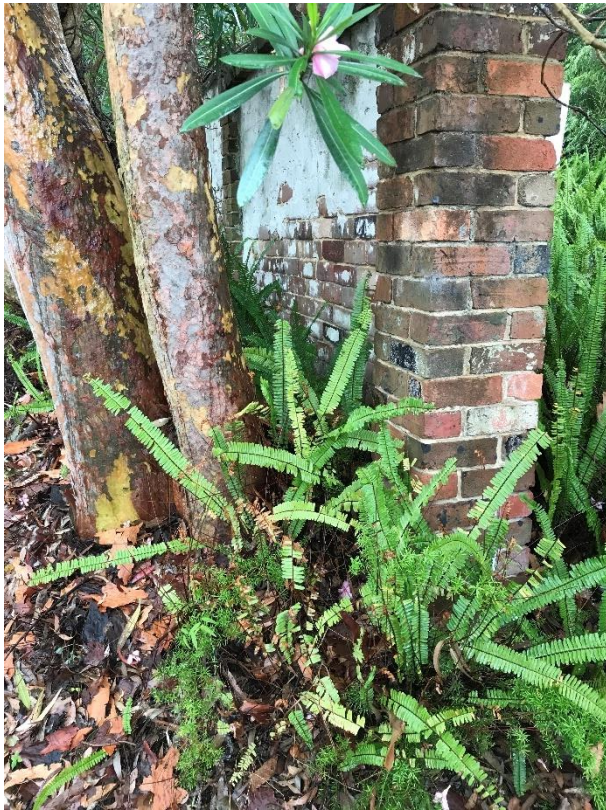
An existing masonry wall is located on the boundary beside trees 27, 28 and 29. A tree root survey was conducted to determine extent of root growth, particularly from tree 29. The trench was excavated beyond the wall to the west. No tree roots of significance were located. The masonry wall is acting as a tree root barrier and preventing tree roots from trees 27, 28 and 29 entering the property of 27 Bellevue Pde Avalon. Any proposed works inside of the existing masonry wall will not affect trees 27, 28 and 29. The incursion for all 3 trees is within the guidelines of AS4970-2009. See figures 13, 14 and 15 below. It is proposed this masonry wall is removed for this development this will increase the available soil volume for these 3 trees.

Figure 13 Masonry wall beside tree 29

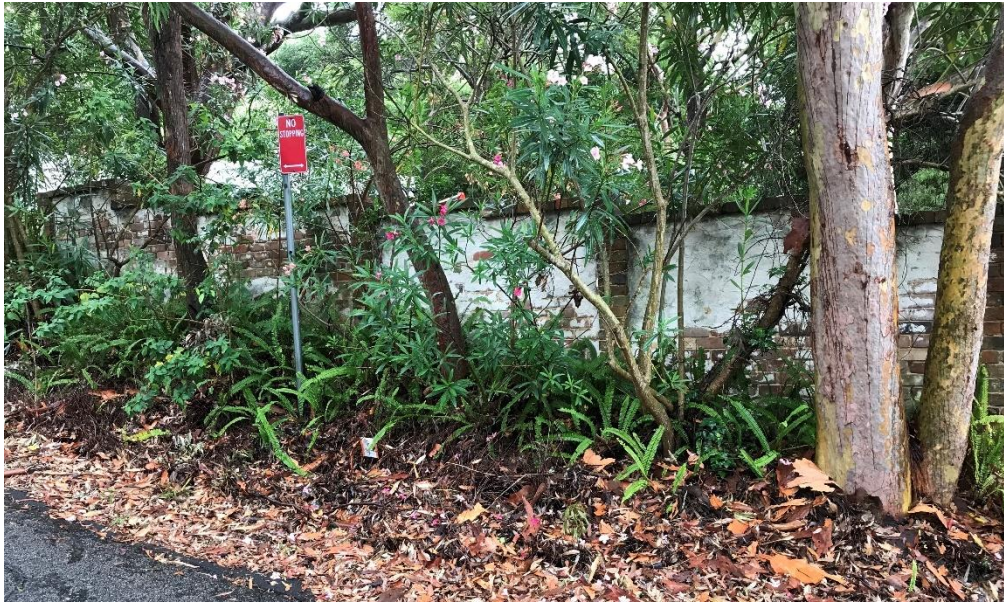
Figure 14 Masonry wall behind trees 27, 28 and 29

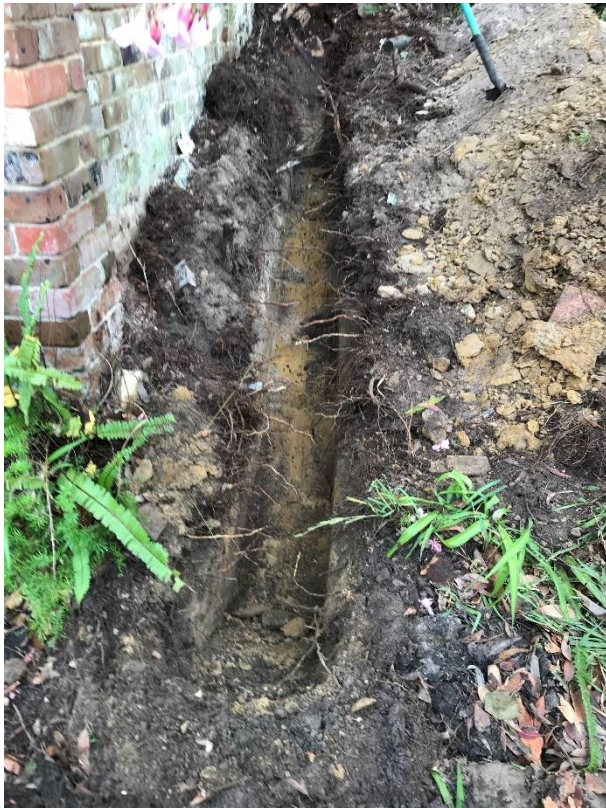
Figure 15 Trench beside tree 29

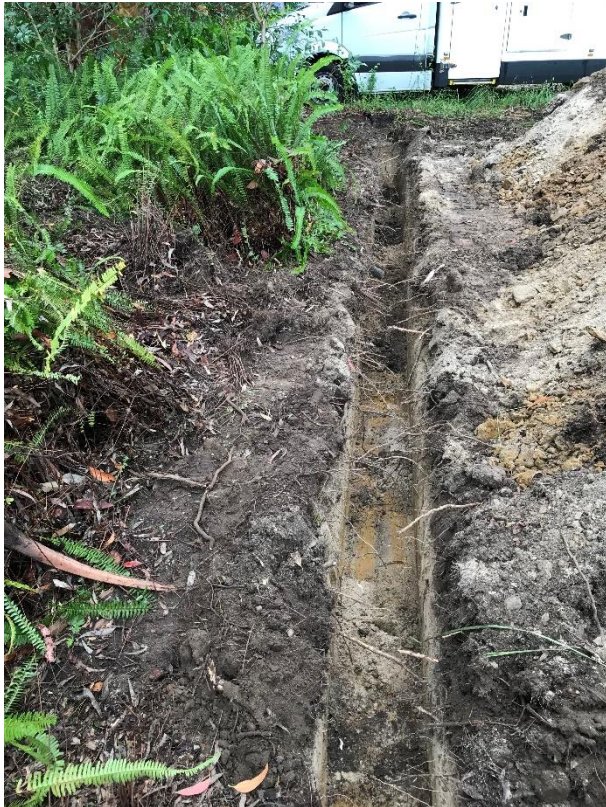
Trees 26 has a calculated 36% incursion to the TPZ when using the Australian Standard formulae. The potential impact to this tree is the building and walkway. A tree root survey was conducted to determine the size and number of tree roots that may be potentially severed for this proposed construction. The trench location found the lower building would not impact this tree as there were no tree roots greater than 10mm located during the survey. The depth of the trench was 700mm. See figures 16, 17 and 18 below.

Figure 17 Trench beside tree 26 looking west

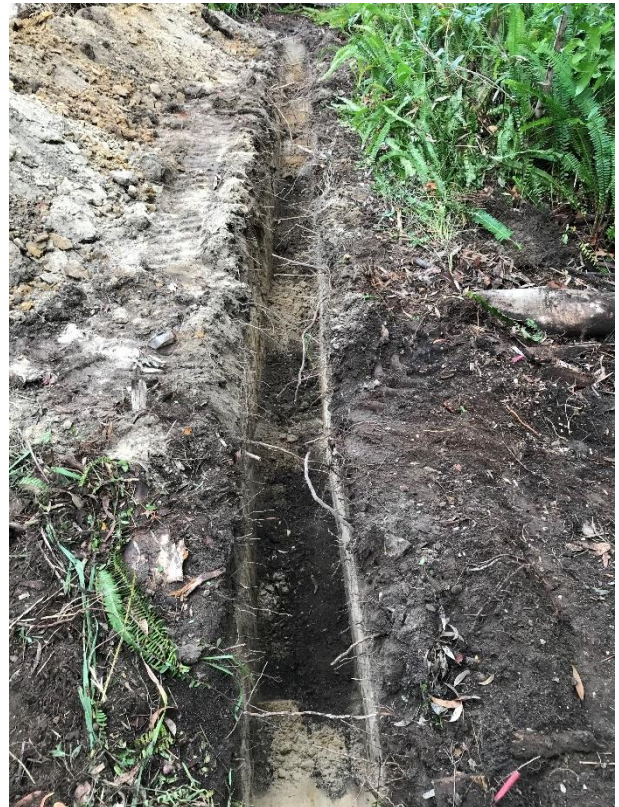
Figure 16 Trench beside tree 26 looking east

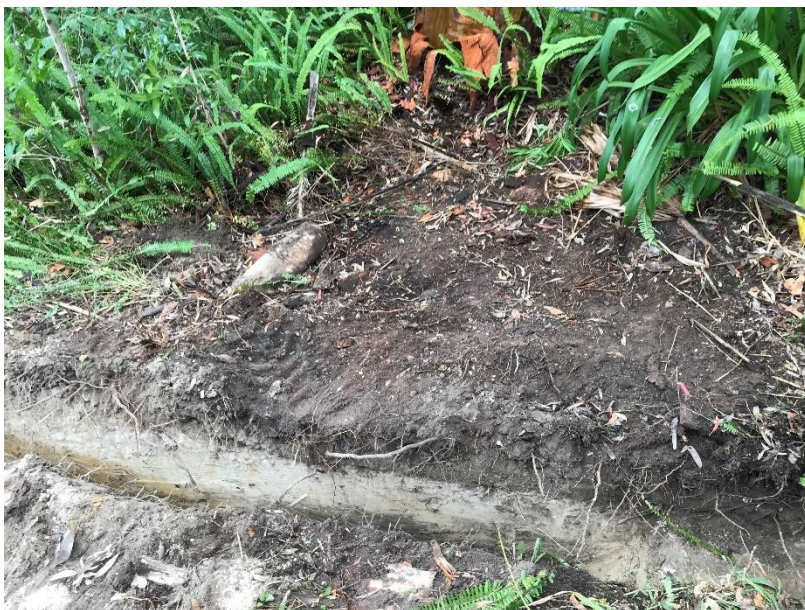
Figure 18 Face of trench beside tree 26, no roots encountered.

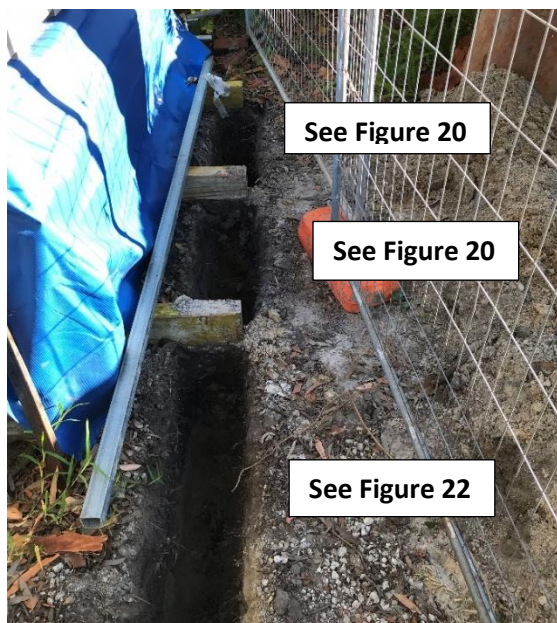
The encroachment into the TPZ for tree 33 has been calculated at 9.7%, the building has been relocated outside the SRZ and this has reduced the basement's impact. To determine the actual impact to this tree a root survey was conducted. A trench was hand excavated 700mm deep to heavily compacted sand, 3 metres from the northern boundary and 2.7 metres from the eastern boundary. The trench was 3 metres long. One tree root 20mm was located and no structural or significant tree roots identified. The proposed impact to this tree is less than 10% and this complies

Figure 19 Trench beside tree 33

Stormwater installation through the TPZ must be undertaken by hand excavation. The removed masonry wall is likely to leave a trench. The stormwater should be located where the masonry fence was located, to reduce its impact.

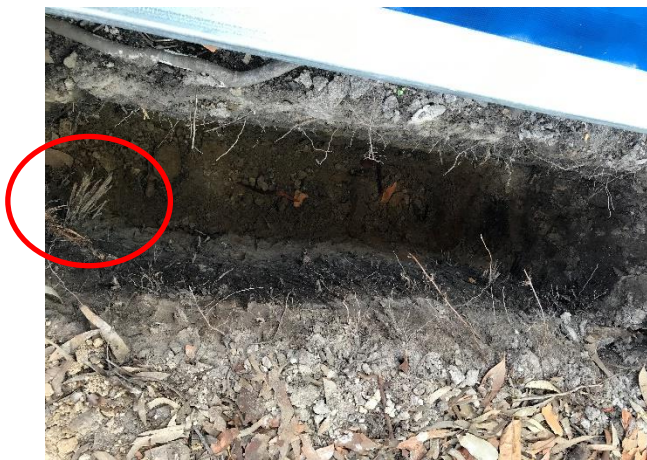
Figure 21 Northern section, 20mm tree root located.
