ARBORICULTURAL IMPACT ASSESSMENT AND TREE MANAGEMENT PLAN

3rd May 2021

Proposed 12 Rooms Boarding House at 227 Bungaribee Rd Blacktown NSW

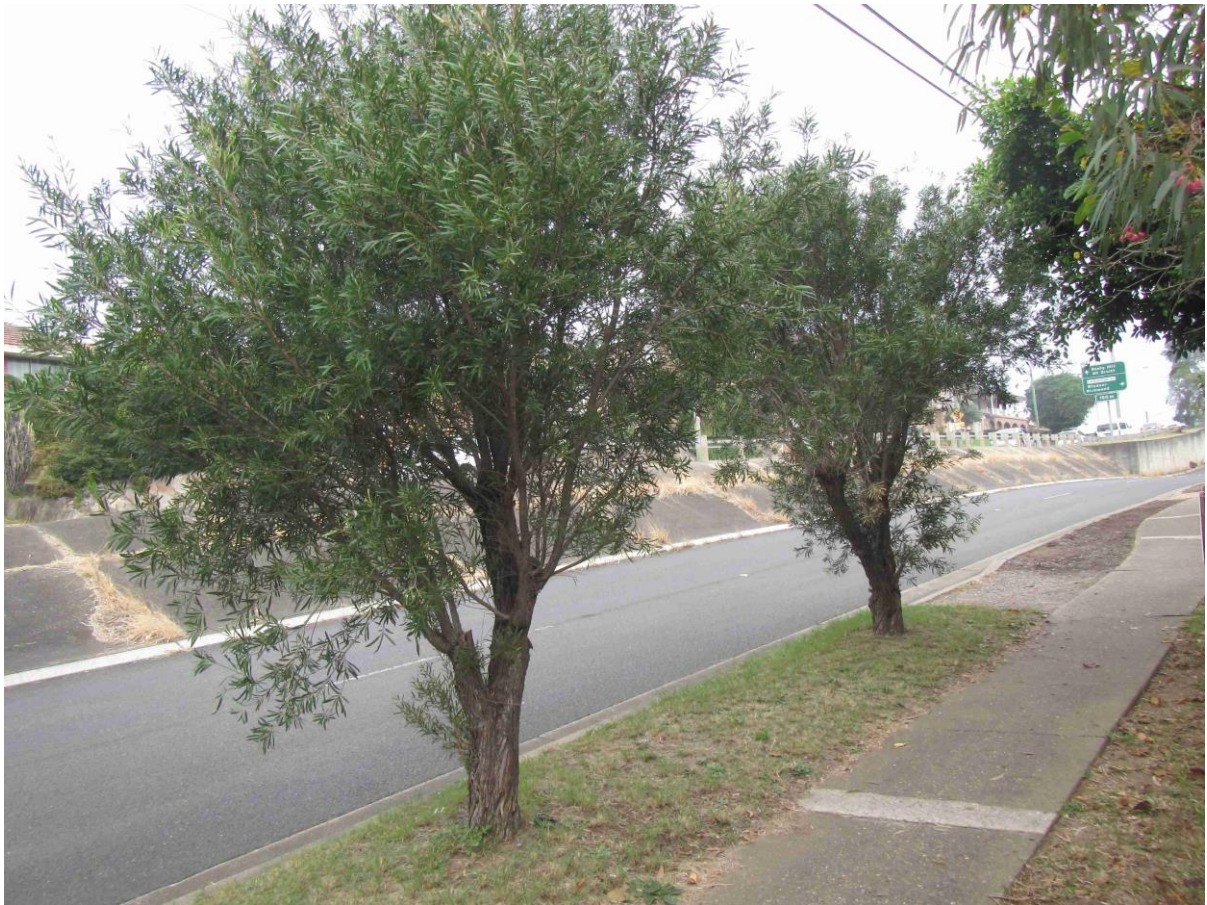
1.	Weeping Bottlebrush <i>Callistemon viminalis</i> Council Street Tree	2.5	260	270	N/A	N/A	Mature	Good	Good	3	Nil	Low	Nil to Low	This minor planted Council street tree is required to be removed as it is located within the proposed new basement driveway viewing sightline for exiting the boarding house, it will be replaced in landscape upon completion.

2.	Weeping Bottlebrush <i>Callistemon viminalis</i> Council Street Tree	2.5	220	230	N/A	N/A	Mature	Good	Good	3	Nil	Low	Nil to Low	This minor planted Council street tree is required to be removed as it is located within the proposed new basement driveway excavation area, it will be replaced in landscape upon completion.

Figure 7 Shows Council street trees numbered 1 and 2 required to be removed

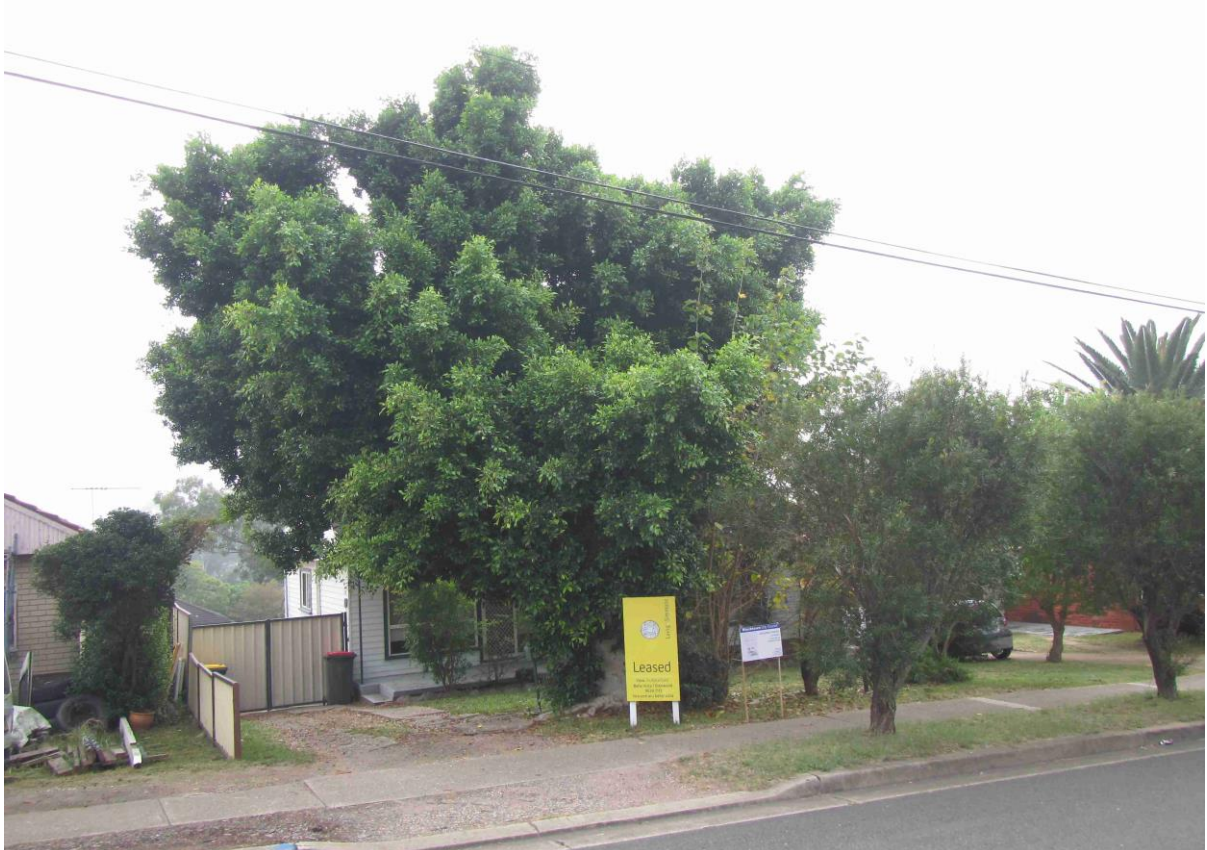
Figure 8 Shows Trees 1, 2 and 3 from a distance to be removed.

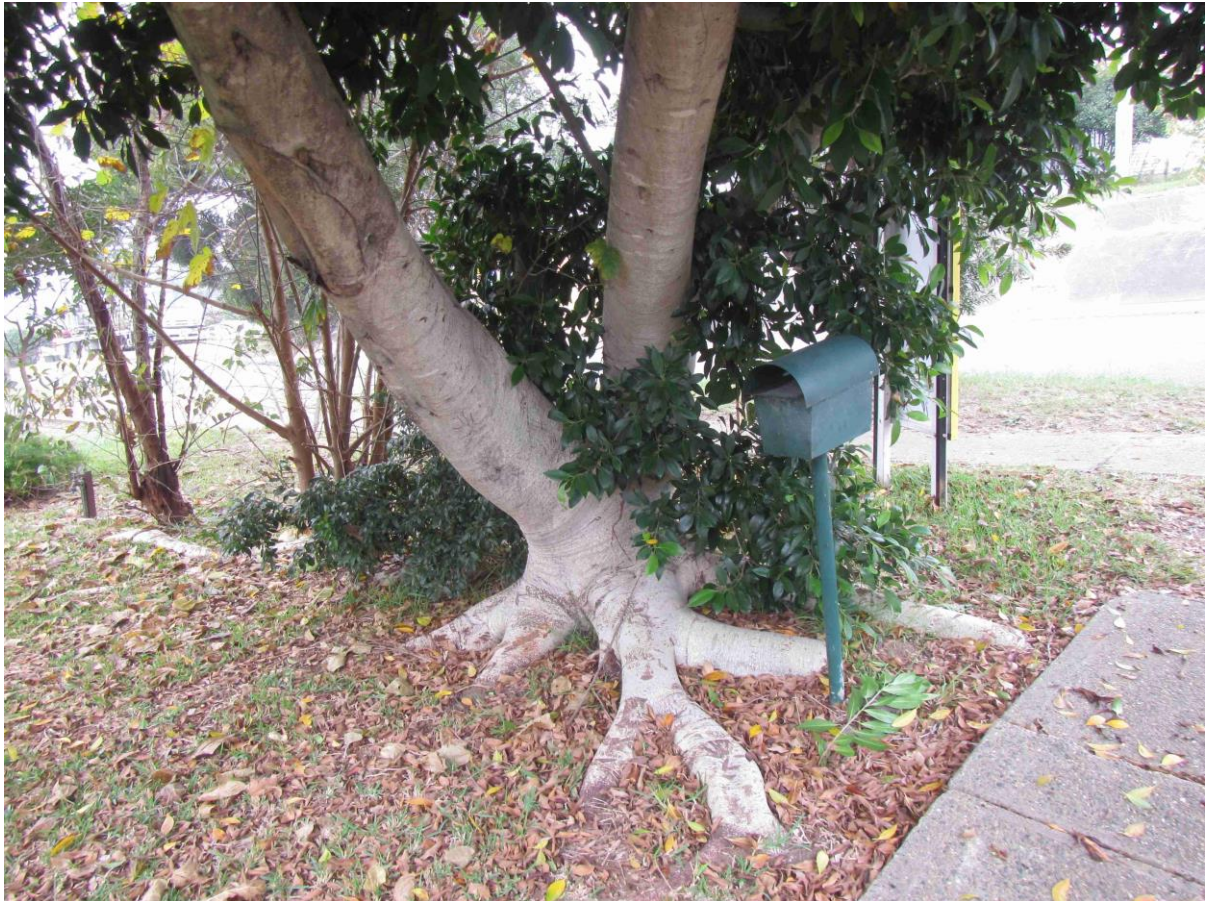
3.	Hills Weeping Fig <i>Ficus microcarpa</i> var. <i>hillii</i>	8	M/T	500	2.5	6	Mature	Good	Good	2	Low	Low to Moderate	Low to Medium	to	This minor planted tree is required to be removed as it is located within close proximity to the proposed new development, considered construction requirement and the trees considered future growth to maturity and long-term impacts to the building assets, it will be replaced in landscape upon completion.

Figure 9 Shows Tree 3 previous pruning and buttress roots system.

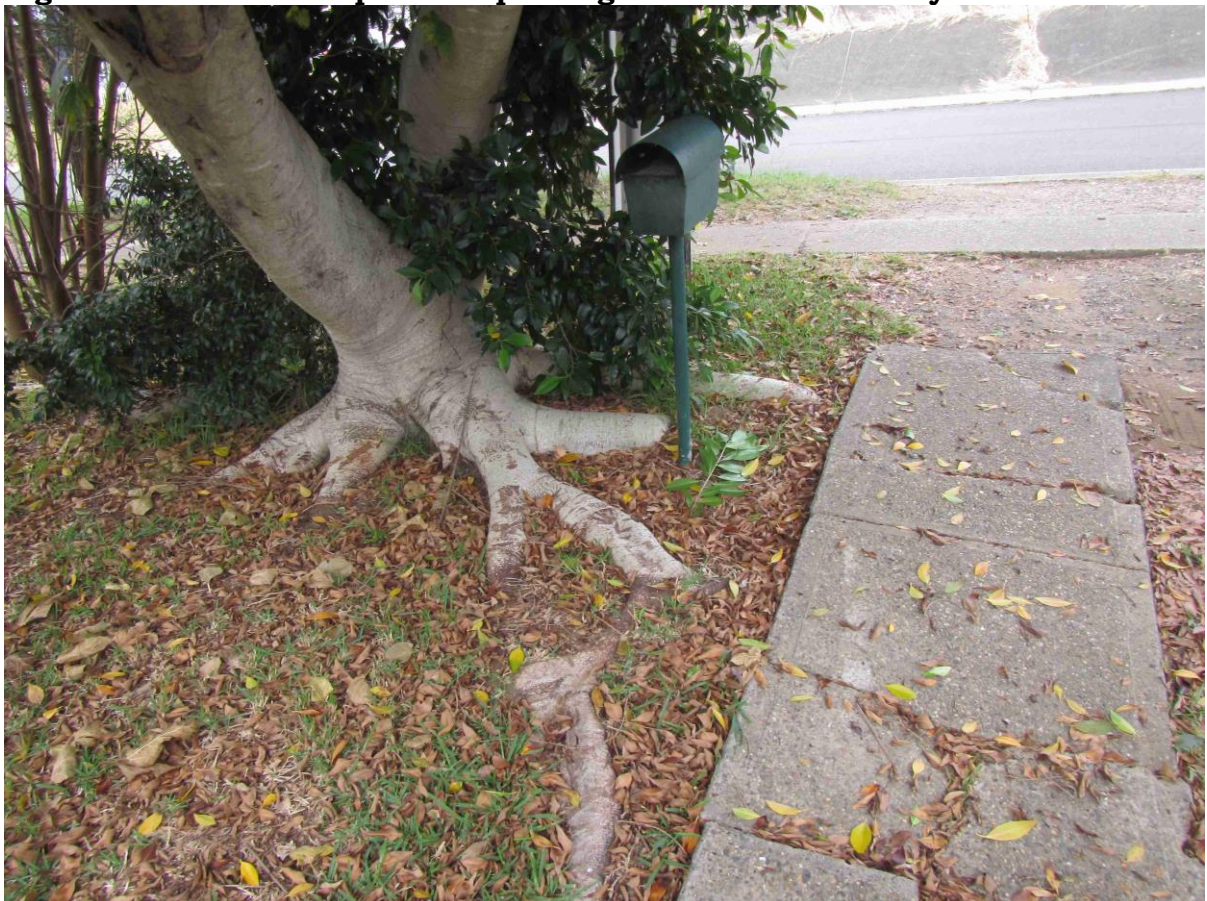
Figure 10 Shows Tree 3 root system lifting the driveway.

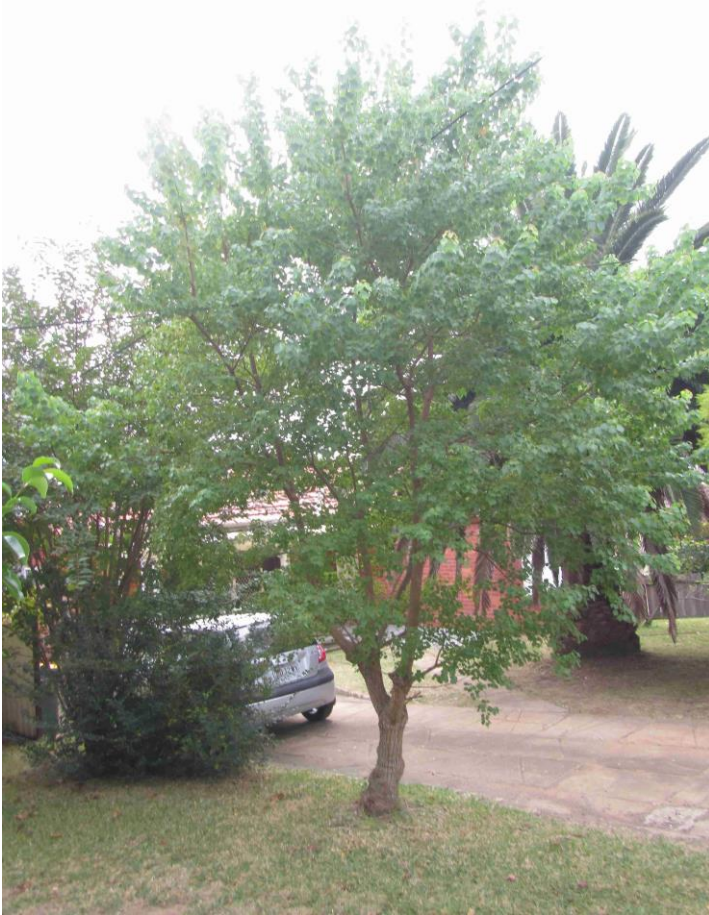
4.	Chinese Tallowwood <i>Sapium sebiferum</i>	3	100	110	N/A	N/A	Mature	Good	Good	3	Nil	Nil	Nil		This minor planted ornamental tree is required to be removed as it is located within the proposed new basement excavation area, it will be replaced in landscape upon completion.

Figure 11 Shows minor Tree 4 from a distance.

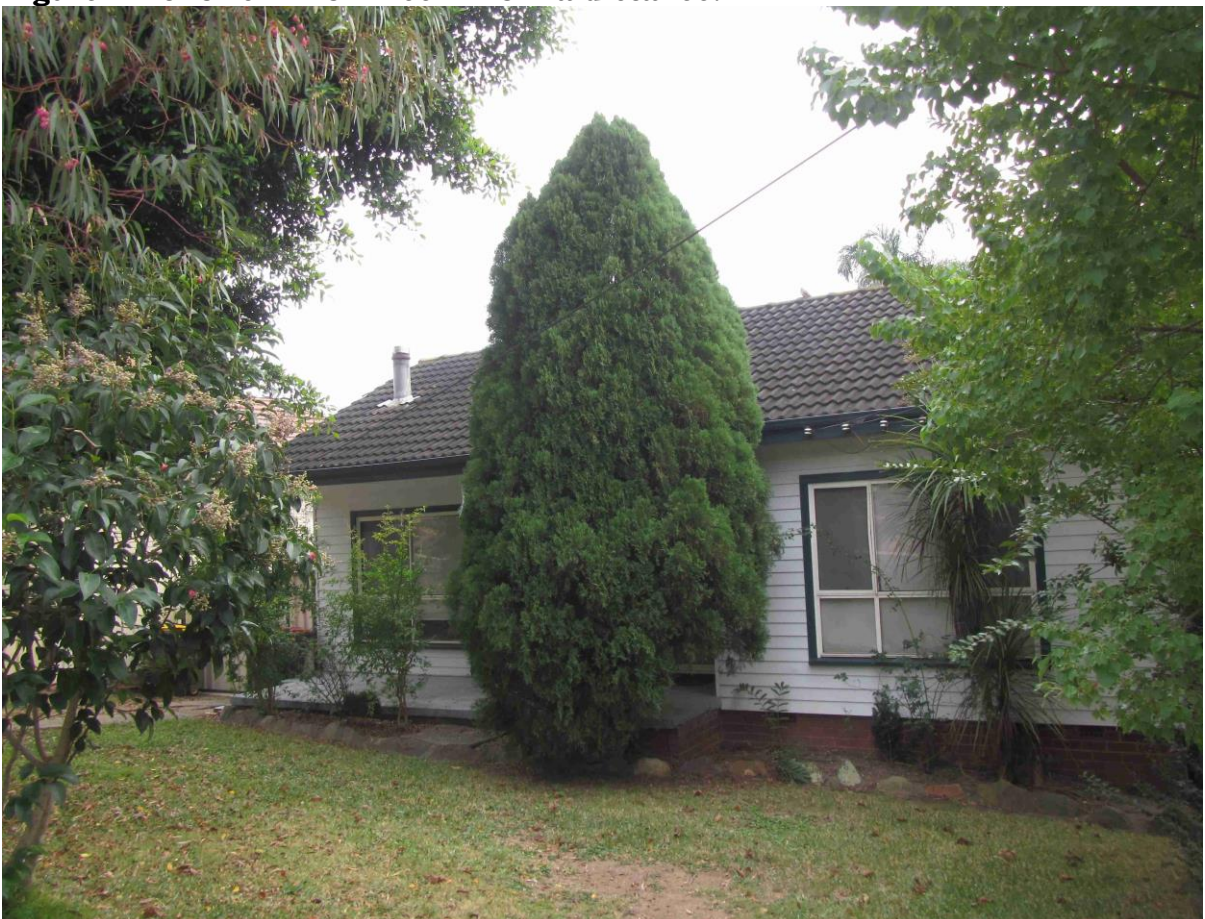
Figure 12 Shows Tree 5 that is currently TPO Exempt and may be removed.

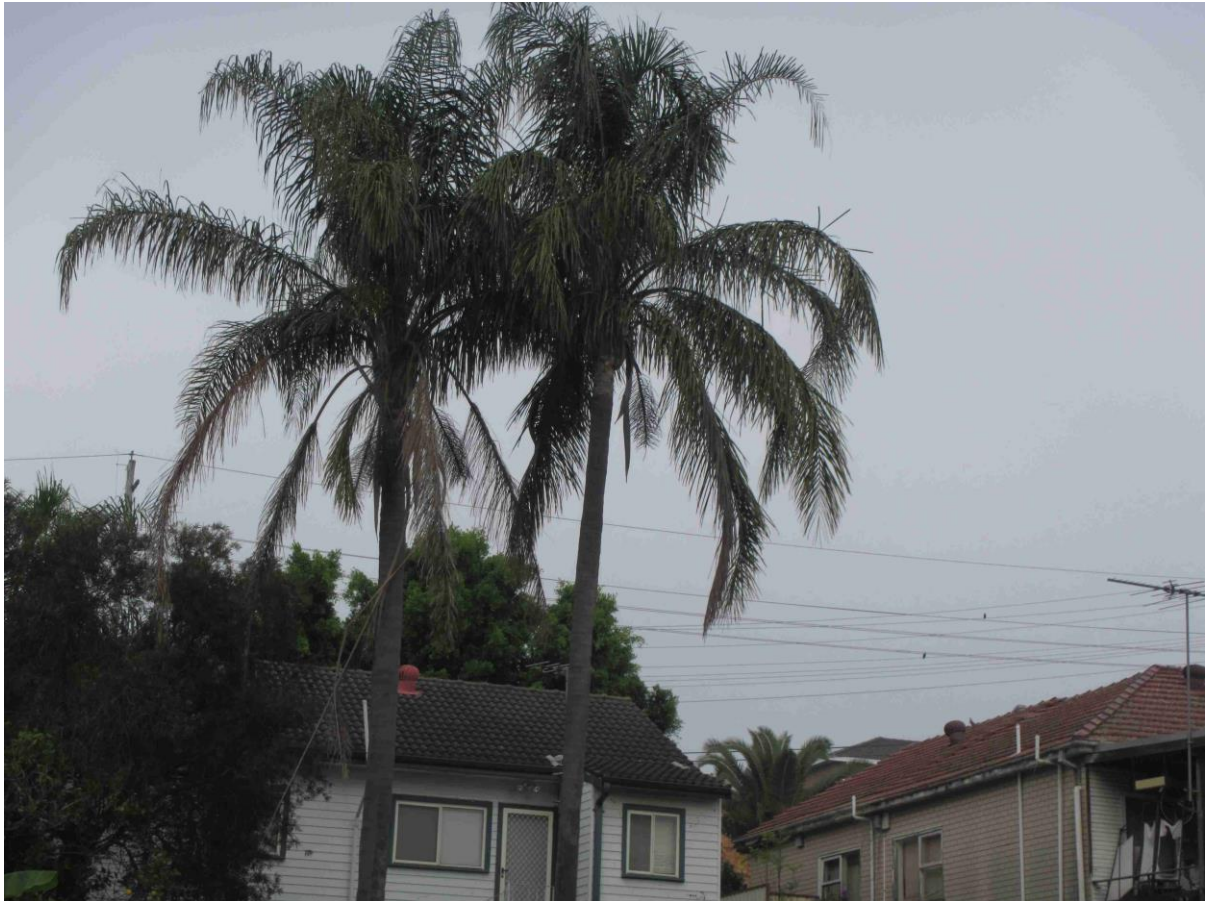
6.	Cocos Palm <i>Syagrus romanzoffiana</i>	5	240	250	N/A	N/A	Mature	Good	Good	3B	Nil	Nil	Nil	This nuisance environmental weed species palm tree is required to be removed as it is located within the proposed new basement excavation area, it will be replaced in landscape upon completion.
7.	Weeping Bottlebrush <i>Callistemon viminalis</i>	5	M/T	260	N/A	N/A	Mature	Good to Fair	Good to Fair	3	Nil to Low	Nil to Low	Nil	This nuisance environmental weed species palm tree is required to be removed as it is located within the proposed new basement excavation area, it will be replaced in landscape upon completion.
8.	Cocos Palm <i>Syagrus romanzoffiana</i>	7	240	250	N/A	N/A	Mature	Good	Good	3B	Nil	Nil	Nil	This nuisance environmental weed species palm tree is required to be removed as it is located within the proposed new basement excavation area, it will be replaced in landscape upon completion.

9.	Cocos Palm <i>Syagrus romanzoffiana</i>	8	250	260	N/A	N/A	Mature	Good	Good	3B	Nil	Nil	Nil	This nuisance environmental weed species palm tree is required to be removed as it is located within the proposed new basement excavation area, it will be replaced in landscape upon completion.
10.	Grey Gum <i>Eucalyptus moluccana</i>	14	480 550	800	N/A	N/A	Mature	Good to Fair	Fair	4C	Medium	Moderate	Medium	<p>This tree is sufficiently distanced to be safely retained and protected from the proposed development and scope of works; however, it is recommended to be removed due to noted structural faults, cracking toward the branch trunk union.</p> <p>It is recommended to be removed and replaced in the landscape upon completion with an advanced tree.</p>

Figure 13 Shows site Cocos palms required to be removed for basement works

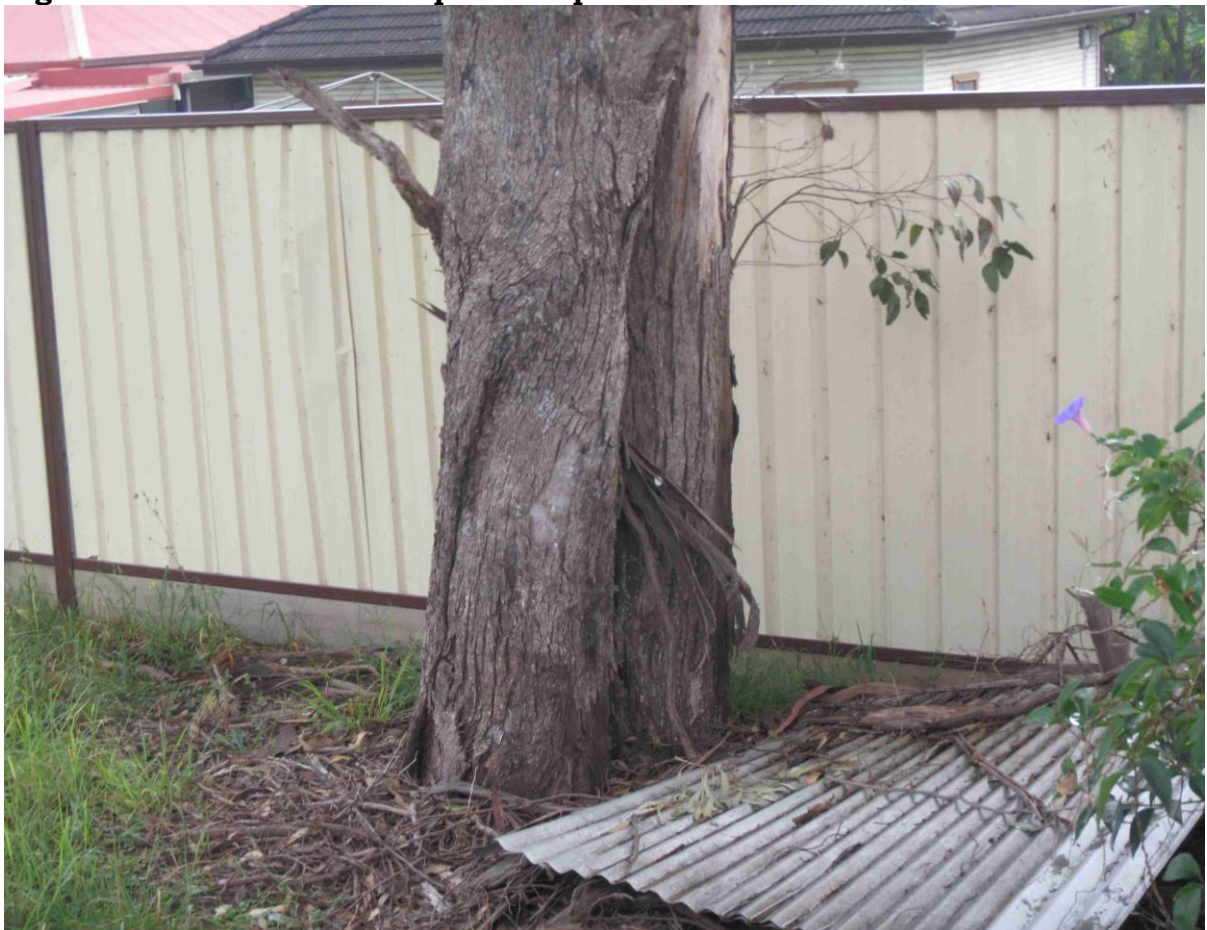
Figure 14 Shows Tree 10 lower trunk located in the corner of the site.

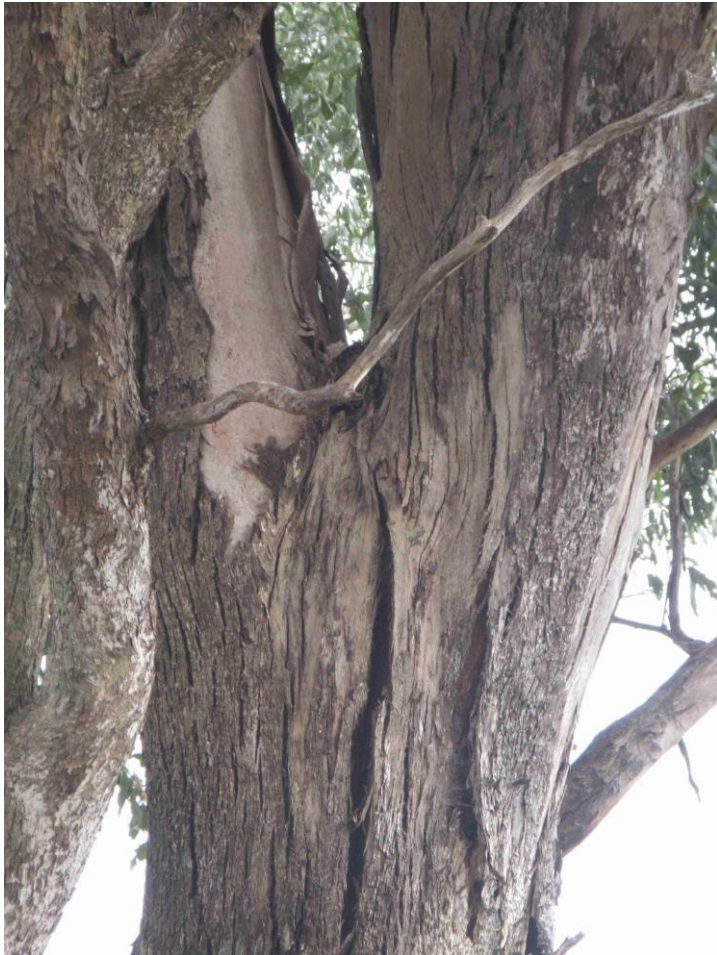
Figure 15 Shows a major split on the trunk towards the branch union.

Tree Numbered 10, is required to be removed due to its poor structural condition with noted open crack/split near the trunk branch union, as it represents a WH&S concerns to site and adjoining properties if retained.

Tree Numbered 10, is required to be removed due to its poor structural condition with noted open crack/split near the trunk branch union, as it represents a WH&S concerns to site and adjoining properties if retained.

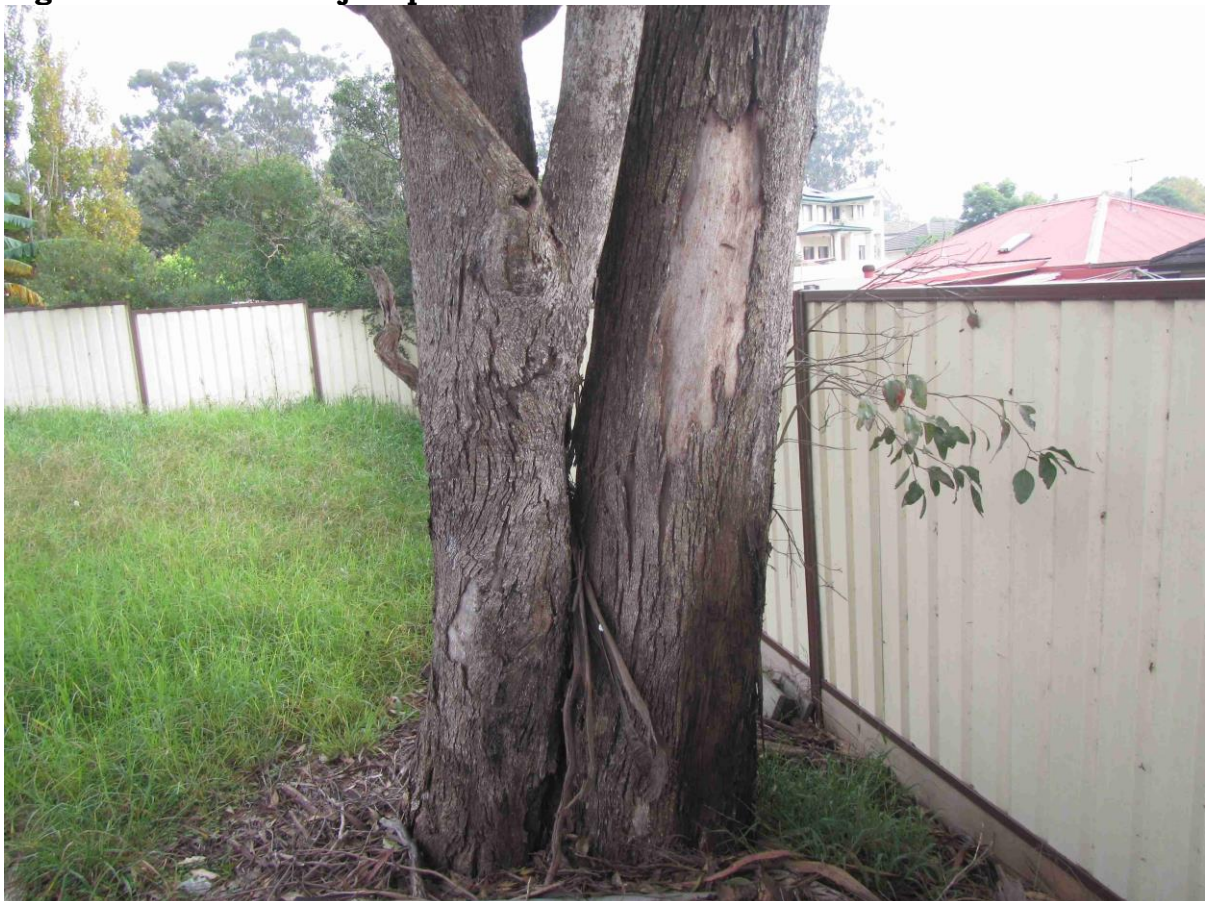
Figure 16 Shows the trees lower trunk from a distance.
