# Preliminary Arboricultural Report

Wesley Mission - Frank Vickery Village Midson Group 101 Port Hacking Road Hunters Hill NSW 2224

19 November 2020

# Preliminary Arboricultural Report relating to four hundred fifty-five (455) trees located at Frank Vickery Village

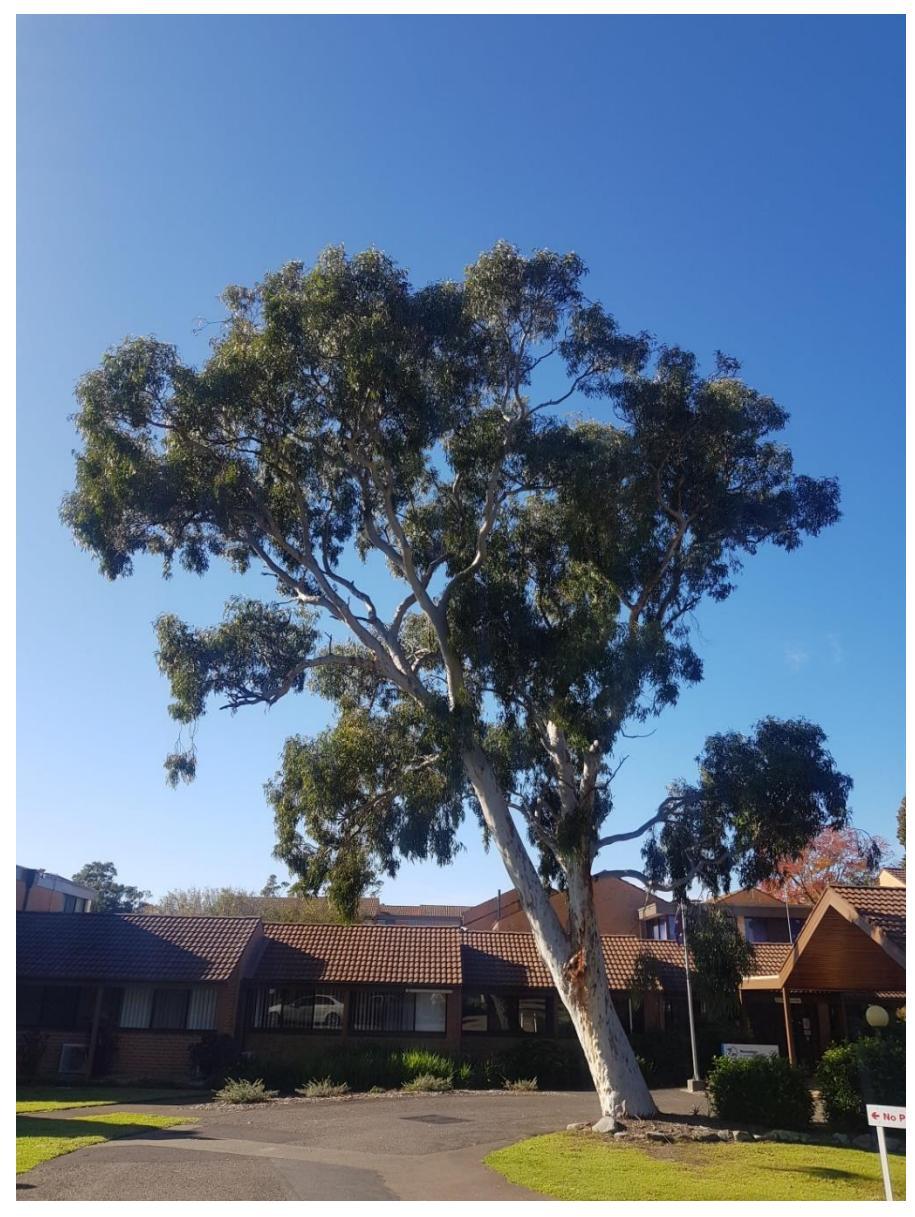
- 5.2.3 Tree 1 (Figure 4) was identified as a mature *Eucalyptus racemosa* (Scribbly Gum). The tree was located within the southern, central area of the site and provided strong amenity value and formed a significant feature within the landscape.
- 5.2.4 Tree 1 was of good health and fair structure and had a life expectancy of 15–25 years.
- 5.2.5 The TPZ for Tree 1 was 9.6m measured at a radial distance from the centre of the trunk.

Figure 4. View from the west of Tree 1 (Eucalyptus racemosa) in its growing environment. (Jamie Oates, May 2020).

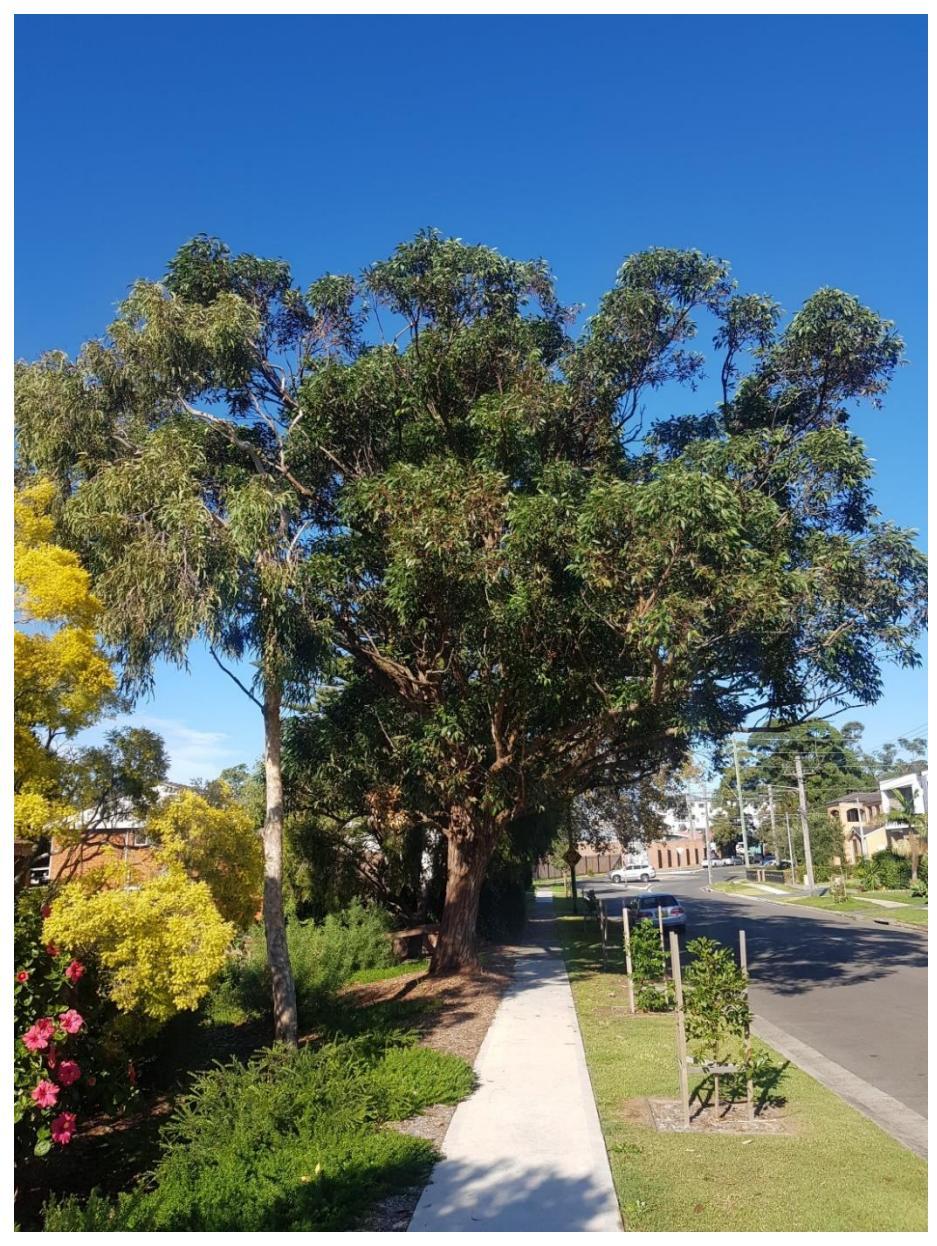
- 5.2.6 Tree 9 (Figure 5) was identified as a semi-mature *Eucalyptus robusta* (Swamp Mahogany). The tree was located within the western aspect of the site towards Bellingara Road and provided screening value due to the large crown dimensions and good health and was considered a significant feature within the landscape.
- 5.2.7 Tree 9 was of good health and structure and had a life expectancy of 25–50 years.
- 5.2.8 The TPZ for Tree 9 was 7.7m measured at a radial distance from the centre of the trunk.

Figure 5. View from the north of Tree 9 (Eucalyptus robusta) in its growing environment. (Jamie Oates, May 2020).

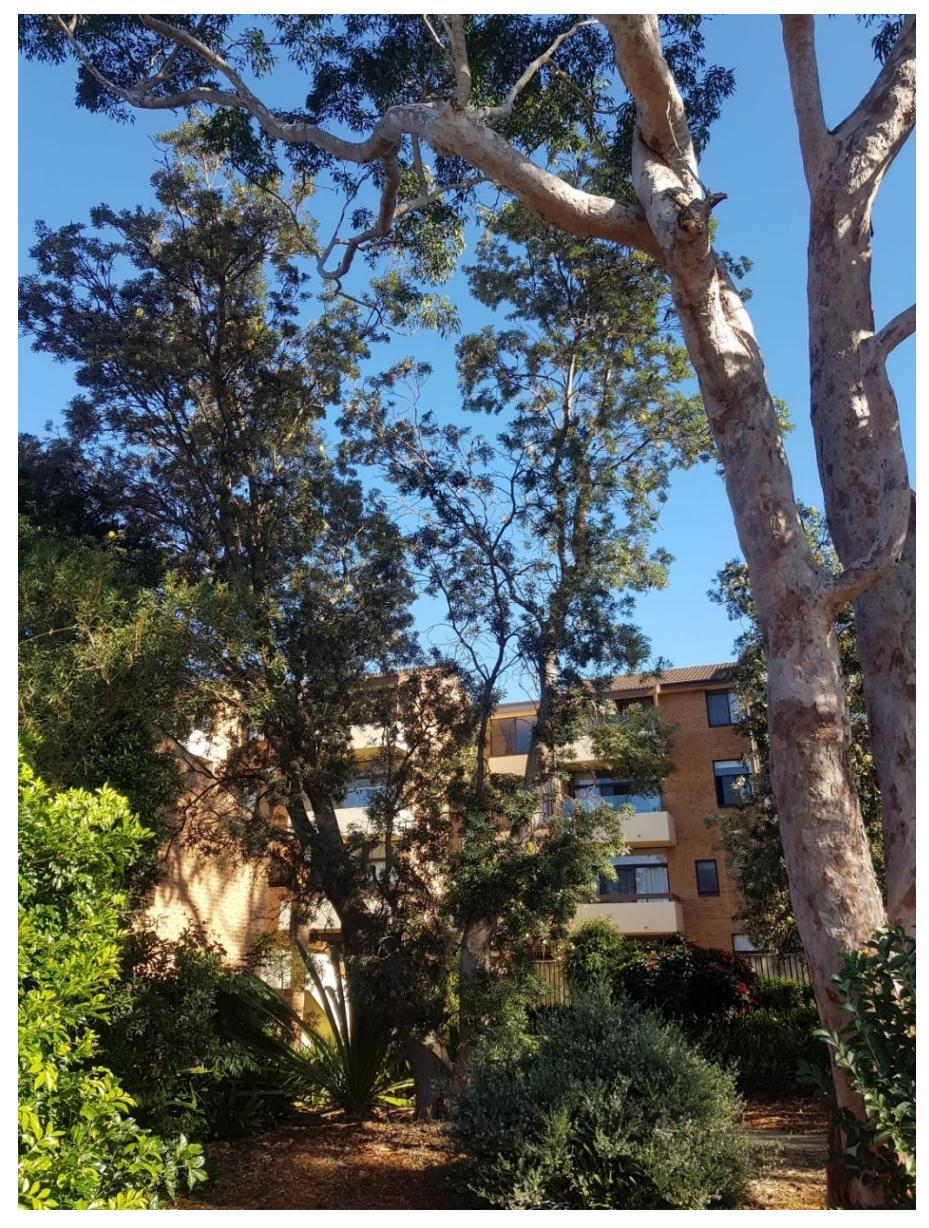
- 5.2.9 Tree 63 (Figure 6) was identified as a mature *Banksia integrifolia* (Coast Banksia). The tree was located between the existing buildings and Port Hacking Road, to the east of the site. The tree was assessed as having good amenity value and provided strong screening and environmental benefit to the immediate landscape.
- 5.2.10 Tree 63 was of good health and structure and had a life expectancy of 25–50 years.
- 5.2.11 The TPZ for Tree 63 was 6.7m measured at a radial distance from the centre of the trunk.

Figure 6. View from the east of Tree 63 (Banksia integrifolia) in its growing environment. (Jamie Oates, May 2020).

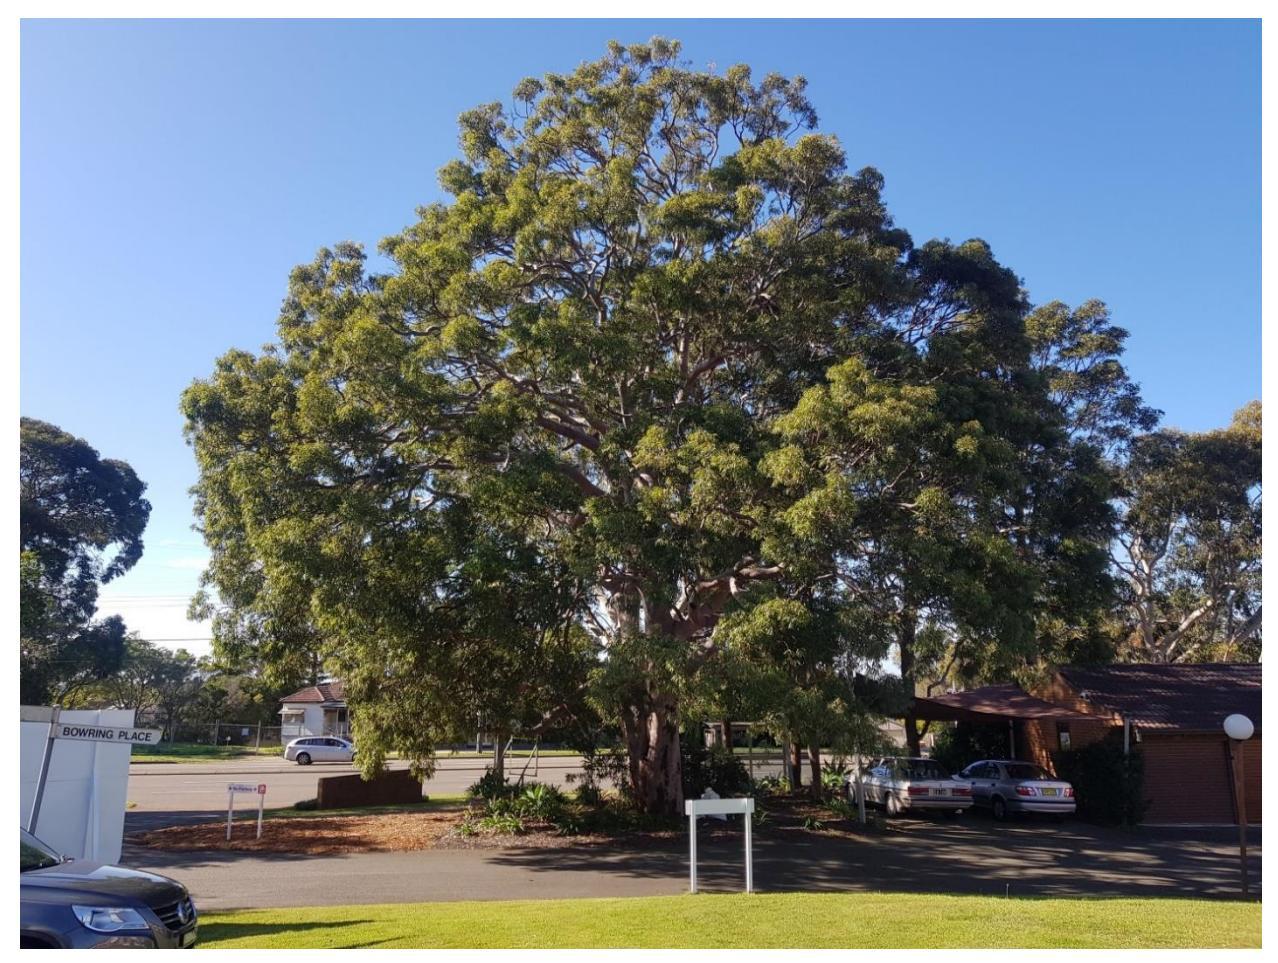
- 5.2.12 Tree 124 (Figure 7) was identified as a mature example of the indigenous species *Angophora costata* (Smooth-barked Apple Myrtle). The tree was located within the central, eastern aspect of the site with other vegetation, forming a screen between the current site and Port Hacking Road. The physical size, species and general attributes classified this tree as having strong amenity value contributing to the local landscape, with potential to continue to do so for many decades to come.
- 5.2.13 Tree 124 was of good health and structure and had a life expectancy greater than 50 years.
- 5.2.14 The TPZ for Tree 124 was 10.8m measured at a radial distance from the centre of the trunk.

Figure 7. View from the north-west of Tree 124 (Angophora costata) in its growing environment, with Port Hacking Rd in the background. (Jamie Oates, May 2020).

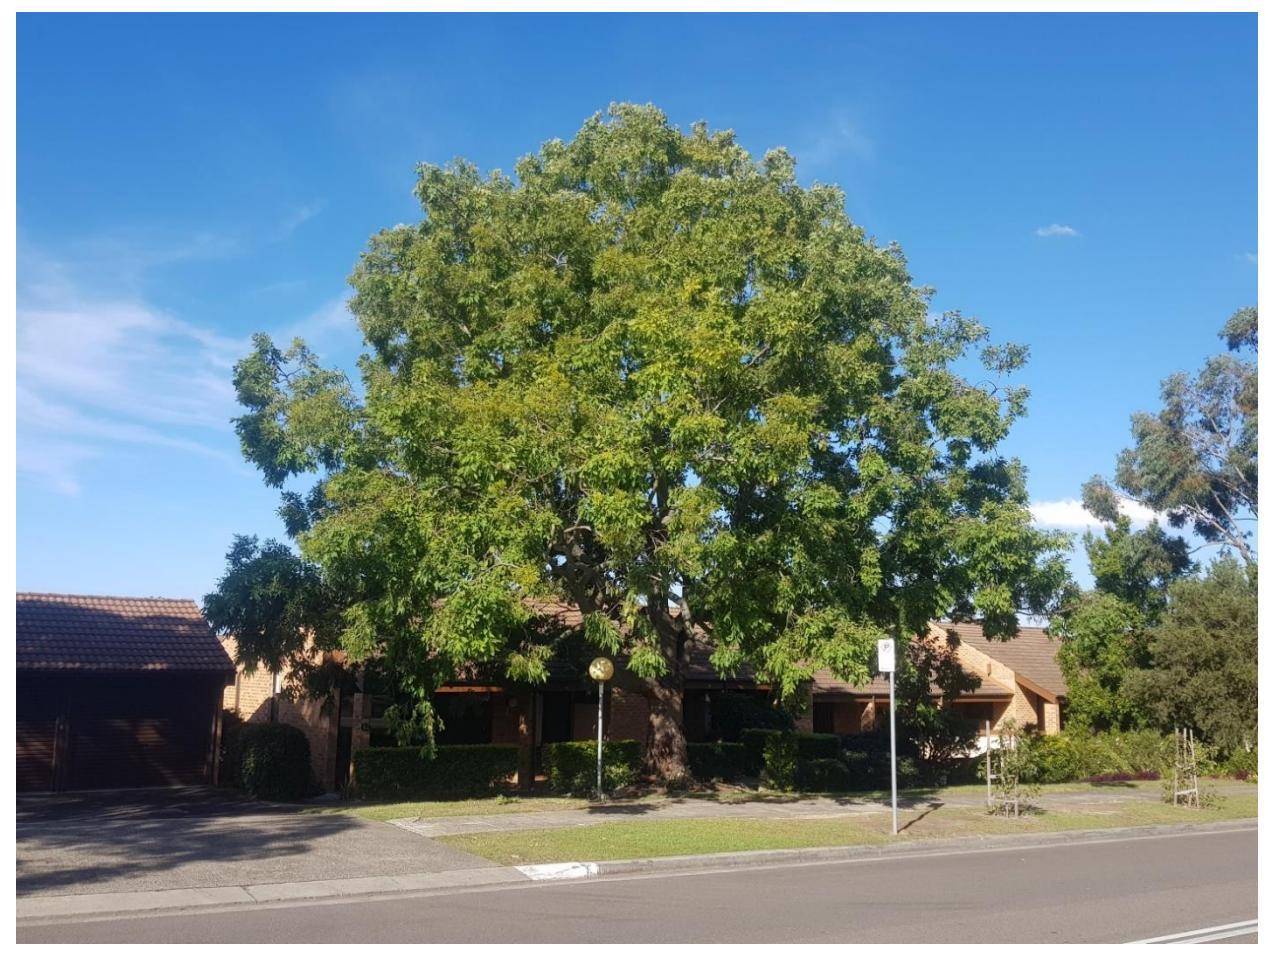
- 5.2.15 Tree 263 (Figure 8) was identified as a mature *Corymbia torelliana* (Cadaghi). The tree was located centrally close to the western boundary of the site and provided good shade and screening value to the subject site. It also contributed strongly to the local landscape and wider canopy coverage.
- 5.2.16 Tree 263 was of good health and structure and had a life expectancy greater than 50 years.
- 5.2.17 The TPZ for Tree 263 was 9.4m measured at a radial distance from the centre of the trunk.

Figure 8. View from the west of Tree 263 (Corymbia torelliana) in its growing environment. (Jamie Oates, May 2020).

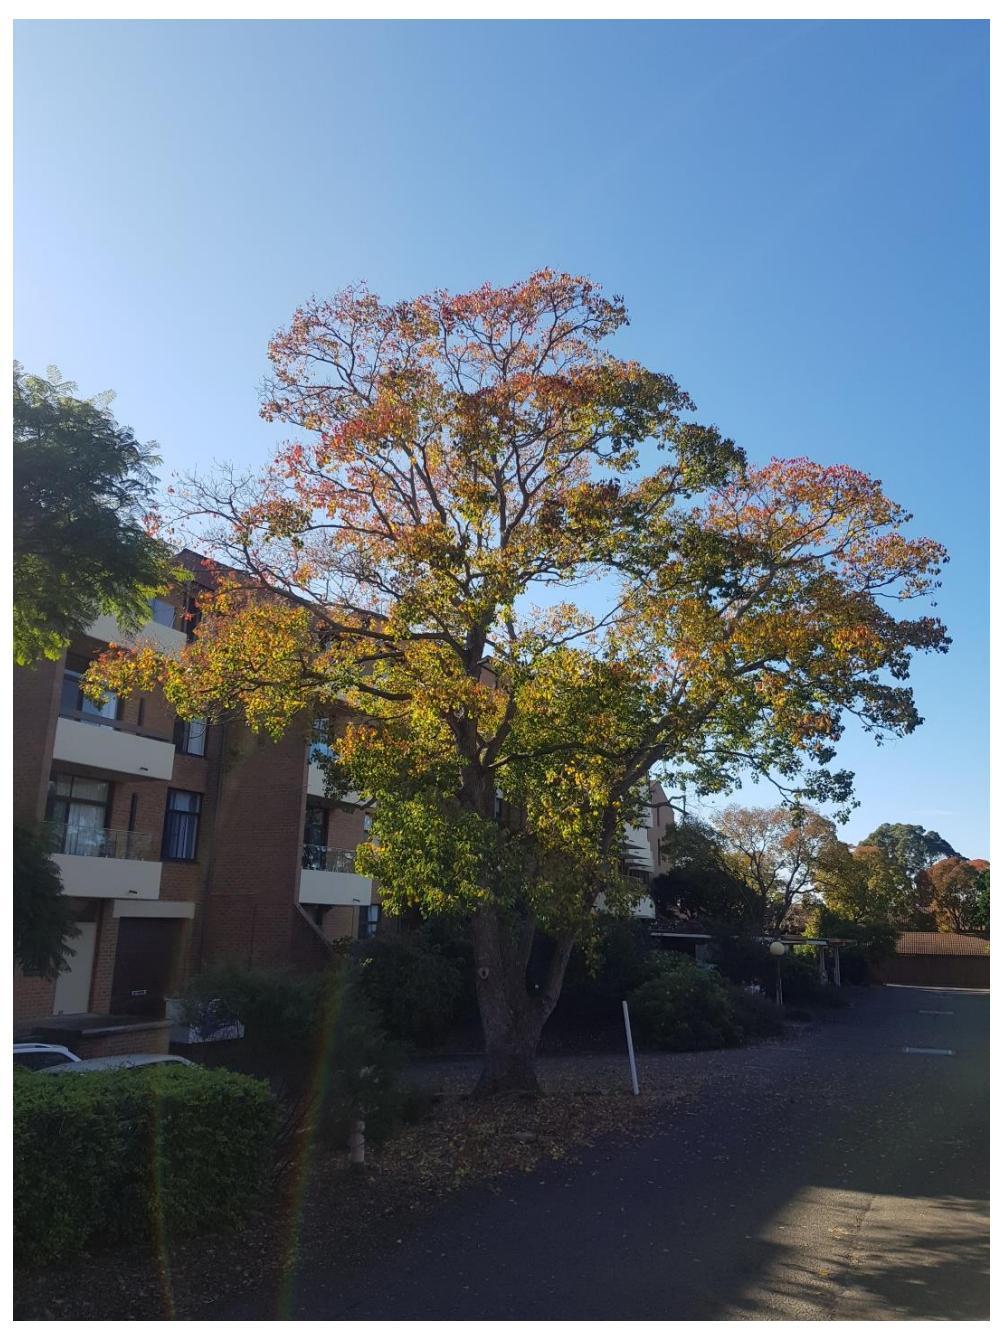
- 5.3.3 Tree 27 (Figure 10) was identified as a mature example of *Triadica sebifera* (syn. *Sapium sebiferum*) (Chinese Tallow Tree). The tree was of moderate size and of good health and structure. It provided amenity value and shading to existing buildings and attractive autumnal colour, although it is described and becoming an environmental weed by NSW Department of Primary Industries (DPI), thereby reducing its retention value.
- 5.3.4 The TPZ for Tree 27 was 6.5m measured at a radial distance from the centre of the trunk.

Figure 10. View from the south-west of Tree 27 (Triadica sebifera (syn. Sapium sebiferum)) in its growing environment. (Jamie Oates, May 2020).

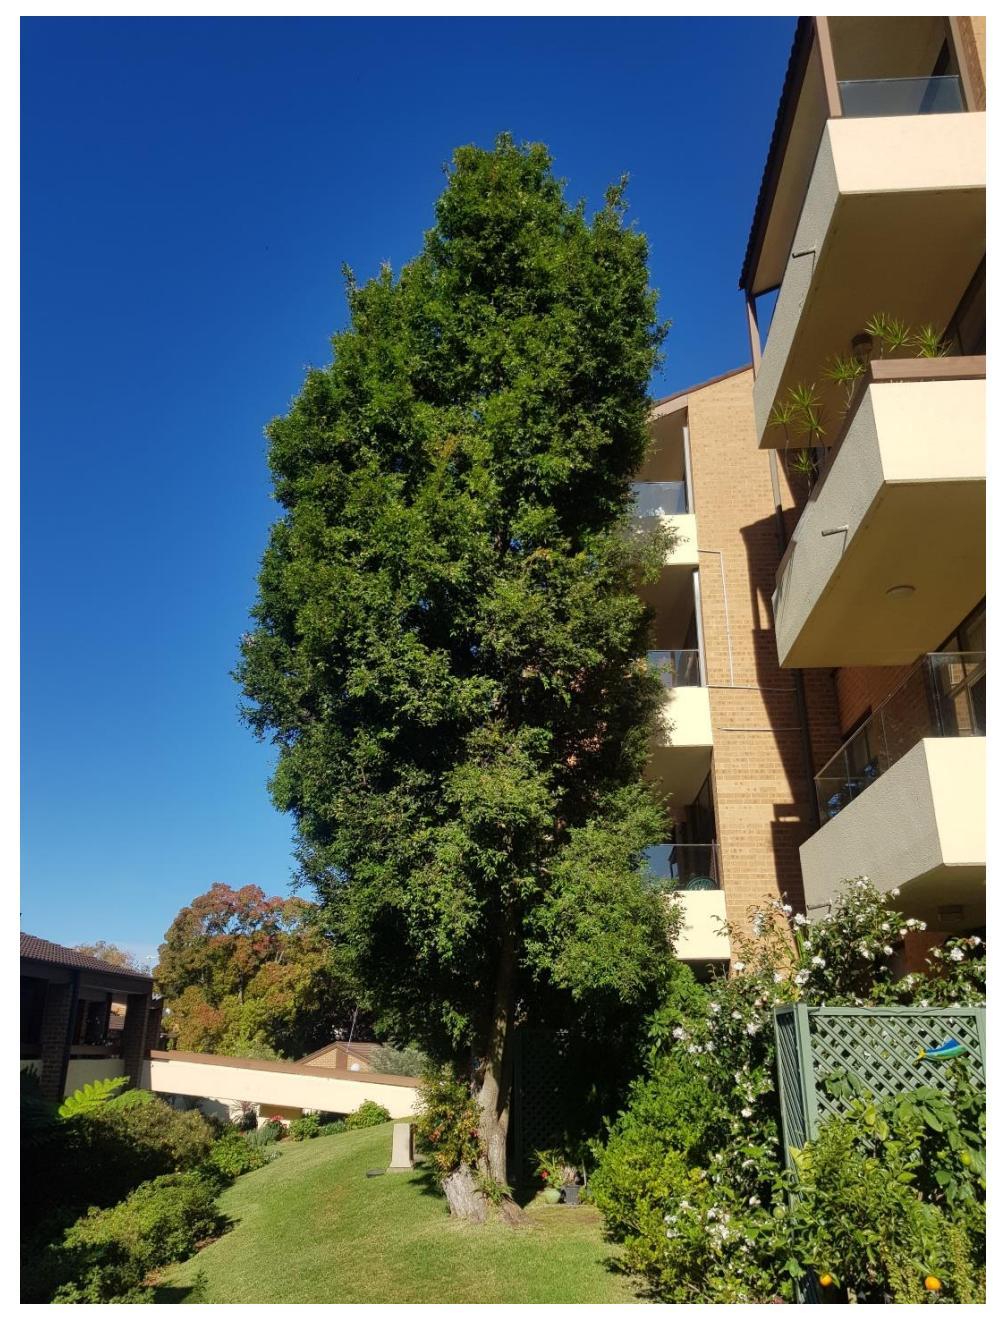
- 5.3.5 Tree 65 (Figure 11) was identified as a semi mature *Syzygium leuhmannii* (Small-leaved Lilly Pilly) located between existing buildings within the south-east aspect of the site. Tree 65 provided screening and shade value to the existing buildings and moderate contributions to the local landscape. It was considered a common species and somewhat replaceable.
- 5.3.6 The TPZ for Tree 65 was 4.8m measured at a radial distance from the centre of the trunk.

Figure 11. View from the north of Tree 65 (Syzygium leuhmannii) in its growing environment. (Jamie Oates, May 2020).

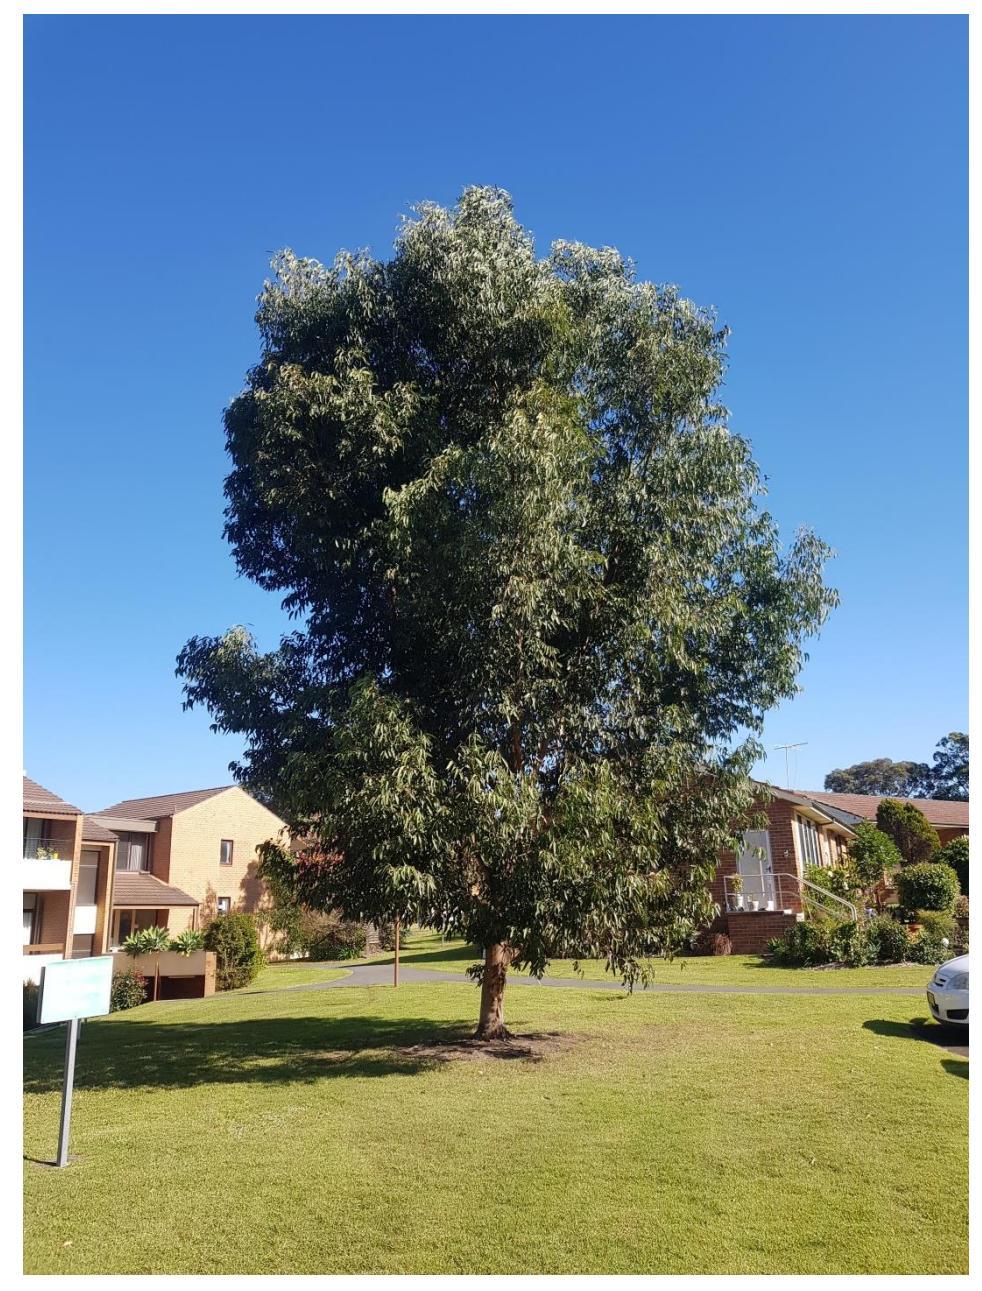
- 5.3.7 Tree 125 (Figure 12) was identified as a semi-mature *Eucalyptus punctata* (Grey Gum). The tree was of moderate size and of good health and structure, with strong potential for longevity within the immediate landscape. The tree provided amenity and environmental value to the local landscape.
- 5.3.8 The TPZ for Tree 125 was 3.4m measured at a radial distance from the centre of the trunk.

Figure 12. View from the east of Tree 125 (Eucalyptus punctata) in its growing environment. (Jamie Oates, May 2020).

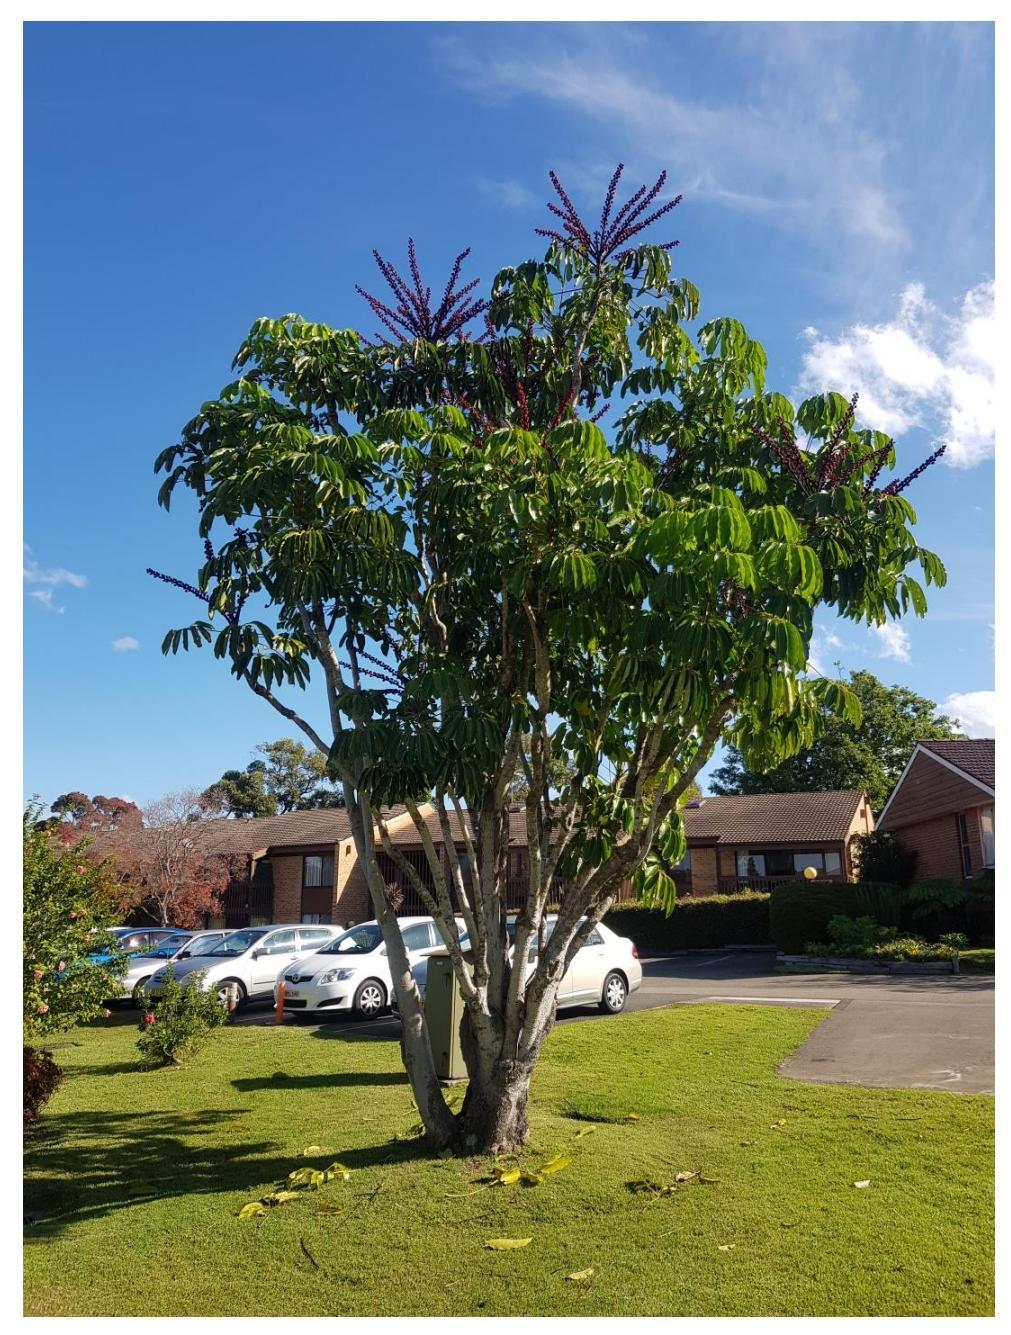
- 5.4.5 Tree 227 (Figure 15) was identified as a mature *Schefflera actinophylla* (Umbrella Tree) and was located within the garden of 138A New South Head Road. The species was considered to have weed potential by the NSW Department of Primary Industries (DPI), described as a garden escape, invading national parks and coastal habitat (NSW DPI, 2020). Therefore Tree 227 was assigned a Category C (Low) retention value and should not be considered for inclusion within any landscaping plans.
- 5.4.6 The TPZ for Tree 227 was 6.5m measured at a radial distance from the centre of the trunk.

Figure 15. View from the north-east of Tree 227 (Schefflera actinophylla) in its growing environment. (Jamie Oates, May 2020).

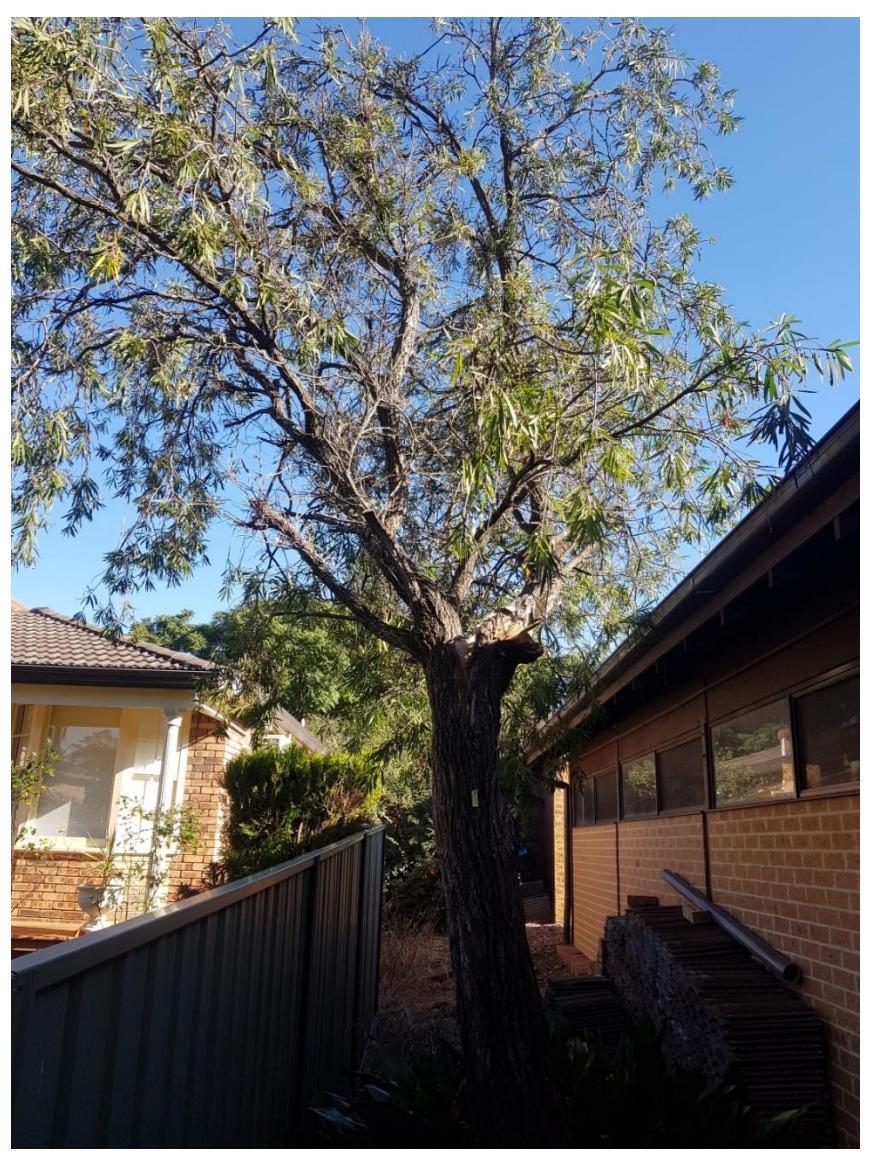
5.5.3 Tree 24 (Figure 17) was identified as a semi-mature example of the native species *Callistemon viminalis* (Weeping Bottlebrush), located on the southern boundary of the site between exiting dwellings and the boundary fence. Tree 24 presented with structural defects that increased its potential for failure within the near future, making it unsuitable for retention and inclusion within planning and design.

Figure 17. View to south of Tree 24 (Callistemon viminalis) in its growing environment. (Jamie Oates, May 2020).

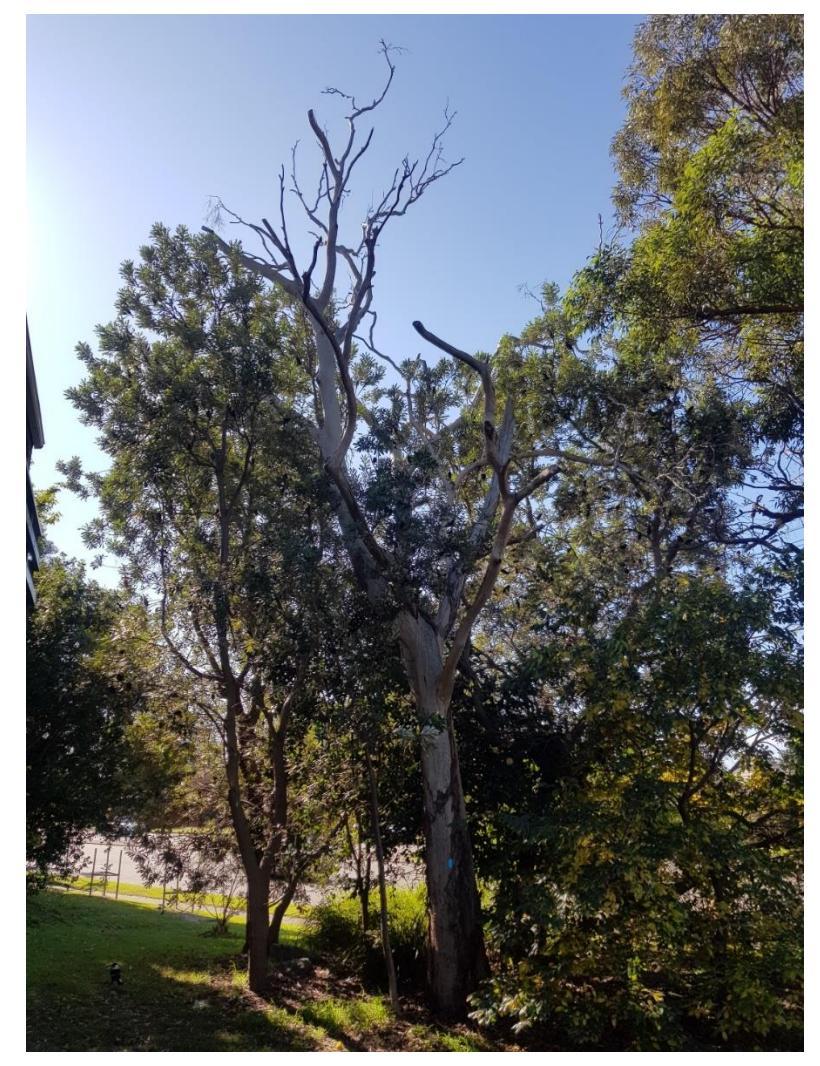
5.5.4 Tree 140 (Figure 18) was dead tree of an unknown species located on the eastern aspect of the site. This tree was recommended for removal irrespective of any further development, unless significant habitat values were identified via ecological survey.

Figure 18. View from the west of Tree 140 in its growing environment. (Jamie Oates, May 2020).
