Report on  
Geotechnical Assessment

55 Coonara Avenue  
West Pennant Hills

Prepared for  
Mirvac Projects Pty Ltd

Project 86072.00  
November 2017

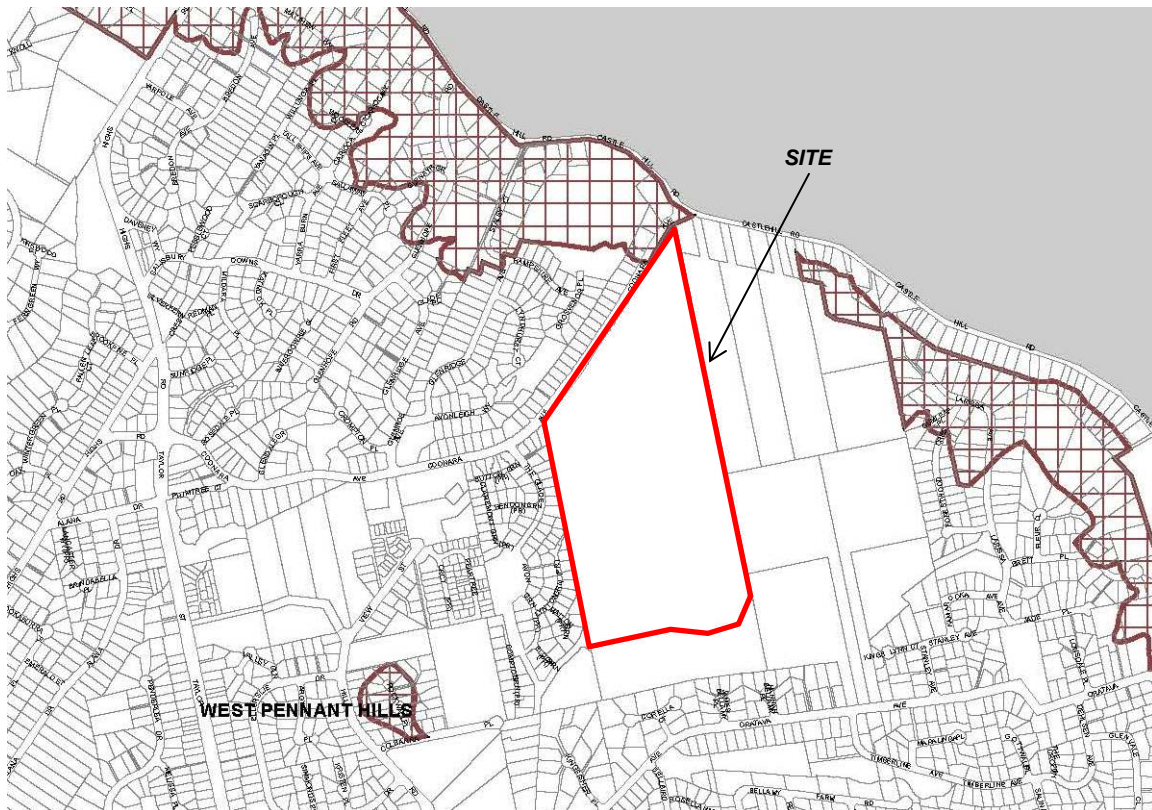
Figure 2: Extract from LEP 2012 (hatched areas show mapped landslide risk)

The mapping indicates that the south-facing slope below the Castle Hill Road ridgeline presents a landslide risk to the west and east of the development site. The map does not show any risks on the subject development site.

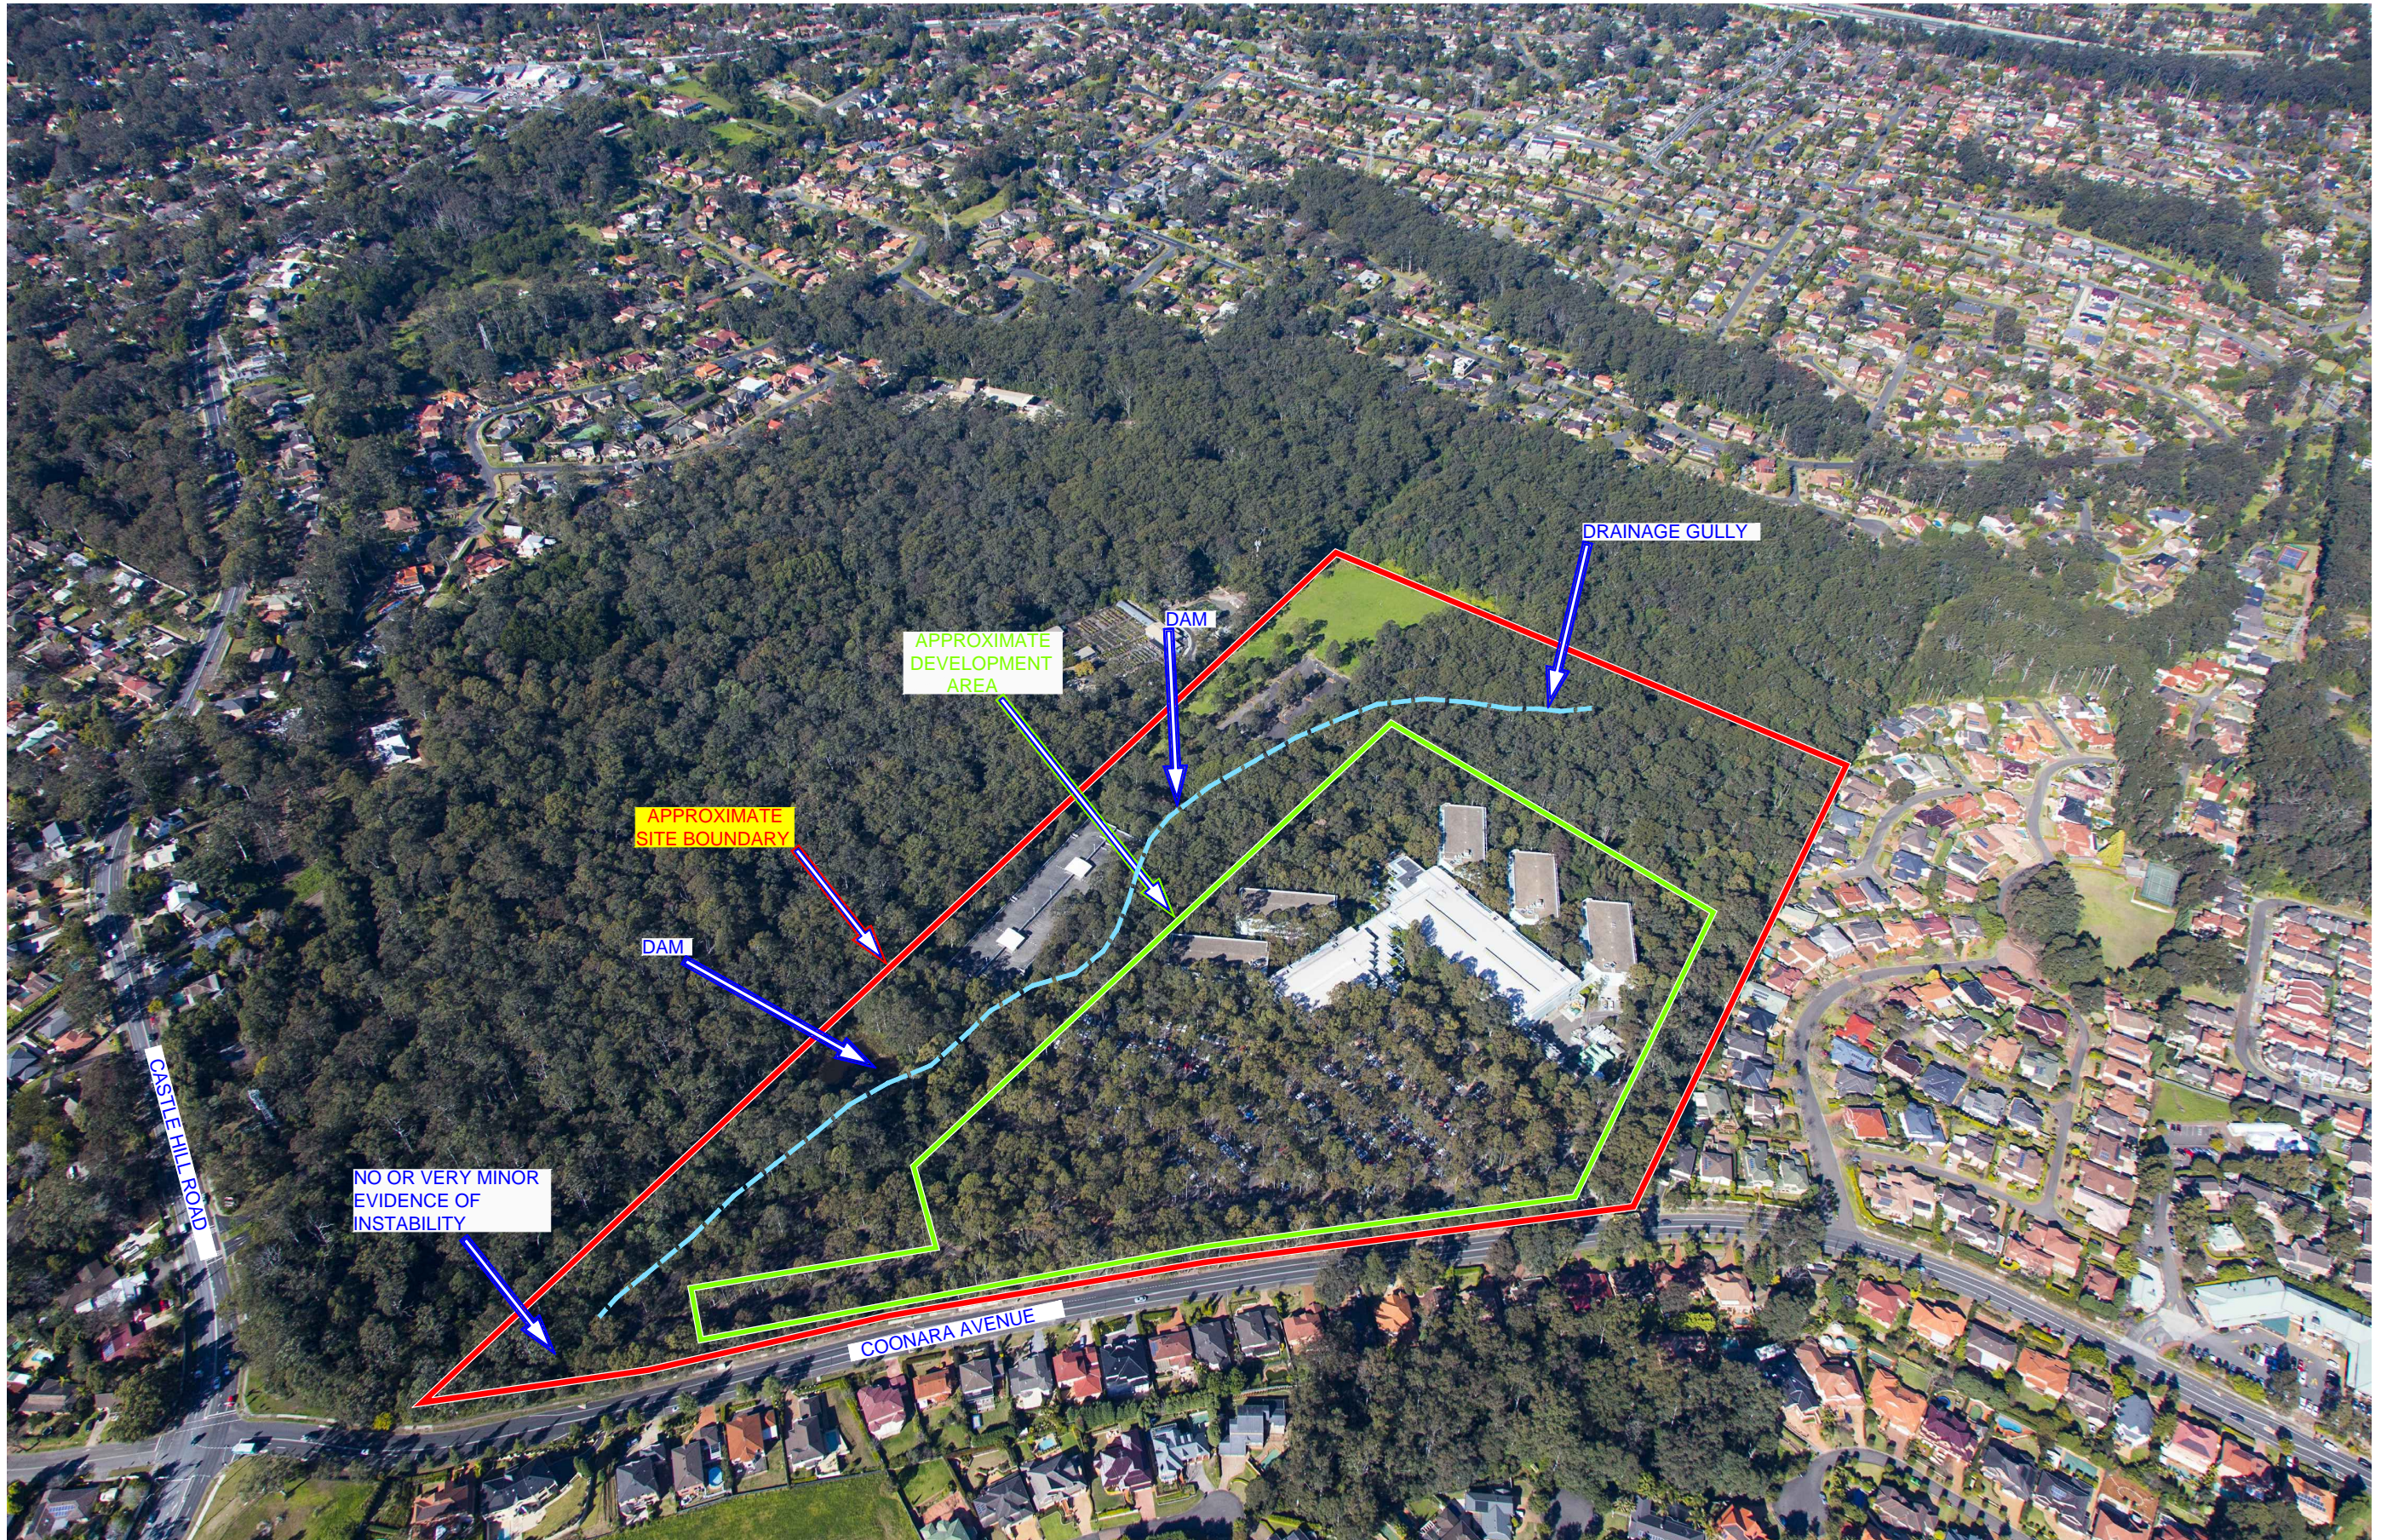
A site inspection was undertaken by a Principal Geotechnical Engineer and a Principal Engineering Geologist on 3 August 2017. The following comments are provided in relation to the inspection:

- The northern tip of the site is relatively steep, however no obvious signs of major landslide activity or risk were identified. Several large trees were present and the trunks were relatively vertical which indicates that significant down-slope movement is not occurring;

- The areas of on-grade parking are generally in good condition and damage associated with landslide movements (e.g. displaced kerb-and-gutters, tension cracks in the asphalt etc.) were not observed;

- The upper dam contained water and there were no major stability issues noted in the downstream embankment. A rock-lined spillway was located in the south-eastern corner of the dam suggesting that controlled outflow occurs in times of high flow rather than embankment overtopping;

- The drainage gully has experienced some minor localised erosion which has exposed residual soils and bedrock along its base. Some colluvial soils and/or filling were observed in the sides of the drainage gully; and

- No areas of springs/water seepage were observed during the inspection.

Notes relating to the inspection are provided on Drawing 1 in Appendix B.

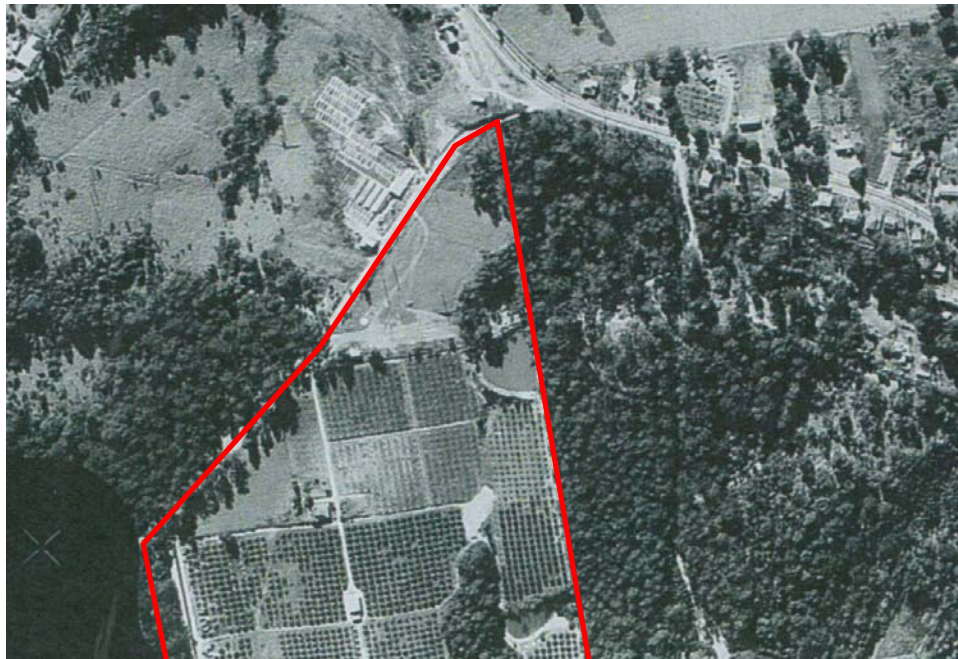
Aerial photograph from 1961

The 1961 photograph shows the northern portion of the site only. It suggests that the site had been cleared of vegetation and redeveloped into orchards. The northern tip of the site appears to be steeper than the remaining area and possibly hummocky. Two dams that appear to be in the same location as the current dams can be seen along the eastern boundary and the drainage gully is evident to the west of the lower dam.

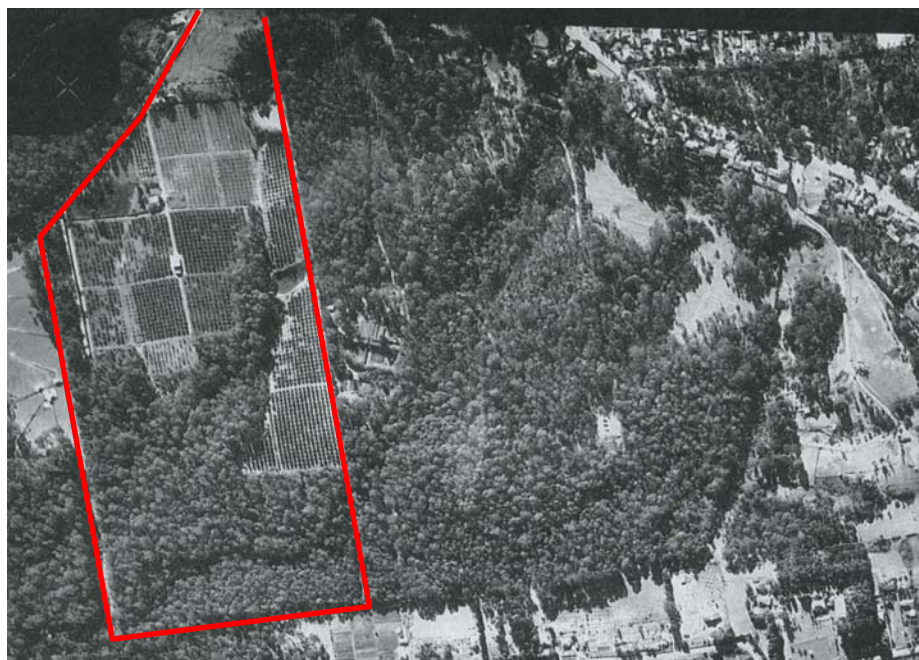
Aerial photograph from 1970

The 1970 photograph shows the extent of the orchards in the southern portion of the site. The drainage gully and the southern and south-western portions of the site remain densely vegetated with what is probably virgin forest.

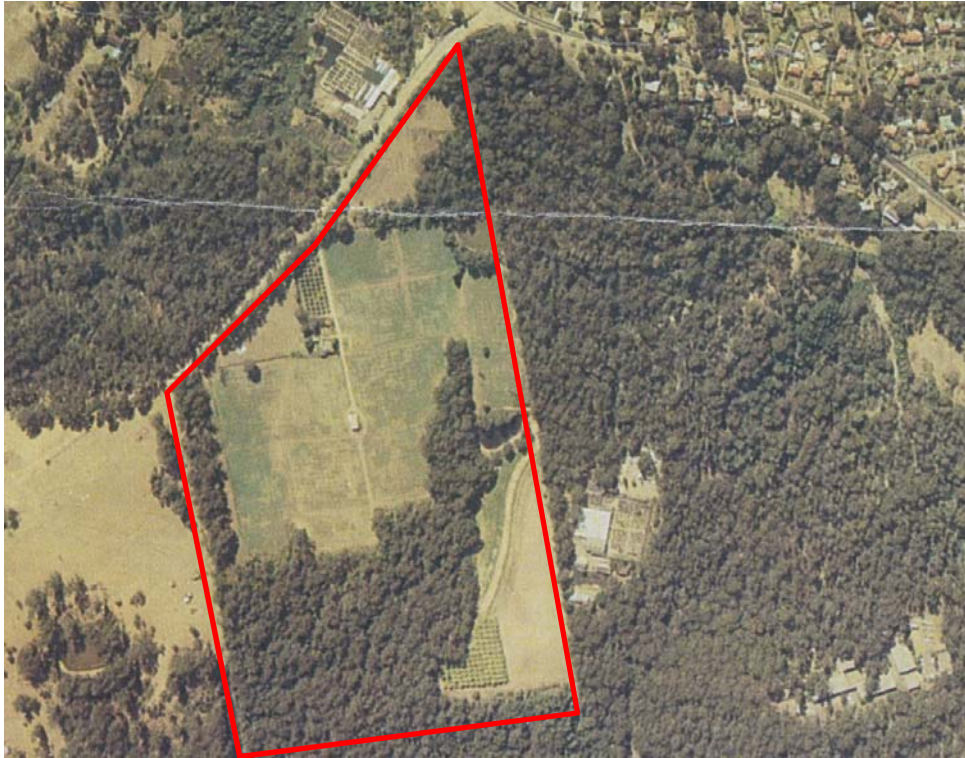
Aerial photograph from 1982

The 1982 photograph shows a similar extent of land development to the 1970 image except that most of the orchard trees have been removed and the site is largely covered by grassed paddocks. The northern tip of the site appears to be slightly more densely vegetated than in the 1961 image.

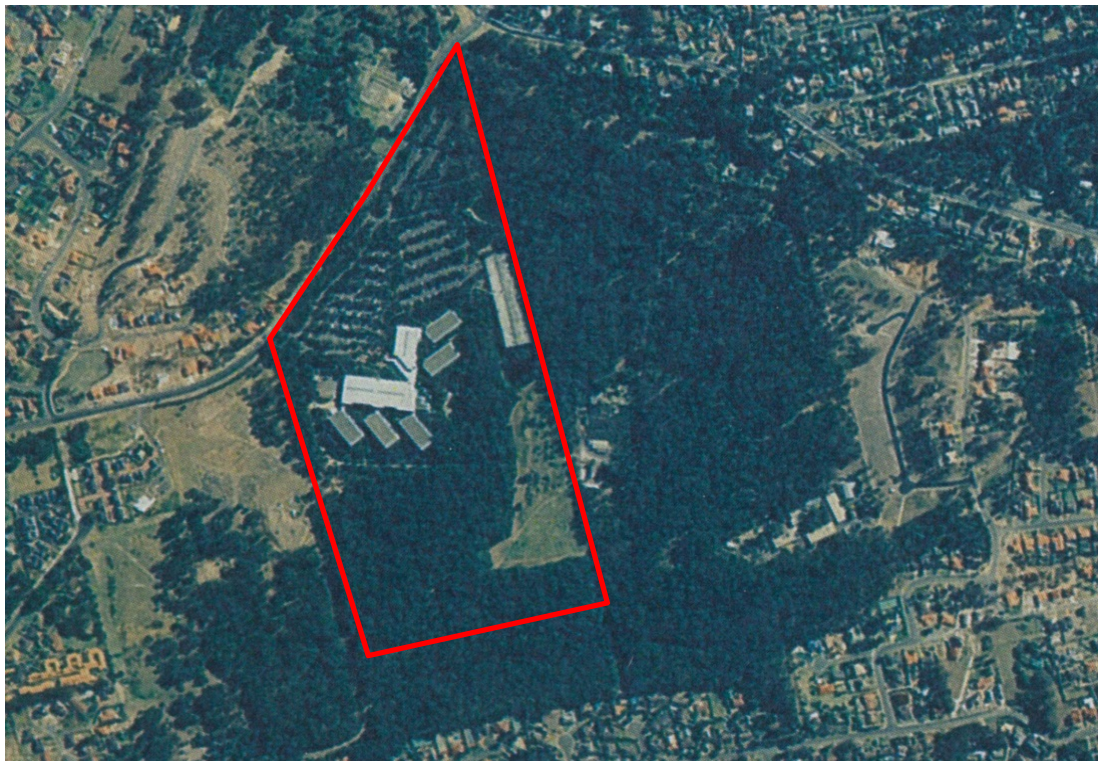
Aerial photograph from 1994

The 1994 photograph shows the site following development of the IBM facility. The buildings and on-grade parking areas have typically been constructed on the former orchard land and the areas around the new works have been re-vegetated. The on-grade parking area to the south of the multi-storey carpark is not shown in this image and therefore this carpark must have been constructed some time after the remainder of the facility.
