Preliminary Contaminated Land Assessment

Rezoning Proposal Lot 22 DP 1073165, 156 Stuart Street Mullumbimby

For:Byron Shire CouncilReport No:17014_sepp55.docxDate:August 2017

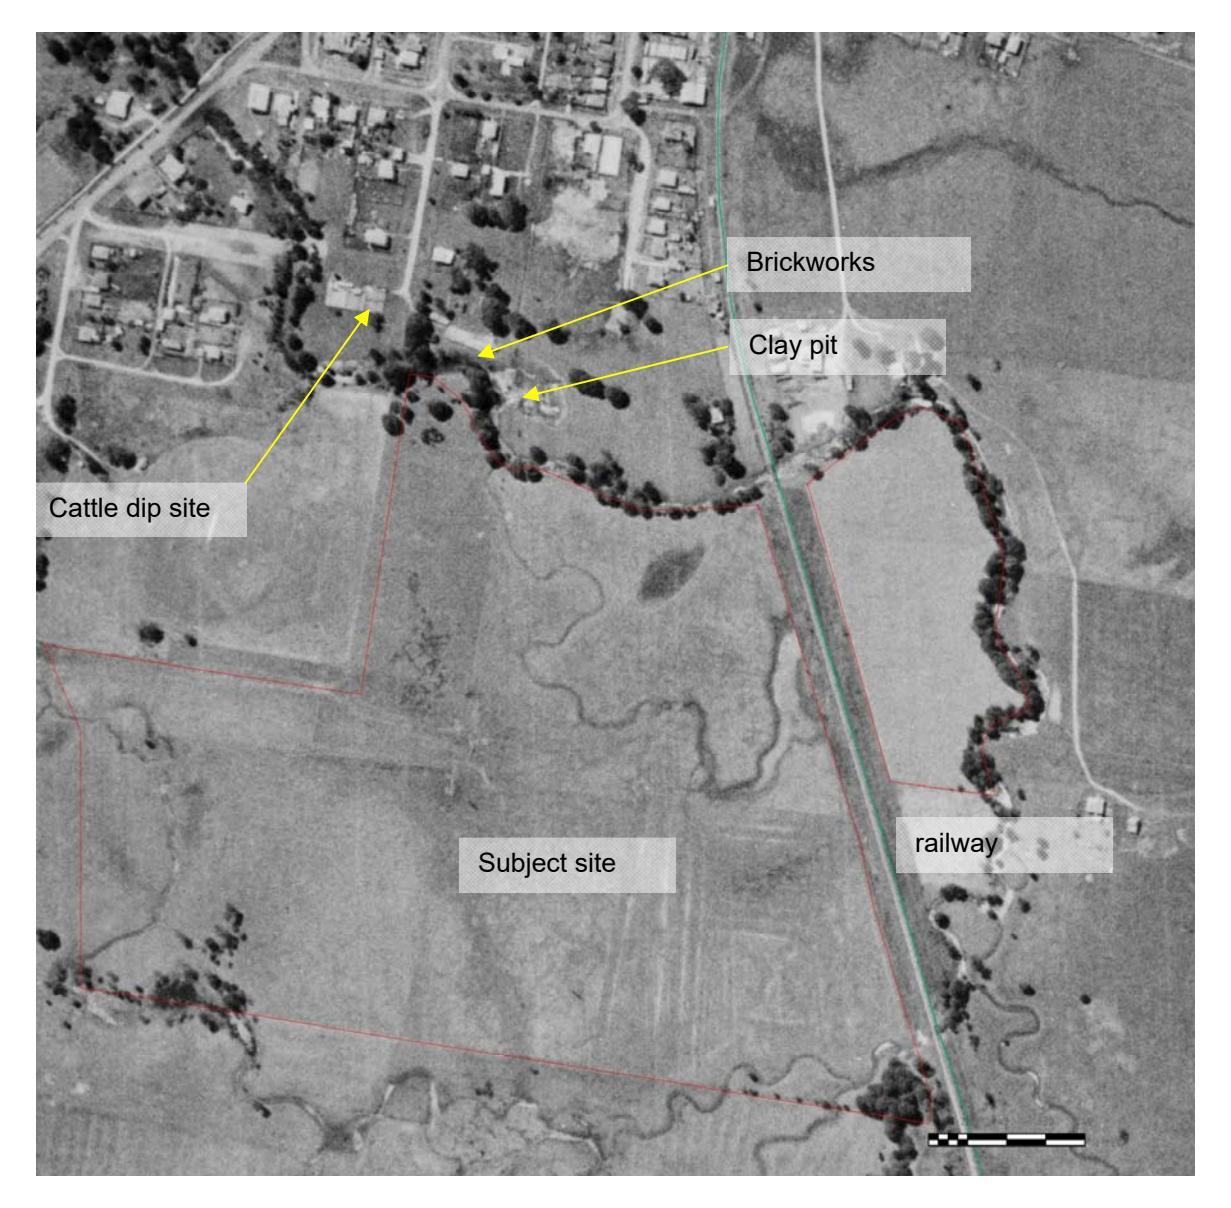
Figure 3: 1958 aerial (NSW LPI, 2017)

1958 Aerial Photograph – this photograph presents that the site had been cleared of trees and appears to be used for cattle grazing. No buildings are present. A cattle dip site is present to the north west of the property. Immediately to the north of the site on Stuart Street, is being used as a brick works.

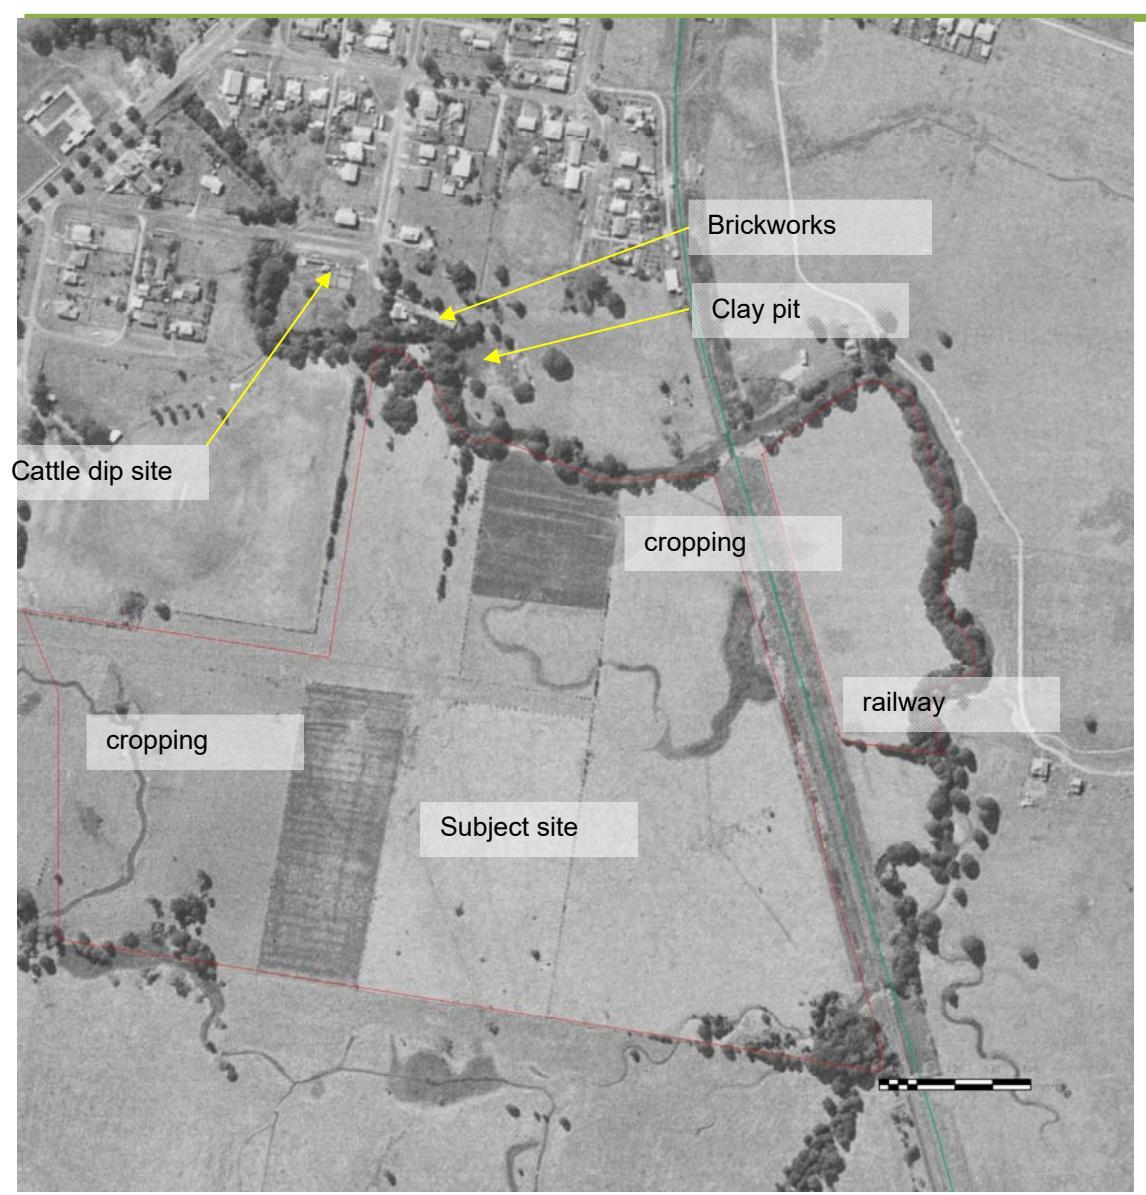
Figure 5: 1971 aerial (NSW LPI, 2017)

1971 Aerial Photograph – cropping is present on this site in the northern section adjacent to Saltwater Creek and from the centre to the southern boundary. It is most likely that the crops grown were cattle fodder/hay and not market garden. However, it is possible that the crops were sugarcane.

Some cropping appears to have occurred at some stage at the property, as it is evident in the aerial photograph from 1971. It is considered that the most likely crop was for cattle fodder, however it may have been for a market garden. NSW EPA (2005) states that pesticides registered for use in orchards and market gardens in NSW include both organic and inorganic compounds. The organics include organochlorines, organophosphates, carbamates, synthetic pyrethroids, triazines, phenoxyaliphatics, sulfonylureas and plant hormones. Inorganic compounds include arsenicals (which also often have a lead component), copper and mercury-based products.

It is considered that a detailed assessment including soil testing should be undertaken of these areas, however, there is a low likelihood of contamination. It is expected that if chemicals were used that these chemicals would be evenly distributed unless there was a spillage of chemical at the site. It is normal that higher concentrations were found at areas where chemicals were mixed, and due to the lack of apparent structures identified on the aerial photographs it is unlikely that 'hot spot' of elevated levels of contaminants would occur at the site.

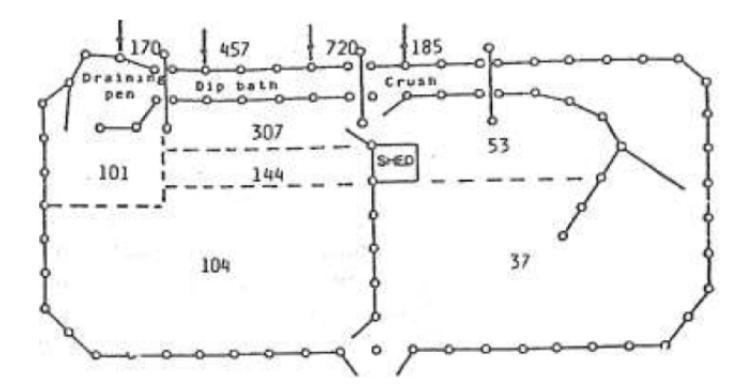
Figure 6: Average Arsenic contamination mg/kg at dipsites

Figure 6 and 7 present the concentration of arsenic and DDT found at dipsites in the Northern Rivers (DIPMAC, 1995). The areas that are most likely area to contain the highest elevation of arsenic and DDT are adjacent to the dip bath and drain pen. High concentration of residue is also expected to be found in the chemical shed where spillages are most likely to have occurred. In 1955 when the use of arsenic was stopped in the baths (due to ticks becoming resistant to arsenic) and replaced with DDT, the arsenic was separated from the dip bath fluid by adding lime. This formed an insoluble arsenic compound which settled to the bottom of the bath, where then it was removed and buried beside the

Both arsenic and DDT are persistent in the environment, with the chemicals binding strongly to clay particles and organic matter, therefore leaching is limited through the profile. The spread of contamination, as depicted in Figure 6 and 7 reduces significantly away from the dip bath.
