**REPORT ON**

#### GEOTECHNICAL INVESTIGATION PLANNING PROPOSAL FOR REZONING PROPOSED SUBDIVISION AND RESIDENTIAL DEVELOPMENT

## NO.39 – 55 (LOT 8 DP1191647) ORATAVA AVE AND PART OF NO.570 (LOT 3 DP1096405) PENNANT HILLS RD WEST PENNANT HILLS NSW

report ref: R/15-004.G Final

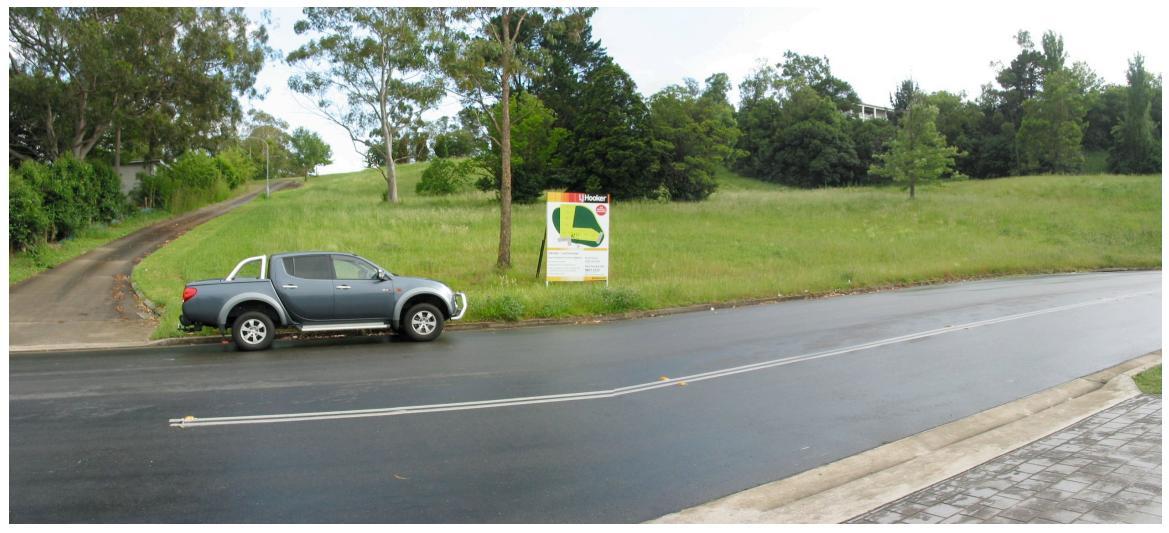
Plate 1 – View north at SW corner of the site.

The remainder of the land is open and grassed. Plates 1 & 2 are indicative of the current condition of the land. Figure 3 shows the site to have been completely cleared of vegetation in the early 1940's.

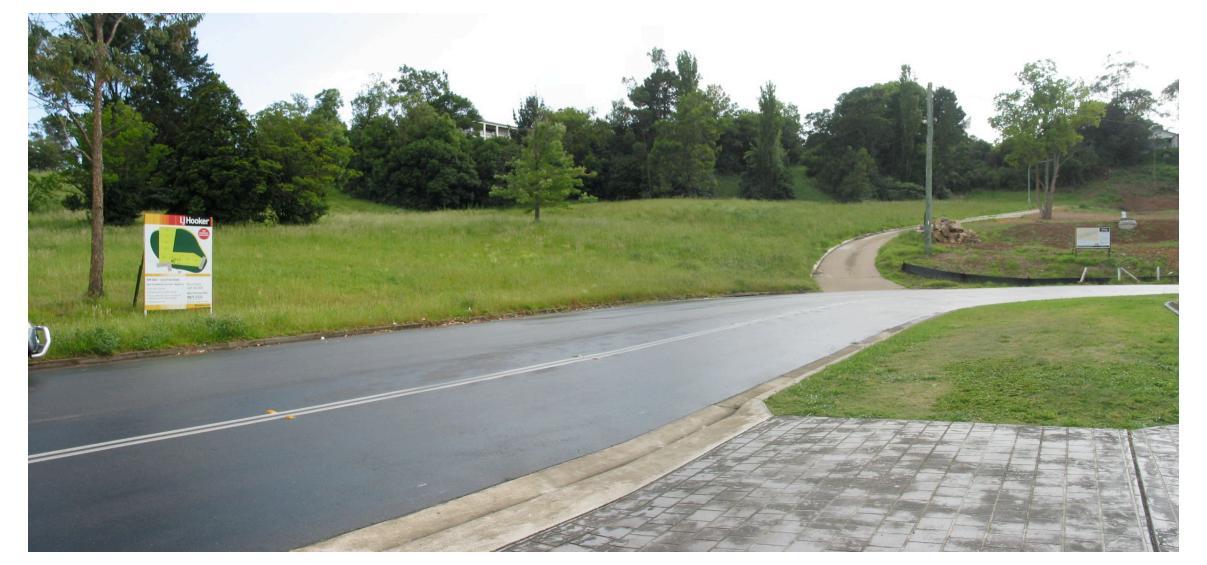
Plate 2 - View to NE at SW corner of the site.
