Preliminary contamination assessment

Daisy Hill Estate

Proposed subdivision of Lot 200 DP825059, Lots 661 and 662 DP565756, Lots 64 and 65 DP754287, Lots 316 and 317 DP754308 Eulomogo Road, Dubbo NSW

Ref: R13365c.2 Date: 23 February 2015

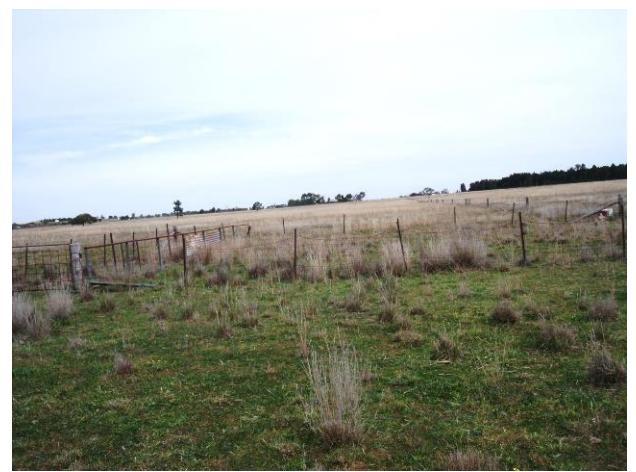
Figure 3.1. Sheep yards on Lot 316

Infrastructure on the lot comprised boundary and internal fencing. Stock water troughs are also present. Sheep yards stockyards are located in the central eastern section of the lot (Figure 3.1). No dips are associated with the sheep yards.

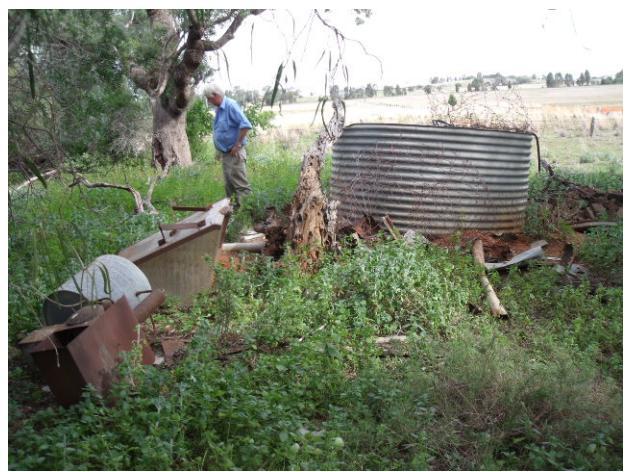
Figure 3.5. Old machinery on Lot 65

Old machinery and metal debris exists around the sheds on the site (Figure 3.5). No potential sources of contamination are associated with the material. No oil staining was observed on the floor of the workshop or other areas of the lot. No pesticides or lubricant storage was observed.

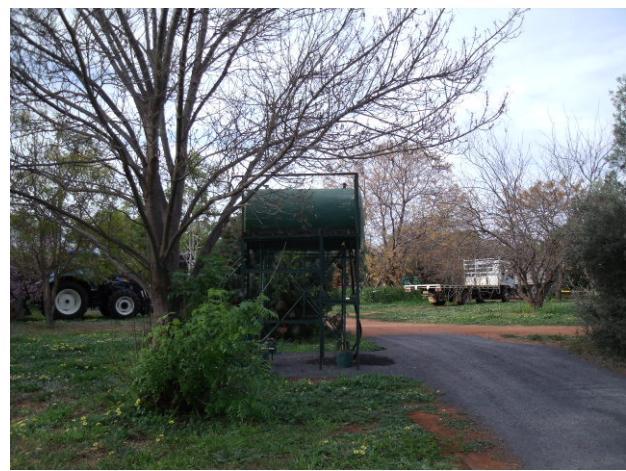
Figure 3.2. AST on Lot 64

Two above ground storage tanks (AST) were located to the north of the homestead. One tank was installed approximately 4 years ago for the storage of diesel and had a volume of approximately 2,000L (Figure 3.2). The ground surface around the tank was covered with basalt gravel. Minor staining was present on the gravel resulting from spills during refiling.

There was no evidence of sheep dips, orchards or other contaminating activities from the historical review. Above ground fuel storage tanks are located on Lot 64 and surface staining is present under one AST.

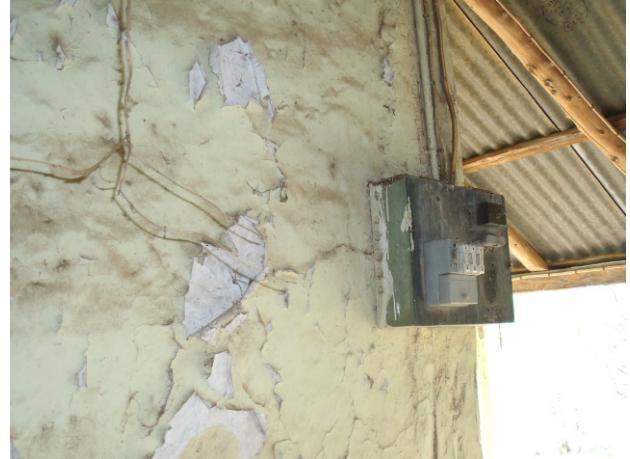
Figure 3.4. Asbestos contianing electrical backboard

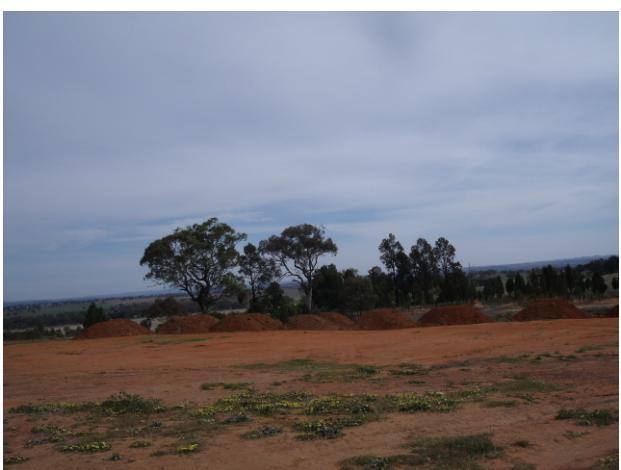
Figure 3.8. Rehabilitation of quarry on Lot 200

- Rehabilitation of the quarry on Lot 200 has begun.
- Bare areas are located in the north eastern section of Lot 661. The bare areas appear to have resulted from removal of vegetation.
