Project 92287.60
29 January 2020
R.003.Rev0
CKM

Geotechnical Investigation Summary Letter
Proposed Rezoning
Tranche 41, Pondicherry, Oran Park

Project 76778.28
August 2017

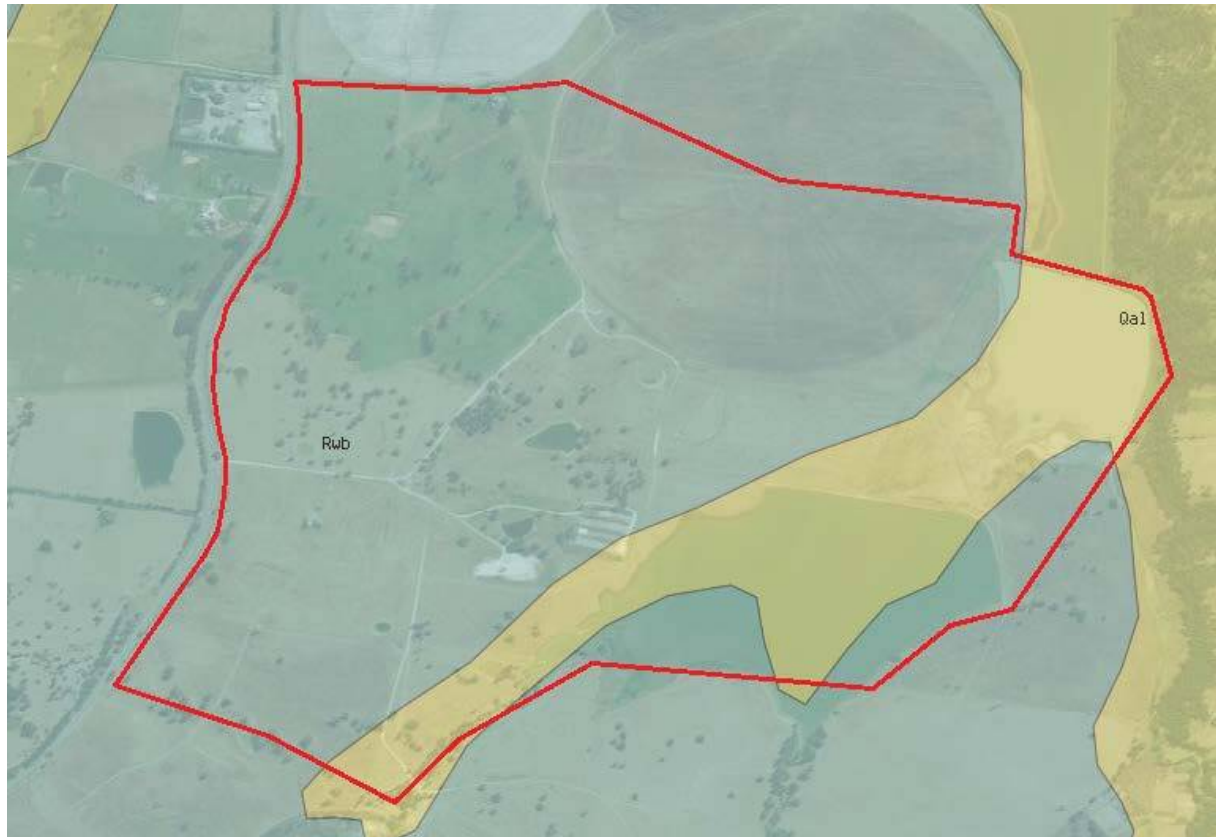
The lower lying eastern portion of the site is generally underlain by Quaternary alluvial deposits (mapping unit Qal) of the Nepean River which are mainly derived from weathering of Permian and Triassic bedrock and typically comprise grey-brown, medium grained quartz sand with layers of silt and humic clay.

Figure A1: Geological Landscapes (Yellow – Quaternary Alluvium and Blue – Bringelly Shale)

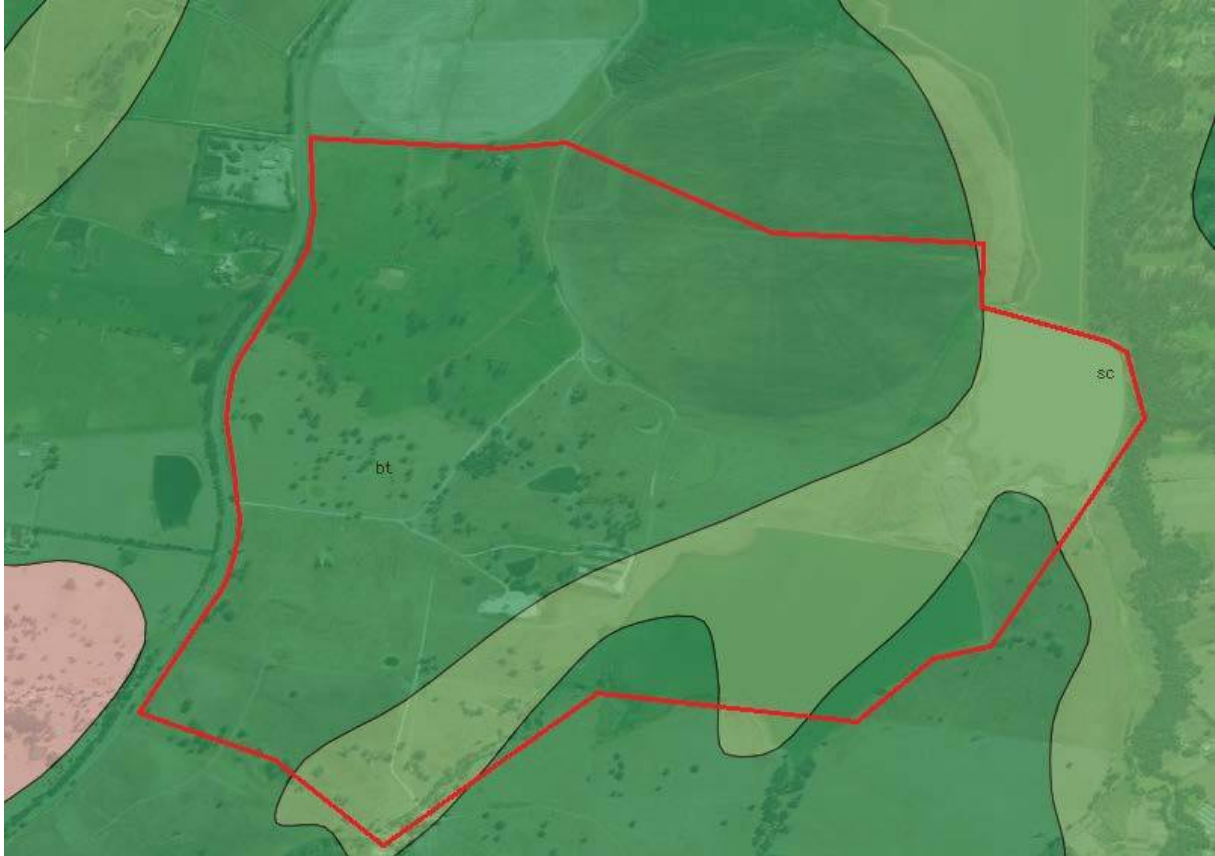
- **South Creek Soil Landscape** (mapping unit sc) is an alluvial soil group associated with floodplains, valley flats and drainage depressions of the channels on the Cumberland Plain. Usually flat with incised channels, mainly cleared, and is mapped along South Creek and associated minor creek extending south and south-west through southernmost dam. Mapping indicates soils associated with this landscape comprise very deep layered sediments over bedrock or relict soils. Red and yellow podsollic soils occur.

Figure A2: Soil Landscapes (Dark Green – Blacktown Soils and Light Green – South Creek Soils)

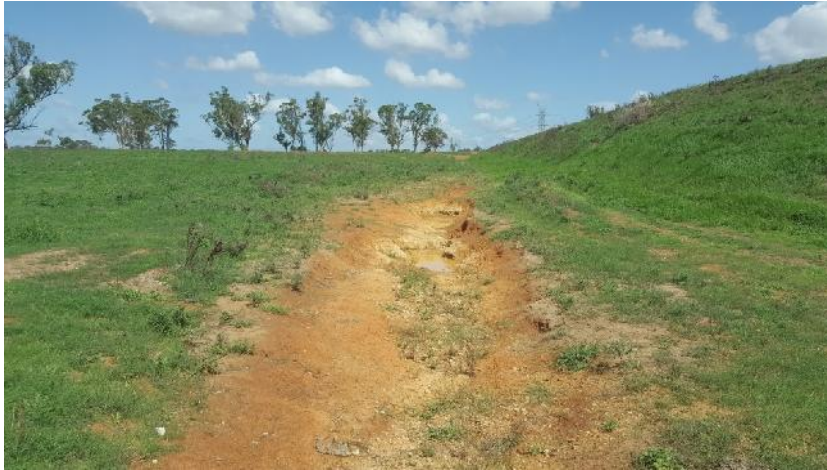
- The landform is predominantly gently sloping undulating terrain of gradual topographical relief. Crests and gullies are mostly broad, although incised gullies to depths of 1 m were noted along some drainage lines (Mapping Reference Point (MRP) 49 shown in Figure A3 and MRP 72, 76);

Figure A3 – Incised gully at MRP 49

- In general the site is considered to be stable with slopes typically less than 10 degrees;
- No areas of hillslope instability were observed during the site walkover (as was expected of such gentle relief);
- Steepened creek banks have the potential for minor instability and localised bank collapse.

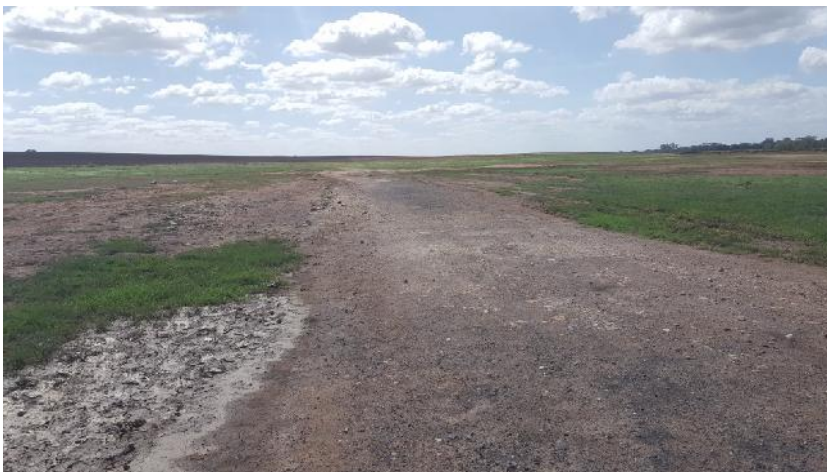
- Sheet erosion is also locally developed where there has been disruption of the vegetation by previous development (e.g. gullies, or recent clearing) and likely large scale flows following inclement weather. An example of this type of erosion (at MRP 41, 45, 47, 49 and 76), which exposes the underlying clays, is shown in Figure A4 and is located on the southern edges of the northern large dam.

Figure A4 – Sheet erosion at MRP 41

It is considered that the erosion hazard within the site would be within usually accepted bounds which may be managed by good engineering and land management practices (refer Sections 8.4 and 8.5).

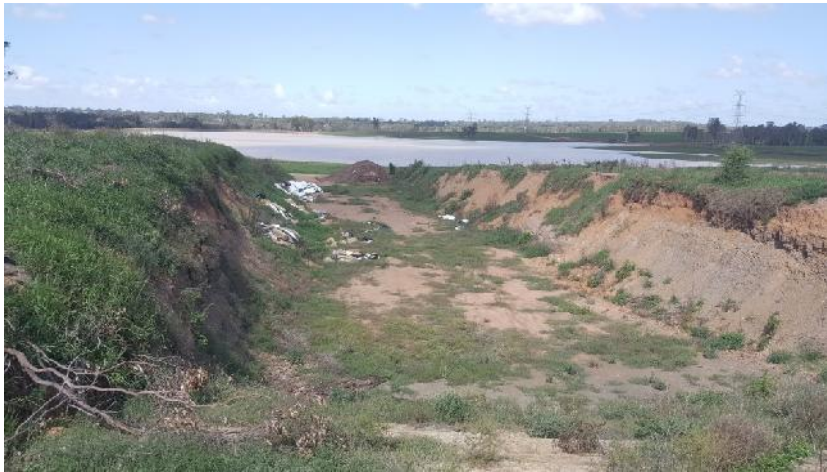
- Where observed topsoil was significantly organic and root affected only in the top 150 mm. Below the topsoil, the profile remained quite silty but was not significantly organic.
- Rock profiles observed in the quarry/silage area indicated a typically fine grained shale (MRP 56), refer Figure A5);

Figure A5 – Shale outcropping at MRP 56
