Moore Trees
Arboricultural Services

Arboricultural Development Assessment Report

160 Burwood Road
Concord NSW 2137
Lot 5 in DP 129 325
Lots 398 and 399 in DP752023
Lot 2 in DP 230294
July 2018
FINAL (Updated 5th September 2019)

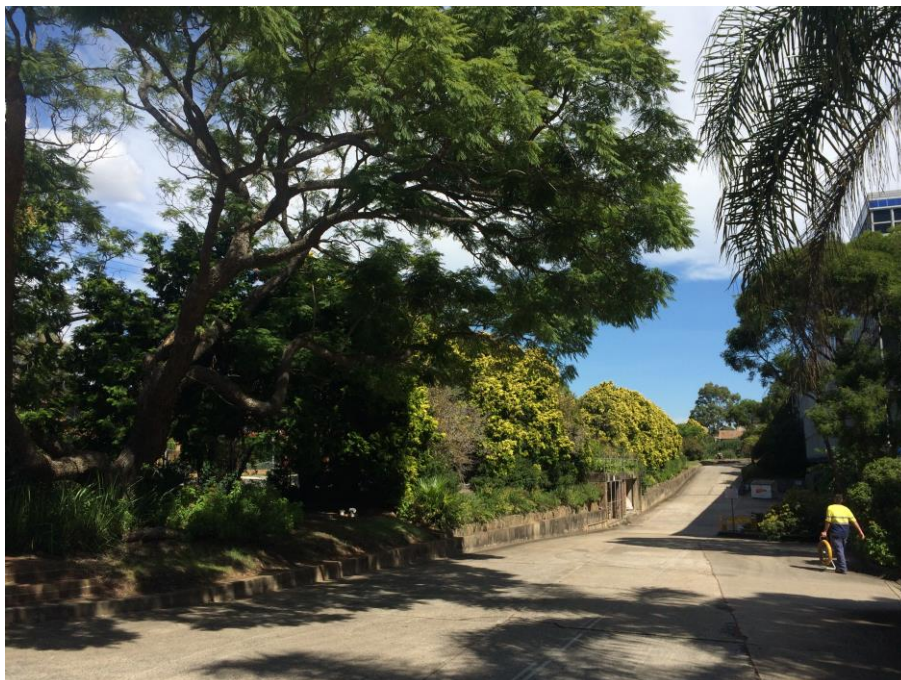
- 3.5** Trees 1-30 are located on the southern side of the site, consisting mostly of conifers and a single specimen Jacaranda (*Jacaranda mimosifolia*) near the main security entry on Burwood Road (Tree 1). This tree is in good health and condition although it does have some quite low lying lateral branches (Plate 1). The main trunk, first and second order branches are free of any cracks, splits or fruiting bodies. New extension growth was noted. The basal area and woody root zone were free of any ground heaving, or lifting.

Plate 1: Trees located along the southern boundary near the entry gate. Tree 1 is to the right of image. P. Vezgoff.

- 4.1** Of the two hundred and twelve (212) trees assessed for this report many are in a poor condition or have been overplanted to an extent where they have become suppressed. Tree 1, the large mature Jacaranda by the front gate is significant. This tree will have an extensive root system that will extend far beyond the drip line as shown in Appendix 8. The proposed building near this tree is very close and extensive pruning of the canopy to comply with scaffolding standards will not allow much of a specimen to be retained. Unfortunately, as it is surrounded by various levels and concrete structures retaining this tree will be difficult.

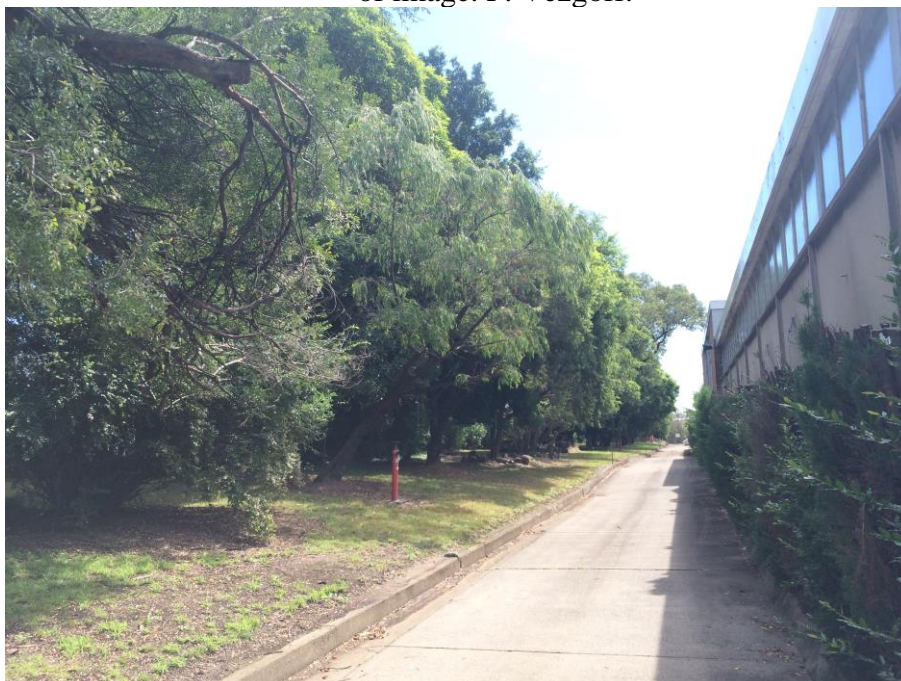
- 3.7** Along the western boundary is a large screen planting (Plate 2) of native and exotic tree species consisting of mature trees including watergum, Jacaranda (*Jacaranda mimosifolia*), Podocarpus, Gum trees (*Eucalyptus sp.*), Brush Box (*Lophostemon confertus*), Oleander shrubs. Generally, these trees are in good health and condition. As individual specimens, these trees are not particularly significant, however as a group they certainly form a good screening of vegetation between the residential dwellings of Duke Street and the warehouse area. Some of the adjoining properties have large trees close to the boundary. These are numbered as Trees 46 and 52. These trees located on the adjoining properties are in good health and condition and would be considered significant. No building works should occur within eight (8) metres of these trees as measured from the centre of each tree. The TPZ's for these trees will need to be implemented on any designs so that irreparable damage does not occur to them. These trees are within two (2) metres of the boundary fences.

Plate 2: Trees 33-67 along the western boundary. P. Vezgoff.

The large group of Trees numbered as 33-67 along the western boundary that form a large screen to the site will be retained. The grafted root zones and codominant canopies will not allow any form of services or stormwater works through this area if they are to be retained. The TPZ distances in the Tree Schedule (Appendix 1) should be used should any potential works fall near these trees.

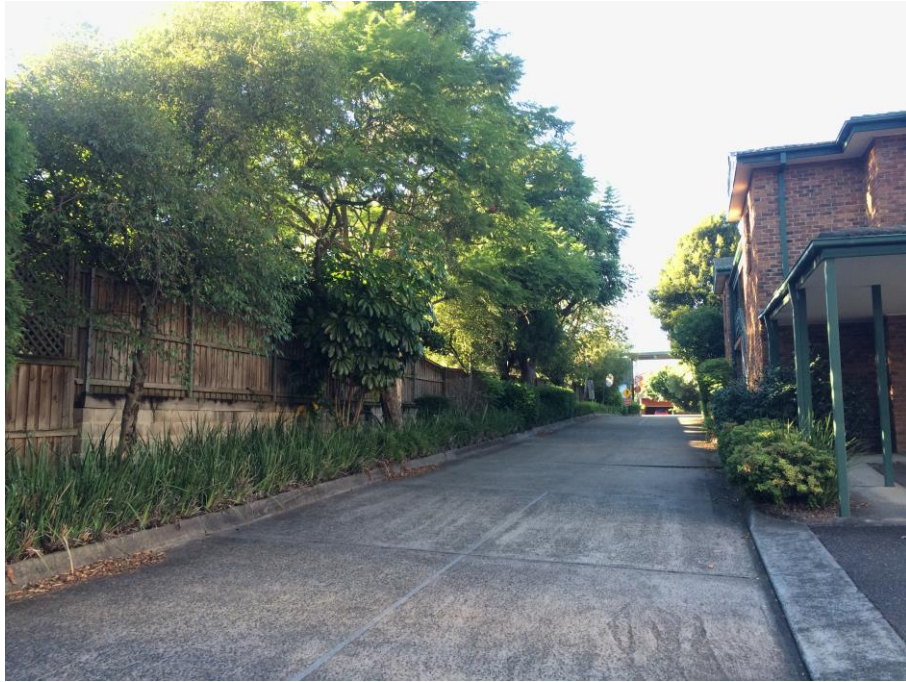
- 3.9** The eastern side of the site consists of a long narrow driveway extending from the security gate on Burwood Road (Plate 3). It has been densely planted with a mix of Broad-leaved Paperbark (*Melaleuca quinquenervia*), Alder (*Alnus jorullensis*) trees and conifers that are generally in fair to good condition with several poor specimens.

Plate 3: Trees 145-166 along the driveway entry. P. Vezgoff.

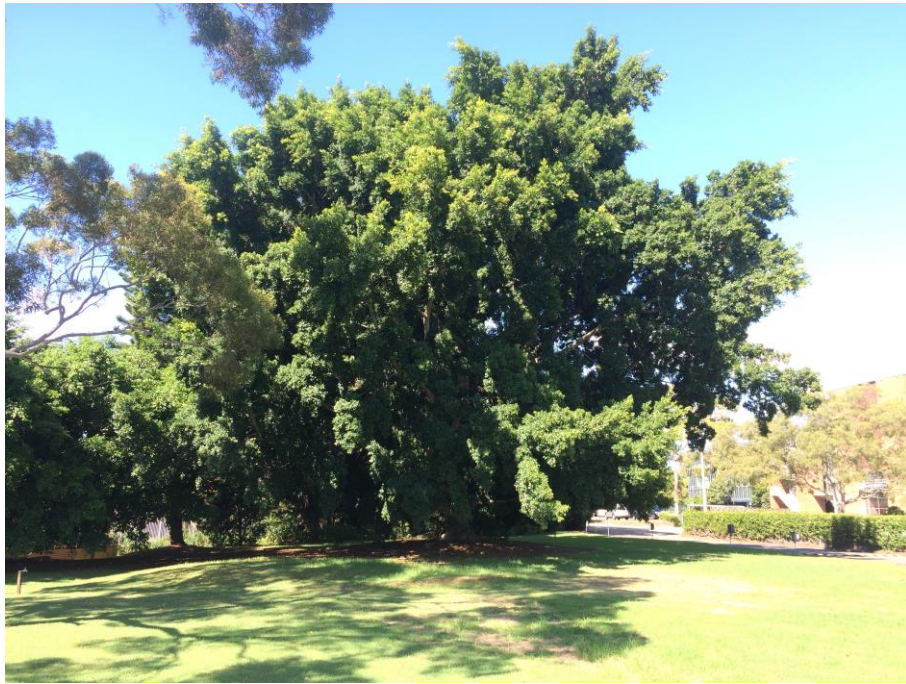
- 3.10** The driveway leads to a large open field area that has Tree 184 (Plate 4), a large mature Hills Weeping Fig (*Ficus microcarpa* var. 'Hillii'). This tree is the largest tree on site and forms a very prominent feature tree. This tree is in excellent health and condition, free of any cracks, splits and fruiting bodies. The woody root zone around the base of the tree has been mulched. It has been well cared for and as a result is certainly worth keeping if possible. It should be noted that this tree species is not indigenous to the Sydney area. The north-eastern corner of the site, around Tree 184, is densely planted forming a thick screen to adjoining residential units. The north-western area contains a mixture of She Oak (*Casuarina* sp.) and Gum trees (*Eucalyptus* sp.). These trees are all in good health and condition. The main car park area has been mostly planted with Broad-leaved Paperbark (*Melaleuca quinquenervia*), all approximately spaced 2-3 metres apart, in varying sizes ranging from 200mm - 450mm stem diameter (Plate 5). These trees are all in good health and condition. Damage to the surrounding asphalt, kerb and gutter is occurring due to the small planter beds these trees are planted in. Also in the car park are two (2) Lemon-scented Gum Tree (*Corymbia citridora*). These are numbered as follows Trees 137 and 138 (Plate 6). These trees are all in good health and condition, free of cracks, splits and fruiting bodies. This species will not tolerate works over the root zone or level changes. These specimens will be approximately 20-30 years old.

Plate 4: Tree 184, the large specimen tree. P. Vezgoff.

- 4.5** Trees 167-190 and 88-102 are located around the lawn area and fronting the foreshore area. Although over planted these trees are mostly in good health and condition and are worthy of retention. Tree 184, the large mature Hills Fig is certainly worth retaining, if possible. At present Tree 184 is proposed to be relocated within the site. A site specific tree relocation specification will be required for a tree of this size.

Tree 184 to be relocated within the site.
Refer to site specific tree relocation specification.

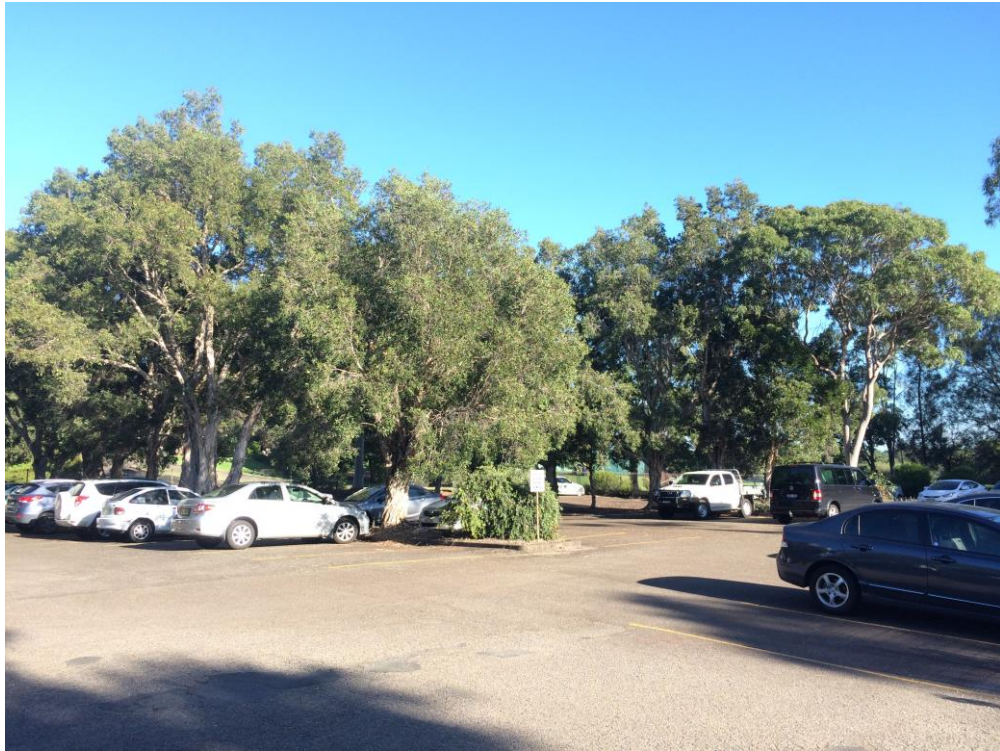
- 4.4** Trees within the main car park area would suffer extensive root damage removing surrounding asphalt and concrete. Woody roots and fine feeder roots would be damaged, making long term viability of any of these trees almost impossible to retain.

Plate 5: Car park trees densely planted. P. Vezgoff.

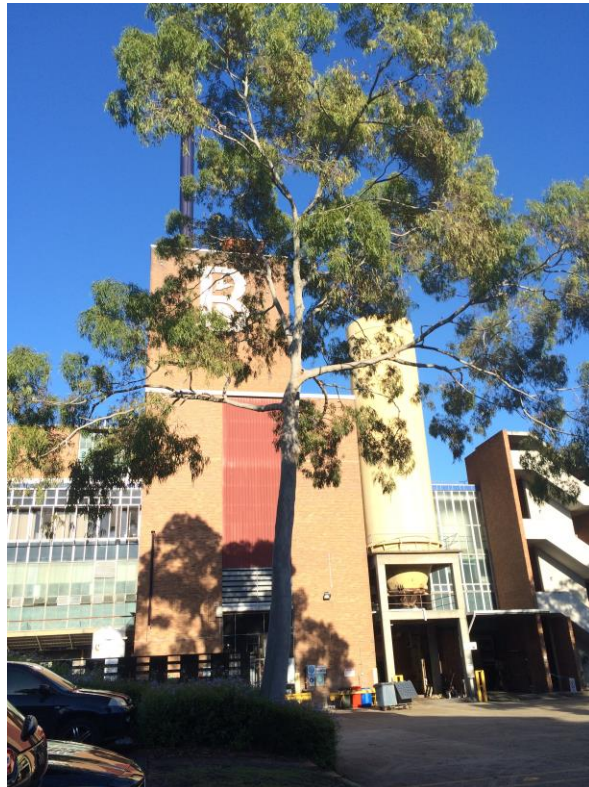
Plate 6: Single specimen trees within the car park such as Tree 138. P. Vezgoff.

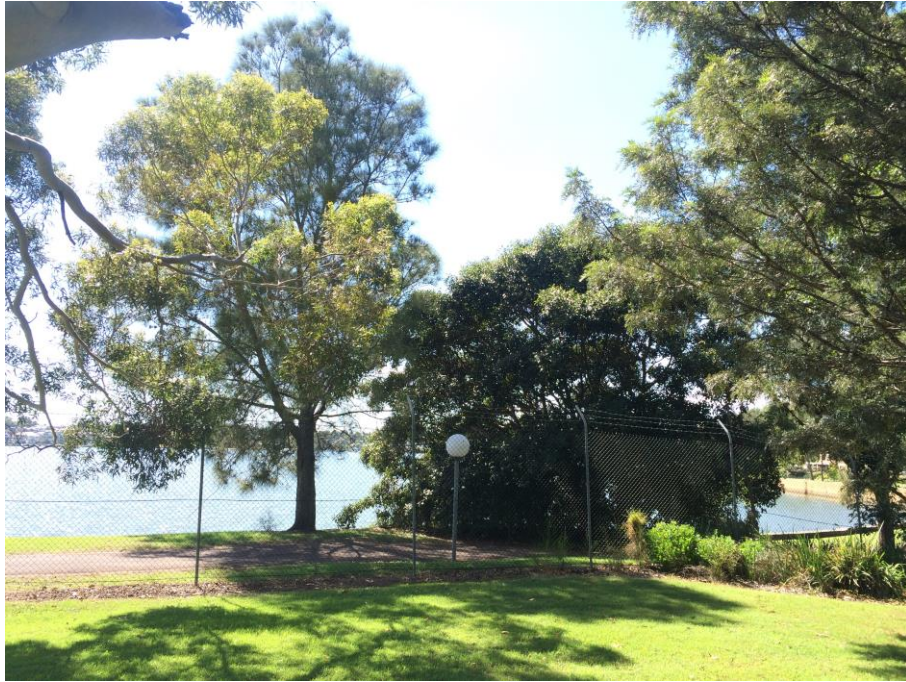
- 3.11** Trees 191 and 192 are located within public open space however they are allocated within the boundaries of the site, growing on the foreshore edge (Plate 7). These trees are single specimens of Port jackson fig (*Ficus rubiginosa*) and Swamp she oak (*Casuarina glauca*). These trees are in good health and condition. The main trunk, first and second order branches are free of any cracks, splits or fruiting bodies. New extension growth was noted. The basal area and woody root zone were free of any ground heaving, or lifting. These trees could be replaced if required as they are less than 15 years old.

Plate 7: Trees 91 and 92 located on the foreshore edge. P. Vezgoff.
