Report on
Preliminary Geotechnical Assessment

Proposed Rezoning
Hydro Aluminium Kurri Kurri
Loxford Portion

Prepared for
ESS Australia
On behalf of
Hydro Aluminium Kurri Kurri

Project 81520
March 2015

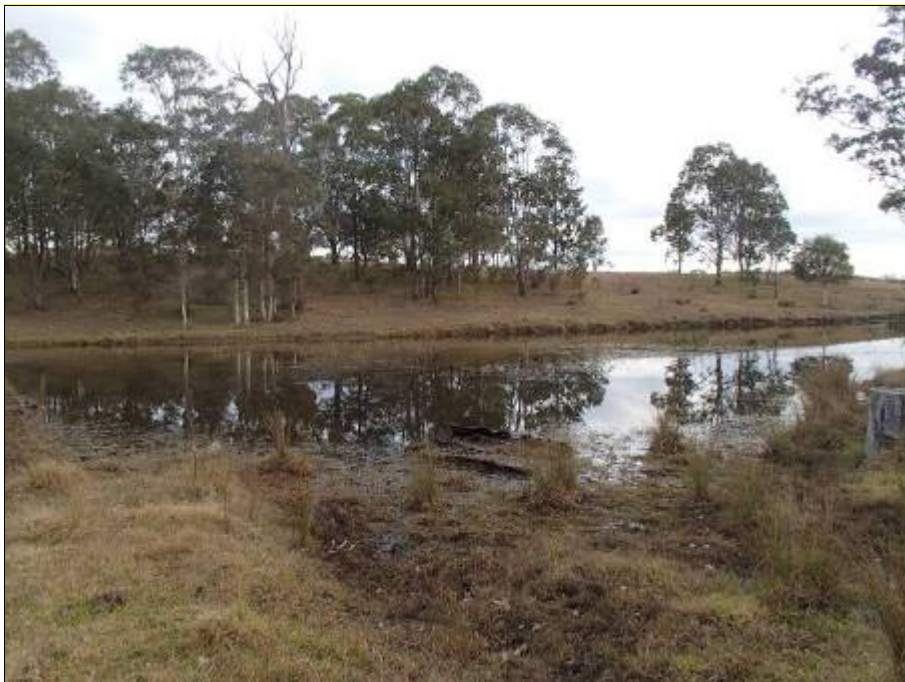
Photo 7: Dam 4 (Residential Central Precinct)

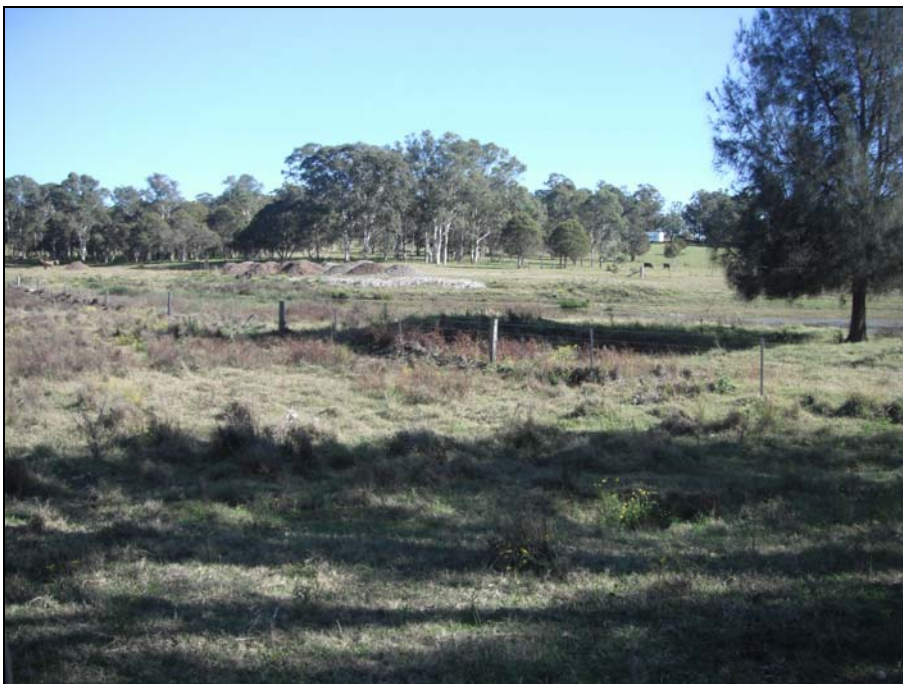
Photo 11: Mounds of filling in vicinity of area between Southern and Central Residential Precincts

In areas where more than 0.4 m of uncontrolled filling is present, a Class P site classification will apply, and design of footings will need to be by engineering principles, unless the filling is removed and replaced with controlled filling.
