## **GROUNDWATER IMPACT ASSESSMENT**

**Part Lot 4 in DP834254  
510 Beach Road Berry**

**Rep.No. 17134-B**

**8<sup>th</sup> March 2018**

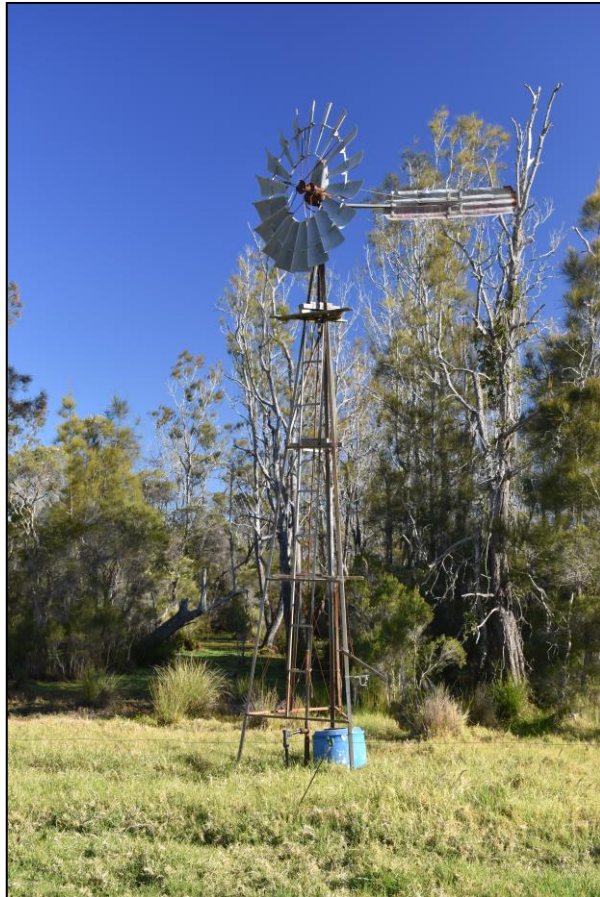
**Plate 1 Windmill**

The Site is a mostly cleared and partly developed parcel of land. A *Google Earth* image over the Site showing existing conditions is presented in **Figure 1**. Fenced paddocks cover the northern 60% of the Site. Three small farm dams are located in the northern part, two of these on the north-eastern fall and the third in the north-western corner. A wind mill is located on the northern edge of Coomonderry Swamp in the southern part of the Site (**see Plate 1**).

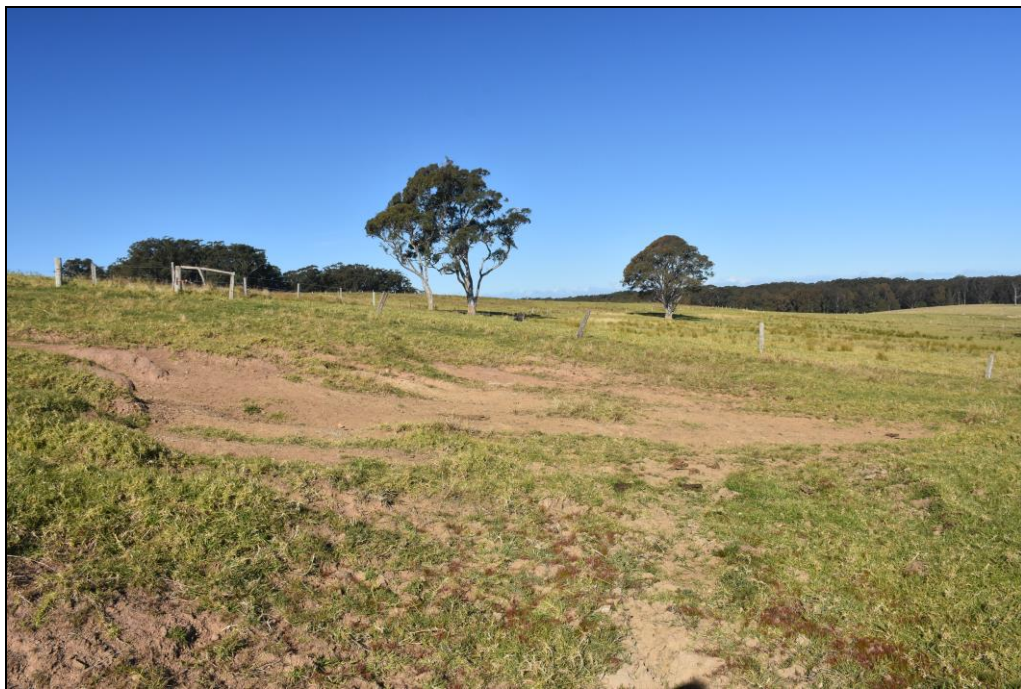
**Plate 2 Spring – Southern Side of Divide**

1. An area of 'dry' exposed, disturbed soil located on the southern elevated side of the central ridge system at about 22 m RL (**see Plate 2**). The spring is located within a 30 m-wide corridor regularly travelled by dairy cows. There was no evidence of any groundwater seeps at the time of the site inspection.

Although the discharges from these springs are believed to vary in response to seasonal and climatic factors, anecdotal evidence indicates that they are low volume intermittent flows and/or seeps sometimes in an amount large enough to form a pool or stream-like flow. Spring discharge of local subsurface flow systems is closely related to recharge of precipitation and can show wide fluctuations in flow. Anecdotal evidence indicates that the seep on the southern side of the ridge system sometimes renders the ground wet (muddy).

In order to achieve an overall lower potential hazard the nominal buffer setback distance between a known spring on the Site and any proposed application of secondary treated wastewater (effluent management) should be no less than:

- 15 m sideslope
- 30 m upslope
- 50 m downslope

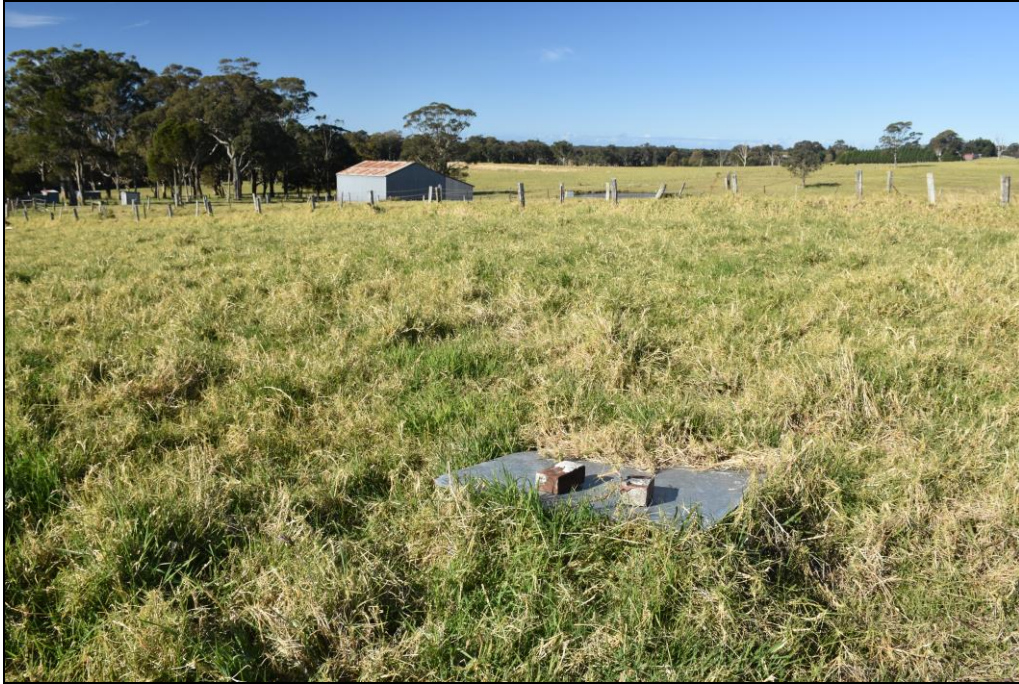
**Plate 3 Spring – Northern Side of Divide North-Western Part of Site**

2. A grassed covered area in a fenced paddock on the northern side of the central ridge south of the dwelling in the north-western part of the Site. The elevation of the spring is approximately 22 m RL (**see Plate 3**). A relatively small covered concrete tank has been historically buried in this location to presumably intercept and detain some of the shallow groundwater discharging at this point.

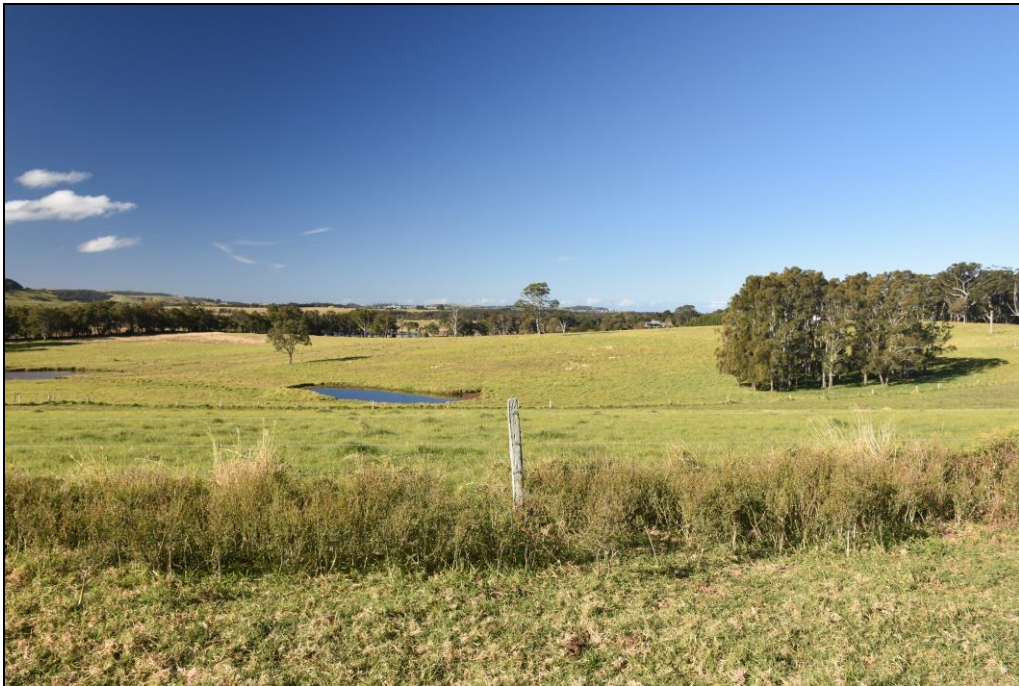
**Plate 3 Spring – Northern Side of Divide Central Northern Part of Site**

3. An area of 'dry' exposed disturbed soil located on the northern elevated side of the central ridge system at about 22 m RL (**see Plate 4**). There was no evidence of any groundwater seeps.

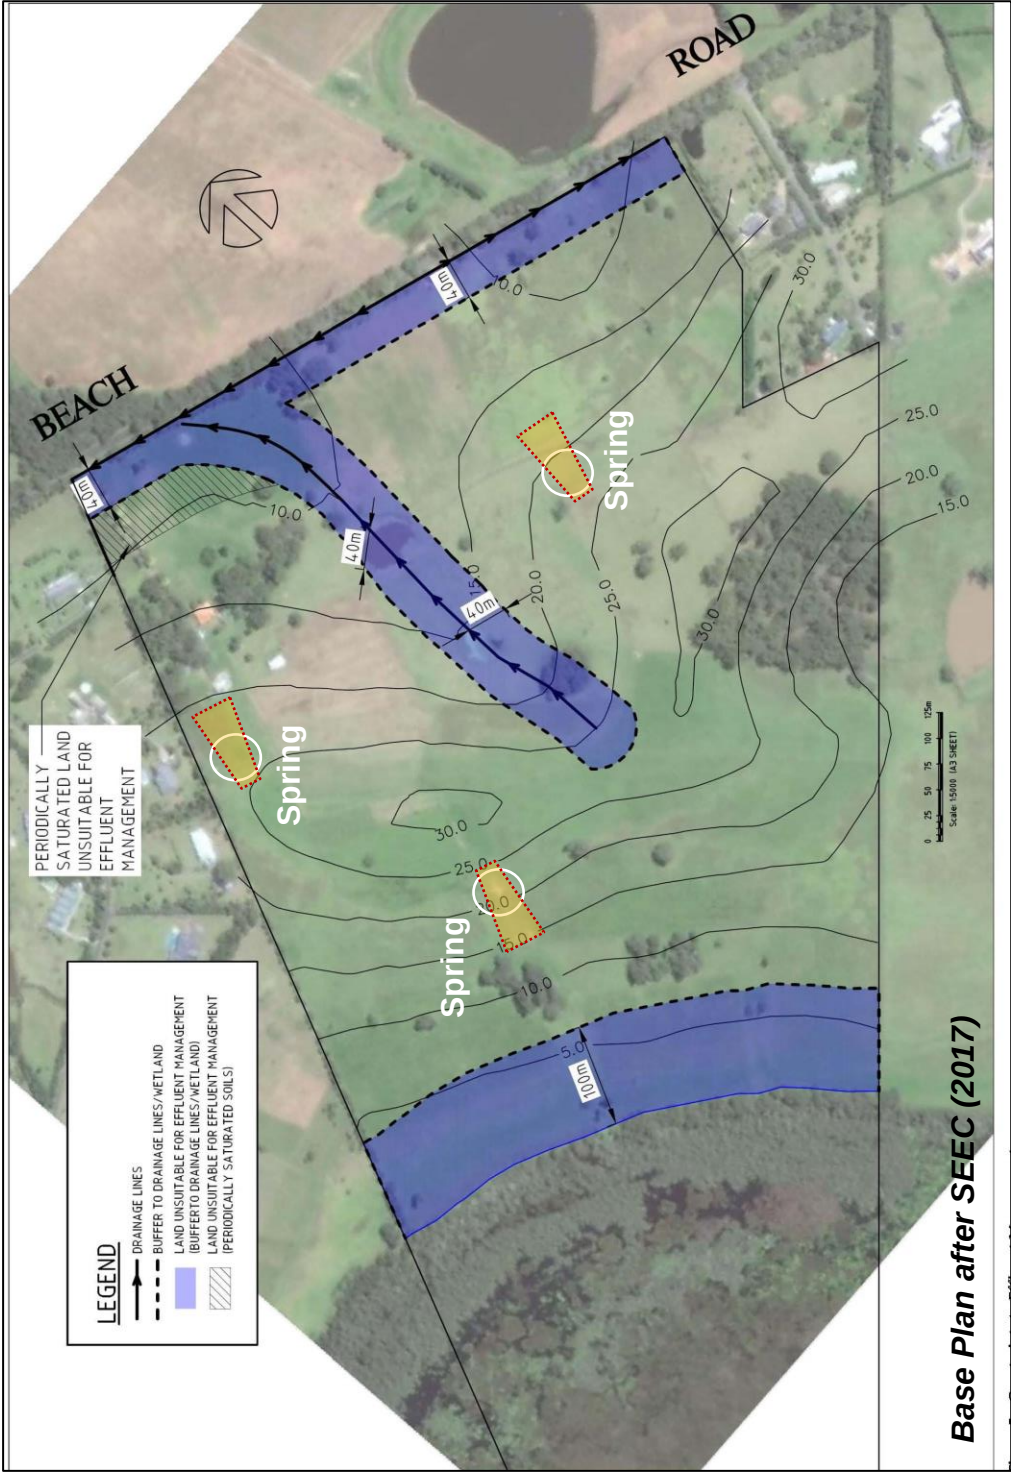
| | Lot 4 in DP834254<br>510 Beach Road Berry<br>Areas Unsuitable for Effluent Disposal | | | <b>FIGURE 4</b> |

The reported existence of springs in the more elevated part of the Site indicates the presence of 'shallow' groundwater which is often collectively referred to as 'water features' or 'springs'. Three discharge sites were identified by the owner and inspected in September 2017. The locations of the known springs are shown in **Figure 4**:

Land Considered Unsuitable for Effluent Management (known springs)

The downslope setback is also nominated to prevent any spring flow migrating downslope and impacting the LAA. The areas surrounding the known springs not considered suitable for application of treated wastewater are annotated in **Figure 4**.
