PROPOSED DEVELOPMENT, MUNIBUNG HILL

Fitzwalter Group Pty Ltd

GEOTWARA20281AE-AE 14 July 2009

URBAN CAPABILITY ASSESSMENT

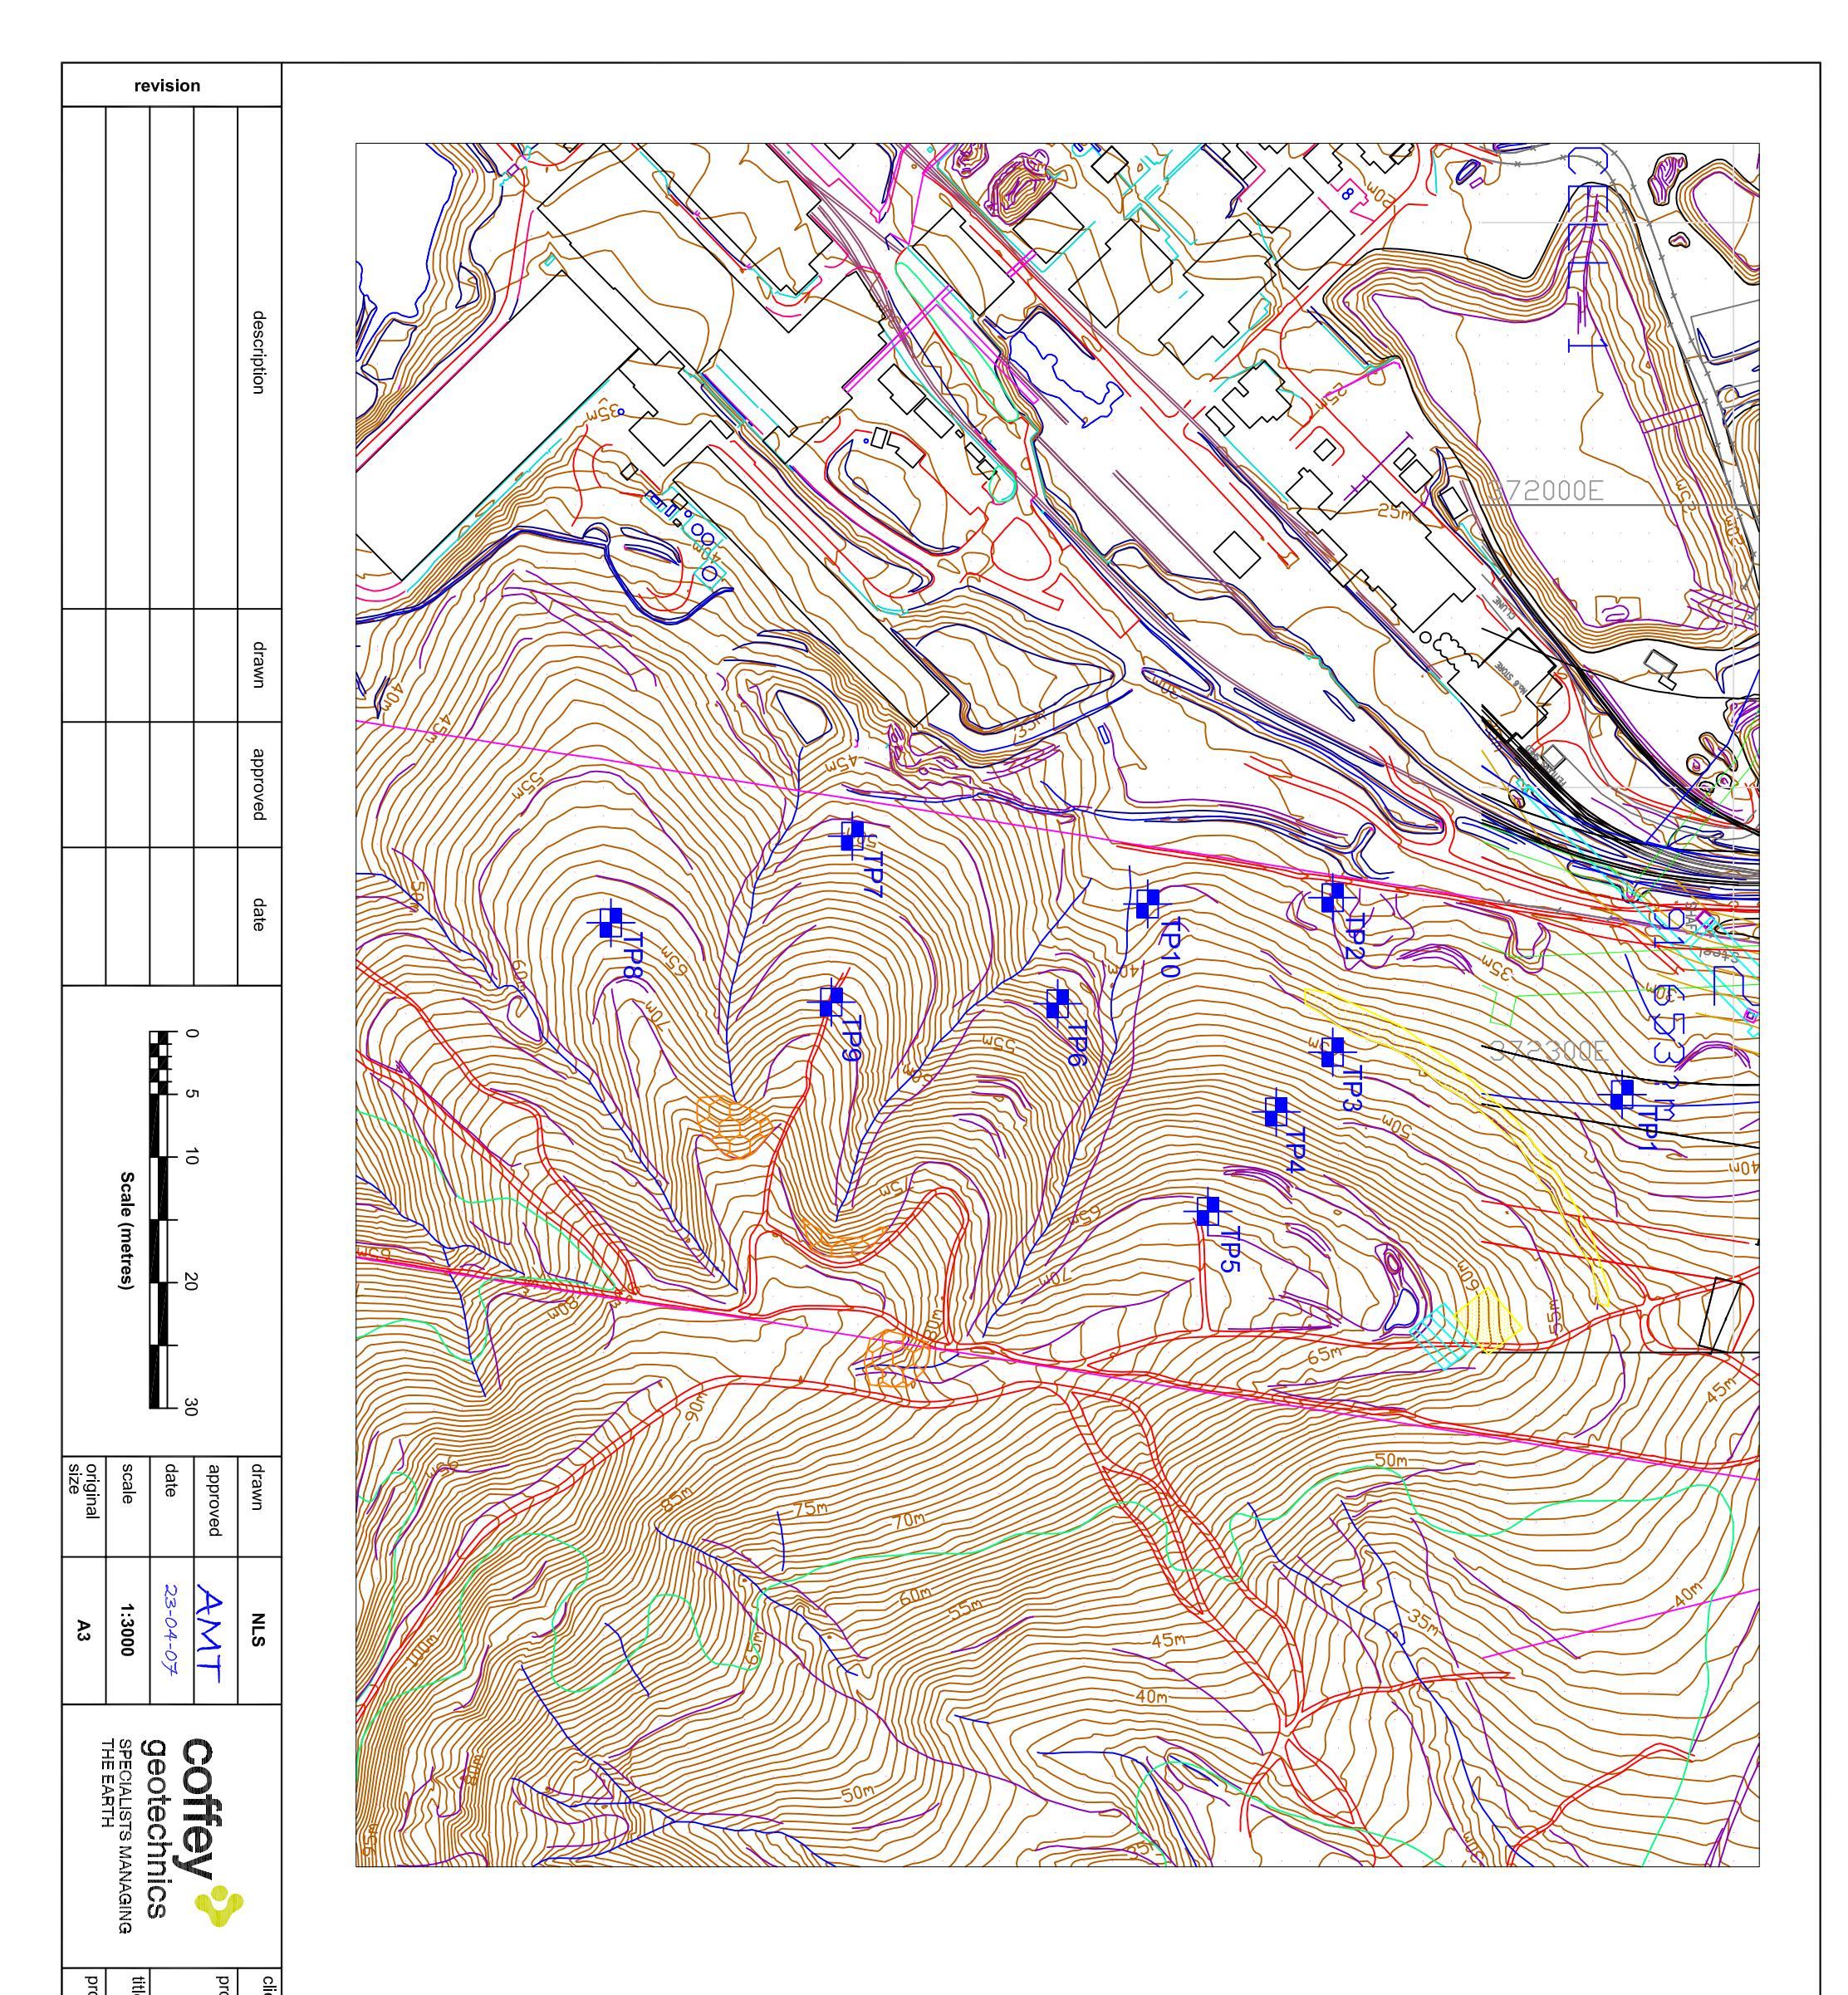
oject no	s s	oject:	ient:	
GEOTSGTE	JBSURFACI	PROPOSE M		
20281AE	E INVESTIG/	ed munibur Unibung h	FITZWAL	GLOMERAT F EXPOSUR
figu	ATION AND	NG HILL DE ILL, BOOL/	TER GROU	E E CE AREA E EXPOSURE
ire no: Fi	MAPPING	IVELOPMEI AROO	P	
GURE 2	PLAN	Т

No inferred sub crop of the coal seams was noted over the site during the investigation; however the Fassifern Seam was encountered in TP 3 at approximate RL 44m (AHD). Locations of some but not all observed exposures of conglomerate, sandstone and tuff are shown in Figure 2.

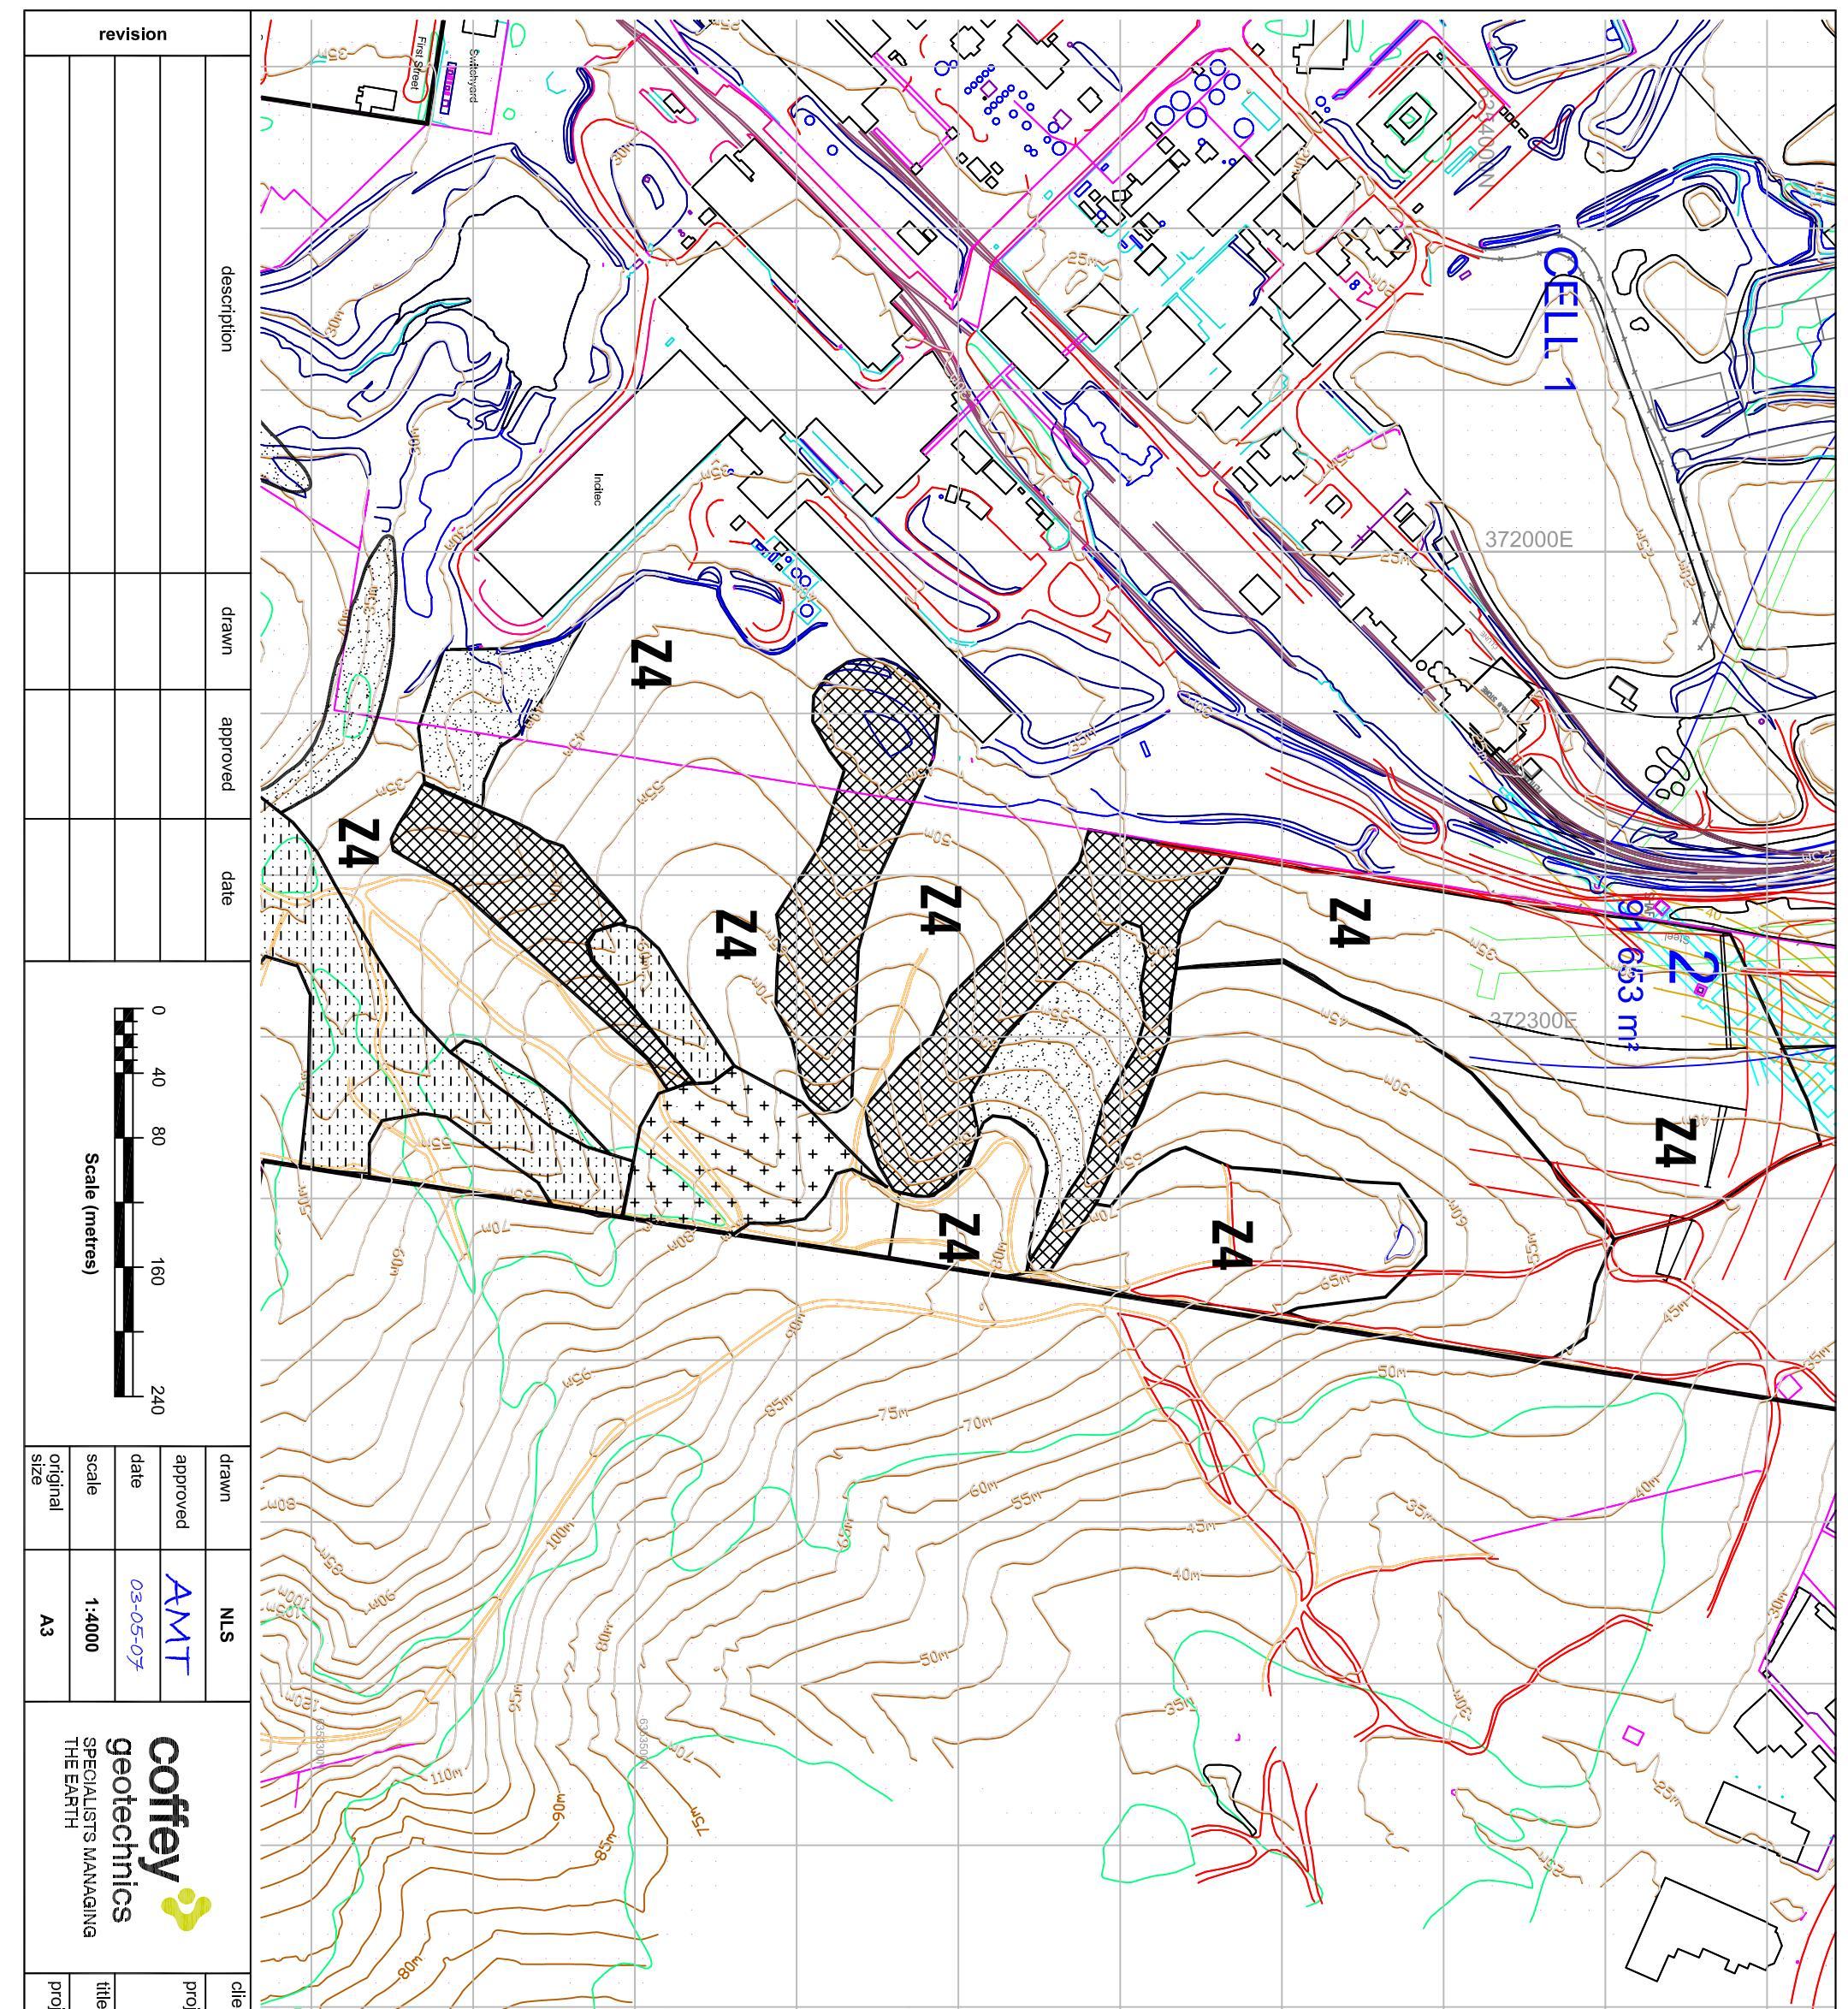
roject: PROPC MUNIBU Ite: SITE CONSTRAINTS roject no: GEOTSGTE2028	N Image: state sta
ZWALTER GROUP OSED DEVELOPMENT UNG HILL, BOOLAROO PLAN - CURRENT INVESTIGATION figure no: FIGURE 3	NONE

The proposed development has been divided into a series of geotechnical zones in general accordance with previous Coffey report N09271/02-AB with the exception of Zone 3 being split into two subgroups Zone 3A and Zone 3B. The zones were based on the results of recent mapping, subsurface investigation and likely surface and subsurface conditions. Due to the size of the site, the classification into geotechnical zones is broad and based on the extent that conditions will impact on potential development. The geotechnical zones are defined in Table 2 and delineated over the development area in Figures 3 and 4.

ZONE 3A	ZONE 3B	ZONE 4
CONSTRAINTS	Possible highly reactive soils, poor construction/hillside practice may create/activate instability, appropriate earthwork controls (cutting and filling) and drainage required	Potentially poorly drained soils, wet subgrade conditions at the mouth of gullies. Erosion issues toward the head of gullies	Possible moderately to highly reactive soils, hard excavation conditions in rock
