Residential Subdivision of Henry Parks Drive Lot 442 DP 1201831 Kiama Downs

Report on Preliminary Geotechnical Assessment

Our Ref: TERRA19419.Rep1.Rev2

27 August 2020

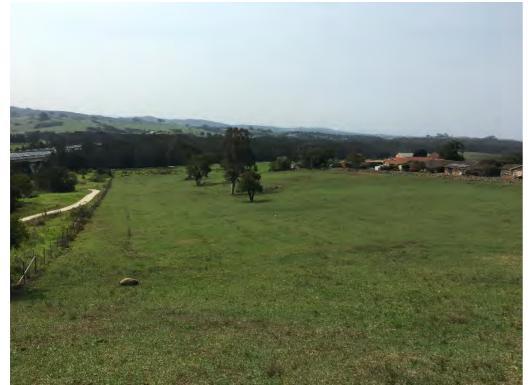
Photograph 1: View of the site (area 1) from the Henry Parks Drive access point, looking along south-west boundary from within area 4.

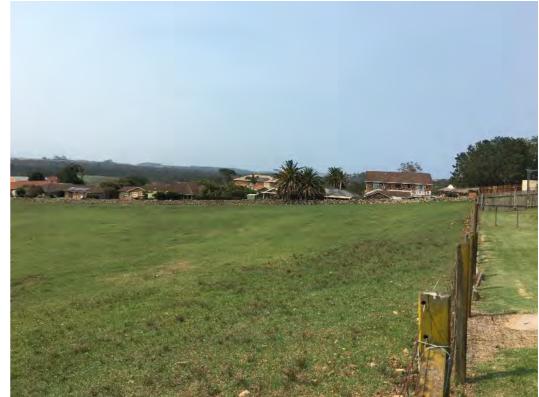
Photograph 2: View of the site (area 1) from the Henry Parks Drive access point, looking along south-east boundary from area 4.

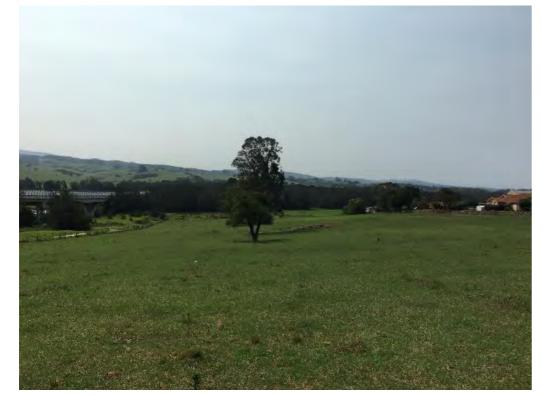
Photograph 3: View of the middle of Area 1, contains four mature trees.

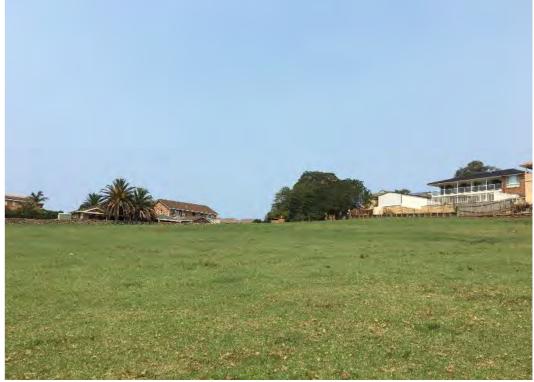
rock wall along the eastern and southern boundaries.

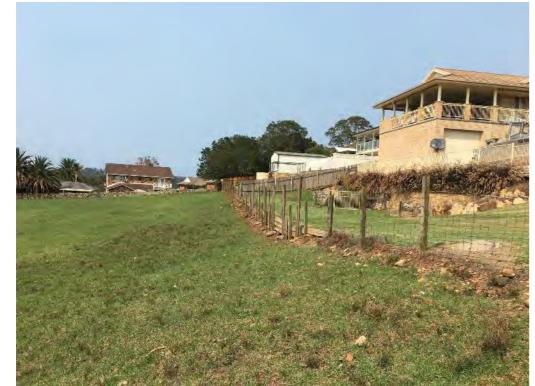
Photograph 5: Small retaining wall on the southern boundary.

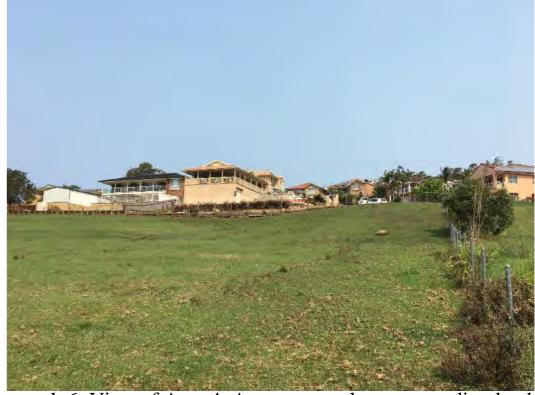
This part of the site is a small area on the access point of the subdivision. This area has a higher elevation and steeper slopes than the remainder of the site. On the ground surface fill material was observed including small sandstone gravel and boulders, potentially associated with the development of land to the south of the site.

Photograph 6: View of Area 4. Area steeper than surrounding land, contains a

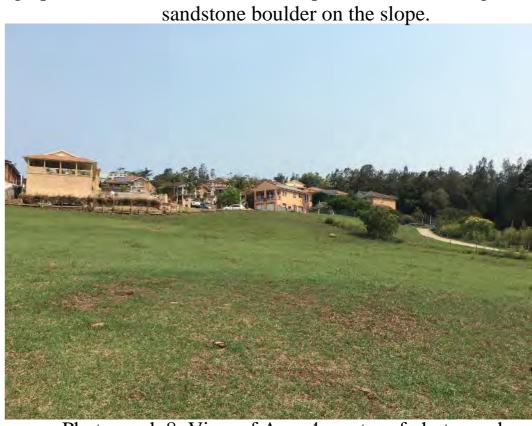
Photograph 8: View of Area 4, centre of photograph.

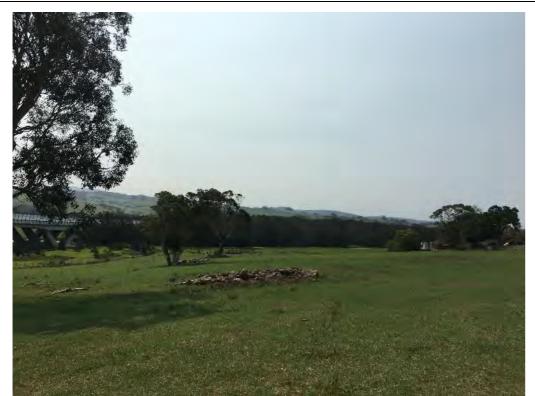
Photograph 9: Centre of Area showing mature trees and pile of latite boulders.

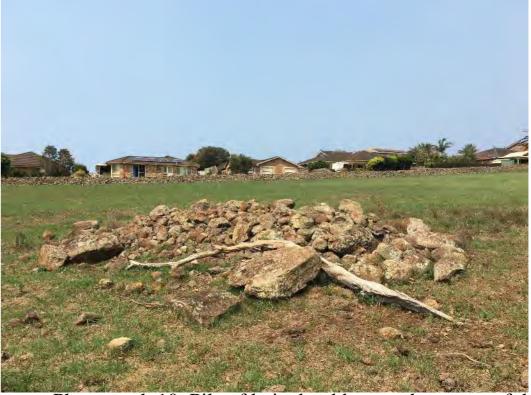
Small areas of outcropping bedrock and small boulders below the surface are found within this area, typically near the upper slopes. Exposed surface soils consisted of a red brown gravelly clayey sand. Piles of latite boulders are present within the area.

Photograph 10: Pile of latite boulders on the centre of the site.

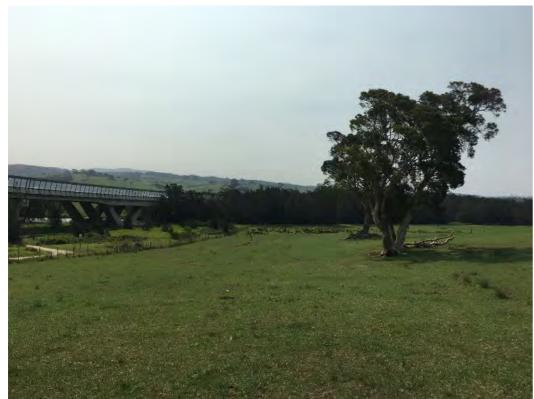
Photograph 11: Slopes on the western half of Area 1, looking north.

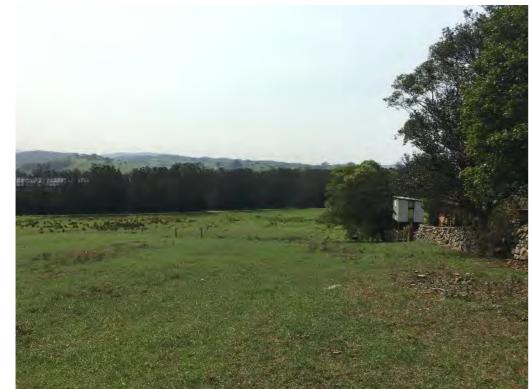
Photograph 13: View looking north-west near the foot slopes of Area 1.

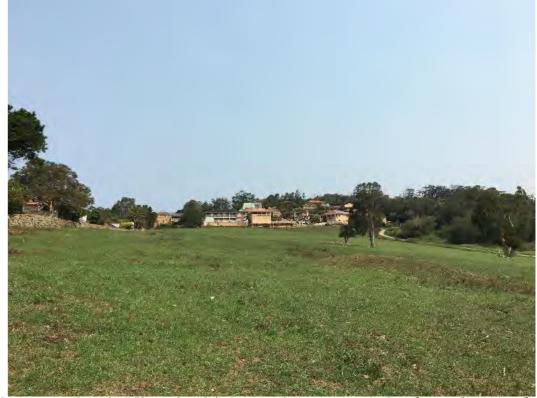
Photograph 14: View looking south-east near the foot slopes of Area 1.

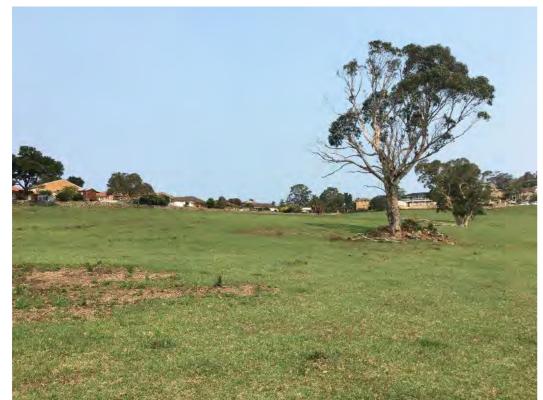
Photograph 15: Centre of Area 1 from the north looking south.

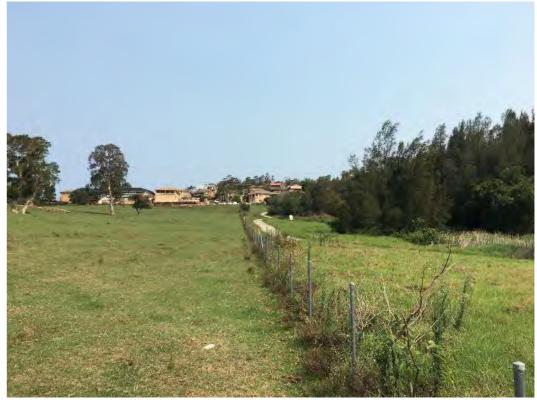
Photograph 16: View along south-west boundary. Slight drainage depression in this area.

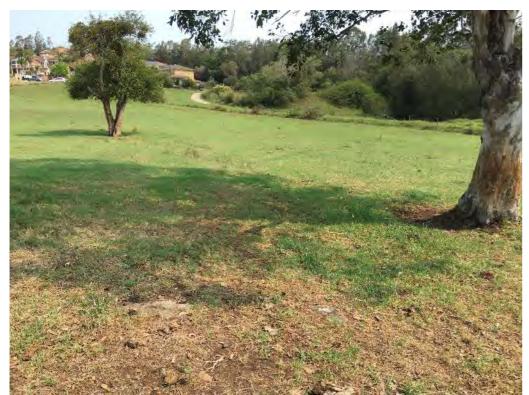
Photograph 17: View of outcropping boulders near mature trees.

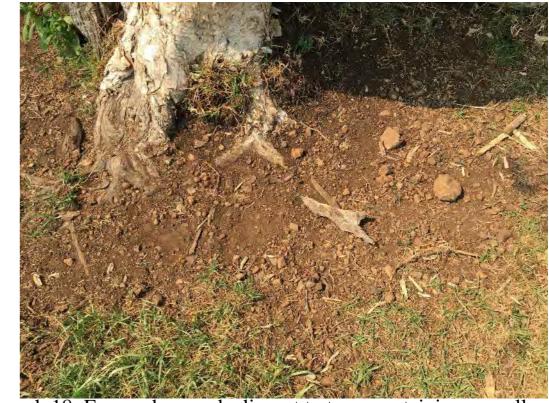
Photograph 18: Exposed ground adjacent to trees containing gravelly clayey sand.

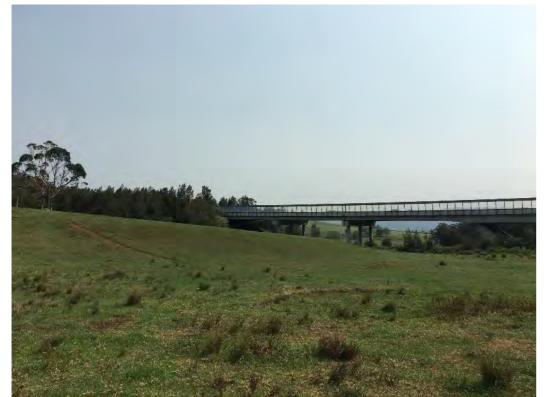
Photograph 19: View of lower lying part of site (Area 3), showing moderate to steep slopes on eastern side.

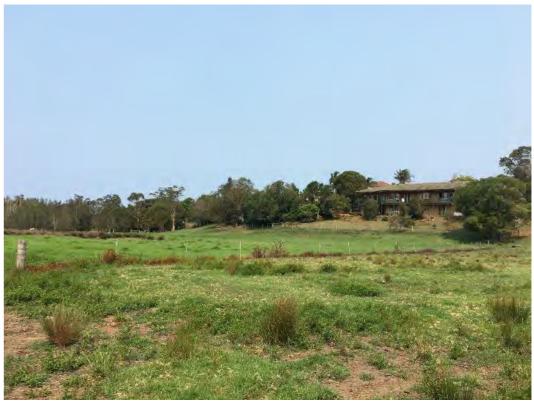
Photograph 20: View showing slopes of Area 3 are similar towards the east and extent of residential development to the east of the site.

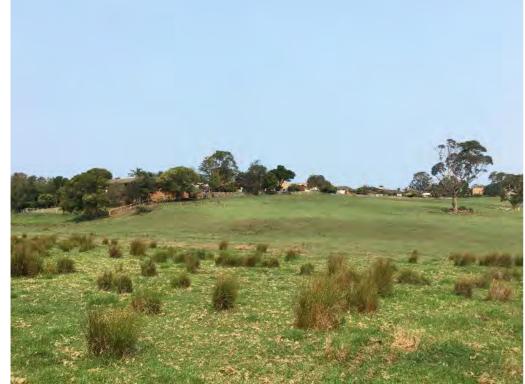
Photograph 21: View of Area 3.

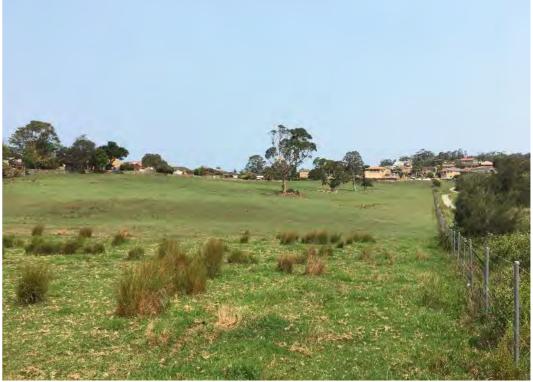
Photograph 22: View of Area 3 and the site from the north.

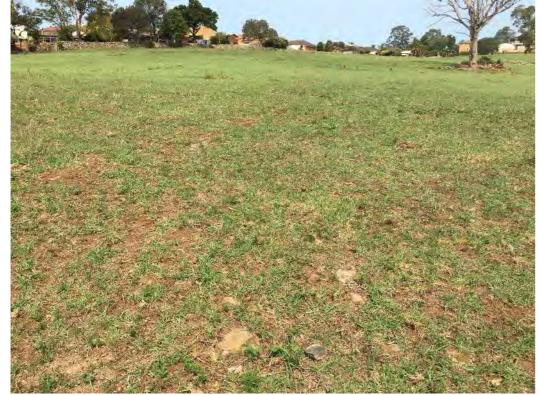
Surface soils consist of a red brown cobbly clayey sand with gravel. Bedrock was not visible in the slope. No signs of surface movement were visible. No signs of seepage were observed. However, it was noted that the climate had been exception dry at the time of the site visit with NSW experiencing drought.

Photograph 23: gravelly clayey sand with cobbles visible in the slopes of Area 3.

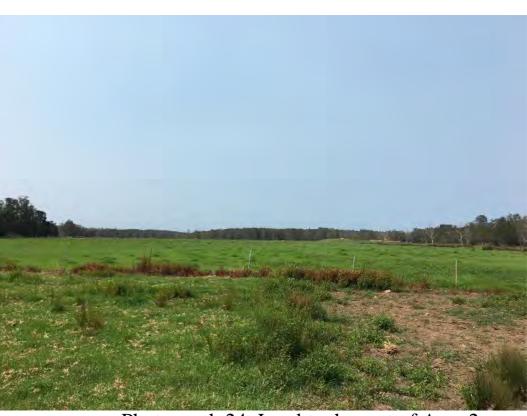
Photograph 24: Land to the east of Area 2.

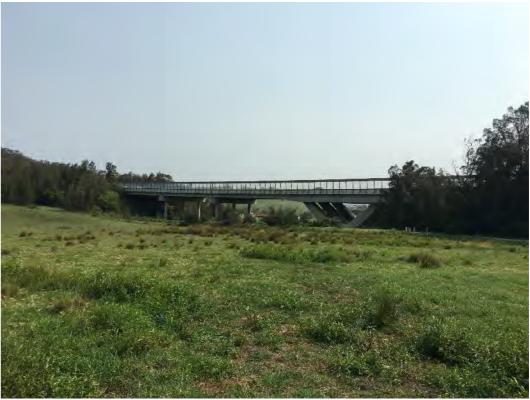
Photograph 26: Level land of Area 2, looking west.

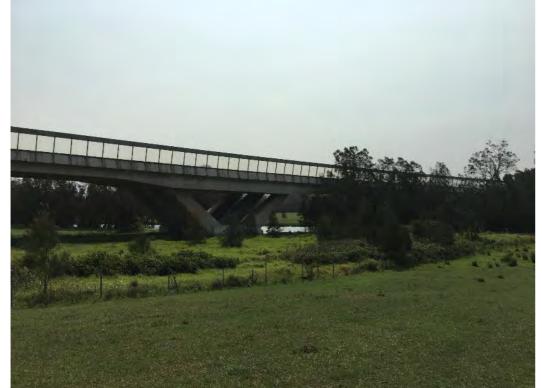
Photograph 27: Land to the north-west of Area 2.

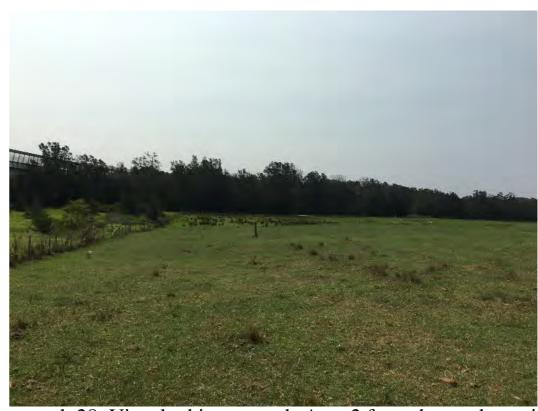
Photograph 28: View looking towards Area 2 from the northern side of Area 1.
