Report on  
Geotechnical Assessment – Urban Capability

Proposed Subdivision  
Lots 1 – 5 and 7 DP771051, Parkwood, NSW

Prepared for  
The Riverview Group

Project 77356  
February 2014

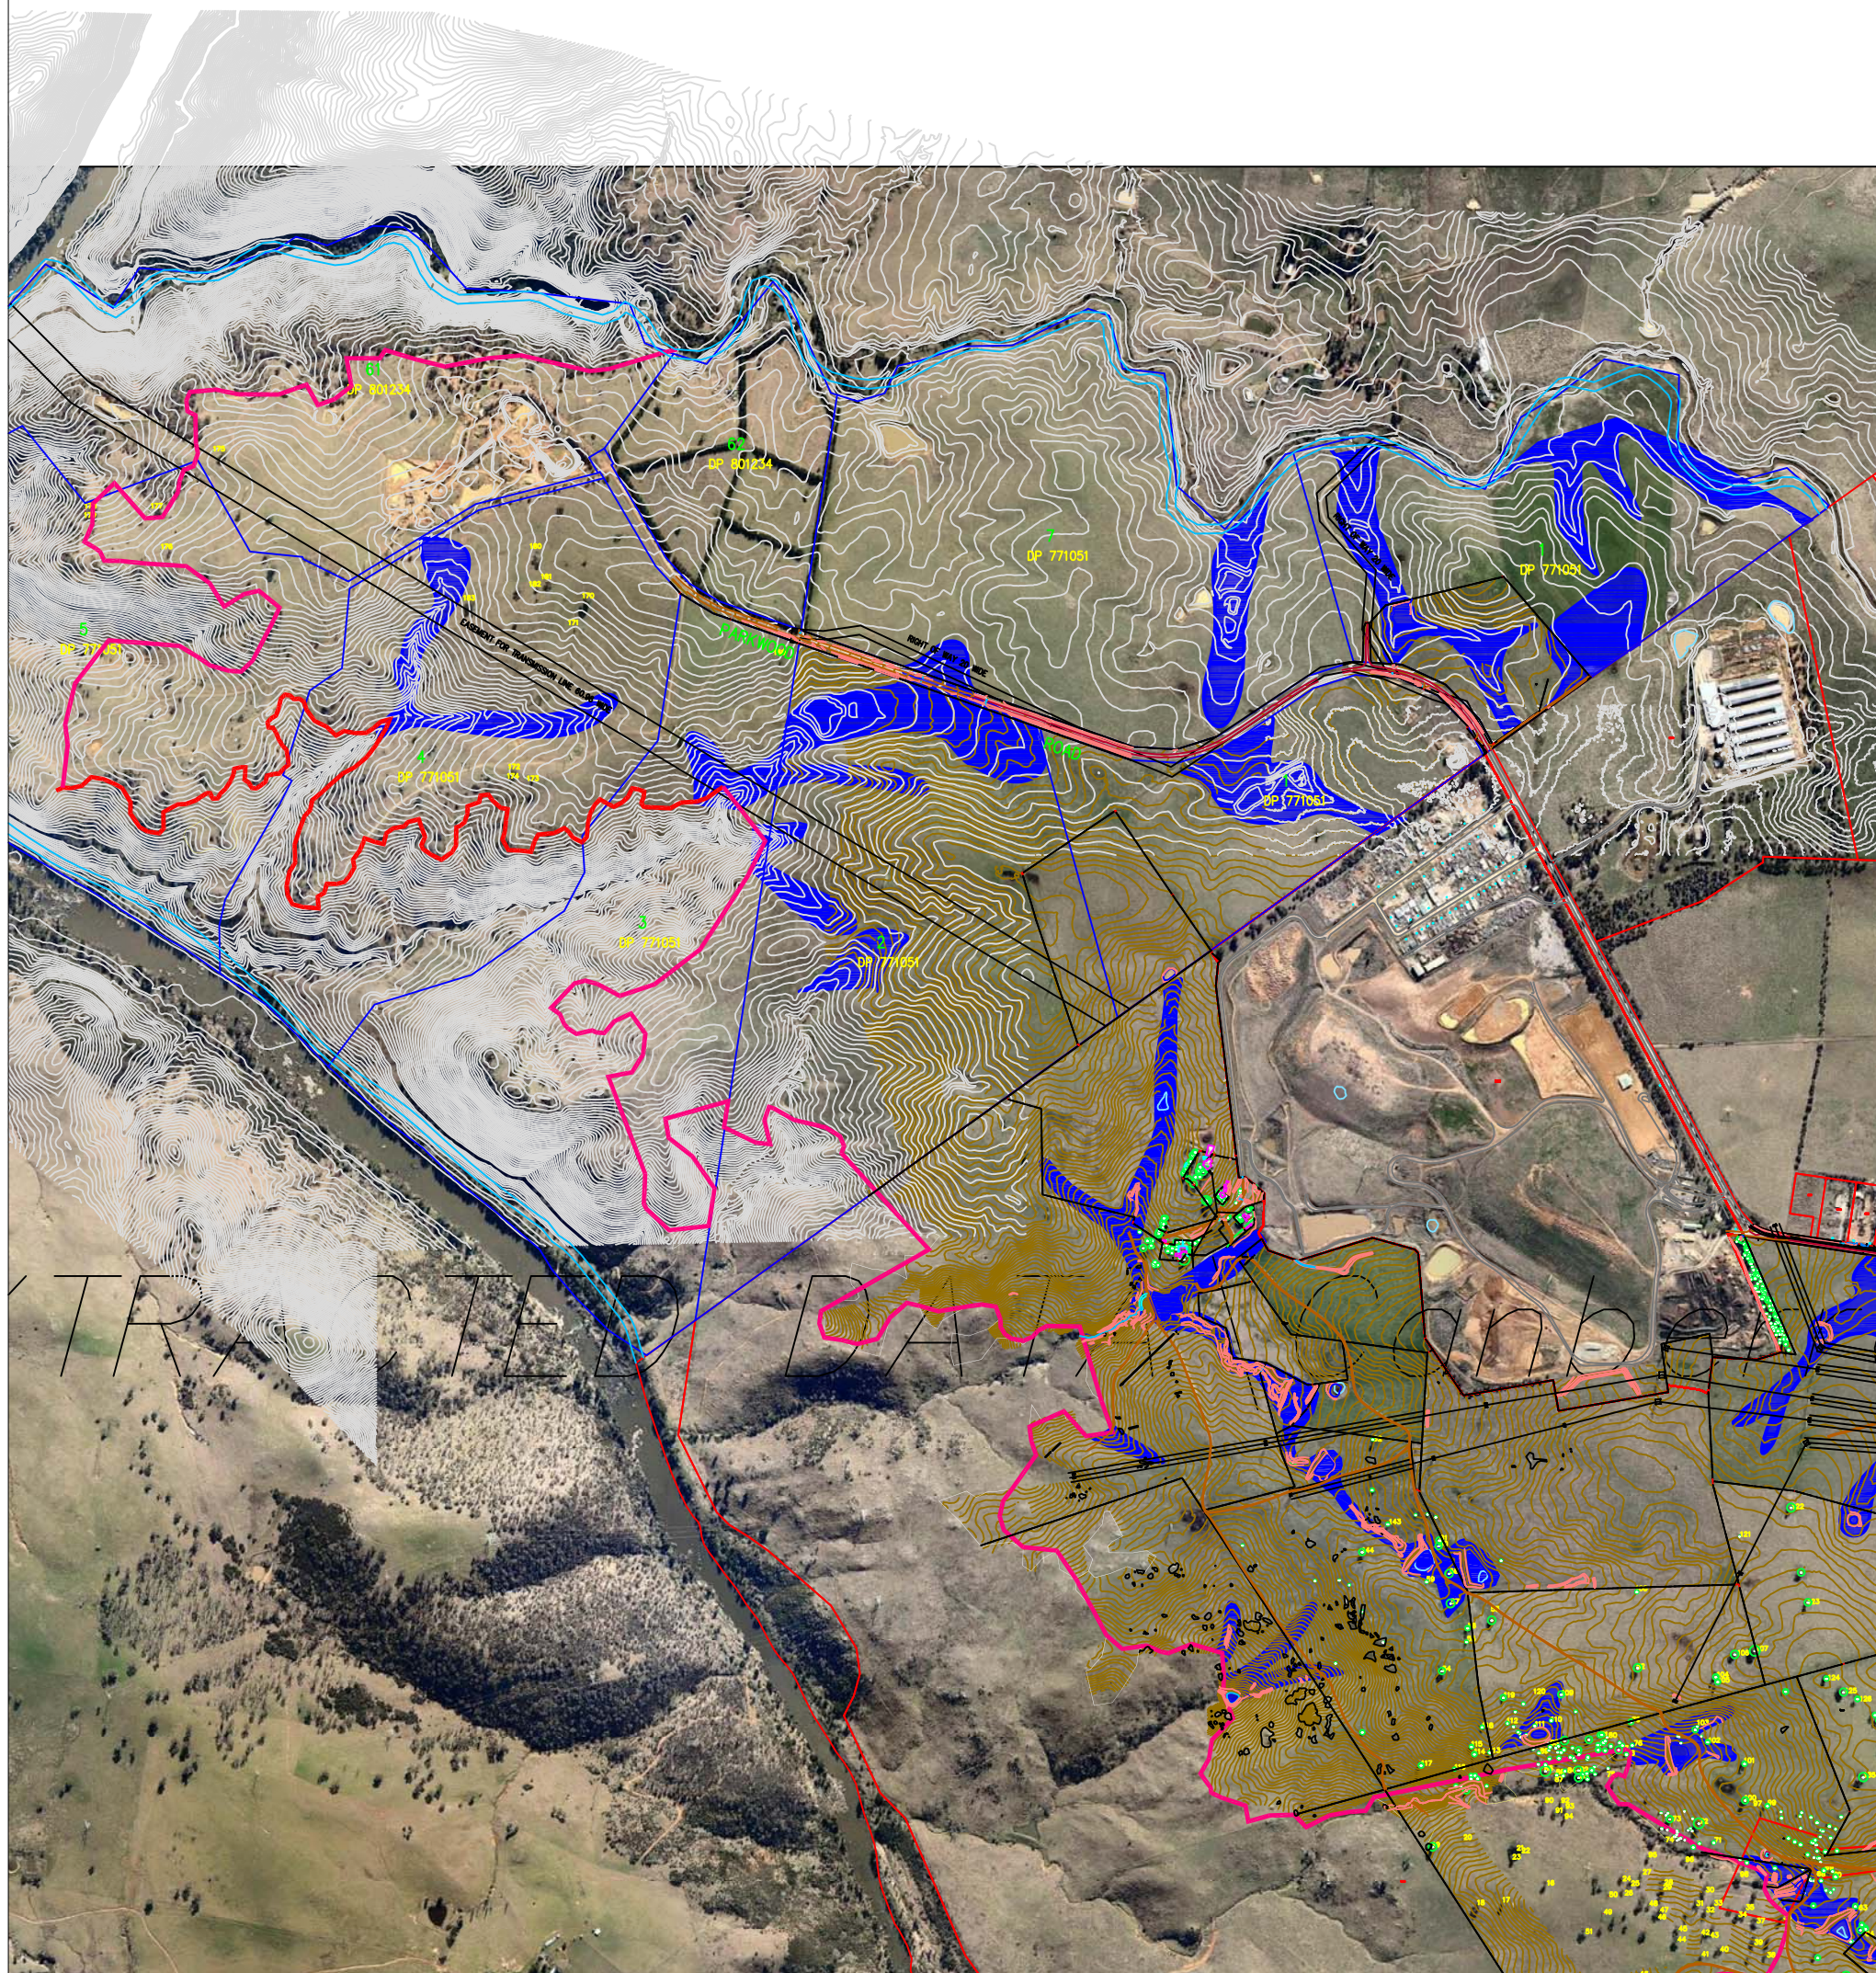
**Waterlogging:** There is evidence of previous wet, soft and/or boggy conditions within several areas identified as potential for waterlogging. These areas are characterised by slightly greener grass and contain grass species which from Douglas Partners experience indicates previous or current presence of elevated soil/ground water levels. Drawing 7 illustrates areas which possibly could be of risk of waterlogging.
