Report on  
Geotechnical Assessment – Urban Capability

Proposed Subdivision  
Lots 1 – 5 and 7 DP771051, Parkwood, NSW

Prepared for  
The Riverview Group

Project 77356  
February 2014

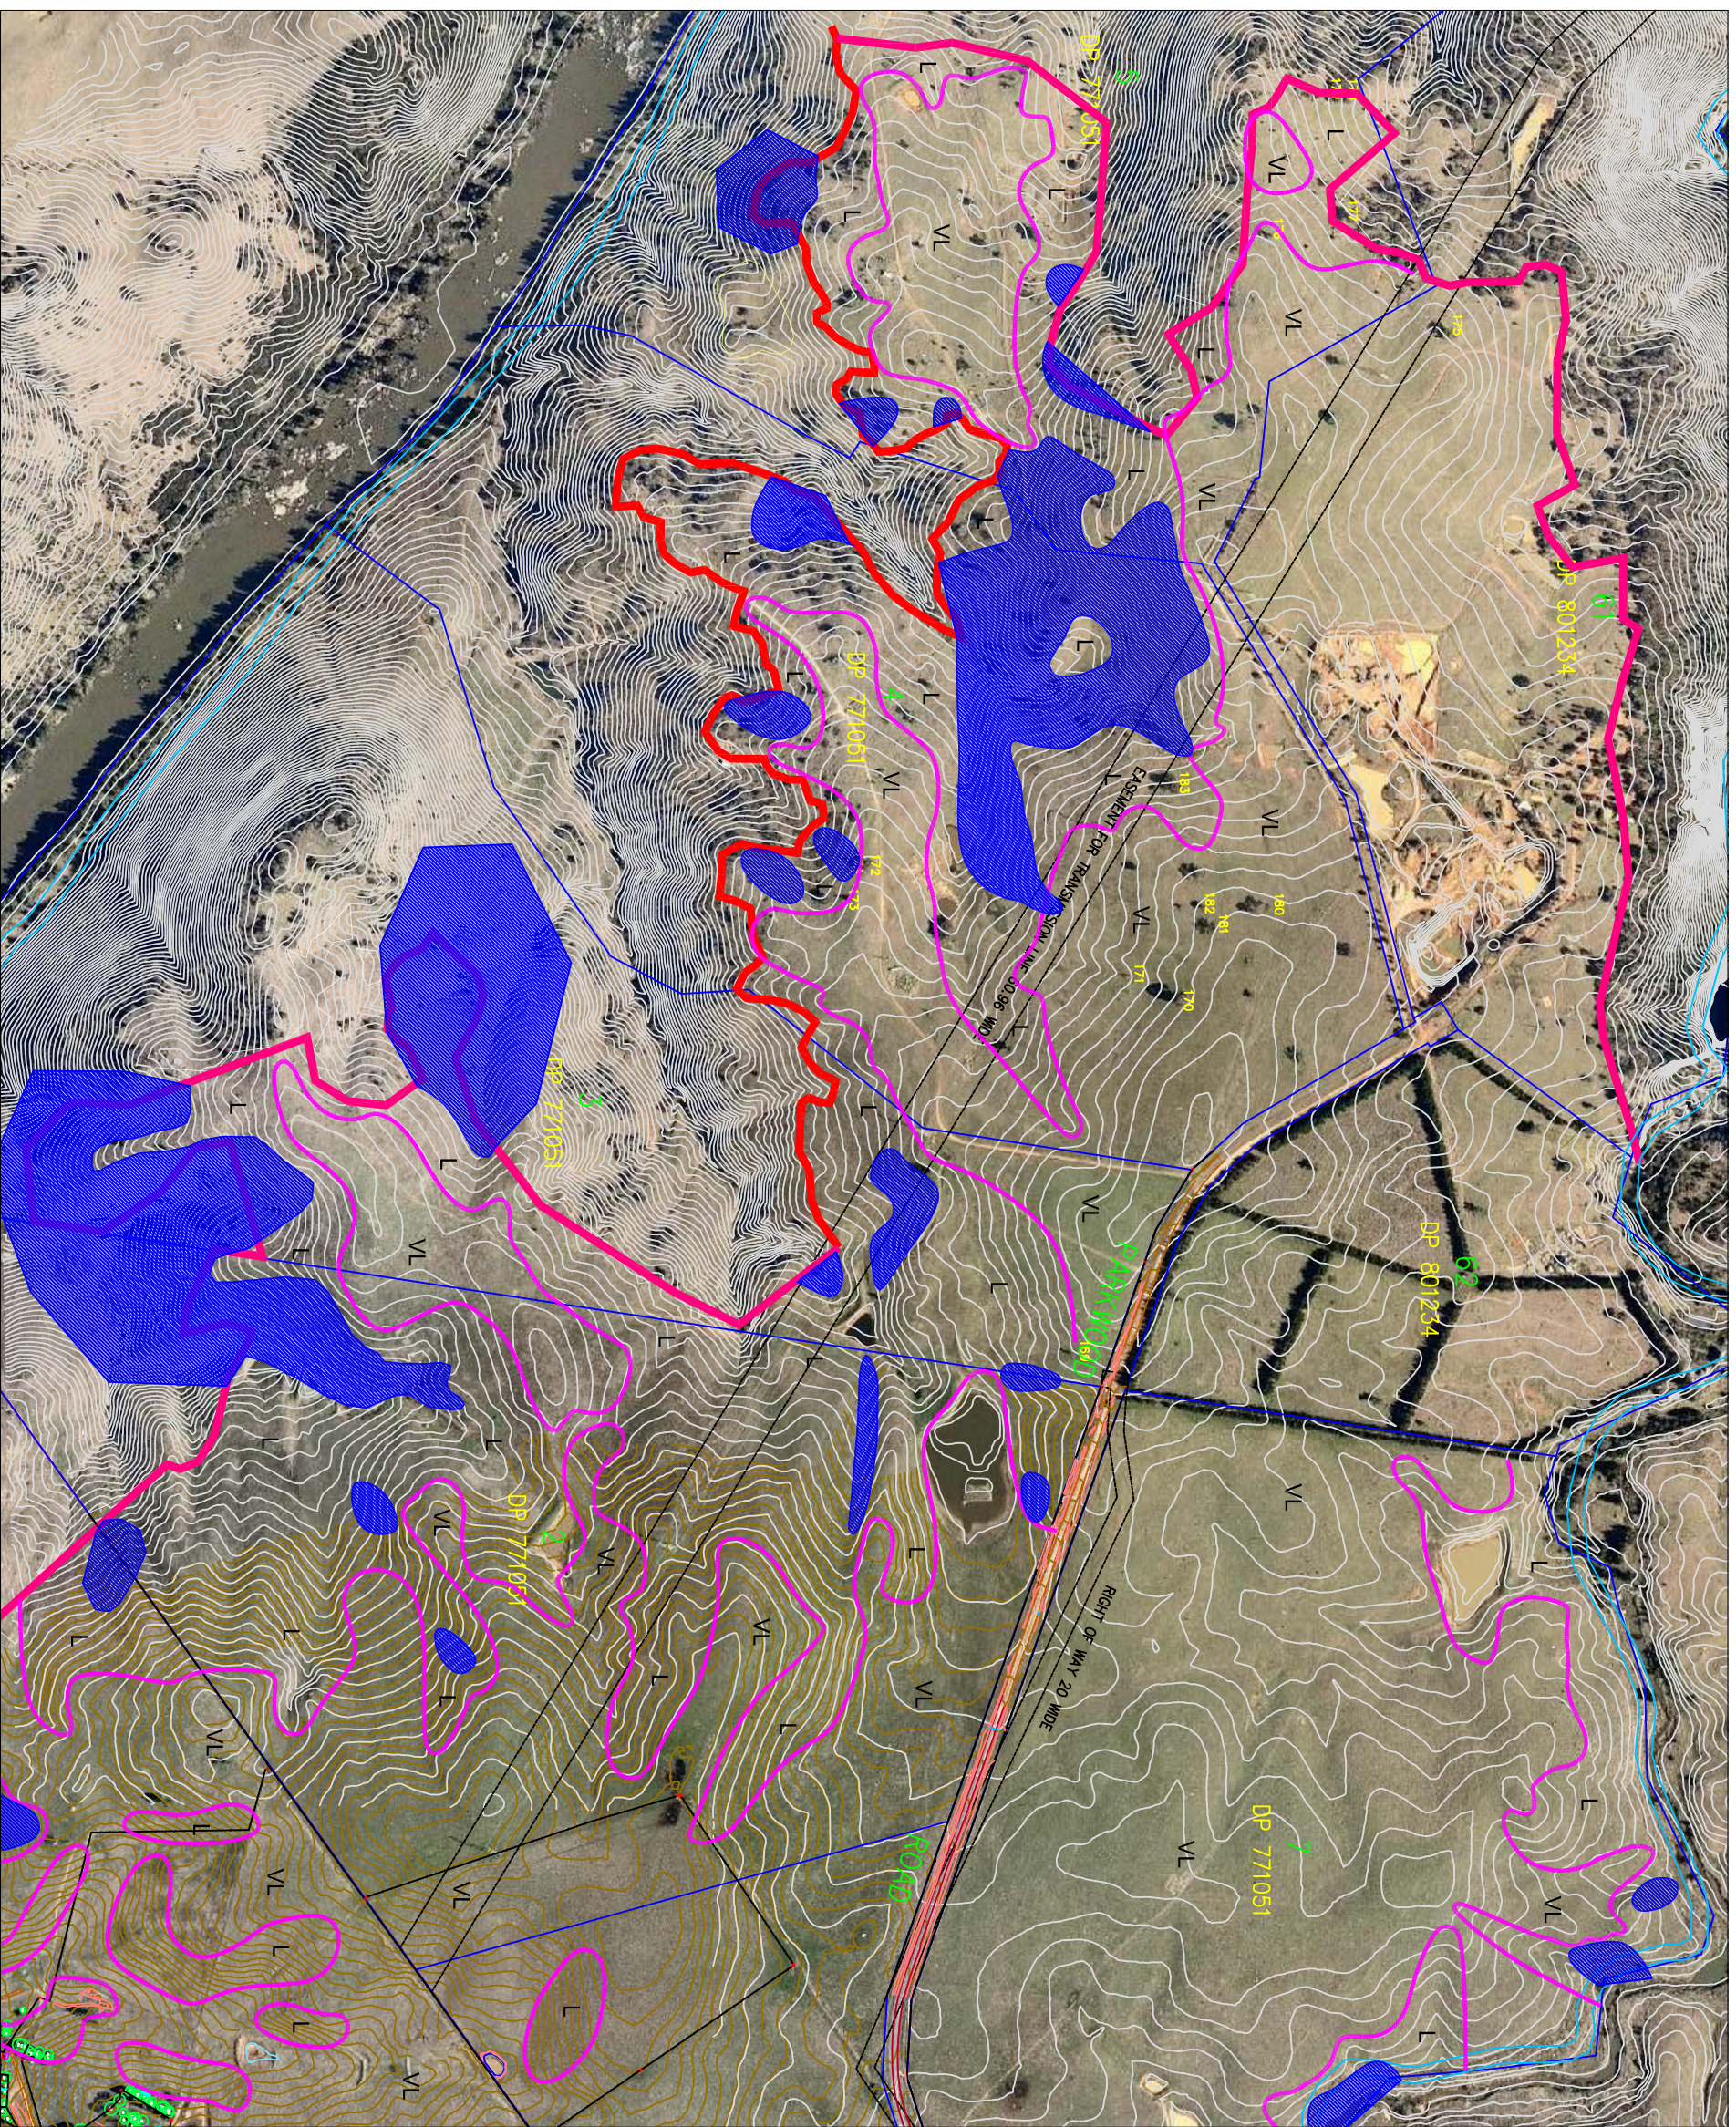
In summary, it is considered that most of the site is classified as very low or low risk of damage to property occurring as a result of slope instability. Several areas are considered of moderate or high risk (refer Drawings 5 and 6) of causing property damage due to the steep ground slopes and possible unsuitable design and construction practice.

**Stability:** Several areas (refer Drawings 5 and 6) have been assessed as having a potential moderate to high risk of damage to property from land instability.

Areas of steeply sloping land (moderate and high risk) are not recommended for residential development at this stage. A detailed site stability assessment including subsurface investigations must be undertaken in these areas to establish an appropriate site model for analysis purposes to assess whether development is feasible in the high risk zones.

At this stage without subsurface investigations, development within the high risk areas are not recommended. A comprehensive site stability assessment will be required if development in those areas are proposed.
