Report on
Preliminary Geotechnical Assessment

Proposed Residential Subdivision
Lot 1 DP707300, Lot 5 DP740252,
Part Lots 101 & 102 DP1077617, Lot 8 DP258605 &
Part of Unnamed Road Reserve, South Kiama

Project 89260.00
December 2019

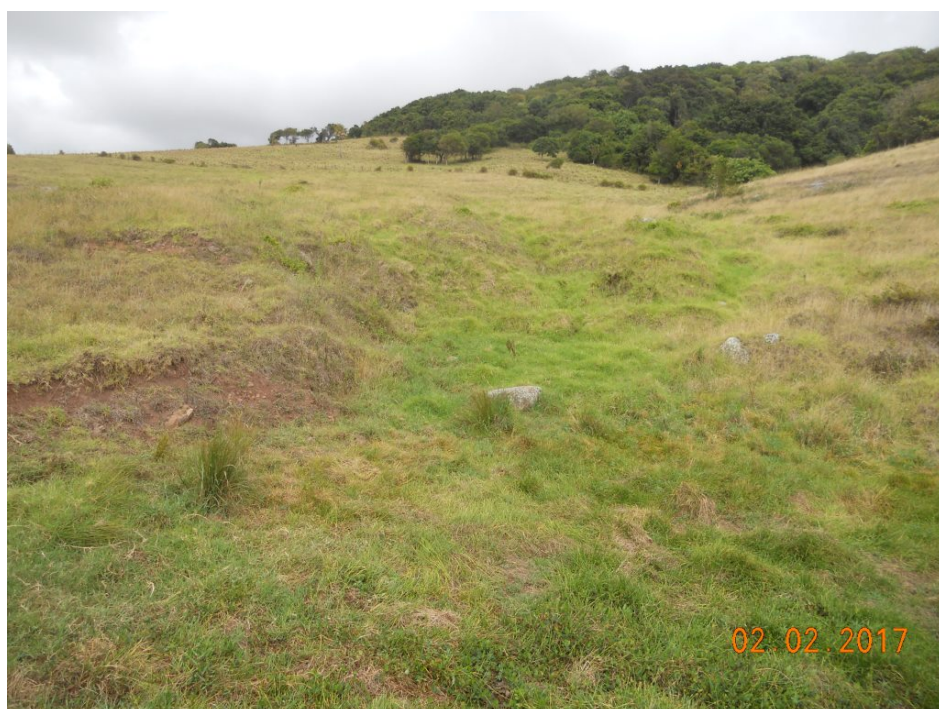
Photo 4 –Boulders and probable colluvium accumulation in the creek line.

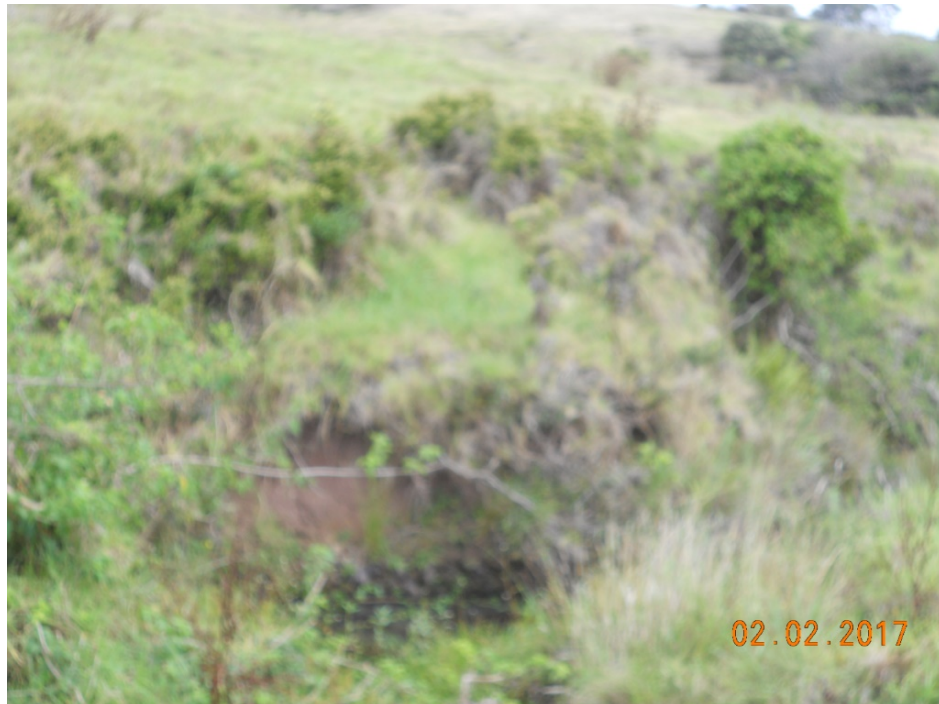
Photo 8 – Near-vertical erosion scarps up to 1.5 m high in creekline.

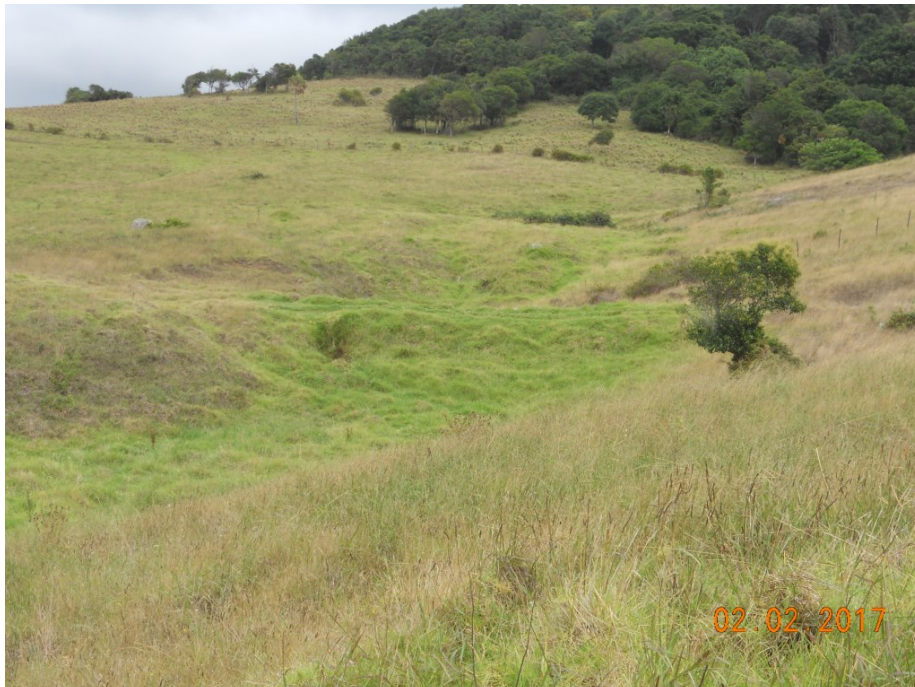
Photo 9 – 2 m high embankment across drainage depression.

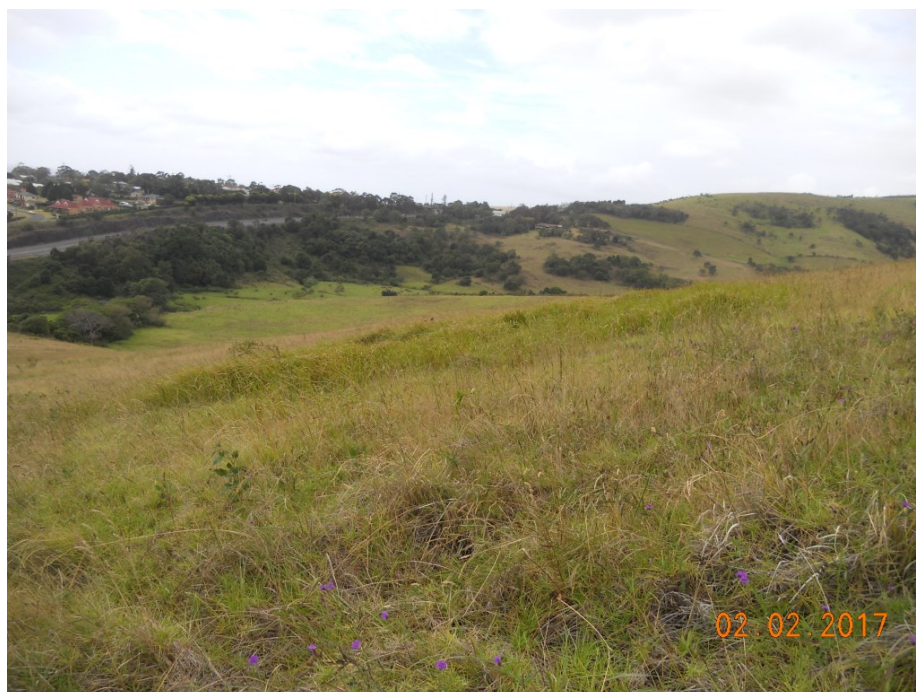
Photo 13 – Lush grass growth possibly indicative of spring activity.

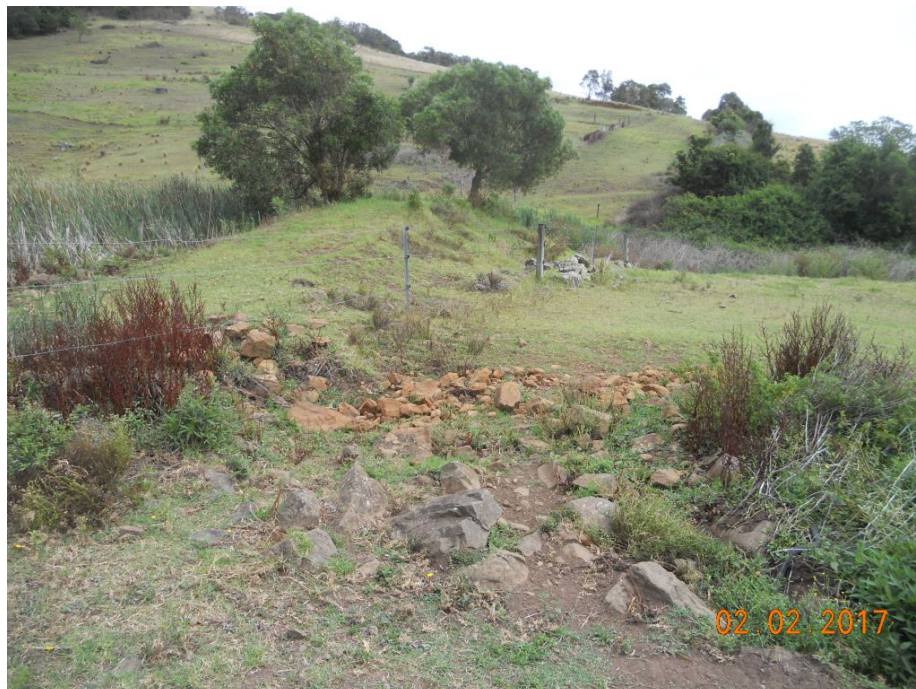
Photo 17 – 3 m high embankment immediately upslope of western site boundary.

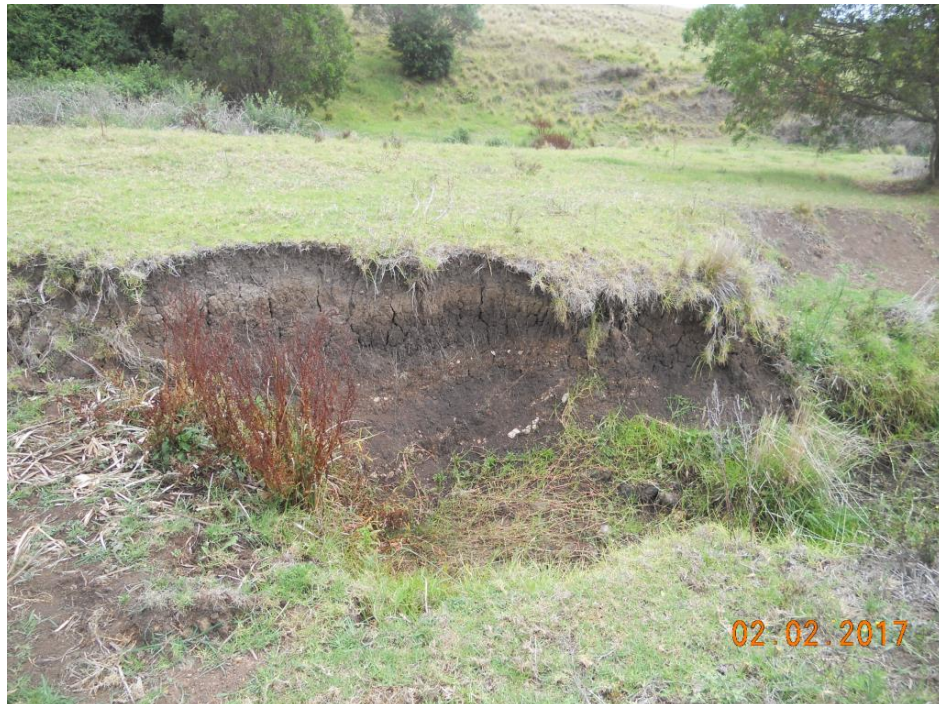
Photo 18 – 2 m high scarps in creekline downslope of farm dam, exposing clays and silts

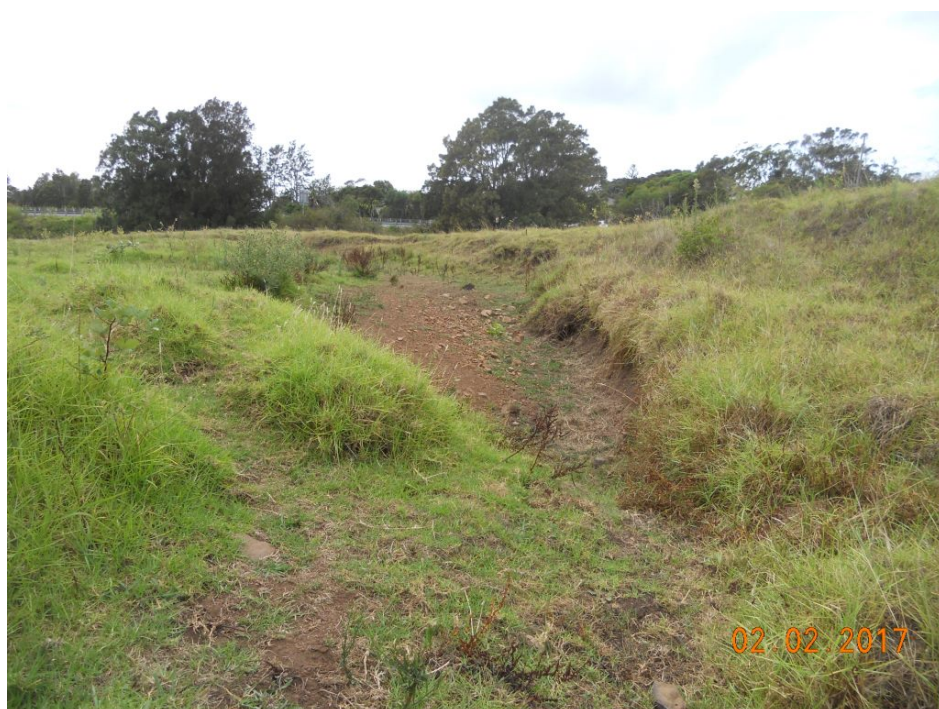
Photo 22 – Scarps in creek banks probably exacerbated by stock movements.

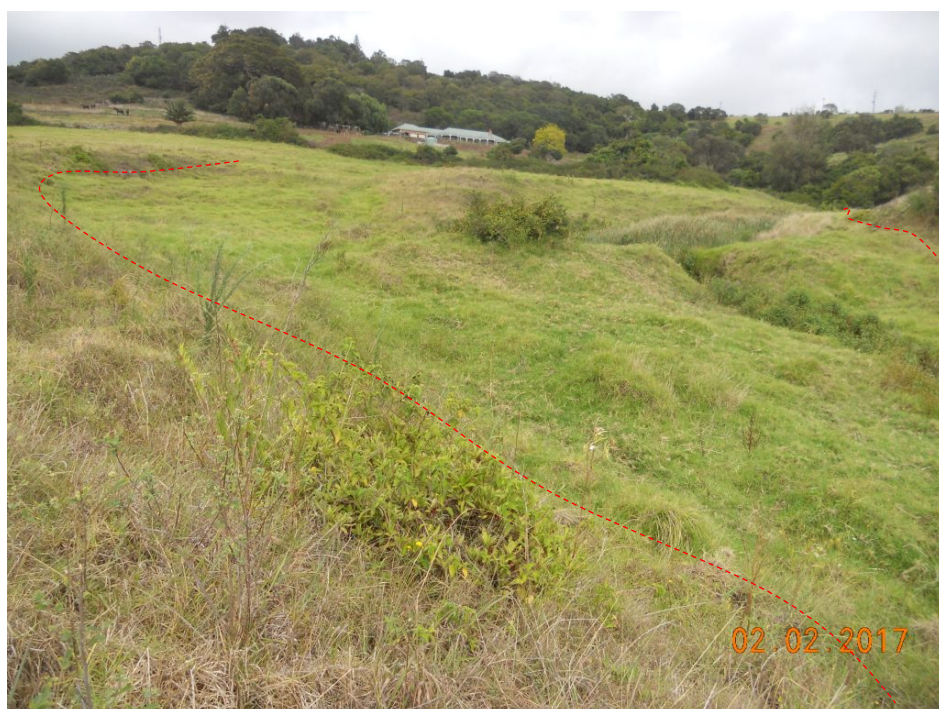
Photo 26 – View of breached dam and likely debris flow or colluvium within drainage depression.

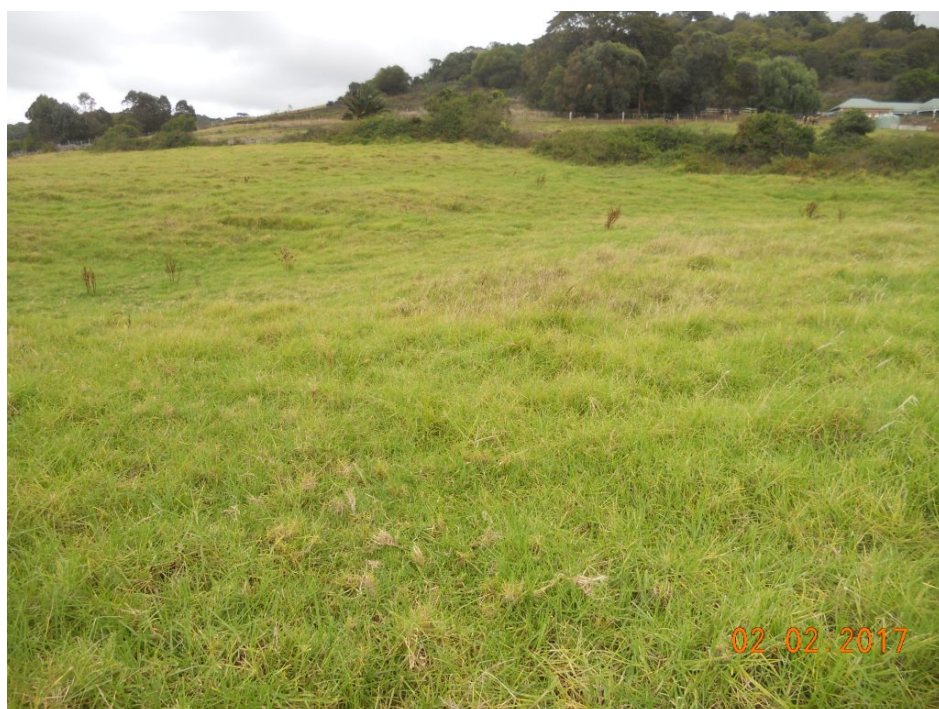
Photo 28 – Irregular, hummocky surface indicative of spring activity and near-surface soil creep.

It is anticipated that the identified section of *moderate to high* risk could be reduced to *moderate* risk, thus enabling residential development provided installation of subsurface drains into bedrock to intercept and control groundwater is undertaken, possibly in conjunction with removal of creep-affected material and replacement with controlled filling.

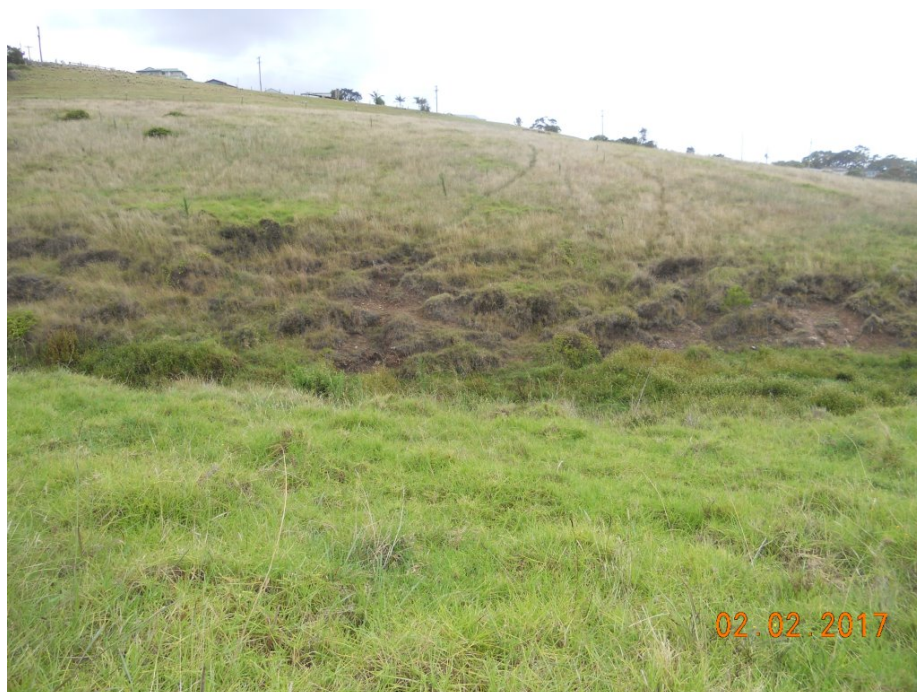
Photo 29 – Scour in steep creek bank of residual soils and extremely weathered rock.

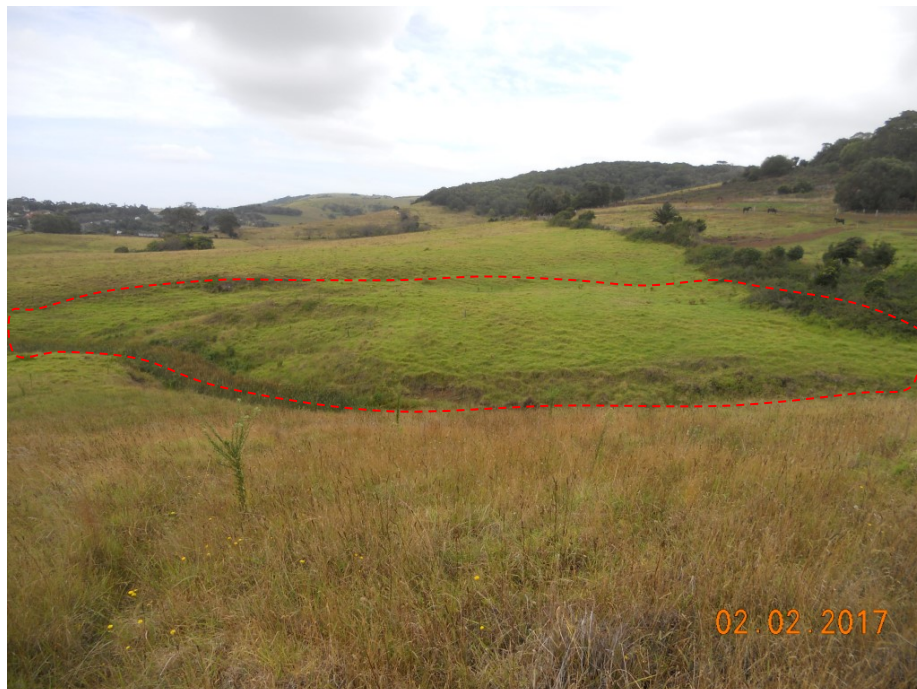
Photo 31 – View of area of likely spring activity and creep-affected soils.

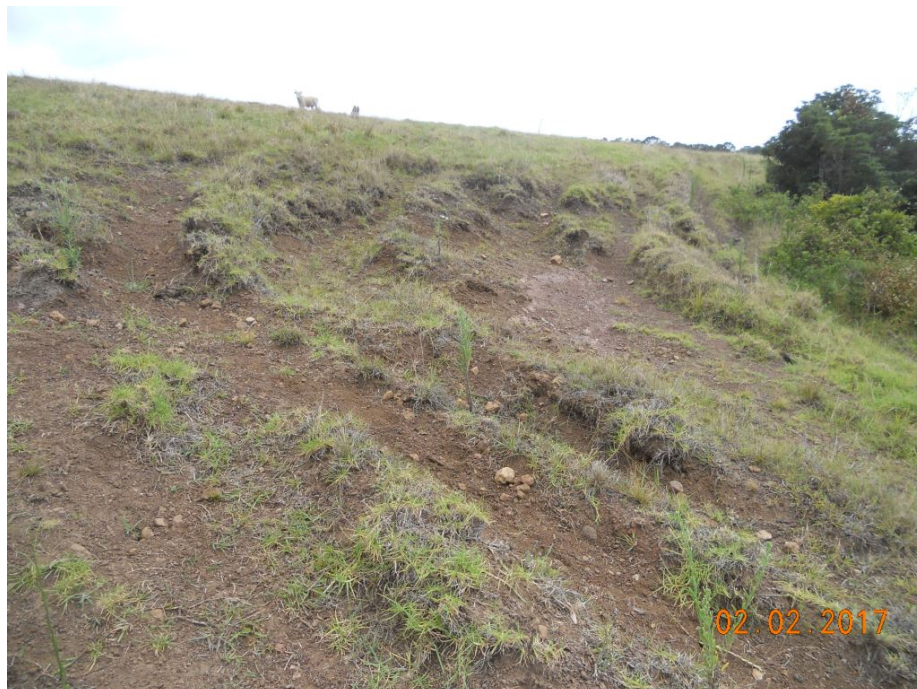
Photo 37 – Rills adjacent to drainage depression exposing residual soils and weathered bedrock.

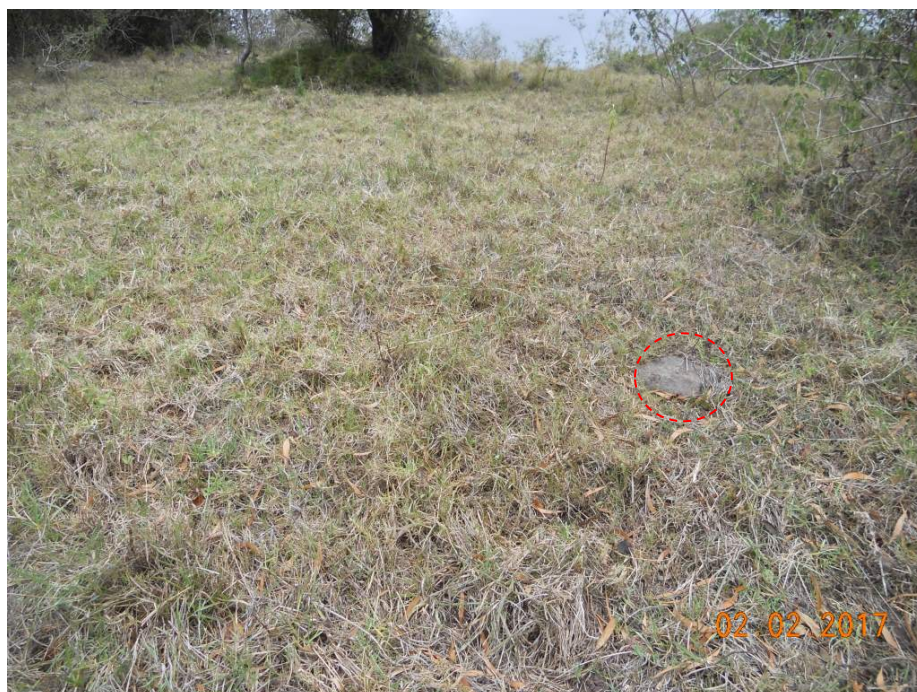
Photo 45 – Some latite gravel and cobbles, possibly indicative of a talus slope.

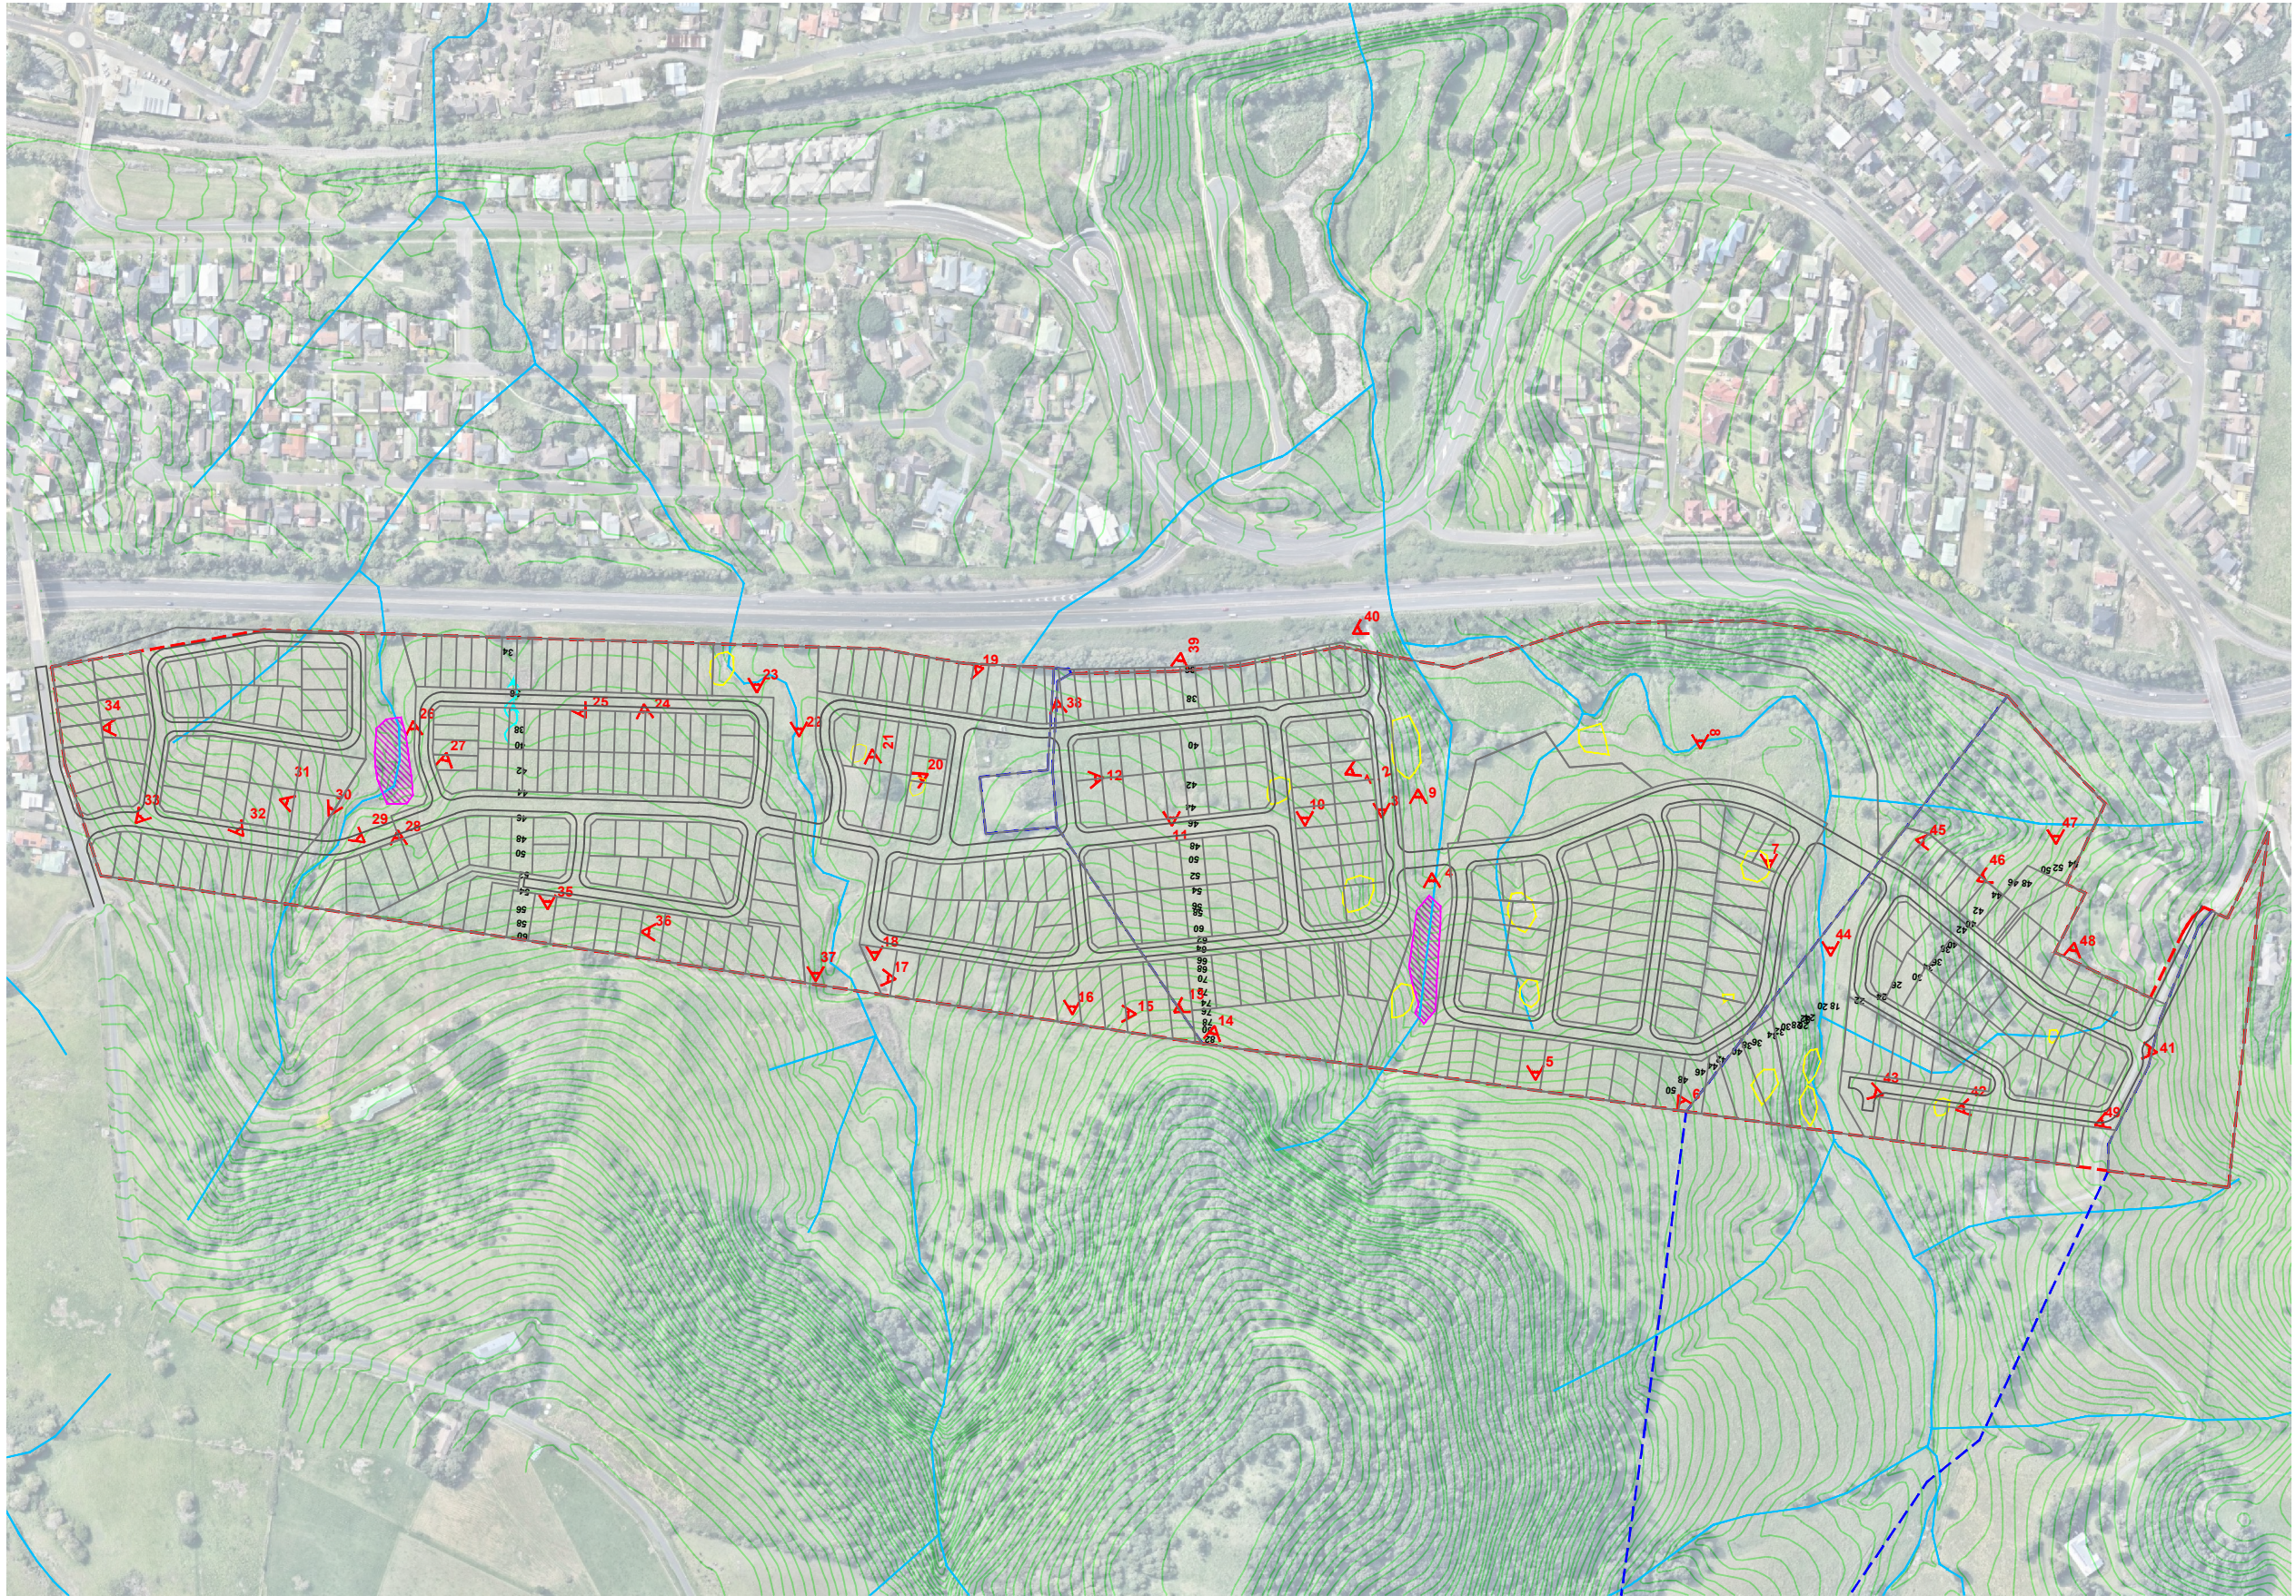
PROJECT No: 89260.00
DRAWING No: 2
REVISION: 1

The site has been divided into three general risk of instability zones (low, moderate and high risk of instability) as summarised below. The approximate interpreted zone boundaries are shown on Drawing 3. It is noted that the boundary between risk zones will commonly be transitional and as such dual classifications (eg. low to moderate and moderate to high risk of instability) have been adopted in some areas of transitional change in slope, also in areas where small areas of lesser surface slope are included within overall steeper areas.
