Horsley Park, Keyhole Site

Biodiversity Assessment

Frasers Property Industrial

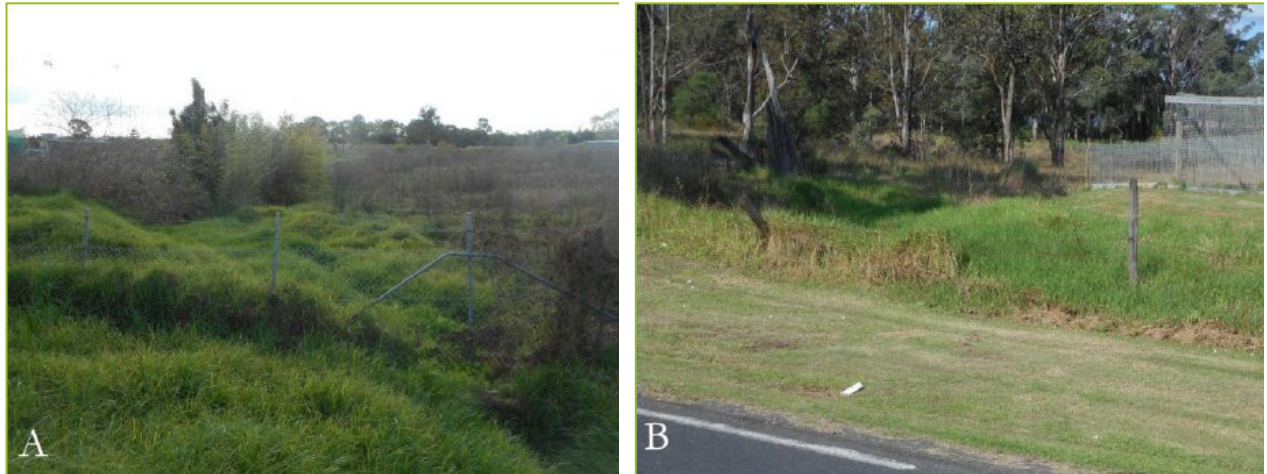
At site 21 there is a very low sinuosity drainage line extending downslope from the road, and upslope the channel passes around what appears to be an infilled agricultural dam. The channel cross section is trapezoidal which indicates anthropogenic modification.

Site 21: 'A' looking down slope and 'B' looking upslope

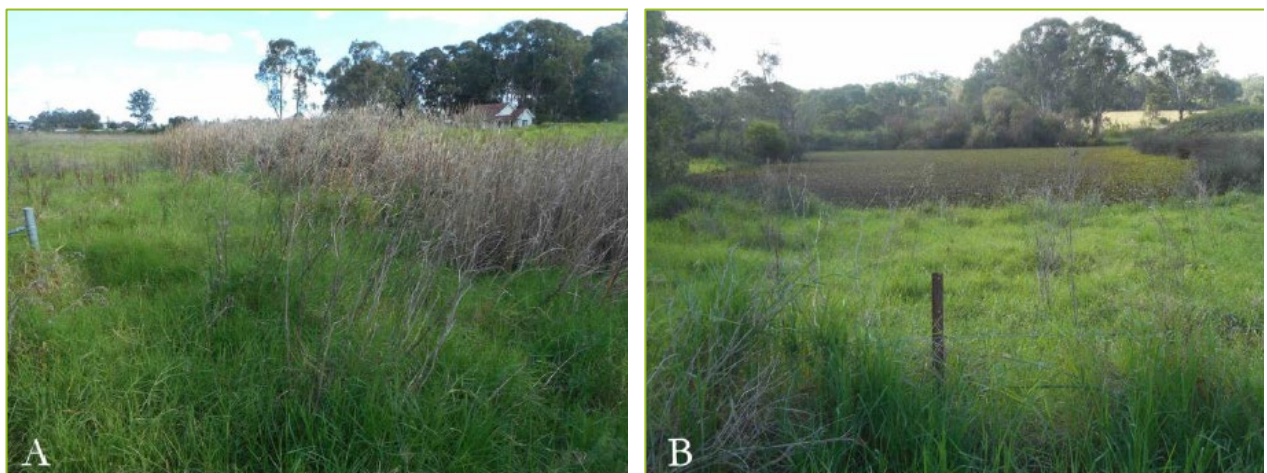
At site 22, downslope from the road, there is a minor flow path, which is less than 2 m wide and is completely obscured by weed infestation. The character of the channel cannot be determined. The flow path leads to weed choked dam down slope (see photo plates below).

There is a similar morphology on the upslope side of road where the drainage channel from an agricultural dam spillway is also choked. The upslope channel appears to be narrow, very low sinuosity, and anthropogenically modified.

Site 22: 'A' looking upslope and 'B' looking downslope

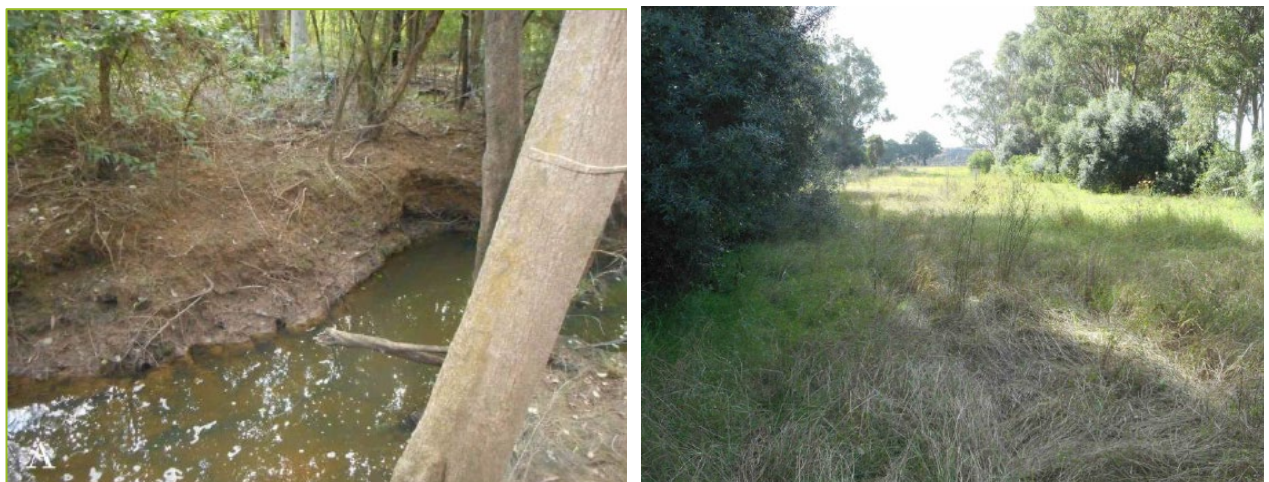
Site 17: 'A' looking downstream

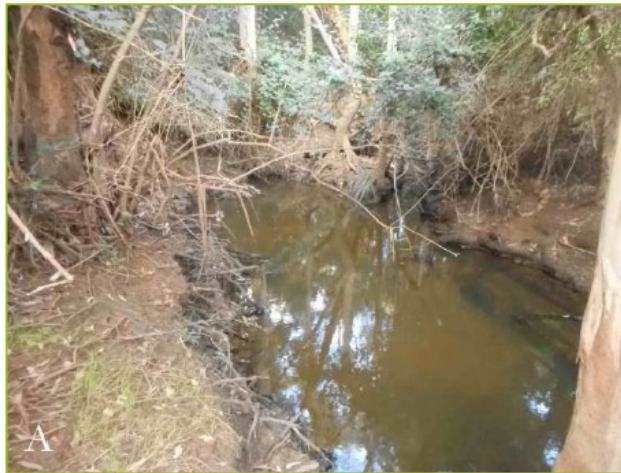
Site 18: 'A' looking downslope to the location of the mapped hydroline meander

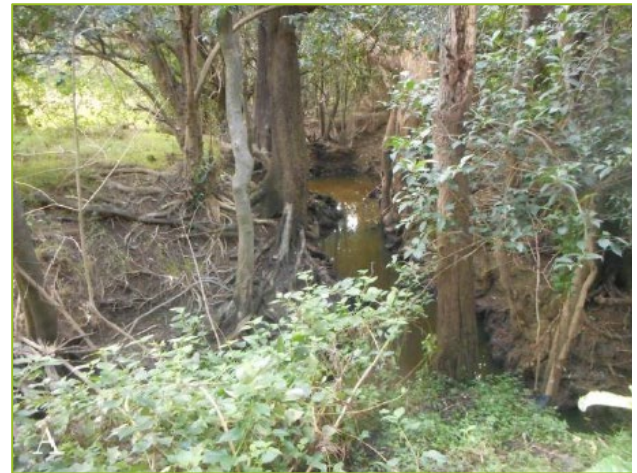
Site 19: 'A' looking upstream

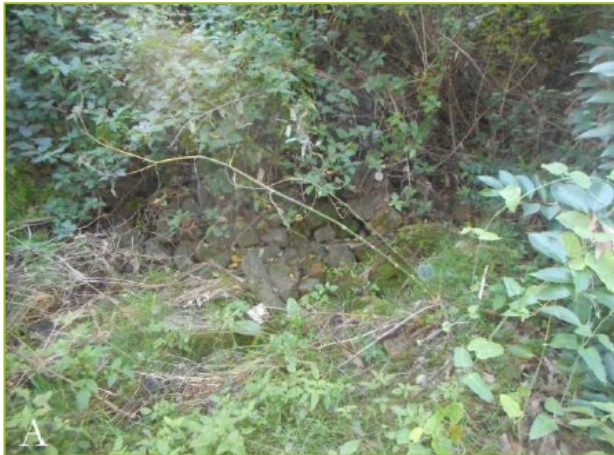
The low flow channel through this reach is well defined with low angled and well vegetated banks. At some locations the banks appear to be two stage which may indicate the passage of a knickpoint through this reach.

Site 1: 'A' showing stabilised rock fill

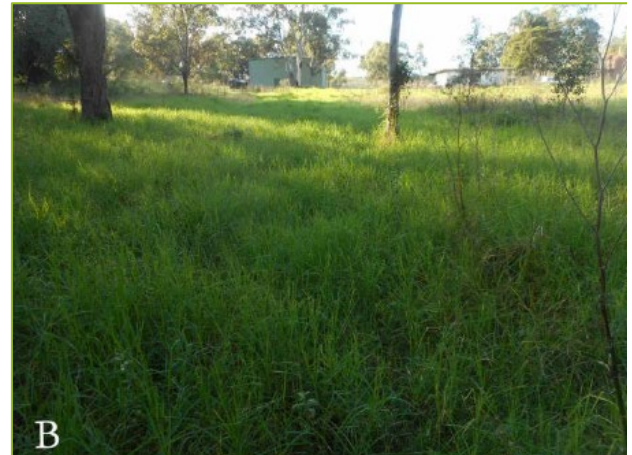
Site 2: 'B' looking upslope and no defined channel

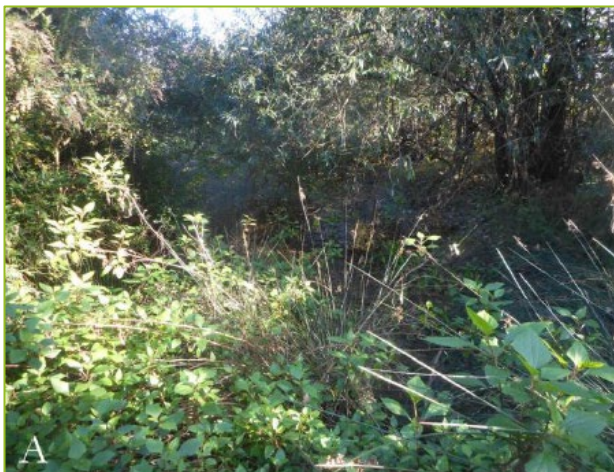
There is also some remnant pond morphology at site 3 where the channel widens out from 2 metres in width to more than 8 metres. The stagnant water that was evident at site 1 is not in evidence here. The channel and pond base has been dry for an extended period.

Sediment spear testing at sites 3 and 4 penetrated easily, with very little resistance to 1.05 m. There is a narrow, sub-horizontal, floodplain pocket at bank top left bank that has sediment to 0.40 m as indicated by sediment spear testing.

Site 3: 'A' looking upstream towards site 4

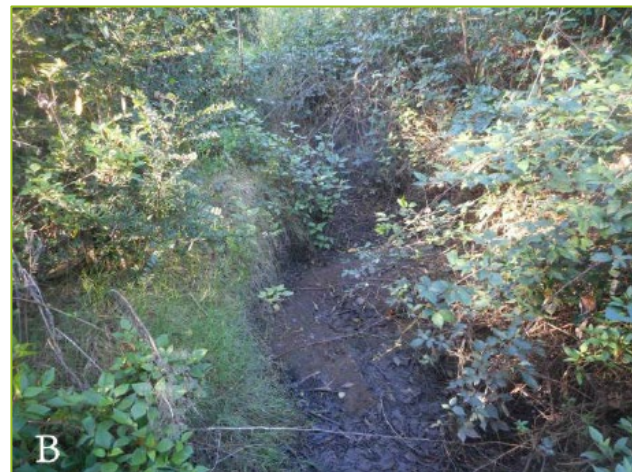
Site 4: 'B' shows recent deposition in the base of the channel

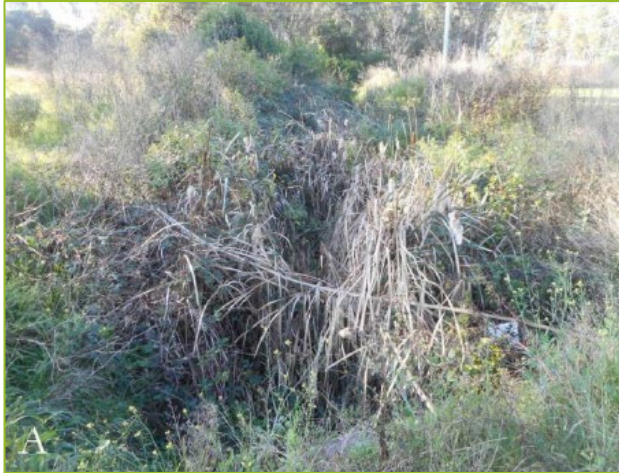
There is a suspiciously straight channel extending upslope of crossing. A straight channel in this environment indicates anthropogenically modified channel or an artificial channel. Sub-vertical banks to 3 m high are vegetated and stable. The channel width, bank top to bank top, is between 5 and 6 m. Access to the channel zone downstream of site 6 is extremely difficult and limited by abundant and dense weed growth, notably blackberry. Site 8 is located on an old dam wall and is looking upstream.

Site 6: 'A' looking upstream from site 6

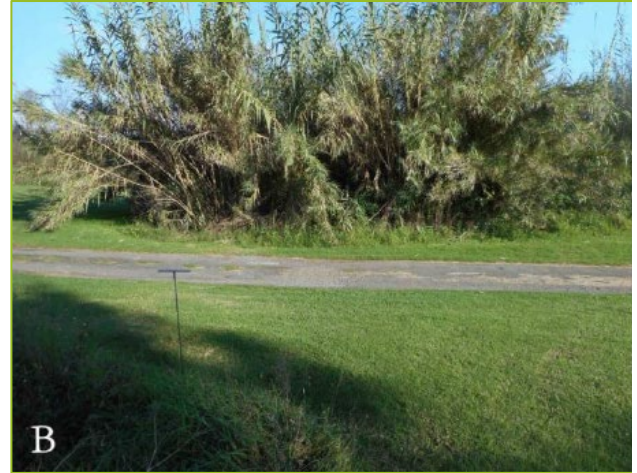
Site 6: 'B' looking downstream from site 6

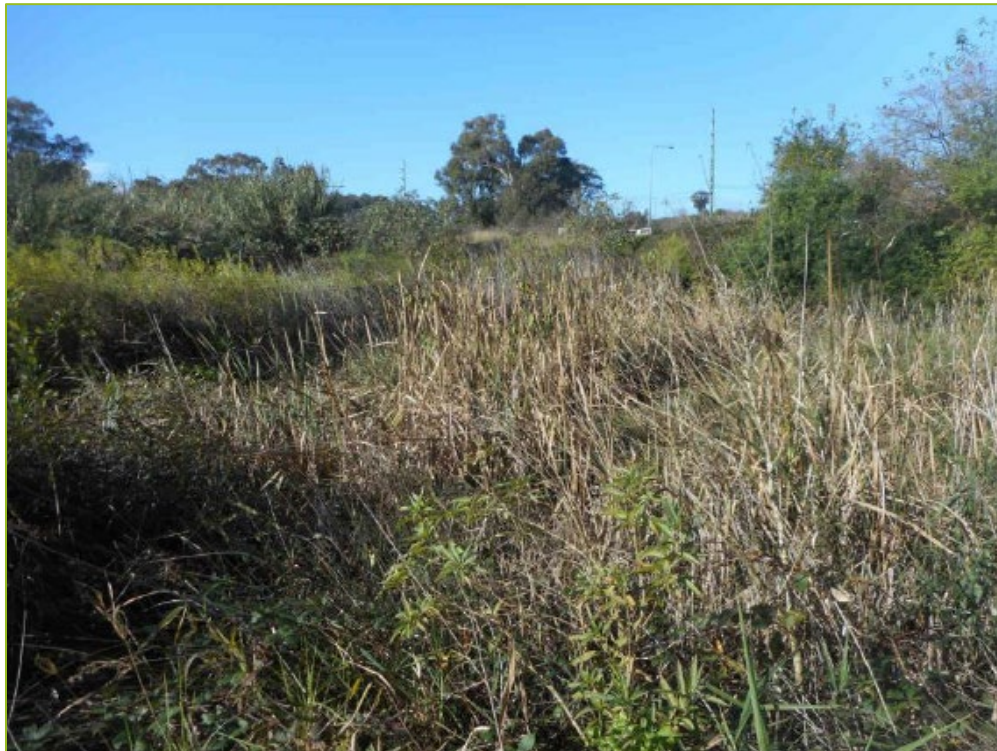
Site 8: looking upstream across the impoundment of an old agricultural dam that is now choked with weeds

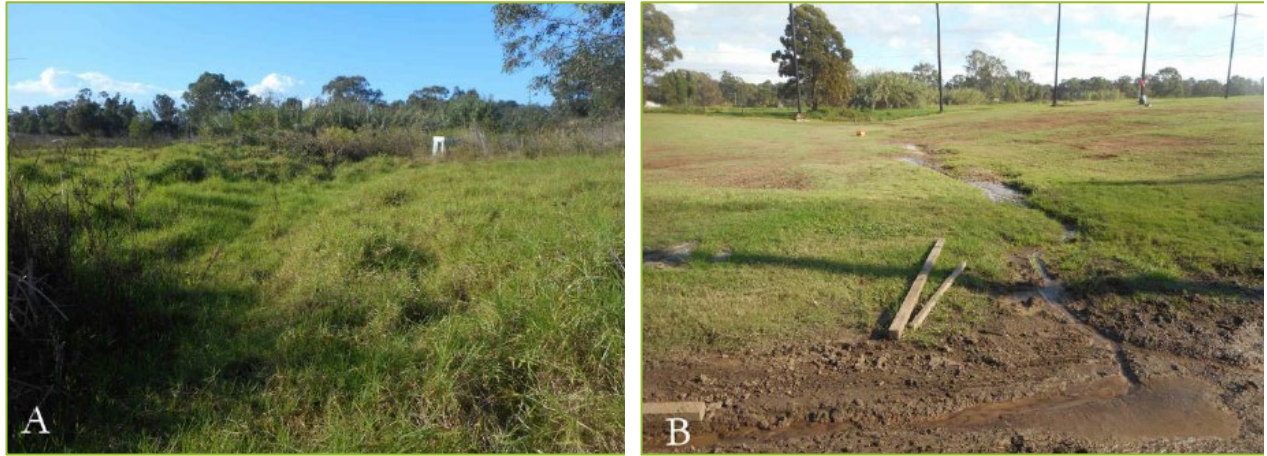
There is a surface low flow channel that has a low to moderate sinuosity with remnant ponds morphology. The low flow channel has a low capacity and discontinuous banks to 0.30 m. Flows that are unable to be contained within the pipe flow across the surface of the golf range. Interrogation of the historic aerial photography for 1978 shows an agricultural dam at this location.

Site 9: 'A' location at golf range boundary, looking upstream to site 8 'B' looking downstream to site 10

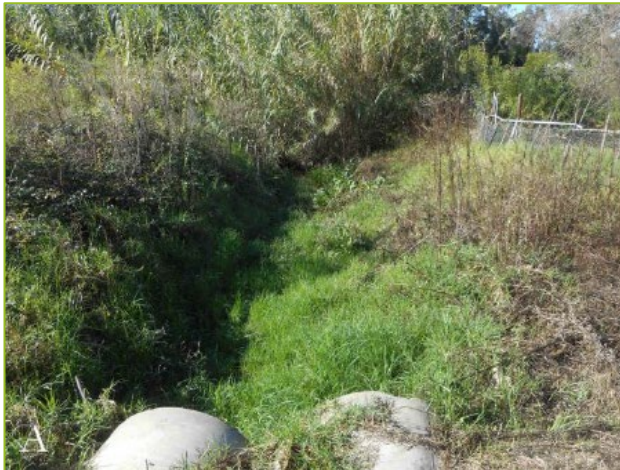
The channel width, bank top to bank top, averages 6.0 m. Downslope, before flowing into a dam at site 14, the channel passes into a narrow slot that is 3 m wide and inset into two stage banks. The channel bank height is approximately 4 m.

Site 13: 'A' artificially straightened channel extending upstream

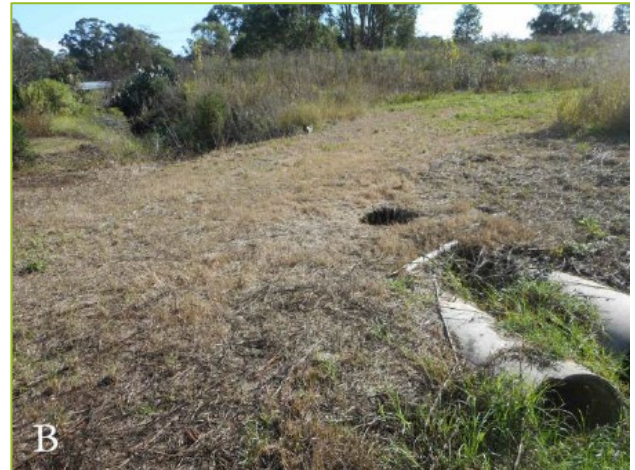
Site 13: 'B' looking downstream

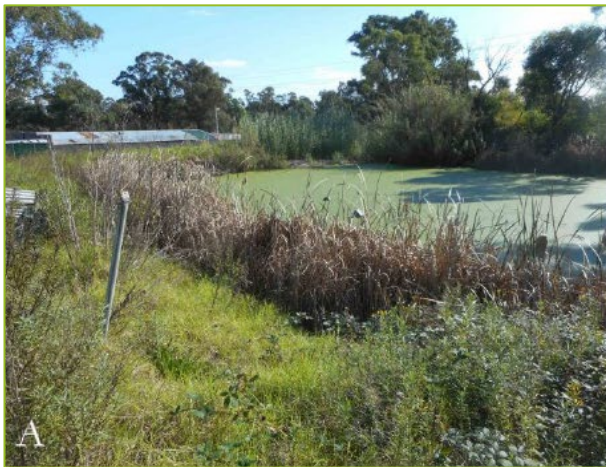
Sites 14 - 16 comprises the end of the channel where it flows into the dam at site 15. Site 16 is at the dam wall at property boundary.

'A' looking downstream from site 15 across dam

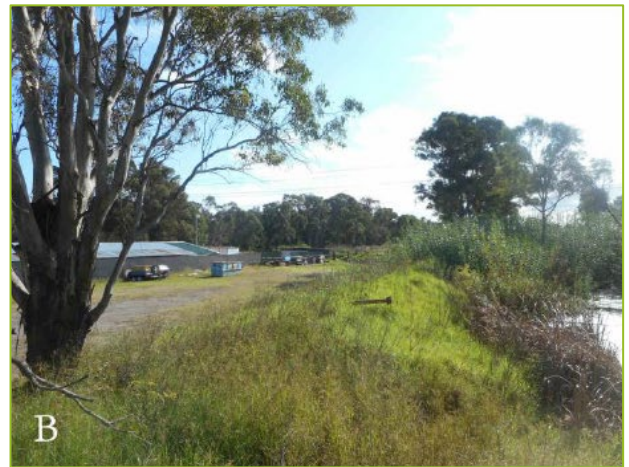
'B' looking across the dam wall to a highly modified zone of degraded channel

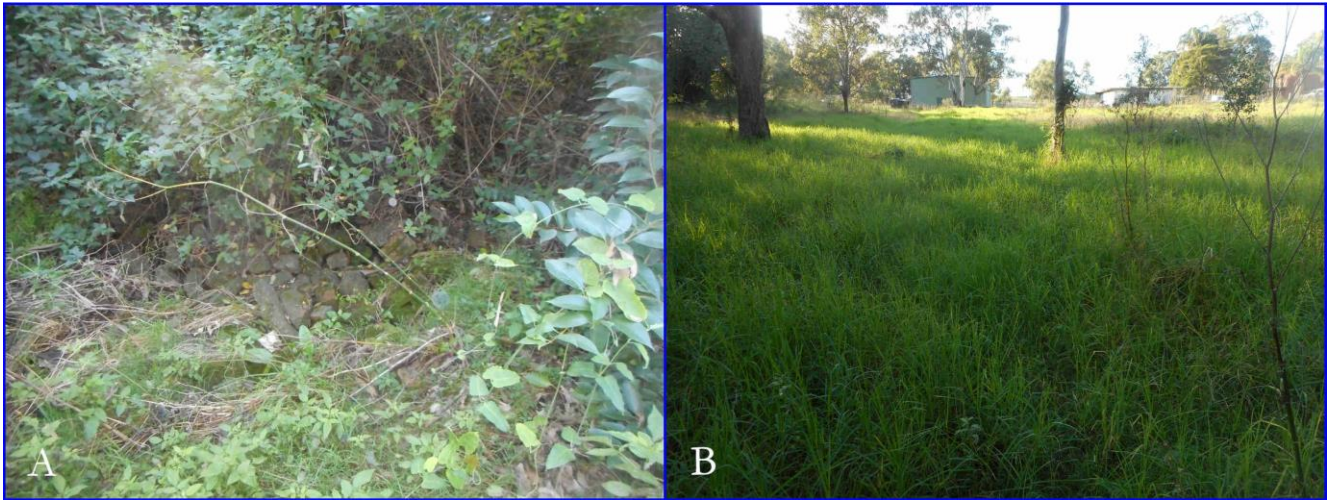
The low flow channel through this reach is well defined with low angled and well vegetated banks. At some locations the banks appear to be two stage which may indicate the passage of a knickpoint through this reach.

Figure 11. 'A' shows knickpoint stabilised by rock fill. Defined channel ends here. 'B' is looking up slope from Site 2; no defined channel

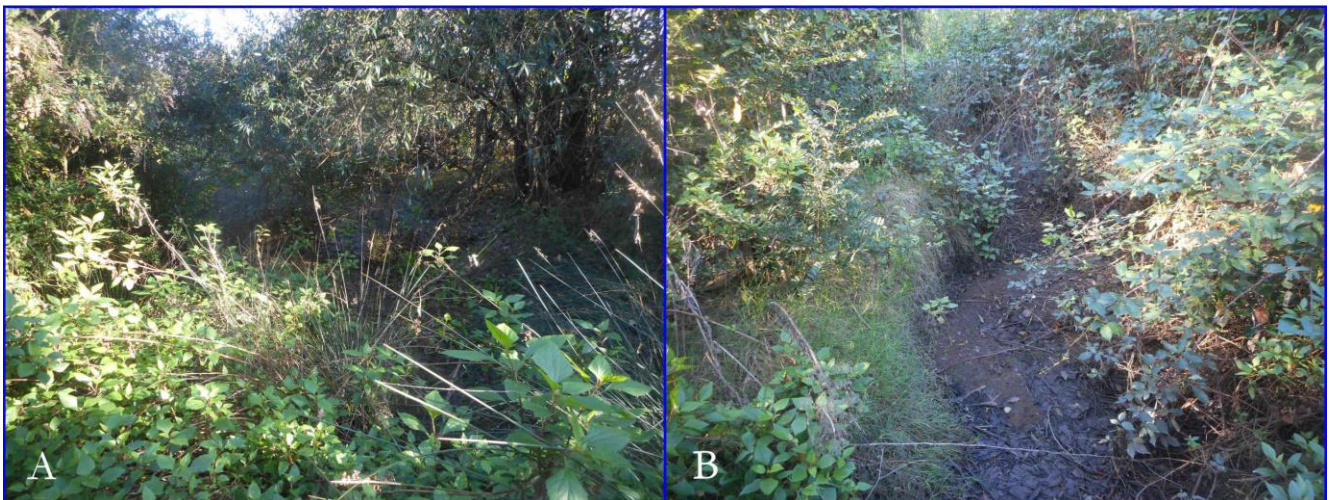
Sediment spear testing at sites 3 and 4 penetrates easily, with very little resistance to 1.05 m. There is a narrow, sub-horizontal, floodplain pocket at bank top left bank that has sediment over saprolite to 0.40 m as indicated by sediment spear testing.

Figure 12. 'A' looking upstream along the tributary towards site 4 and 'B' the tributary joining from left margin with recent deposition in the base of the channel

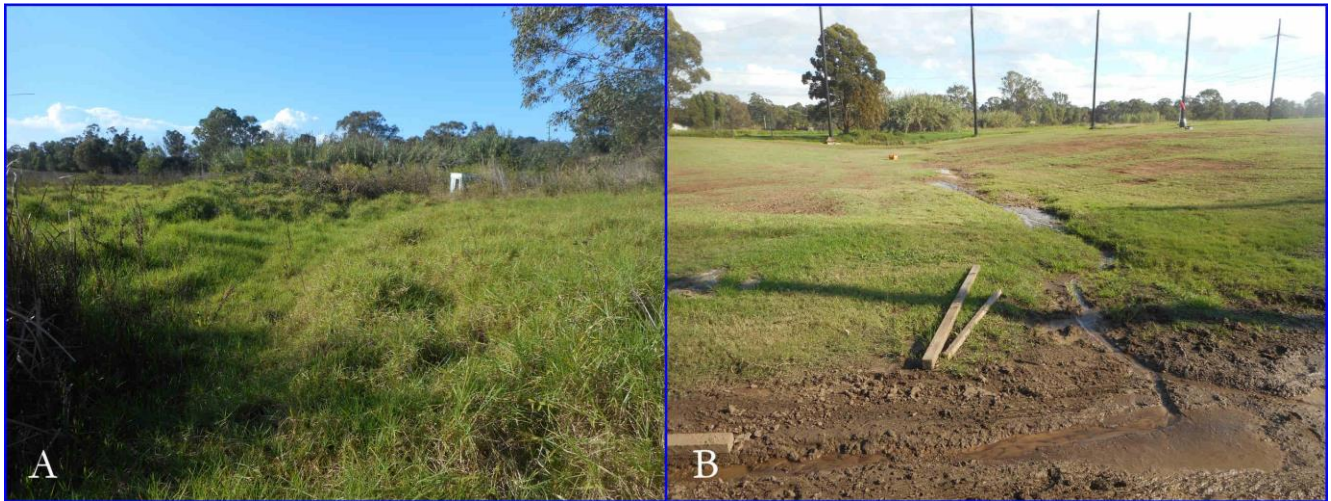
There is a surface low flow channel that has a low to moderate sinuosity with remnant ponds morphology. The low flow channel has a low capacity and discontinuous banks to 0.30 m. Flows that are unable to be contained within the pipe flow across the surface of the golf range. Interrogation of the historic aerial photography for 1978 (Appendix 3) show an agricultural dam at this location.

Figure 15. Location is site 9 at golf range boundary. 'A' is looking upstream to site 8 and 'B' is looking downstream to site 10.

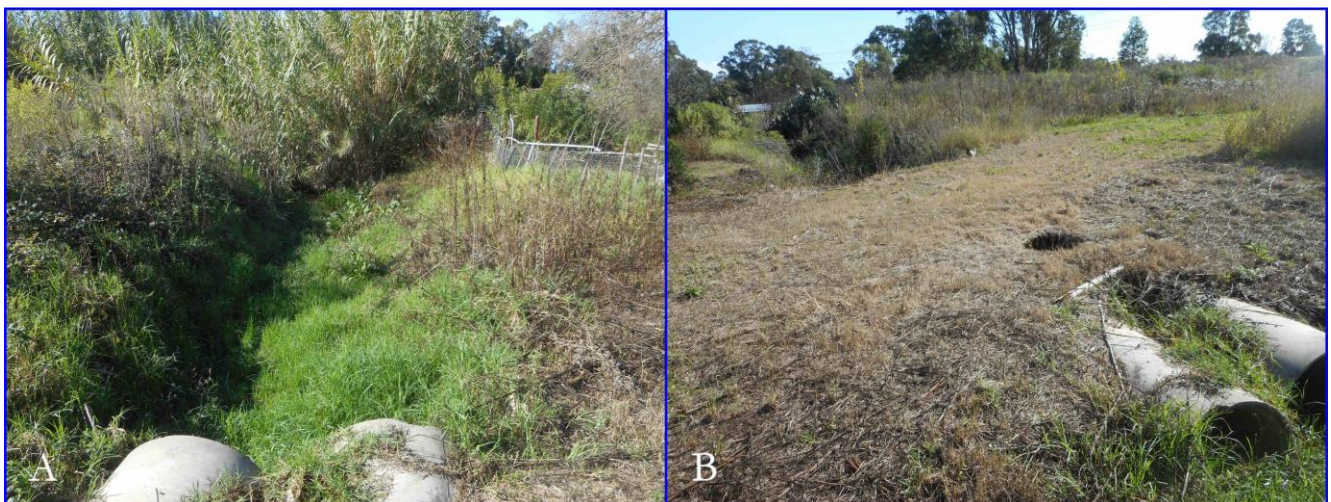
There is a very low sinuosity channel that shows evidence of anthropogenic realignment. Most of this reach was unable to be viewed and was largely inaccessible due to the abundant growth of blackberry, and other weed, obscuring the channel.

Figure 16. Site 13. Artificially straightened channel extending upstream 'A' and downstream 'B'
