52 McLaren Street

Summary of contamination status

To	Sydney Metro		
Copy to	Scott Robinson (GHD)		
From	Henry Luo, Senior Environmental Engineer and Helen Milne, Technical Director		
Subject	Summary of contamination status at 52 McLaren Street, North Sydney (Lot 2, DP218407)	GHD Project no.	2127384

GHD Site Visit Photograph Log- 25 June 2021

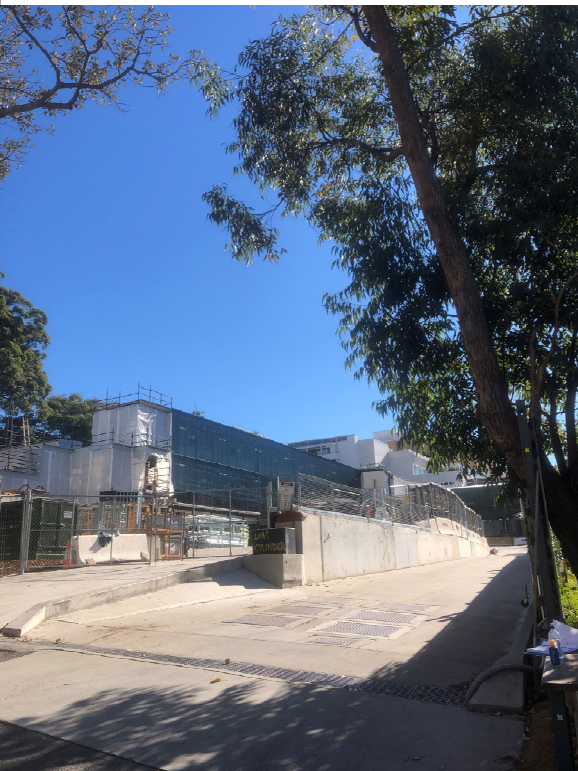
<p>Photograph 1- View of the site entrance from McLaren Street showing two driveway entrance points.</p>

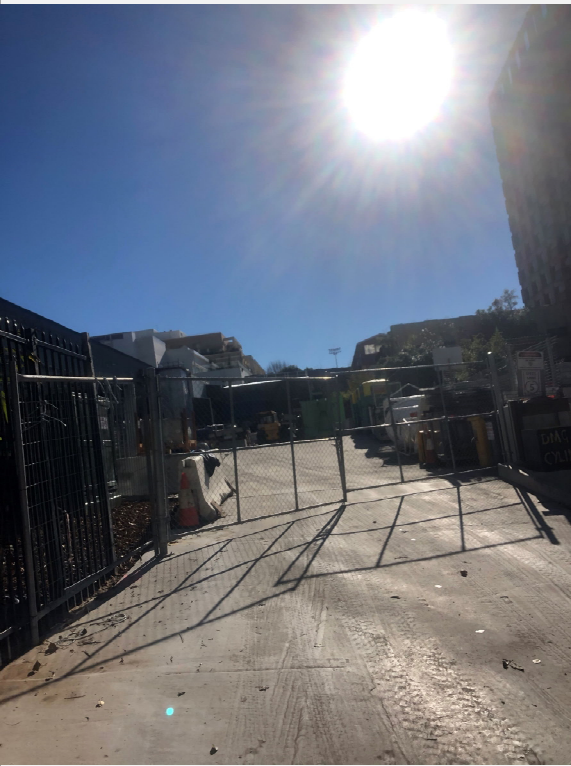
<p>Photograph 2- View looking into the first driveway entrance point from McLaren Street</p>

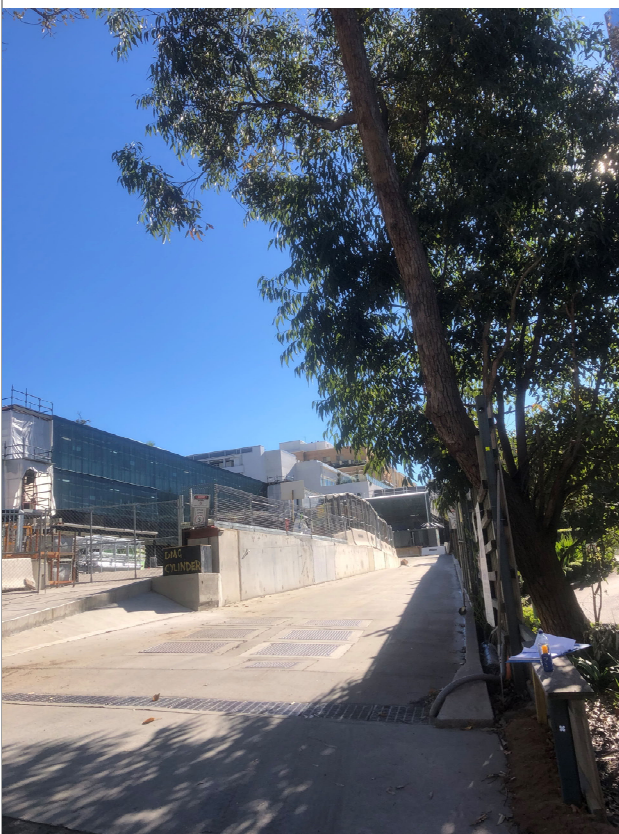
Photograph 3- View looking into second entrance point from McLaren Street and Lot 1 DP 536008 in the background.

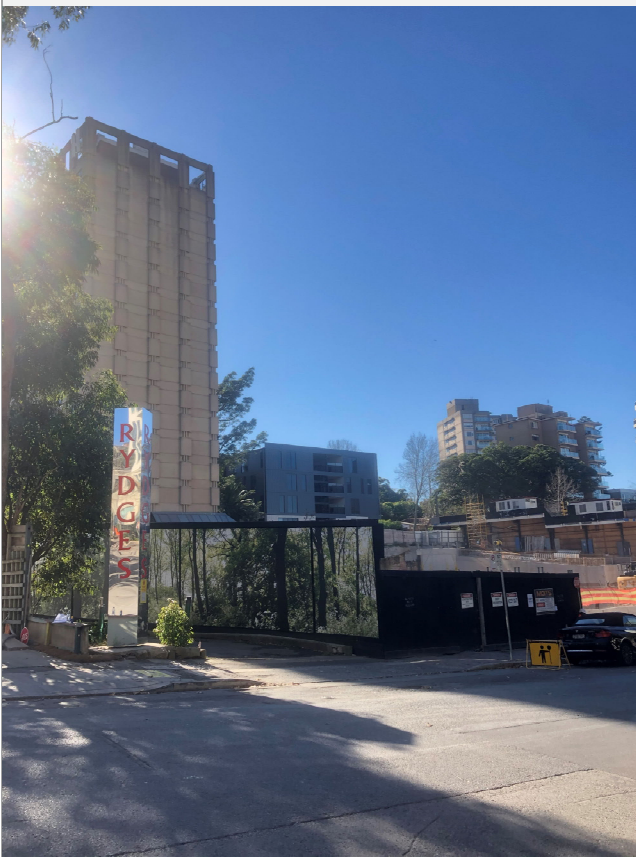
Photograph 4- Adjacent site, Rydges Hotel and adjacent construction site.

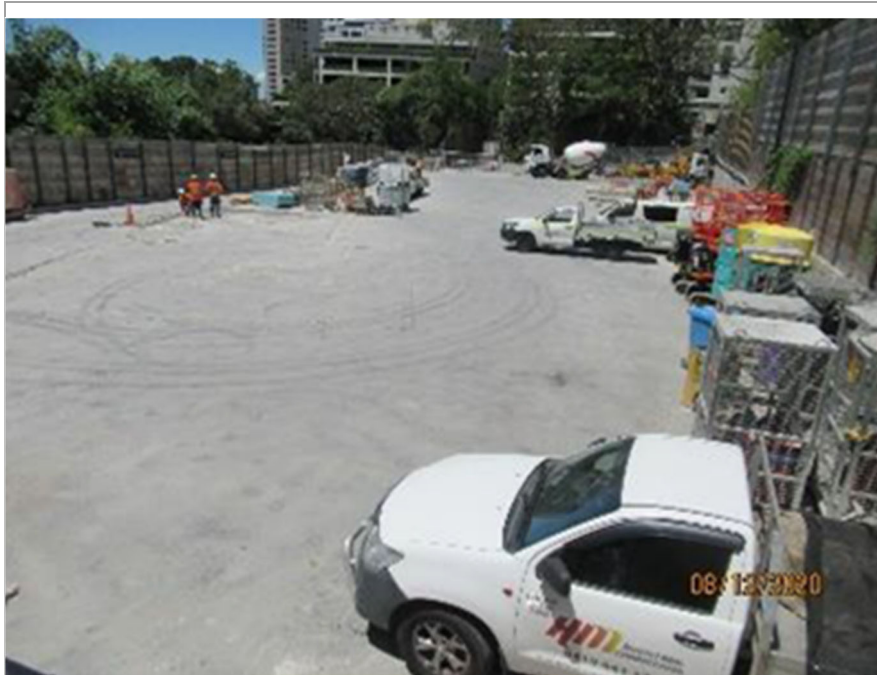
Photograph 7- View of the rear of Lot 2 DP 218407 where the shed was previously located. Material in this location has been covered by the Validation Report and has been removed from site. The area was covered by concrete and has since been demolished.

The site when handed back to Sydney Metro will be fully cleared with hoarding.
