# FLOODING AND STORMWATER IMPACT ASSESSMENT FOR PROPOSED REZONING

# 40 RAYFORD STREET, 19 DAYDAWN AVENUE AND 18 WINTERLAKE ROAD WARNERS BAY

Project: 16/155 JUNE 2018

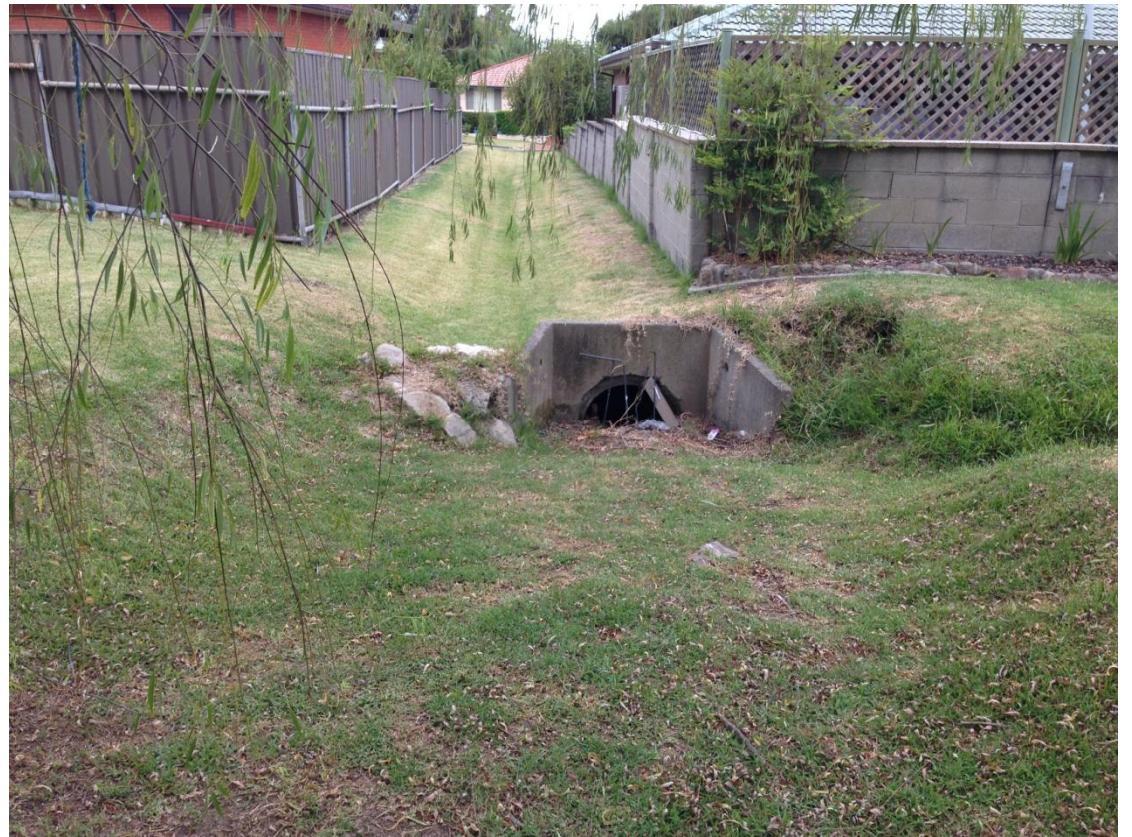
Photograph 1: Outlet A, looking from the subject land toward Peachwood Close

Outlet A is a formal overland flow path between Lots 8 and 9 DP 244868 at 5 and 7 Peachwood Close. This formal flowpath contains a 675mm diameter concrete stormwater pipe connecting with the stormwater pit and pipe system in Peachwood Close. A grassed channel aligned along the boundary of the subject land, intercepts surface flows from a greater area and channels this toward Outlet A.

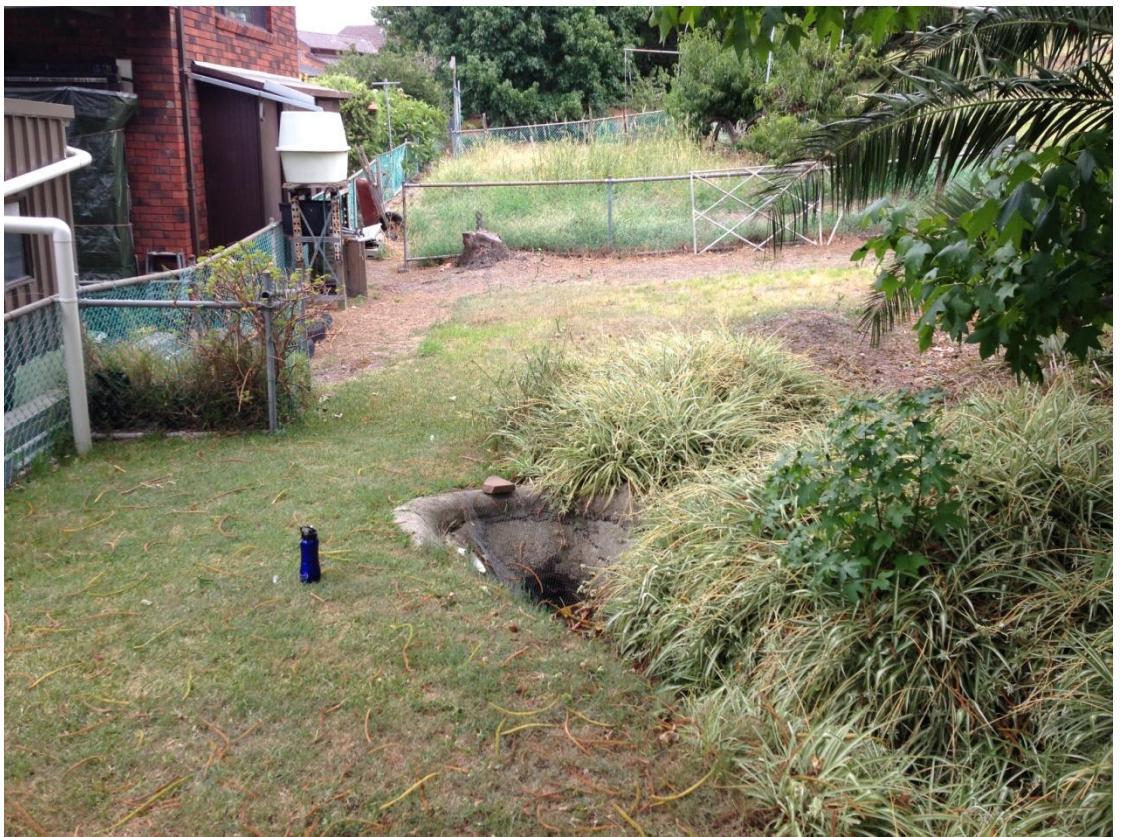
Photograph 2: Outlet B, looking to the south.

Outlet B is a small diameter pipe draining through an easement over Lot 8 DP249244, 12 Rayford Street. This pipe is not recorded on Council's stormwater records and is therefore assumed to connect to the existing stormwater pit at the front of number 10 Rayford Street. At the time of field investigation, this drain was described as frequently overtopping and causing inundation of the rear surrounds of this affected property. It is noted that the flooding of this drain coincided with overflows of the farm dam located approximately 50m upslope of the property.

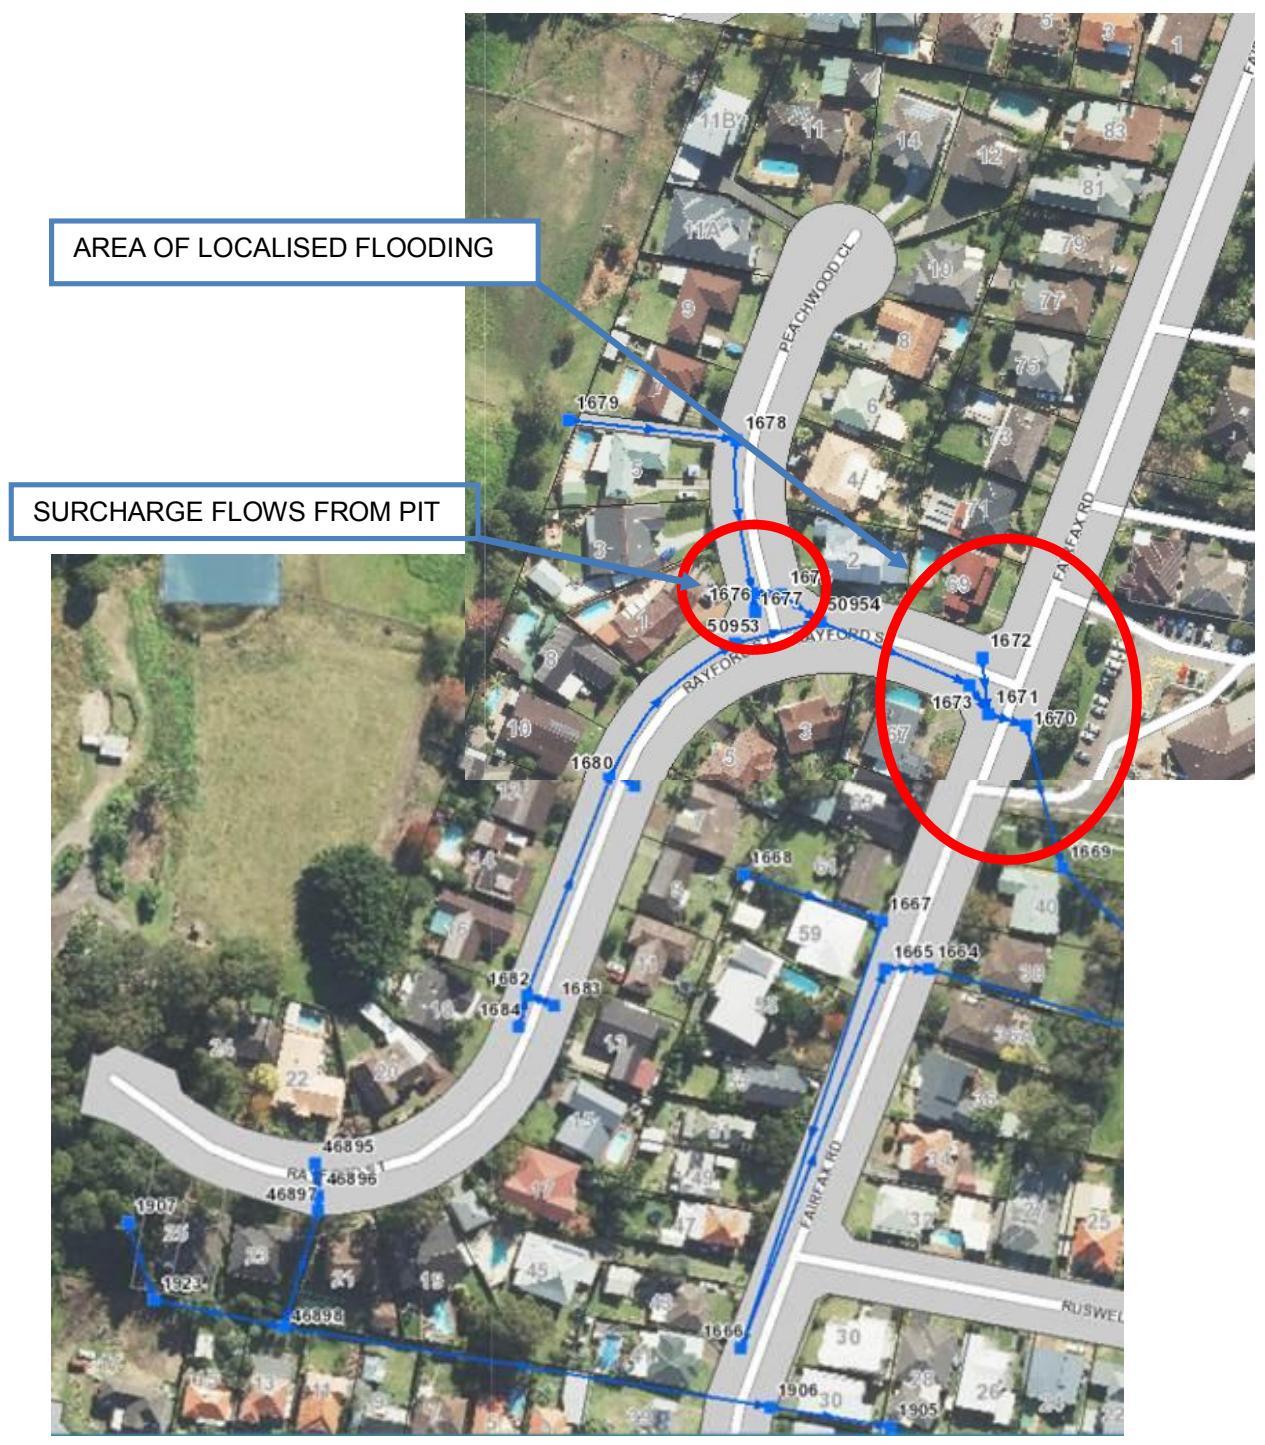
Figure 4 - Existing Network with Identified Issues

LMCC is aware of localised flooding downstream of the subject lands during most rainfall events, particularly at the intersection of Fairfax Road and Rayford Street (Adjacent to Warners Bay Private Hospital).

A detailed hydrological examination of the existing stormwater network was undertaken to identify the current operational capacity of the network. Figure 4 identifies problem areas that must be addressed to satisfy the 10% AEP design guidelines established by LMCC.

- 1. Additional Pits & Pipes on Fairfax Road The additional pits will capture flows and convey them directly into the network, assisting in the elimination of localised ponding at the sag pit (1672) located on the corner of Rayford Street & Fairfax Road. The additional pits will reduce flow widths and any likely bypass flow that currently occurs in a storm event.

- Additional Pit Rayford Street The insertion of a 3.0 Extended Kerb Inlet upstream of sag pit (1672), will assist in conveying bypass/gutter flow from upstream into the pipe network consequently reducing localised ponding at the sag pit.

- 3. Re-configuration of pit & pipes on the corner of Rayford Street & Peachwood Close by removing the existing pipe between Pits 1677 & 1676 and relaying a pipe from Pit 1677 to Pit 1675. This modification of the existing system will improve flow through the network and minimise any surcharge occurring from a given storm event.

- 4. Upsize Pit, Pipe & Headwall Upgrade the existing 600mm pipe connecting Headwall (1679) & Pit 1678 to a 900mm concrete pipe. This upgrade will ensure that current and future flows are captured more readily by the existing system.
