Report on Desktop Geotechnical Assessment

Proposed Apartments NBN Studio, Mosbri Crescent, The Hill

> Prepared for Nine Network Australia Pty Ltd

> > Project 81843.00 November 2015

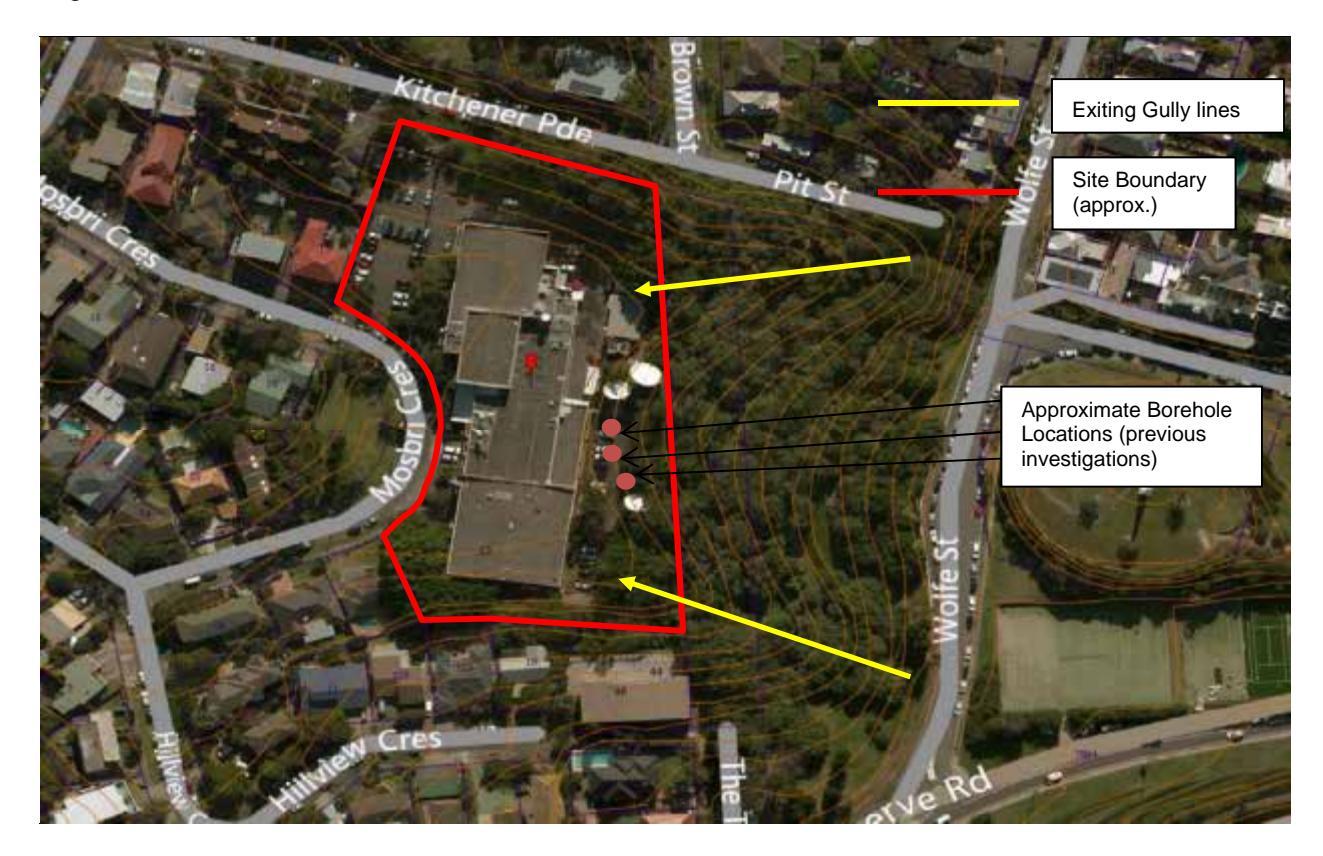
Figure 2: Elevation contours (2 m) at Mosbri Street Site Location

Elevation contours for the site are shown in Figure 2. Two existing gully lines were observed during the site visit extending from the eastern site boundary adjacent to Wolfe Street through the adjacent vegetated reserve towards the site.

- Based on the site walkover, no evidence of deep seated or overall slope instability was observed;
- Some evidence of very minor creep or translational sliding was observed in the gullies of the adjoining property to the east (Figure 2);

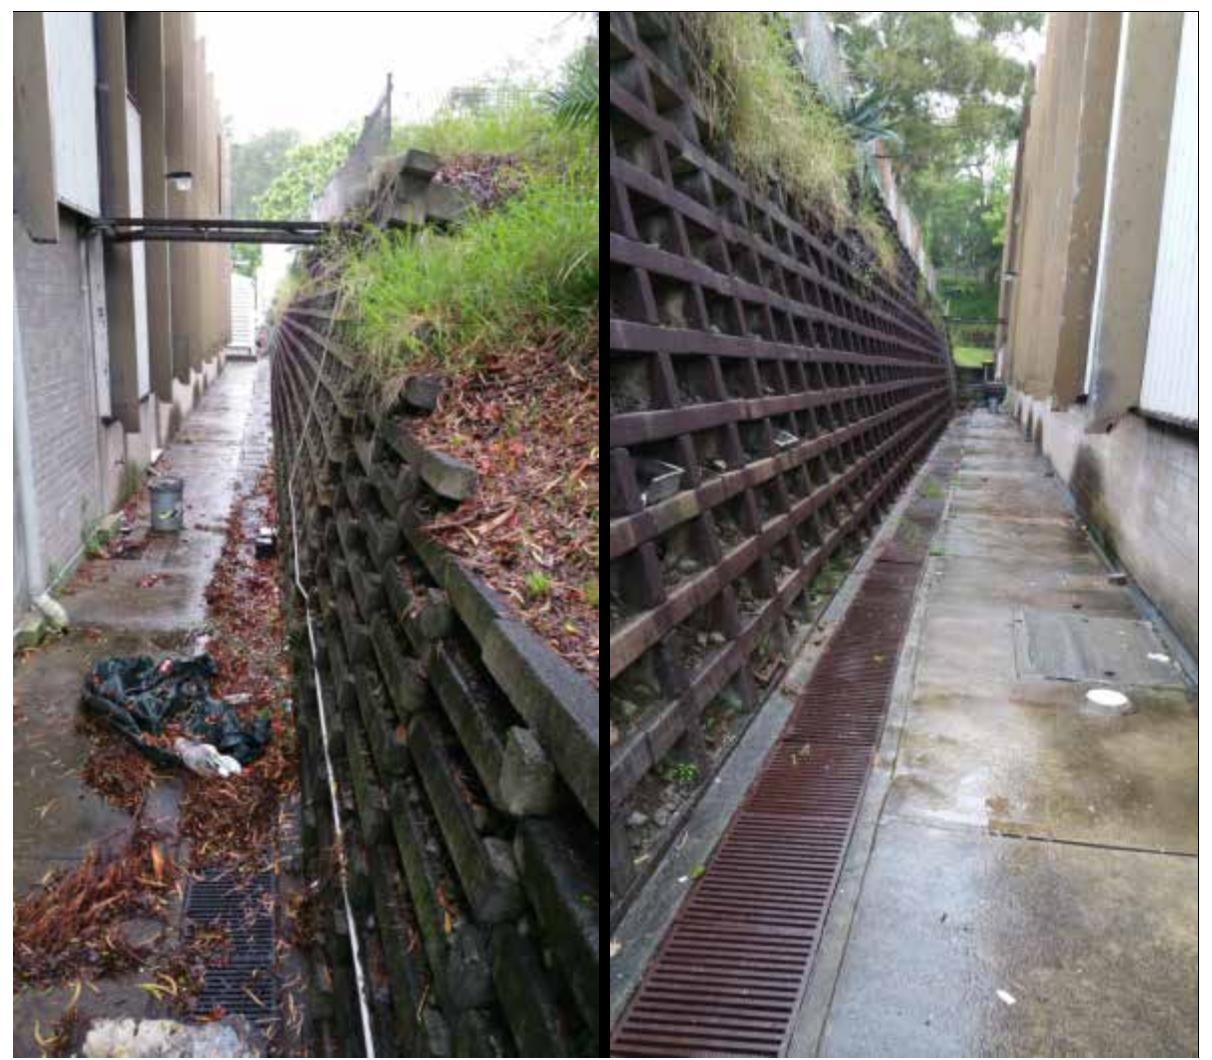
Figure 3: Existing Crib Retaining Wall along Eastern edge of existing NBN building (looking north, looking south)

The existing NBN building has been extensively cut into the landscape and is surrounded on the northern, eastern and southern edges by crib retaining walls (refer Figure 3).

- In the absence of detailed design and works-as-executed drawings, it is not possible to comment
  on the suitability of an existing retaining wall. Nonetheless, the existing crib walls immediately
  surrounding the NBN building (Figure 3 and Figure 6) do not appear to show evidence of
  significant distress. The crib walls along the southern, eastern and northern site boundaries
  (Figure 4 and Figure 6) do show signs of localised distress and spalling that has exposed the
  internal reinforcement. This reinforcement has corroded significantly where spalling has occurred;

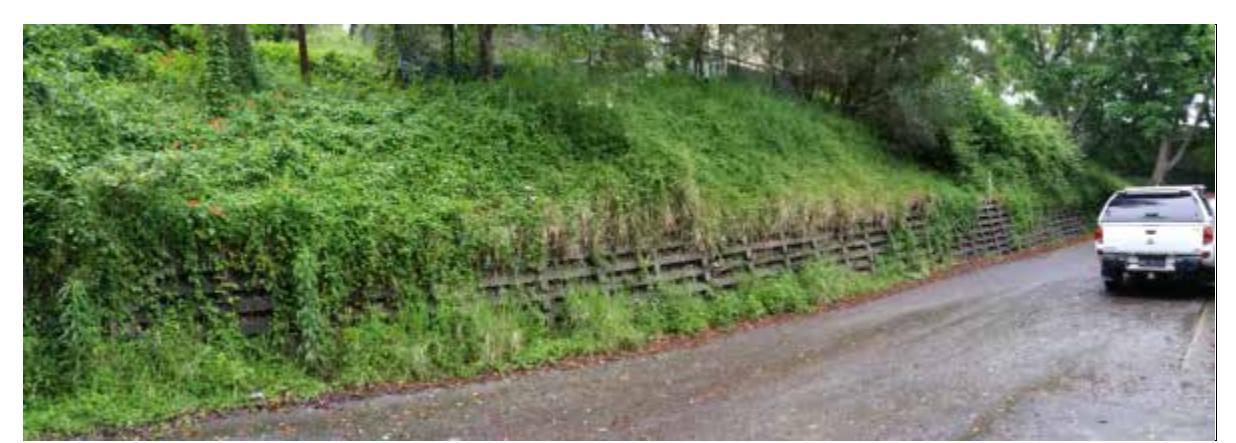
Figure 4: Existing Crib Retaining Wall along Southern Site Boundary (looking west)

In addition to the retaining walls surrounding the main NBN building, the northern, eastern and southern car park / pavement areas are also supported by a mixture of crib and rock retaining walls (refer Figure 4, Figure 5 and Figure 6).

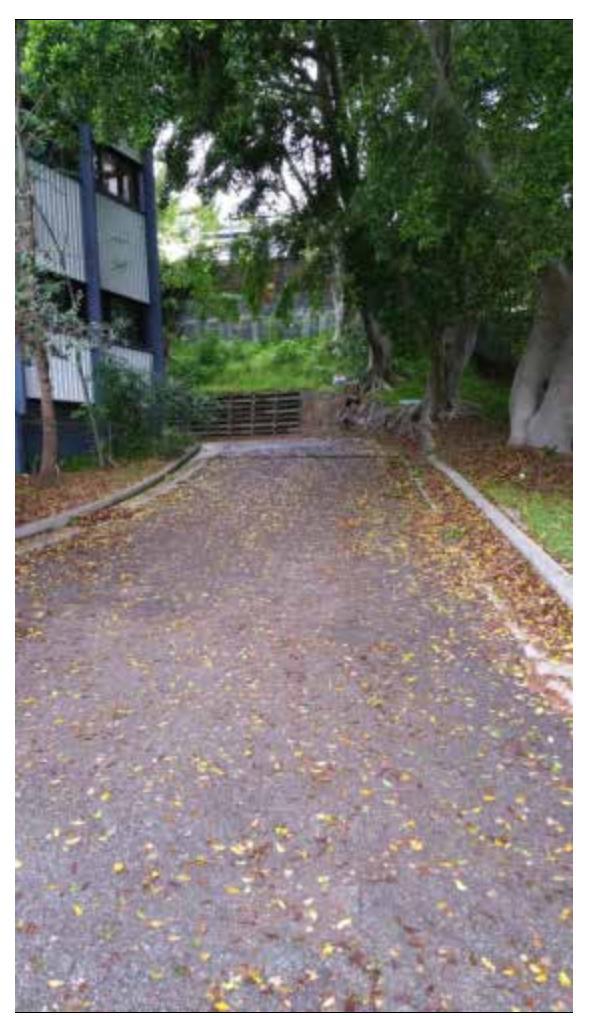
Figure 8: Large diameter trees along far southern boundary adjoining Mosbri Crescent

The northern and southern boundaries are grass covered with she-oaks and other shrubs with a basal diameter of up to 200 mm, several very large diameter trees exist along the very far length of the southern boundary.
