Report on  
Geotechnical Assessment – Urban Capability

Proposed Subdivision  
Lots 1 – 5 and 7 DP771051, Parkwood, NSW

Prepared for  
The Riverview Group

Project 77356  
February 2014

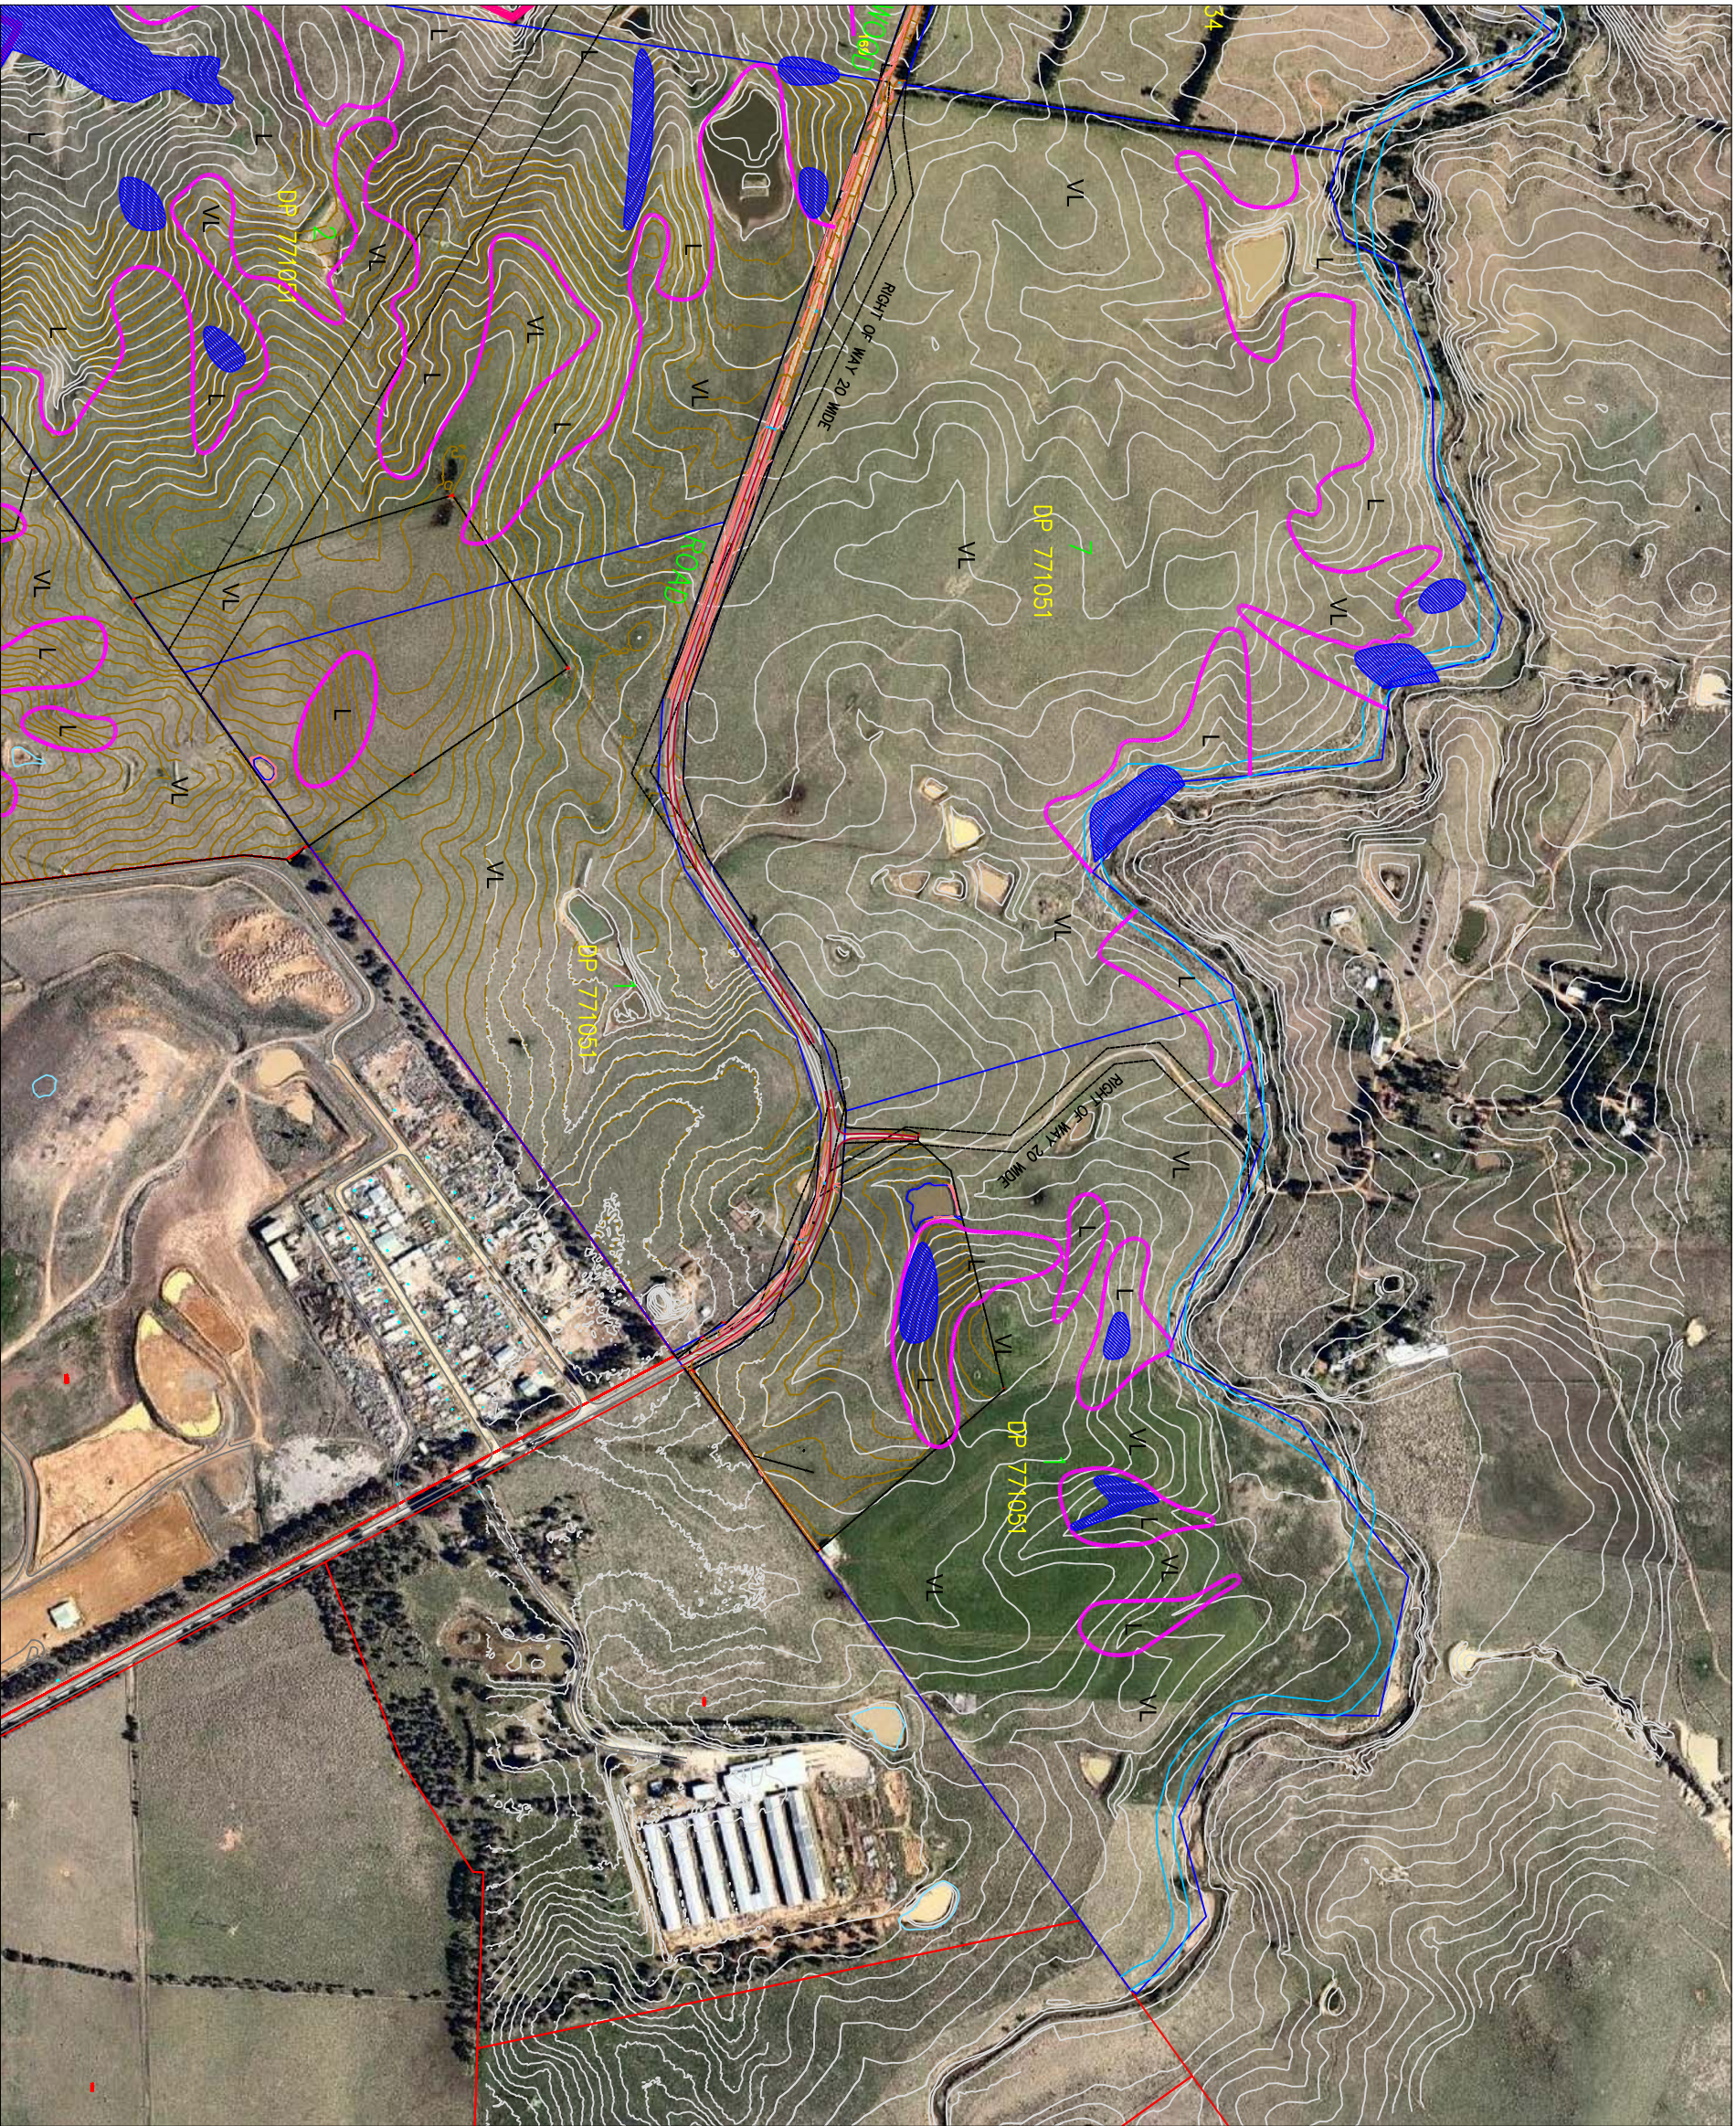
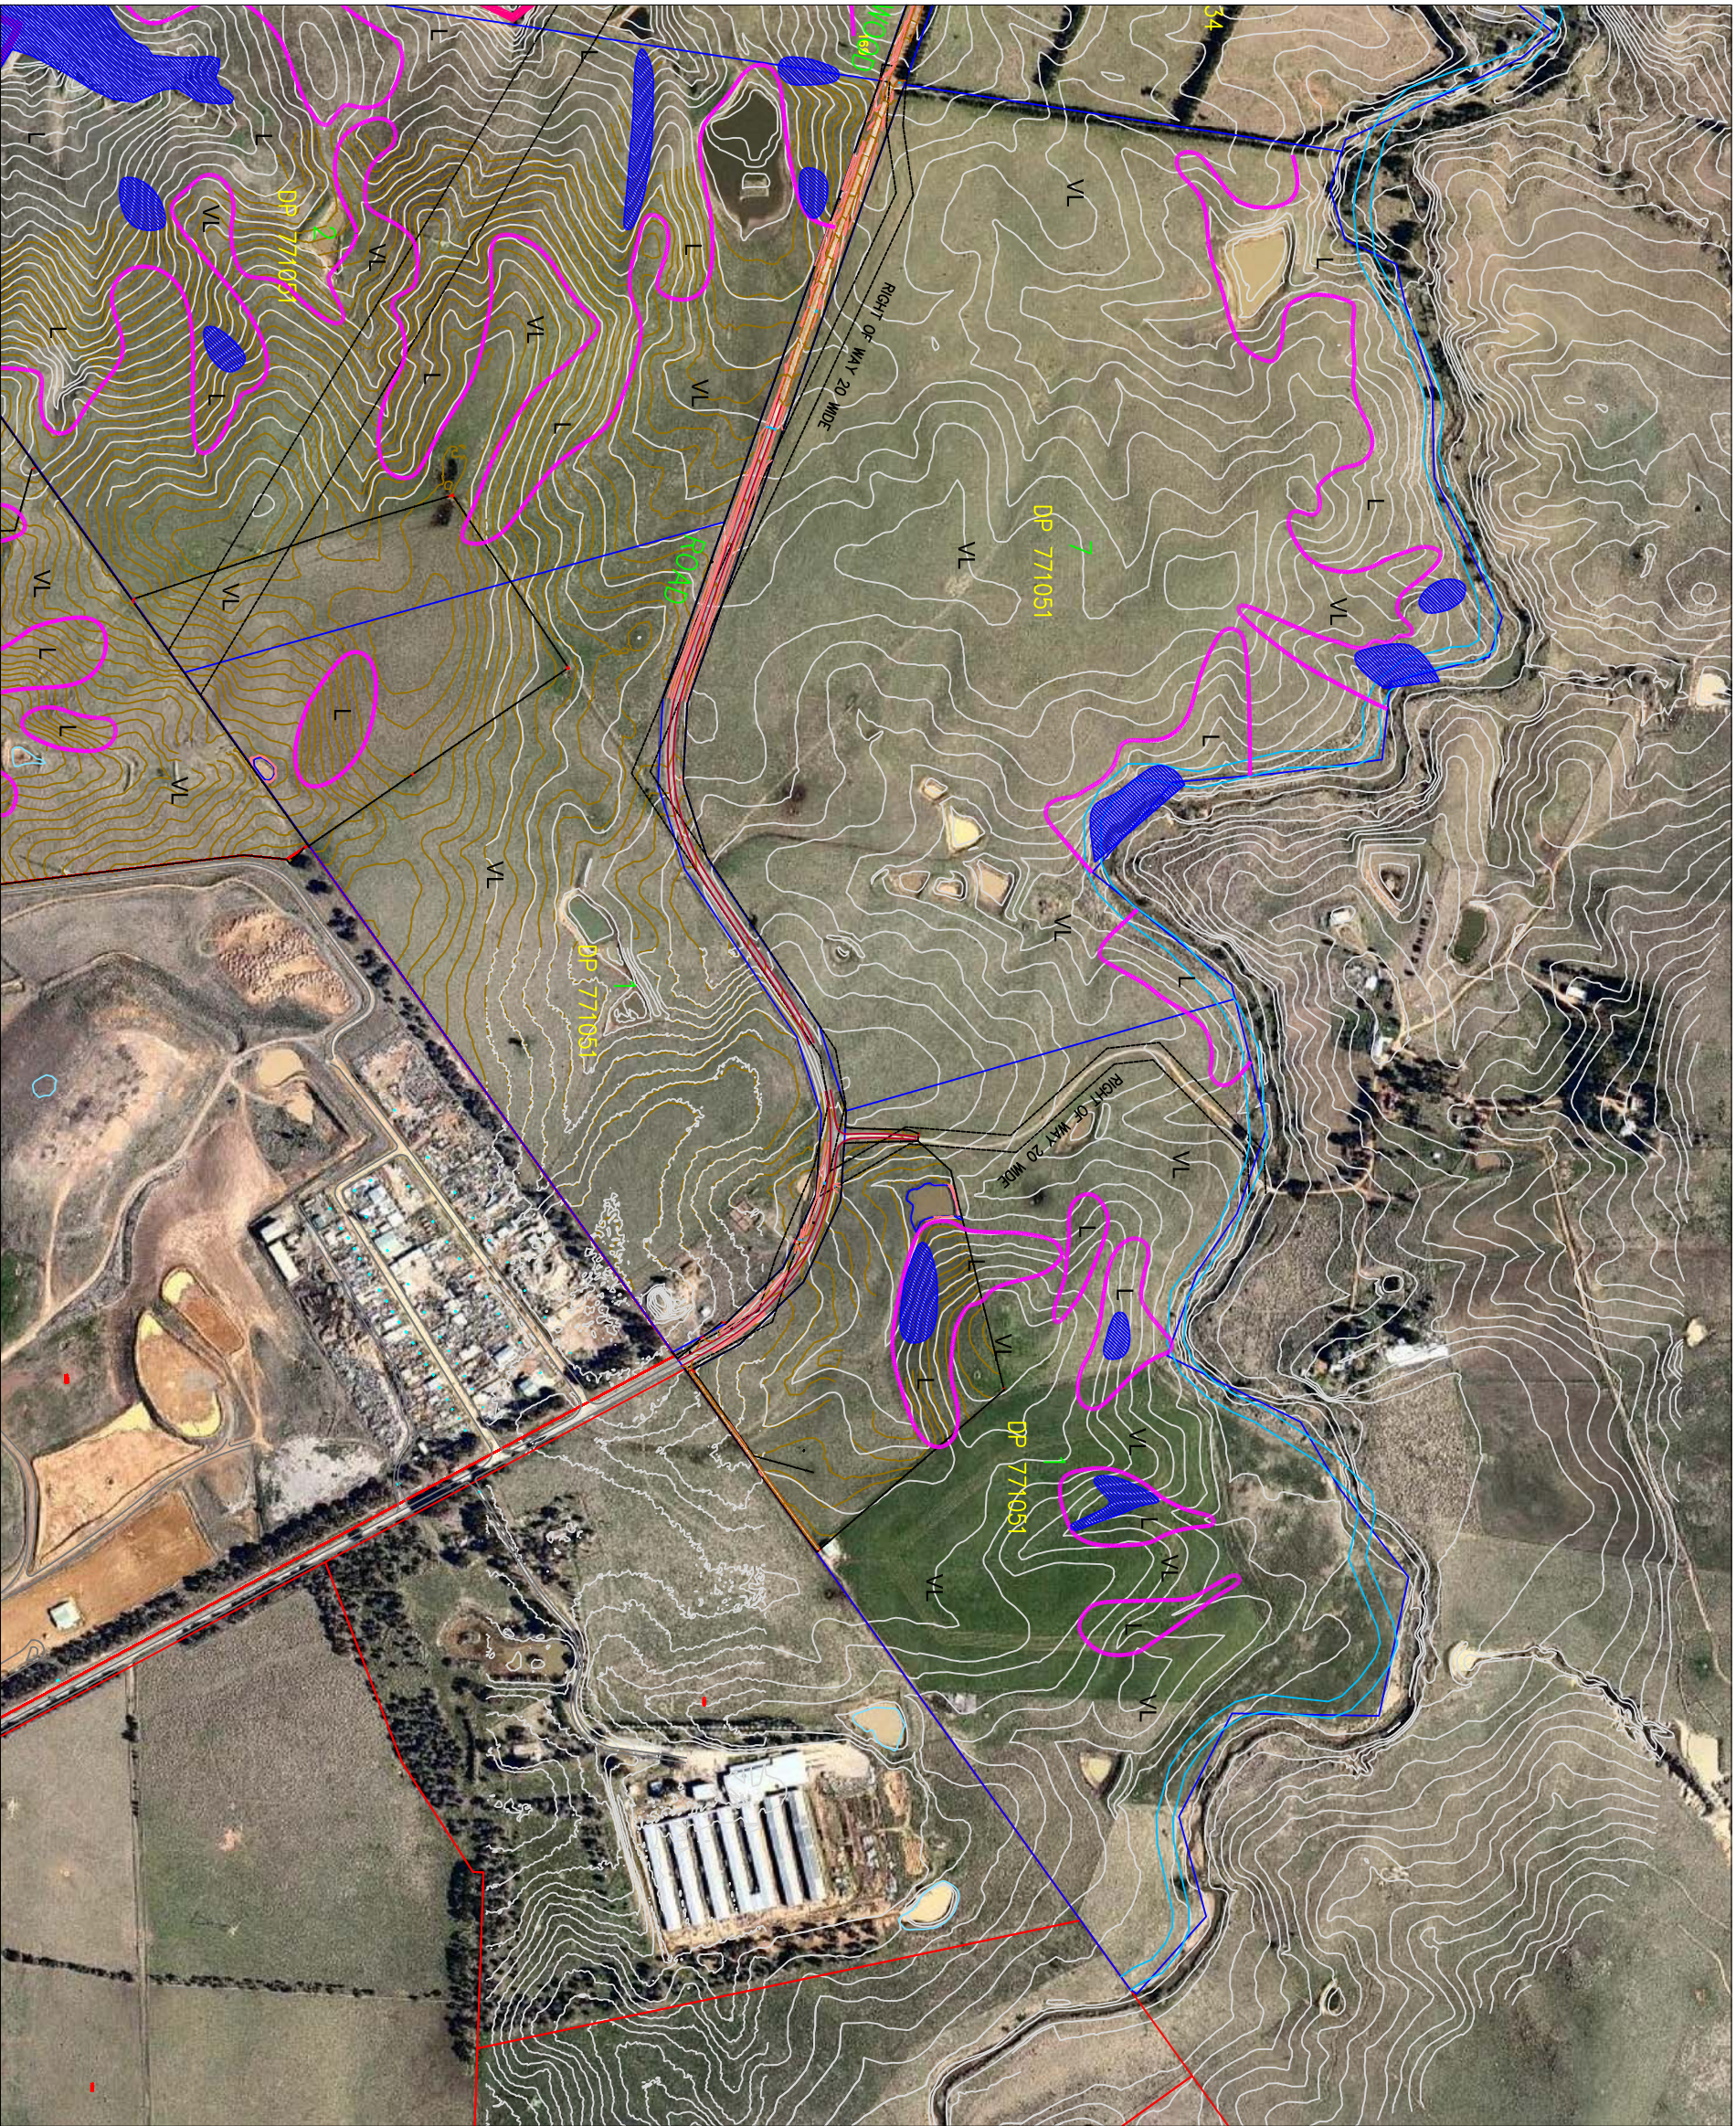
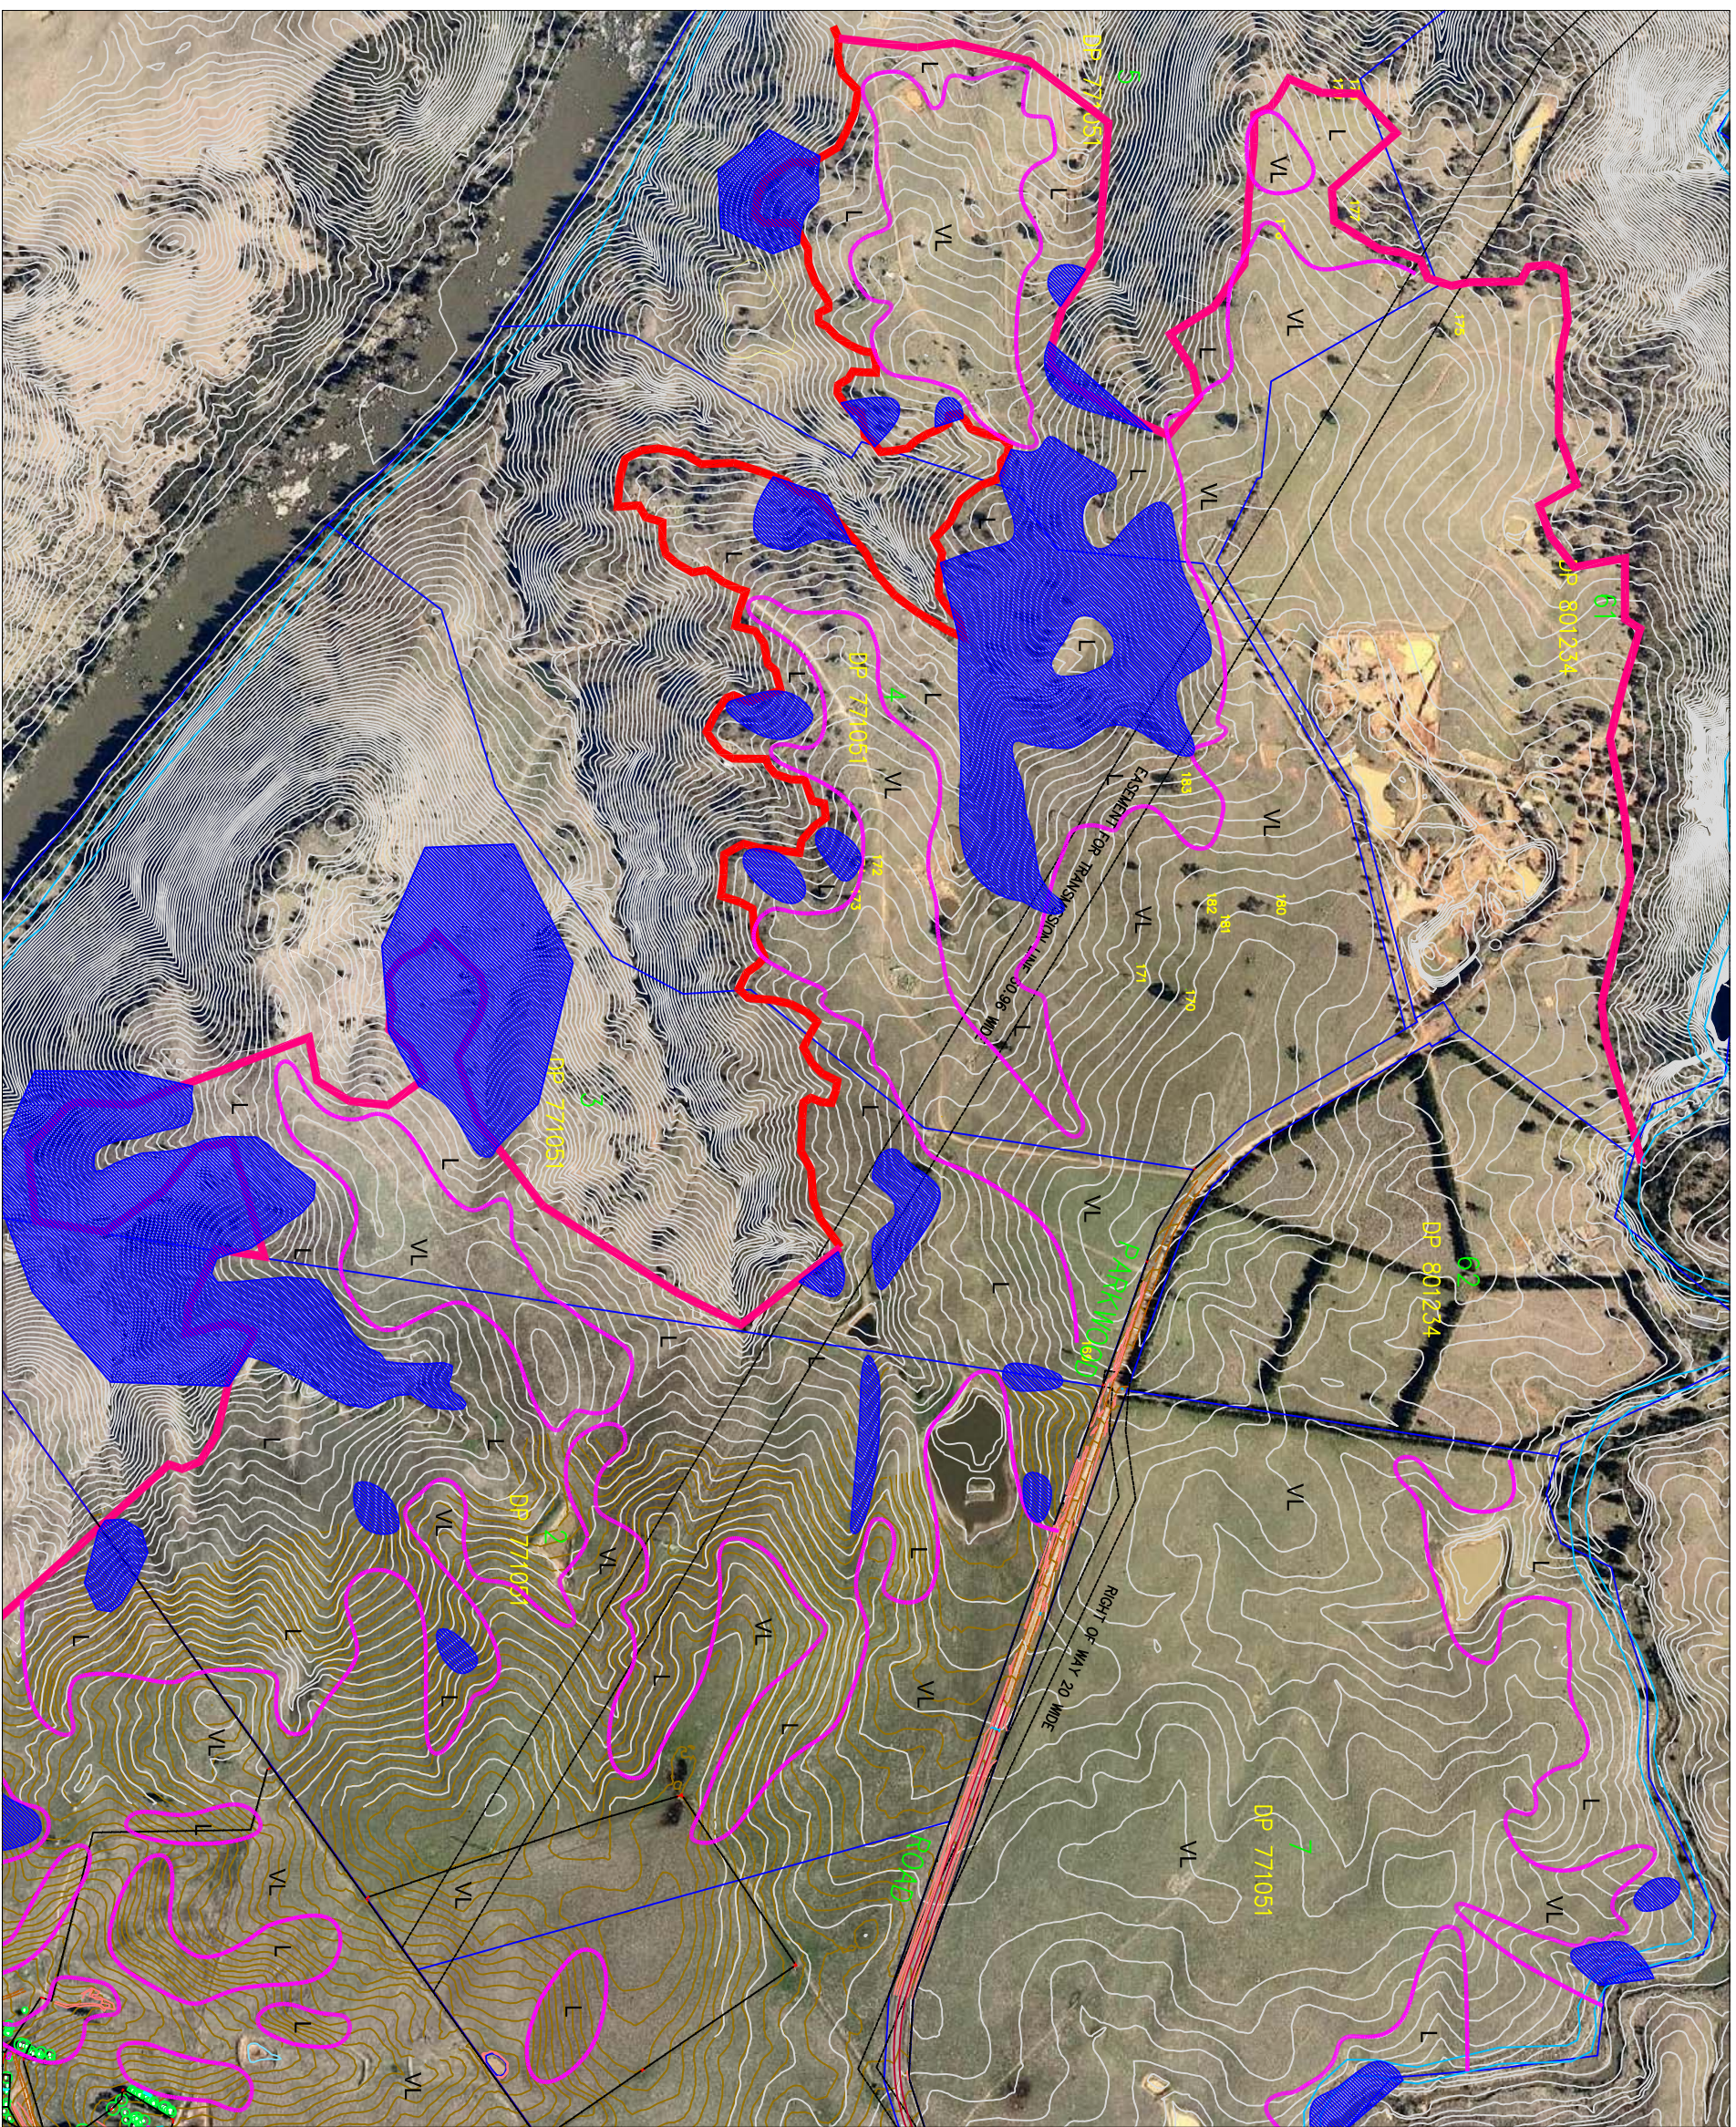
PROJECT No: 77356	
DRAWING No: 5	
REVISION: 0

In summary, it is considered that most of the site is classified as very low or low risk of damage to property occurring as a result of slope instability. Several areas are considered of moderate or high risk (refer Drawings 5 and 6) of causing property damage due to the steep ground slopes and possible unsuitable design and construction practice.

**Stability:** Several areas (refer Drawings 5 and 6) have been assessed as having a potential moderate to high risk of damage to property from land instability.

Areas of steeply sloping land (moderate and high risk) are not recommended for residential development at this stage. A detailed site stability assessment including subsurface investigations must be undertaken in these areas to establish an appropriate site model for analysis purposes to assess whether development is feasible in the high risk zones.

It is noted that revisions to the above risk classifications may be necessary following completion of bulk earthworks. It is recommended that if development is proposed within the moderate and high risk areas, further delineation and assessment be undertaken.

At this stage without subsurface investigations, development within the high risk areas are not recommended. A comprehensive site stability assessment will be required if development in those areas are proposed.

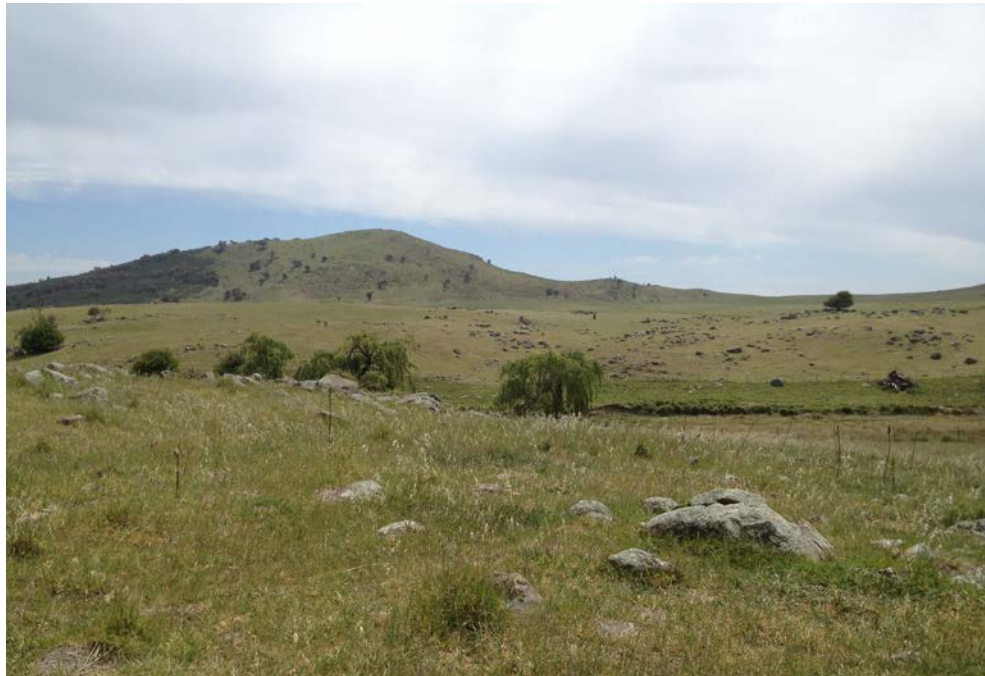
Photo N20 – Rock outcropping. Refer Drawing 3 for locality and direction

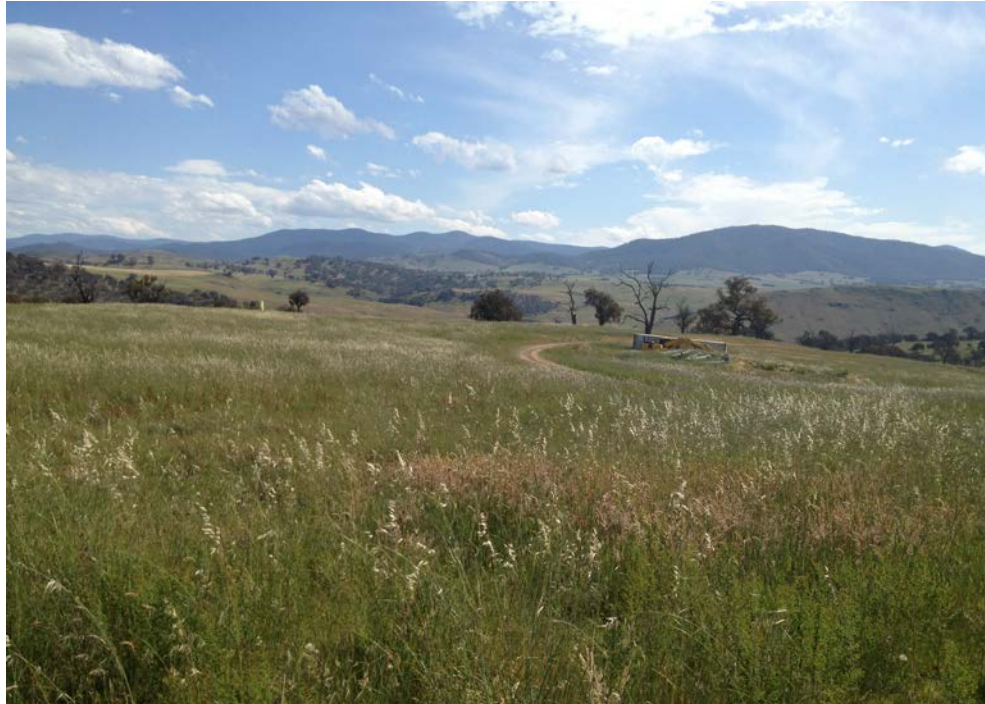
Photo N61 – Storage container. Refer Drawing 4 for locality and direction

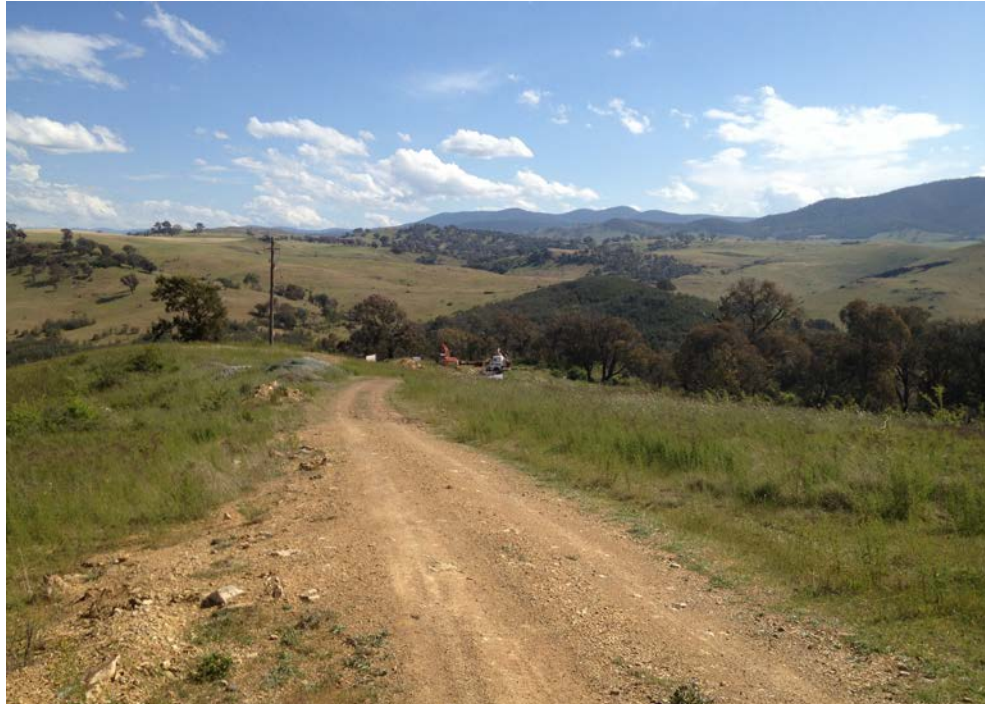
Photo N67 – Equipment storage. Refer Drawing 4 for locality and direction
