## **Studies (Part 1)**

## **Aboriginal Cultural Heritage Assessment Report**

### **Proposed Rezoning and Sub-division for Residential Development 15 Malloway Road Chain Valley Bay Lot273 DP755266**

Report for  
Optima Developments Pty Ltd

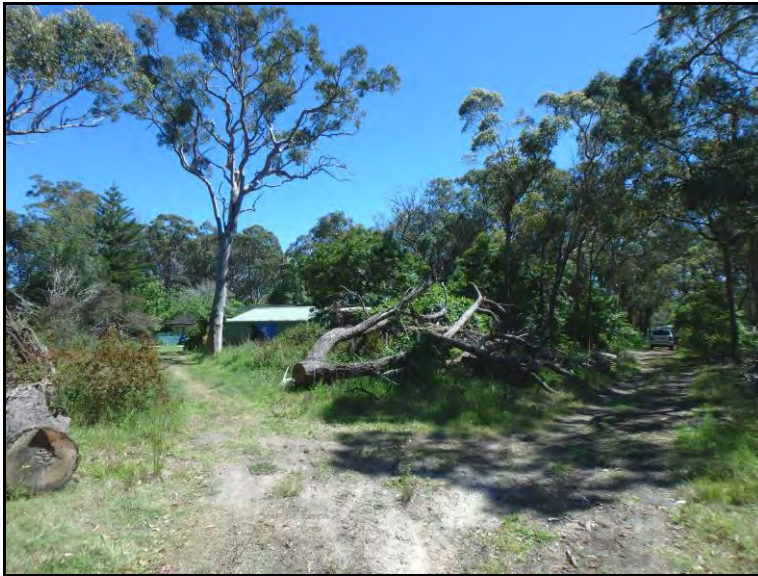
Figure 8: Vehicle access tracks and vegetation behind the residential dwelling and shed, approximately 150m south of Mulloway Road. View north west.

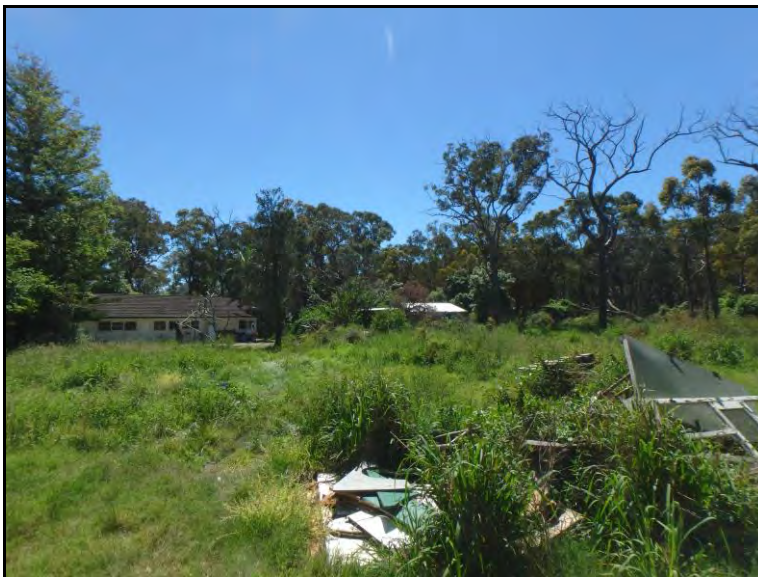
Figure 9: Thick vegetation and rubbish at the rear of the residential dwelling. View north.

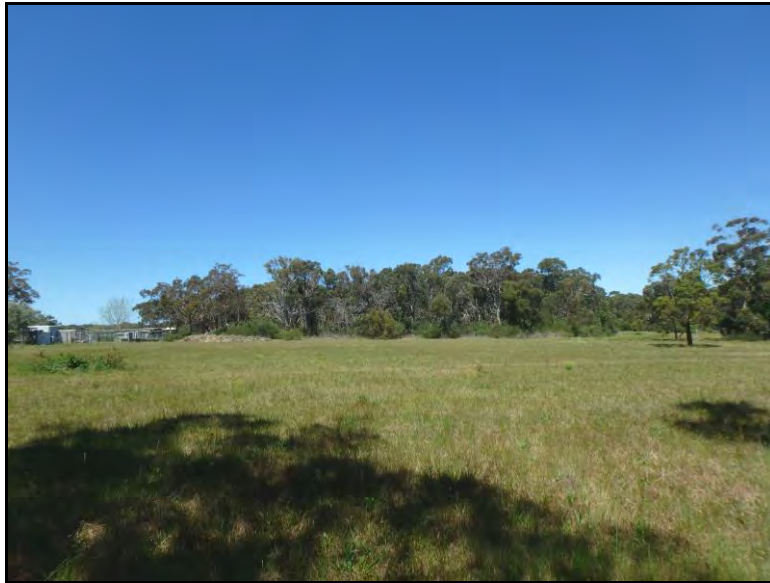
Figure 10: Cleared section of the property. Grass cover did not allow ground visibility. View south east.

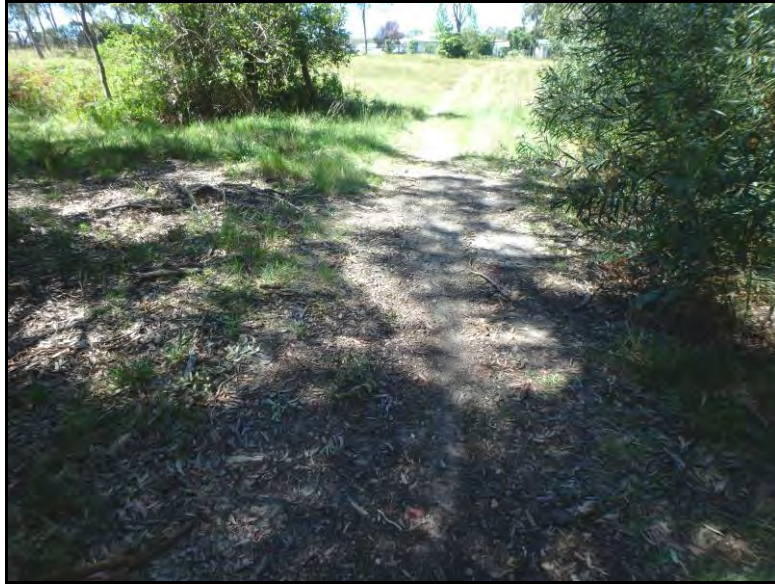
Figure 12: Ground exposure near the dam due to vehicle tracks. View east.

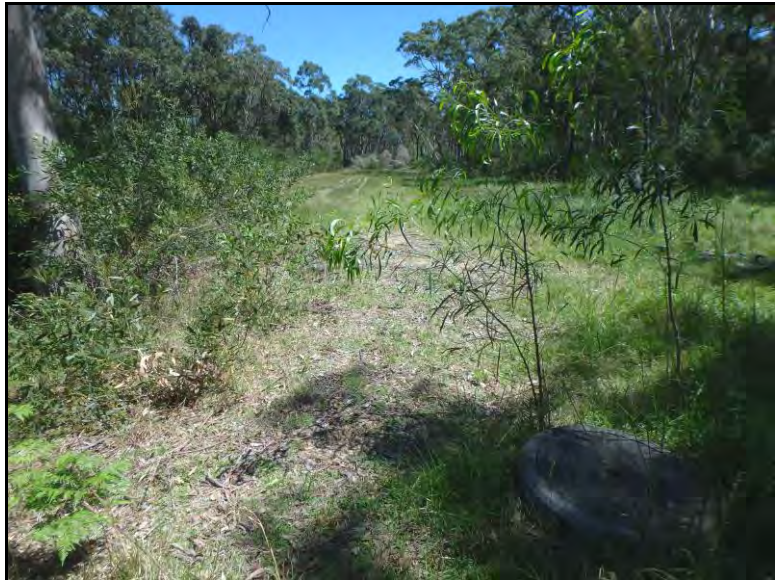
Figure 13: Sewer line toward the south of the property and associated vegetation clearance. This sewer line marks the southern boundary of the proposed development. View west.

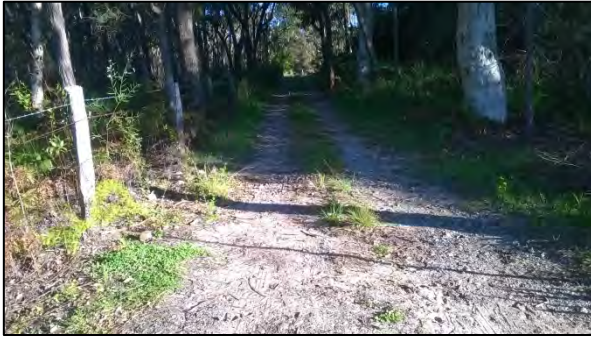
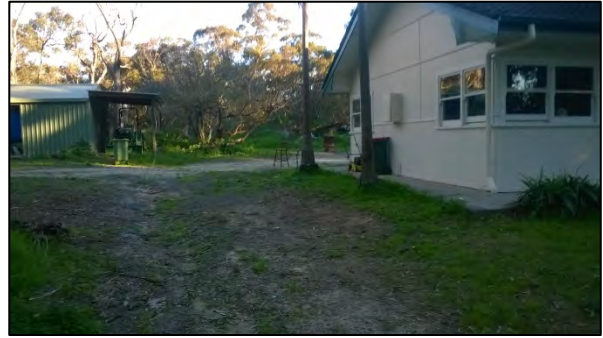
Figures 9 and 10 – Photograph of access driveway into site from Mulloway Road with some recycled aggregate materials used to surface the driveway. Photograph of residence and detached shed. The shed was used to house several cats, with a tractor parked under the attached awning.

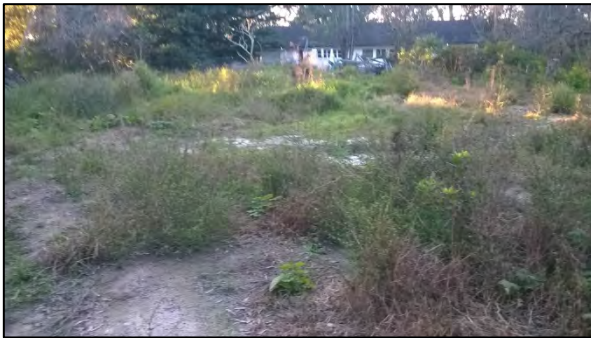
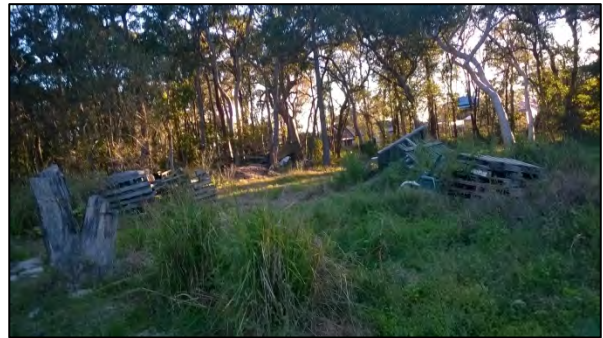
Figures 11 and 12 – Inspection of the general site conditions in the locality of the residence indicated that the area immediately to the south was cleared with a scattered grass/weed cover. Surface soils appeared to have been disturbed in the past possibly as a result the livestock known to occupy the site. Various materials and debris (i.e. mix of metal, timber, plastic, concrete and foam) were stored in this portion of the site.

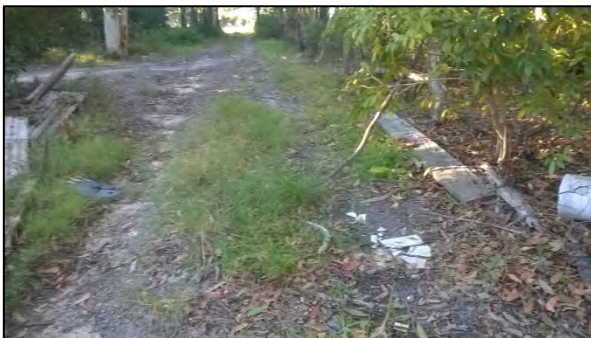
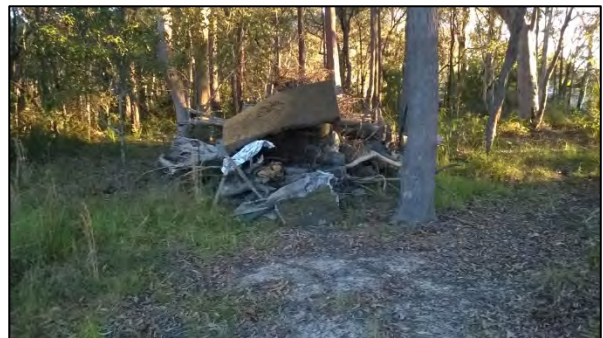
Figures 13 and 14 – Photograph of various materials and debris were stored in general locality of the residence (refer to Drawing 1, Appendix A). Materials observed comprised a mix of metal, timber, plastic, concrete and foam, a derelict truck, tractor and trailer, and small quantities of suspected asbestos-containing-material (ACM) fragments were observed at the ground surface (refer to Figure 13) at three locations.

Suspected asbestos has been detected by observation on the surface of the site. Building demolition materials, such as concrete were also located in other areas of the site and these are considered as indicative of the possible presence of hazardous building materials (HBM), including asbestos. It is therefore considered possible that HBM, including asbestos, may be present in unobserved parts of the site, and hence no warranty can be given that asbestos is not present.

Prior to completion of the further intrusive contamination investigations it is recommended that a licensed contractor is engaged to remove all debris and waste materials and suspected ACM fragments observed at the ground surface (refer to Drawing 1, Appendix A).

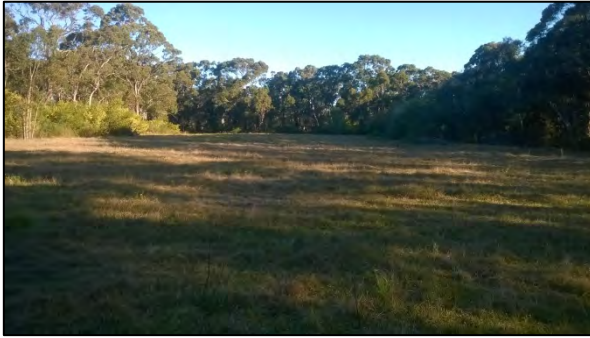
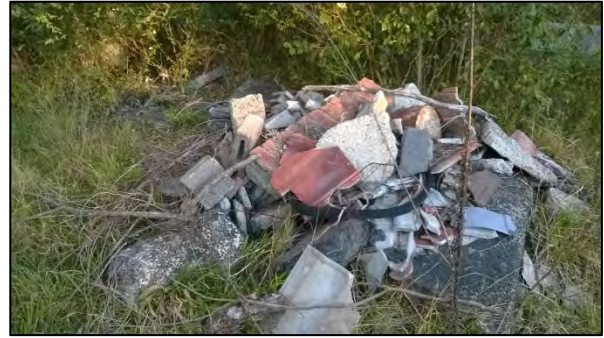
Figures 15 and 16 – Remaining portions of the site comprised bushland with several grass surface clearings linked with typically unsurfaced access tracks. No obvious signs of widespread filling were identified during the walkover, however, isolated areas on the tracks appeared to have been resurfaced with concrete rubble. Small stockpiles of building waste materials (i.e. mix of brick, concrete, tiles and metal - refer to Figure 16), soils and timber logs (suspected to be sourced from fallen trees) were observed during the walkover. No additional suspected ACM fragments were observed at the surface of the stockpiles.
