Report on  
Land Capability Assessment

Site 1 - Lake Munmorah Rezoning  
Lake Munmorah and Crangan Bay

Prepared for  
Darkinjung Local Aboriginal Land Council

Project 83115.01  
November 2017

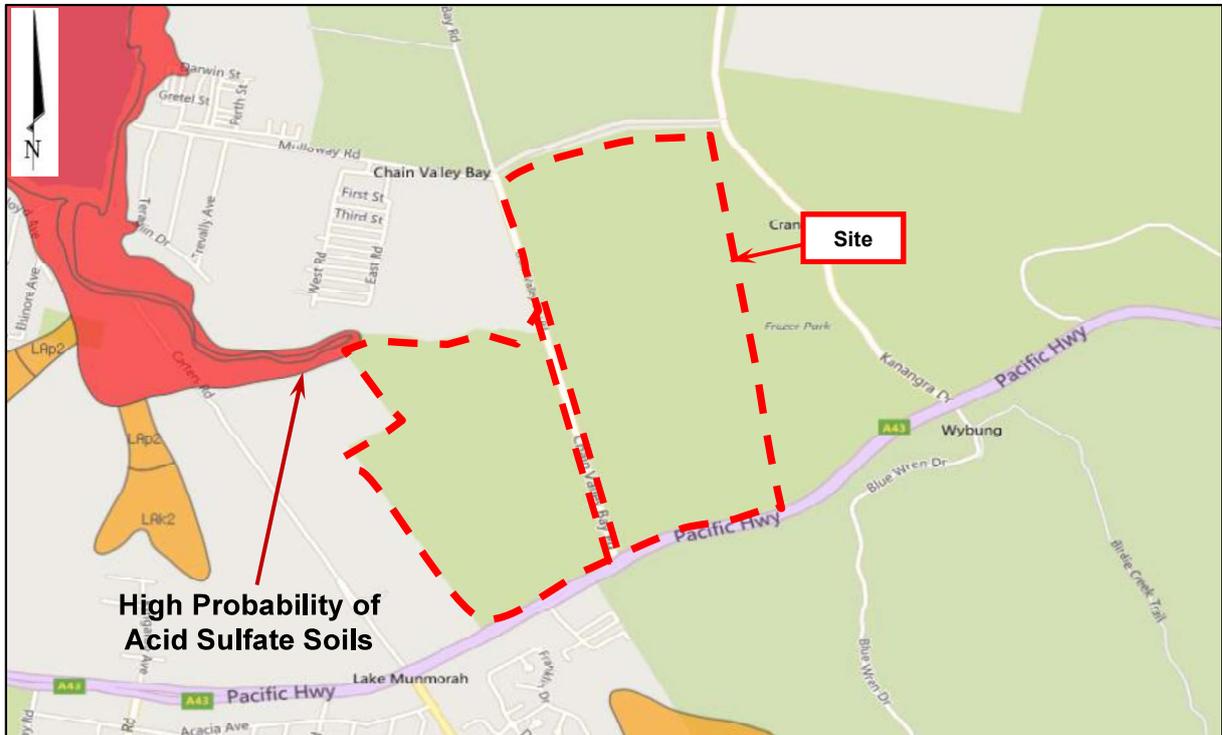
**Figure 6: Site Acid Sulfate Soil Risk Mapping** (image sourced from Microsoft Virtual Earth with Acid Sulfate Risk Mapping Sheet overlay)

The local acid sulfate risk mapping indicates that the north-western boundary of the site adjoins an area mapped as having a high risk of acid sulfate soils within 1 m of the ground surface. The remainder of the site is located within an area mapped as having no known occurrence of acid sulfate soils. Figure 6 is a street map of the local area and shows the site in relation to areas mapped as having a probability of acid sulfate soils.

It is noted that the mapping generally only provides an indication of the presence/absence of acid sulfate soils. In this regard, during the site walkover, waterlogged areas were present in the central portions of Lot 100 and the northern portion of Lot 642 which are associated with Karignan Creek. These correspond with the areas mapped as Quaternary Alluvium 'Qa' in Figure 4, which also match the areas mapped as Wyong Alluvial 'wy' and Tacoma Swamp 'ts' in Figure 5.

Development within Site 1 is proposed in areas that are mapped as being underlain by the Munmorah Conglomerate formation ('Rnm' in Figure 4) and do not encroach into the areas mapped as Quaternary Alluvium ('Qa'). For the current indicative subdivision layout, acid sulfate soils are, therefore, not considered to be an issue. If the areas of proposed development were to change such that work is expected to encroach into the lower-lying areas associated with the watercourses, then further review and assessment for the presence of acid sulfate soils would be required.
