Our Ref: PSM4854-004L Rev 1

**RE: WILTON PARK ROAD & BERWICK PARK ROAD -  
PLANNING PROPOSAL - REV 1**

**SELECTED SITE PHOTOGRAPHS**

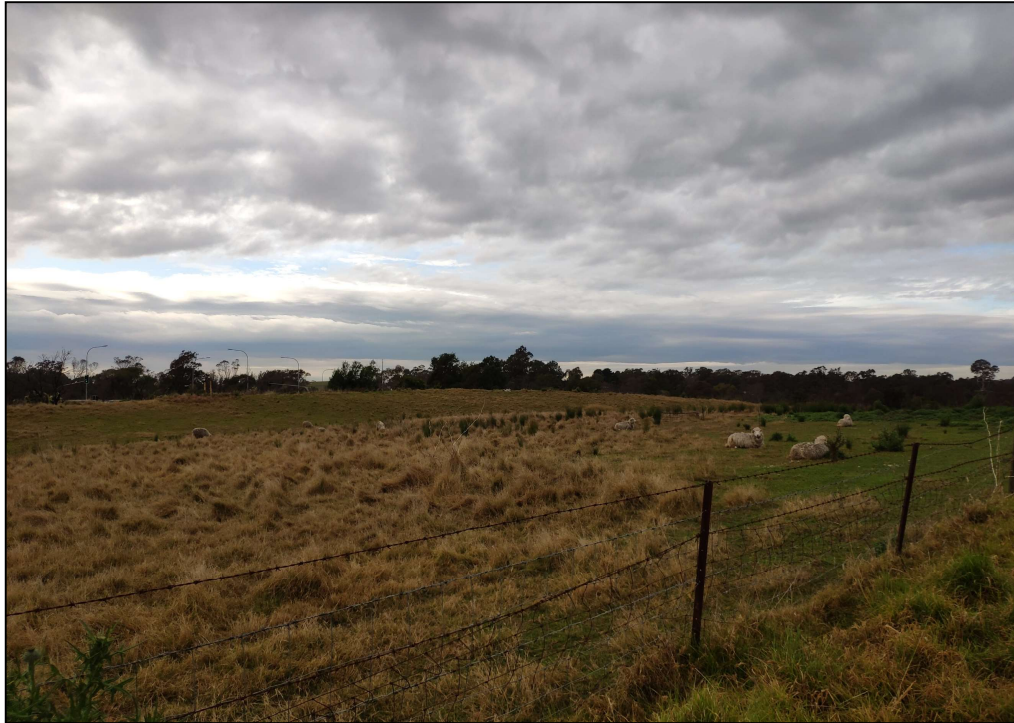
Photo 1: General view of the site at 30 Berwick Park - looking South-East

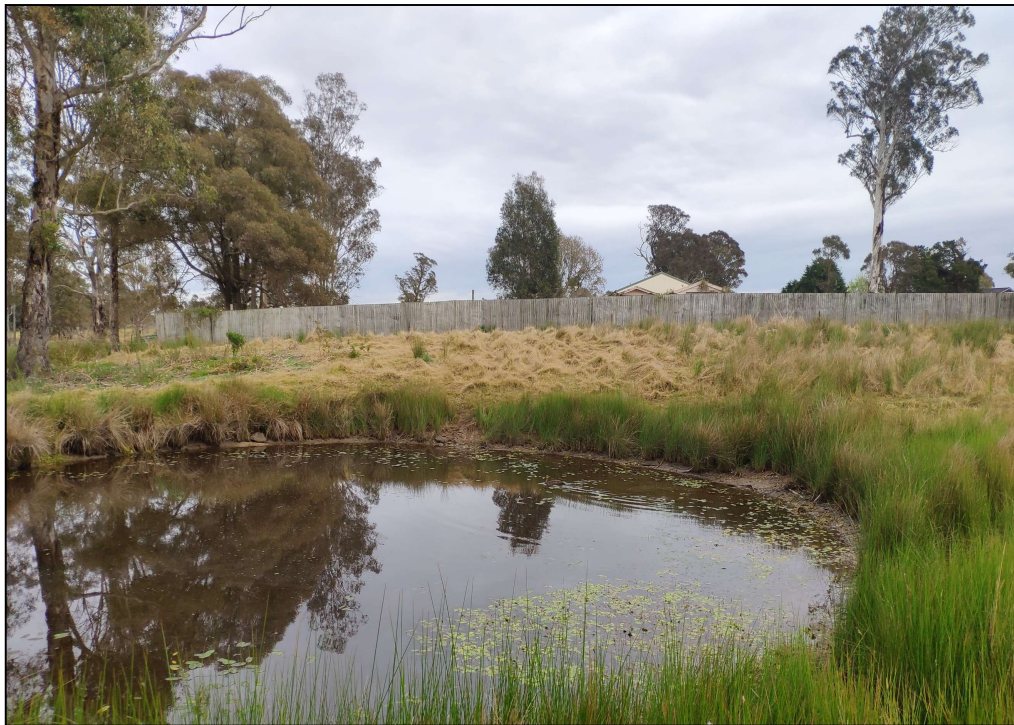
Photo 2: General view of the dam at 30 Berwick Park

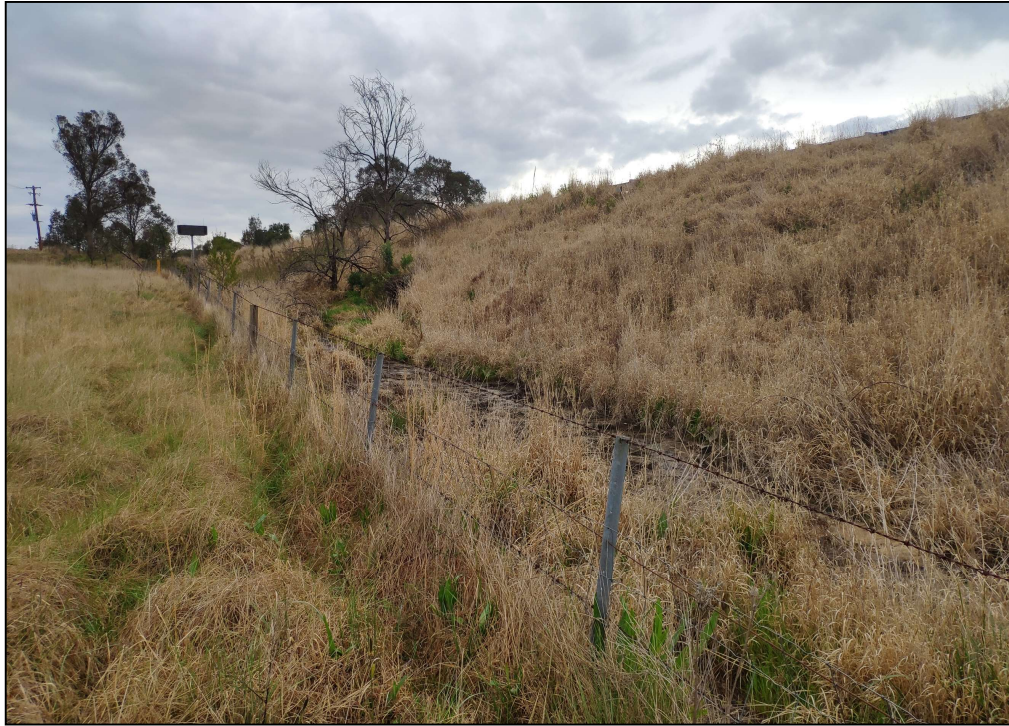
Photo 3: 30 Berwick Park - ground sloping upwards and towards existing Hume Motorway

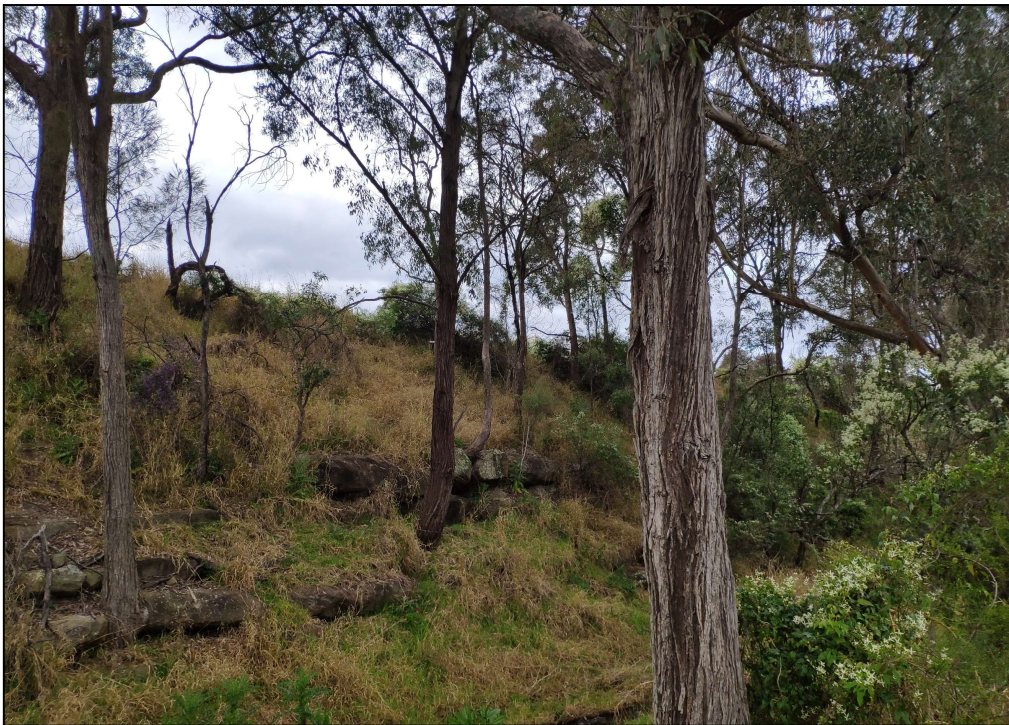
Photo 4: Manmade sandstone blocks embankment at the existing Hume Motorway

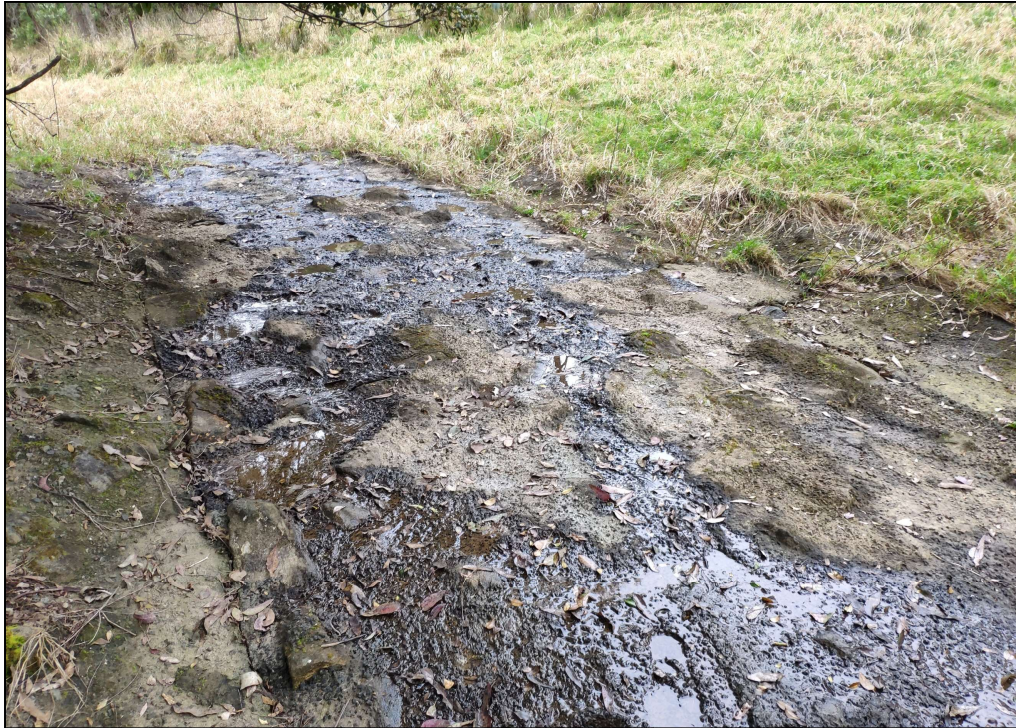
Photo 5: Sandstone outcrop at the waterway towards Nepean River at 30 Berwick Park

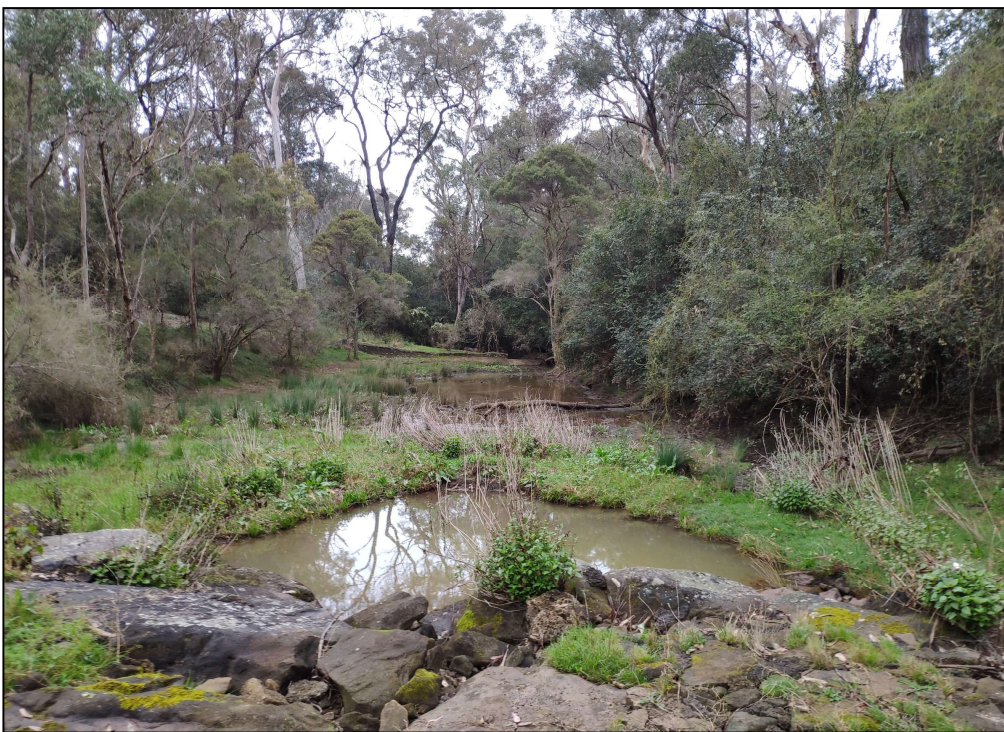
Photo 6: Pond and waterbodies towards the Nepean River at 30 Berwick Park

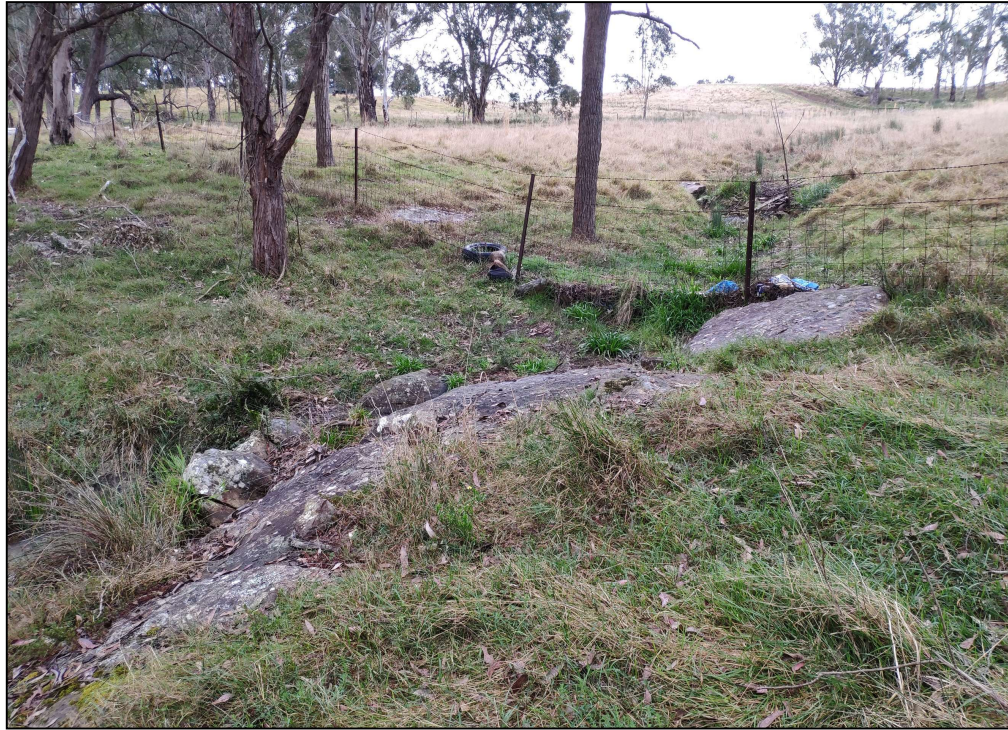
Photo 7: Sandstone outcrop and sloping ground upwards and towards the north at 30 Berwick Park

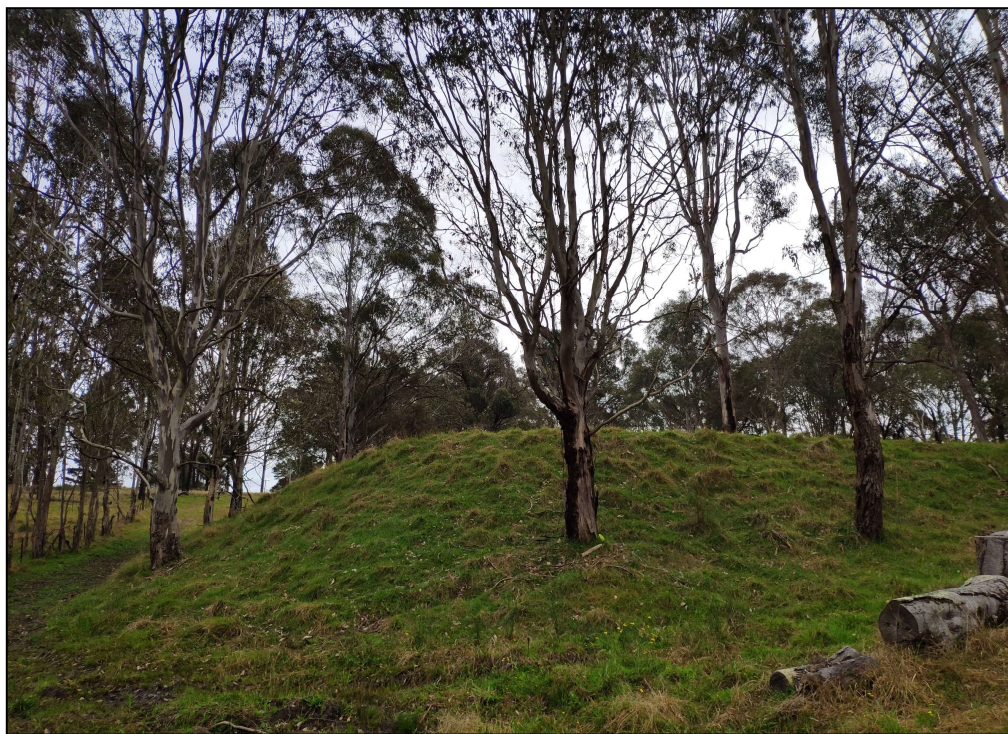
Photo 8: General view of the dam embankment at 10 Berwick Park

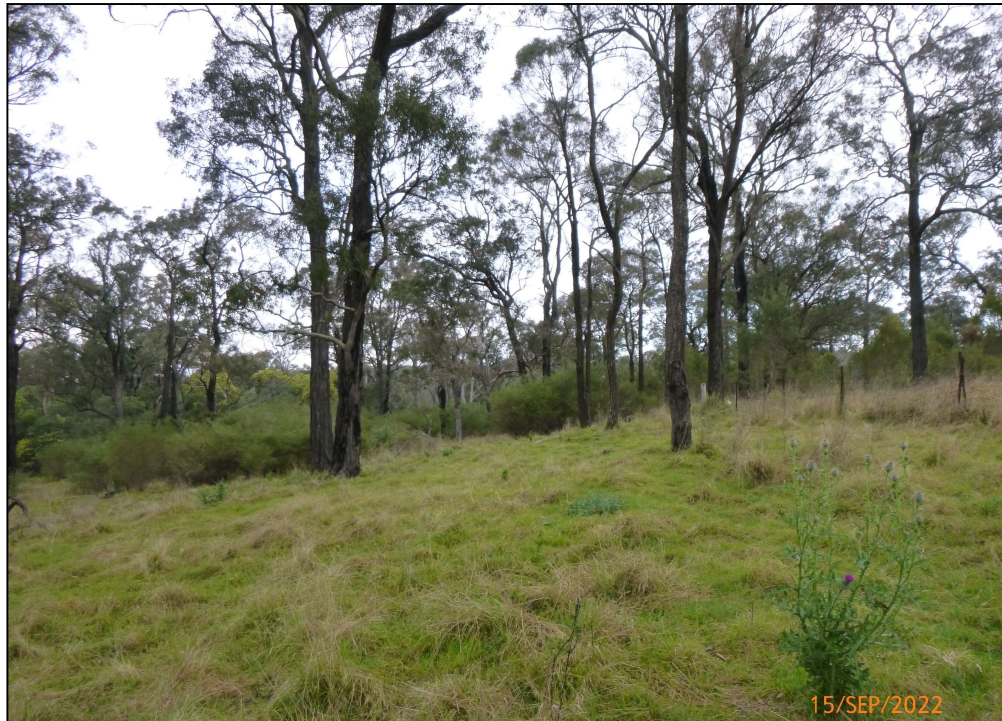
Photo 9: Thick vegetation close to the Nepean River at 10 Berwick Park

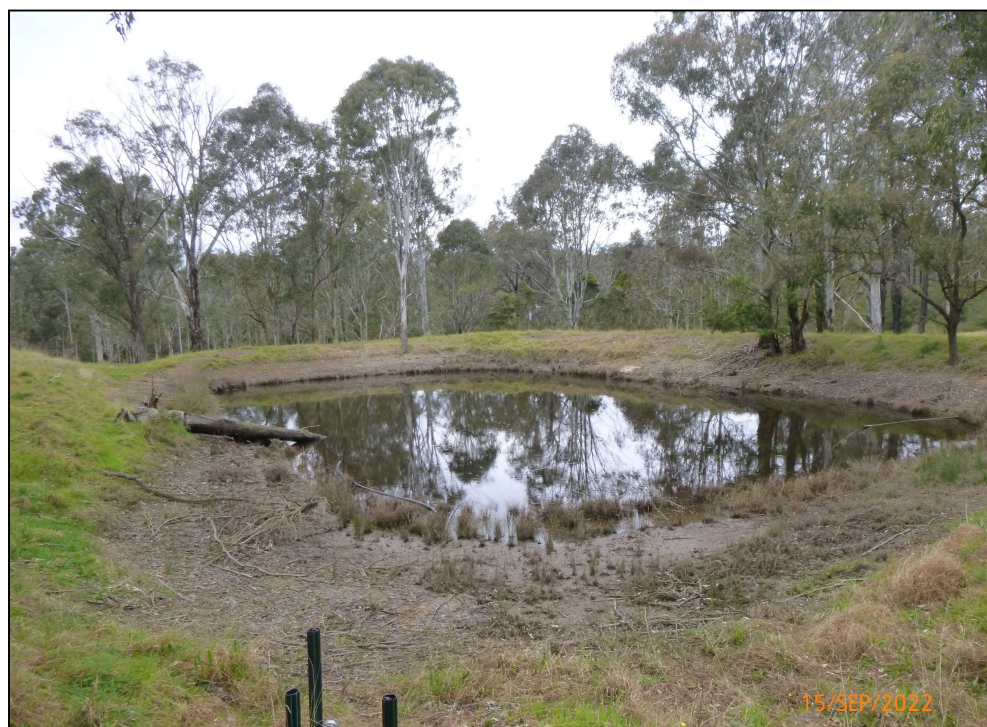
Photo 10: General view of the Dam at 10 Berwick Park

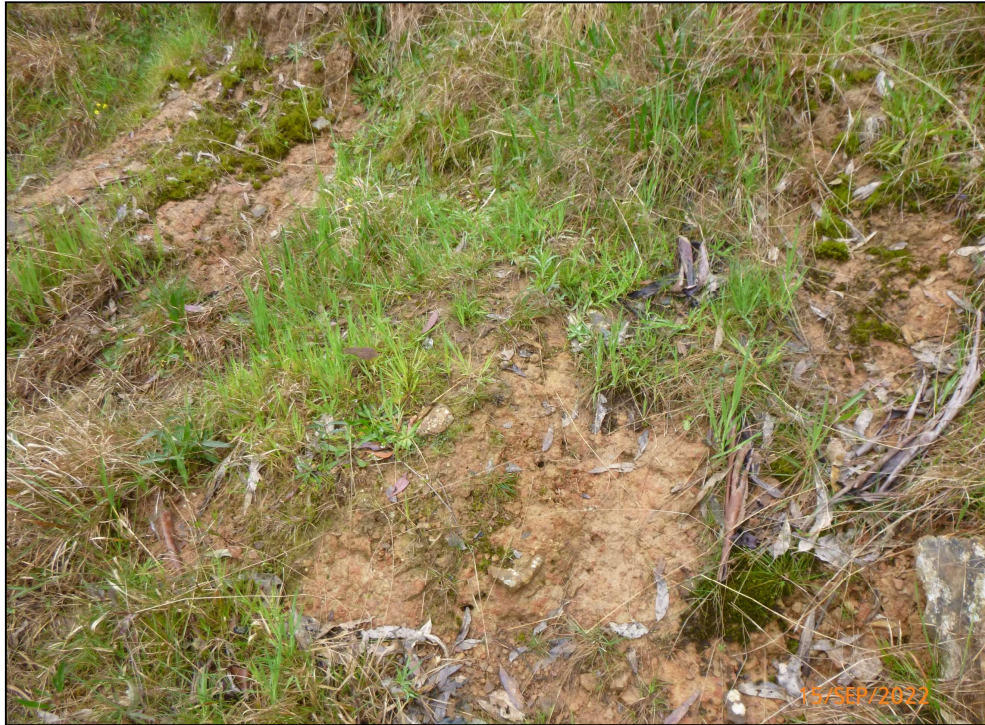
Photo 11: Lateritic soil near the Dam at 10 Berwick Park

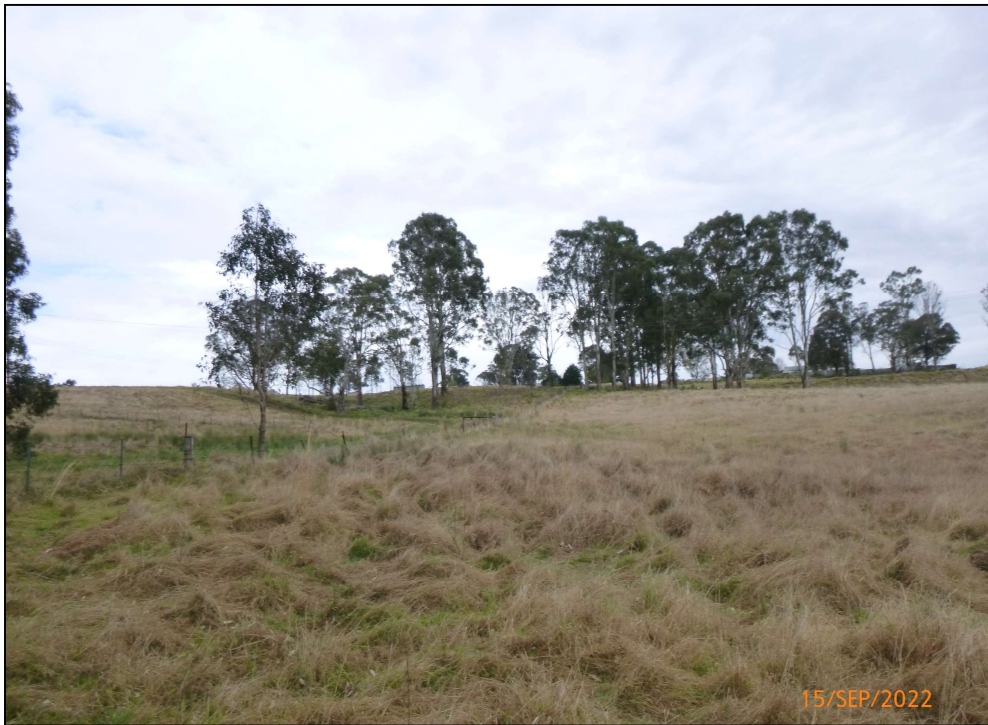
Photo 12: General view of the ground sloping upwards and towards north at 30 Berwick Park

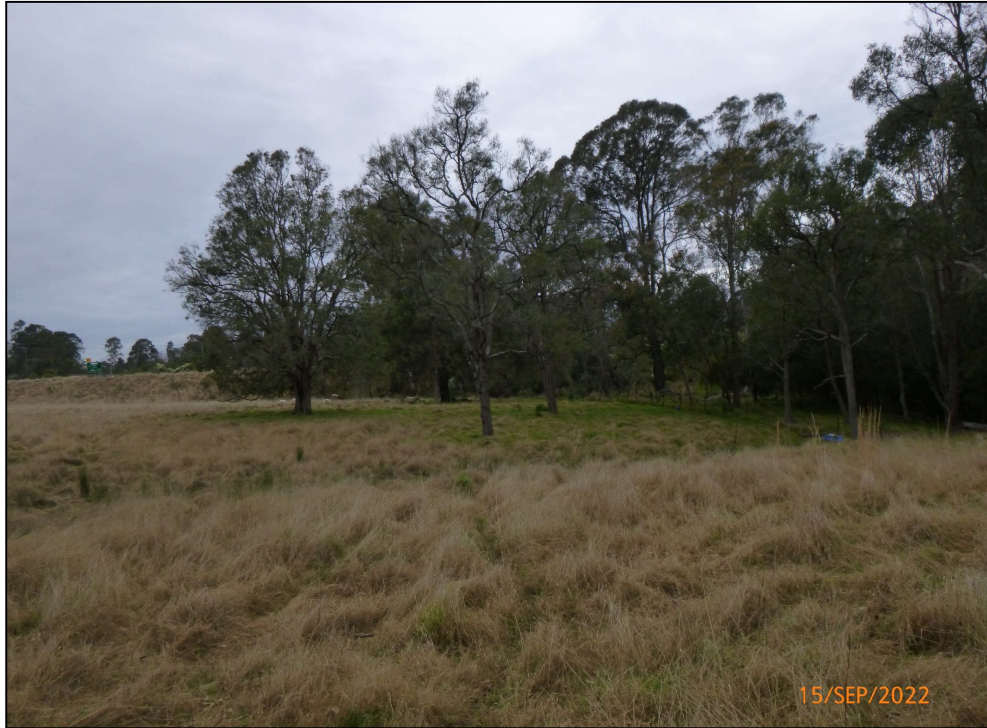
Photo 13: General view (looking East) of the ground sloping down towards Nepean River (on the right)

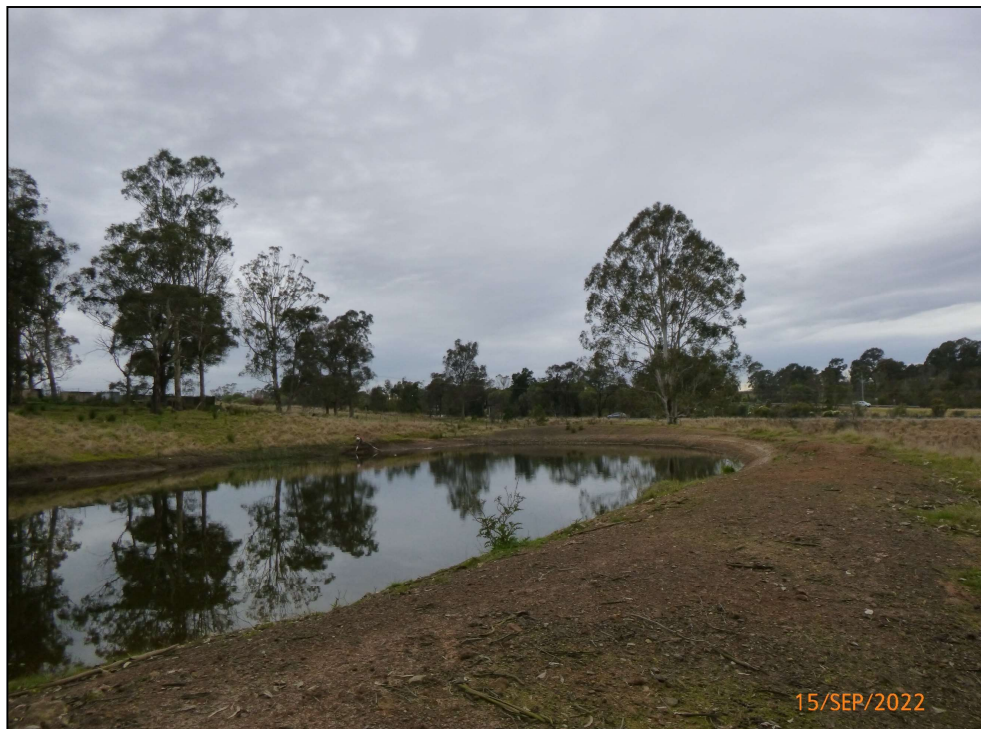
Photo 14: General view of the dam at 30 Berwick Park

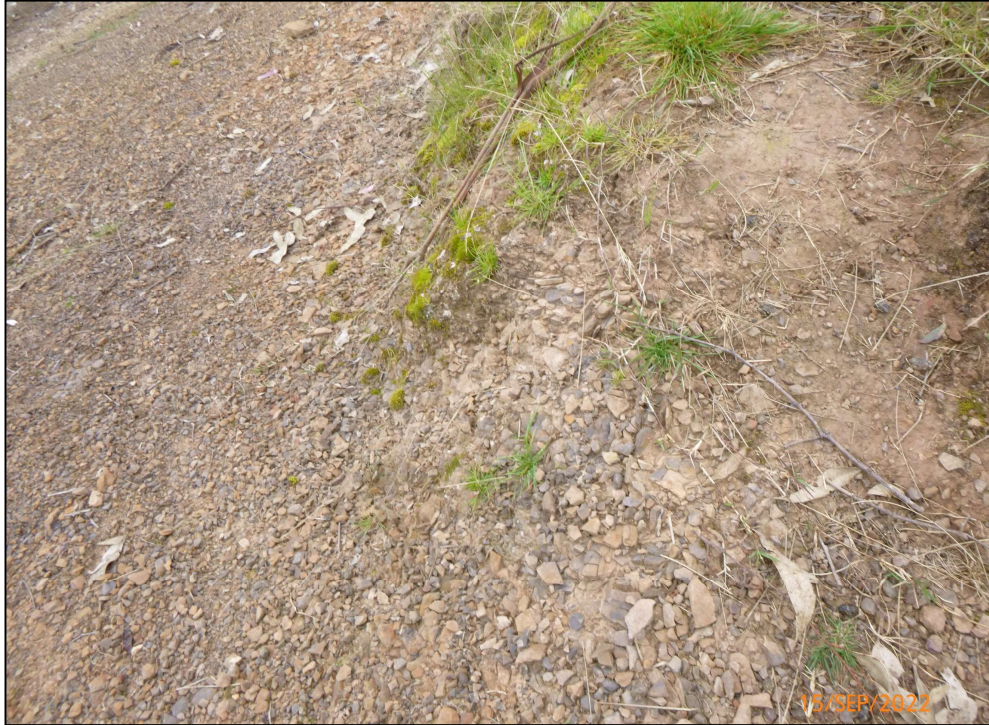
Photo 15: Shale outcrop around the dam at 30 Berwick Park

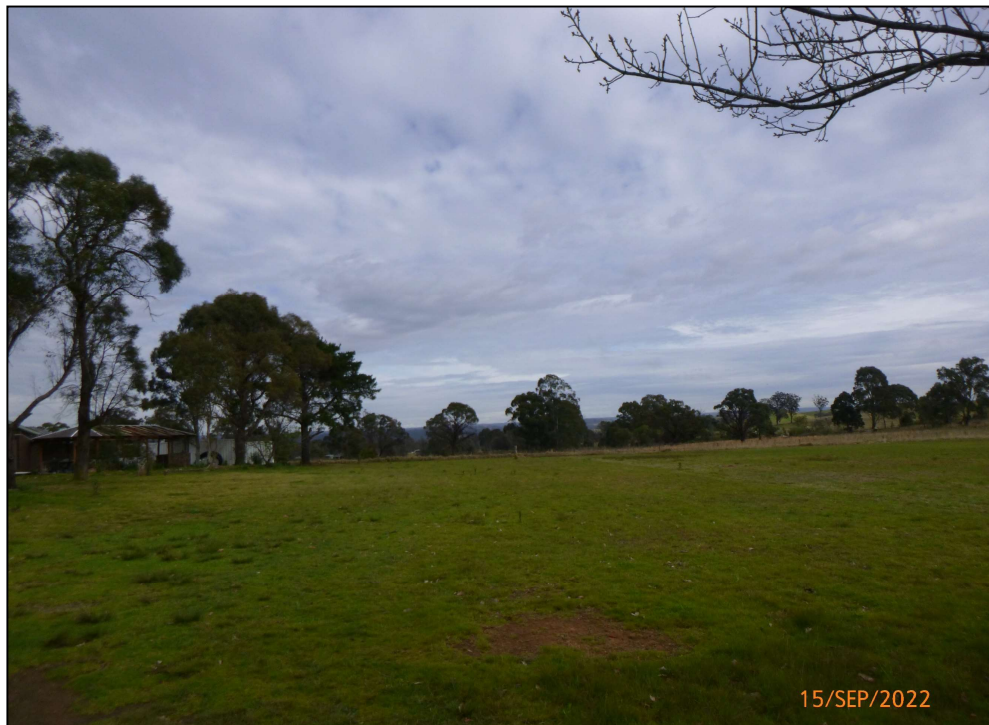
Photo 16: General view of the site at 20 Berwick Park - looking West

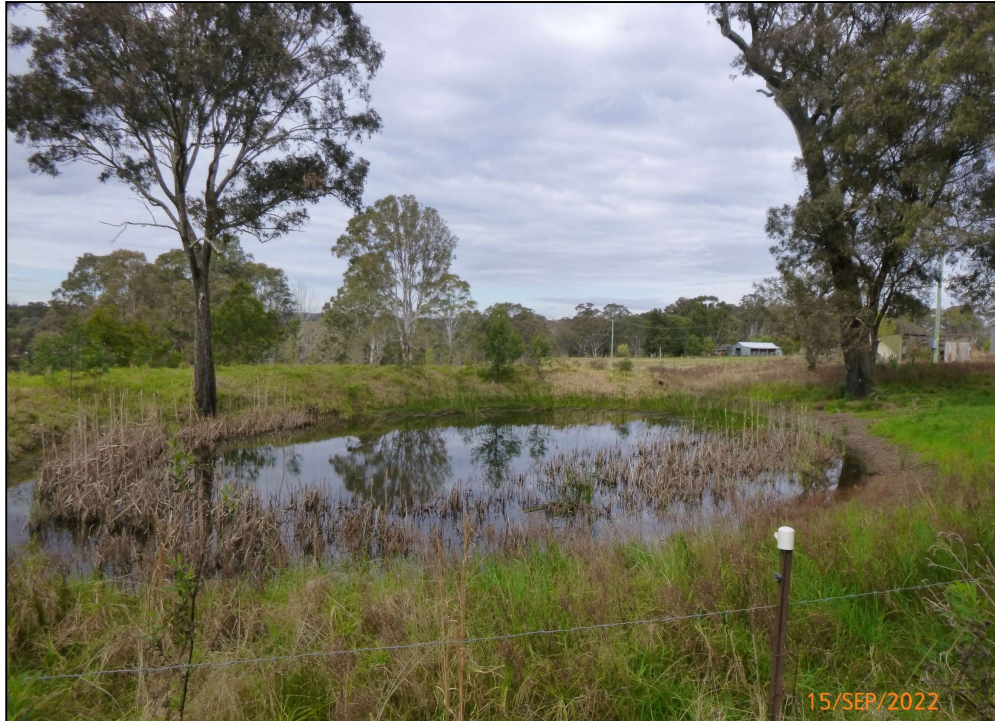
Photo 17: General view of the dam at 20 Berwick Park

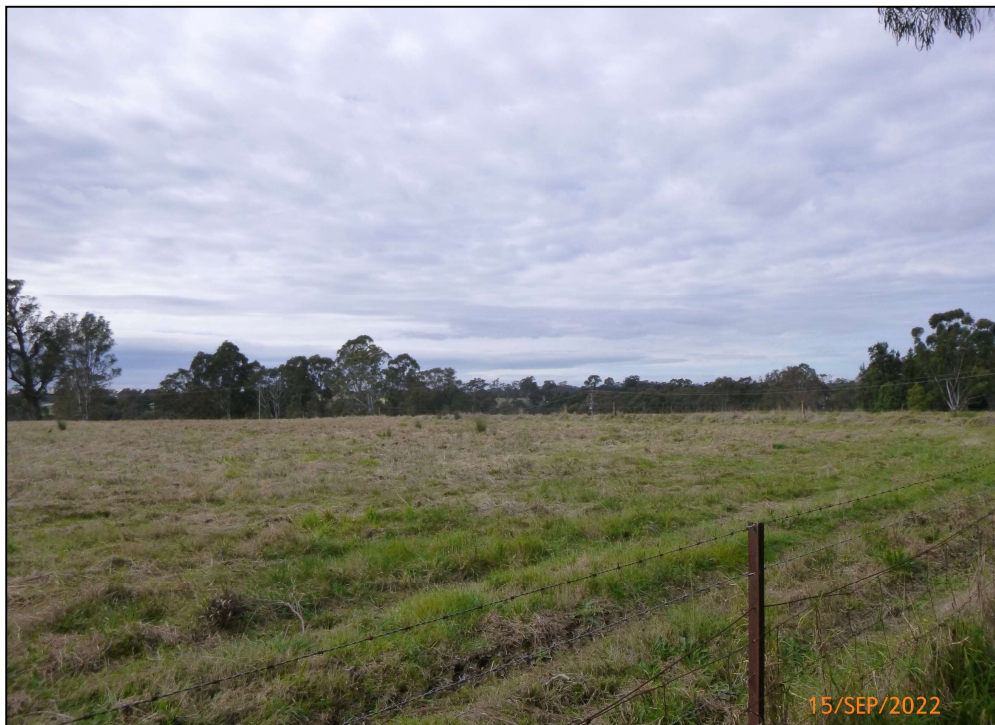
Photo 18: General view of the site at 10 Berwick Park - Looking South-East

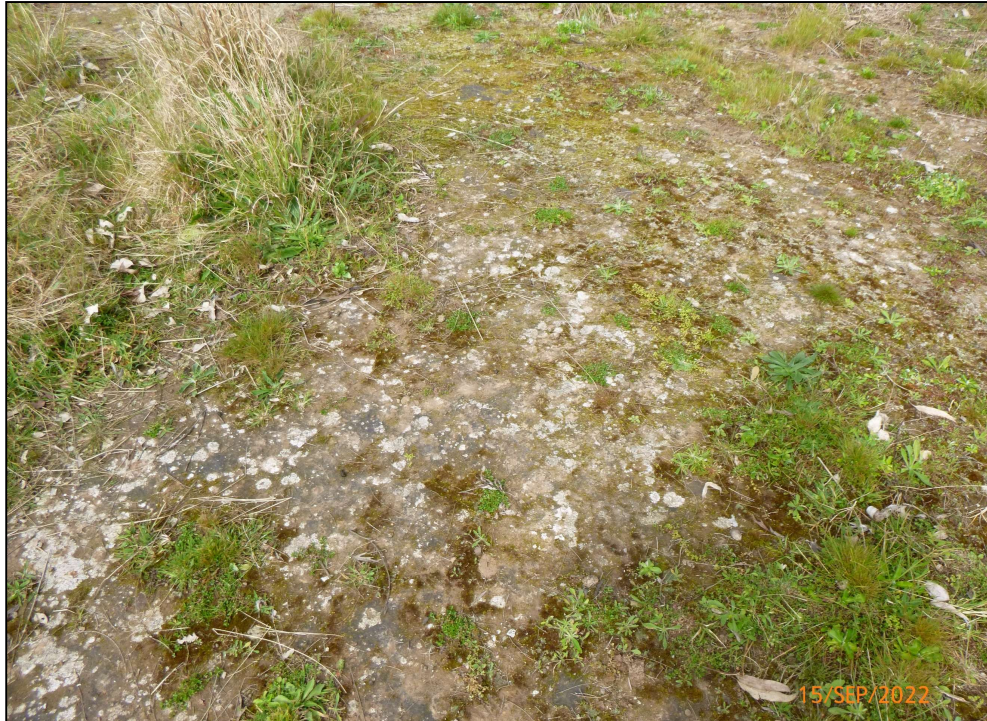
Photo 19: Sandstone outcrop at 10 Berwick Park

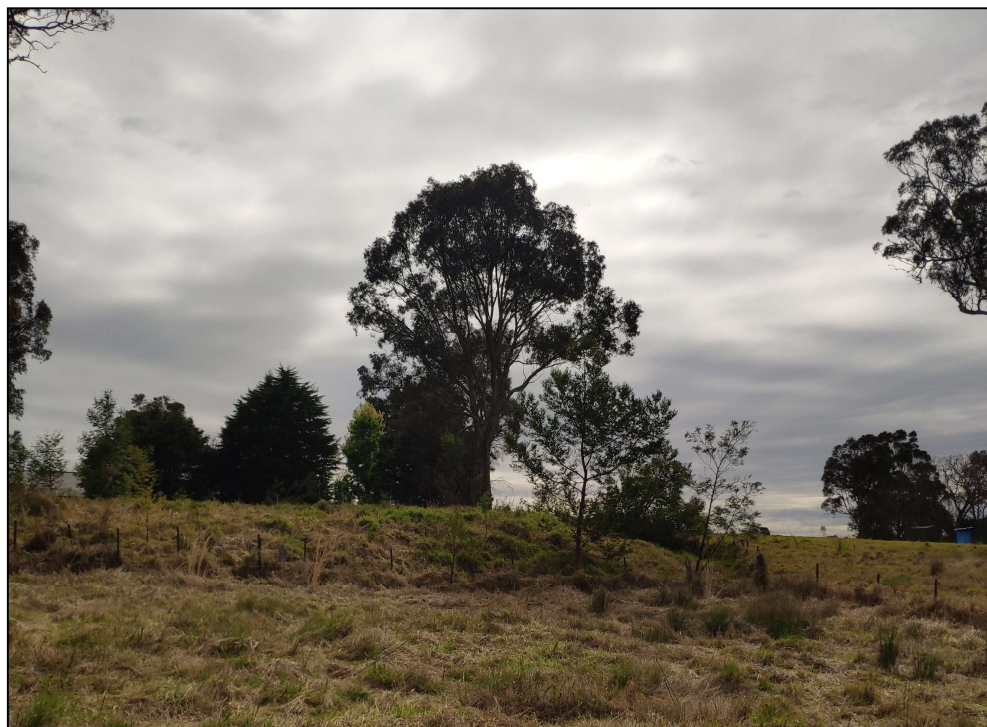
Photo 20: General view of the dam embankment at 20 Berwick Park

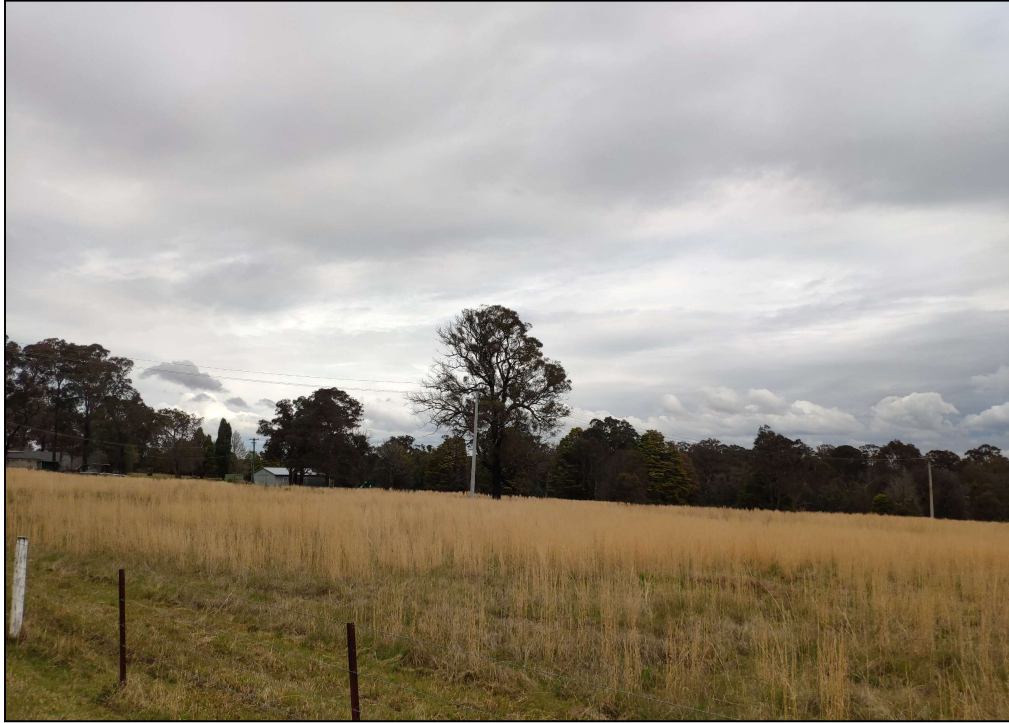
Photo 21: General view of 25 Wilton Park - Looking South-West

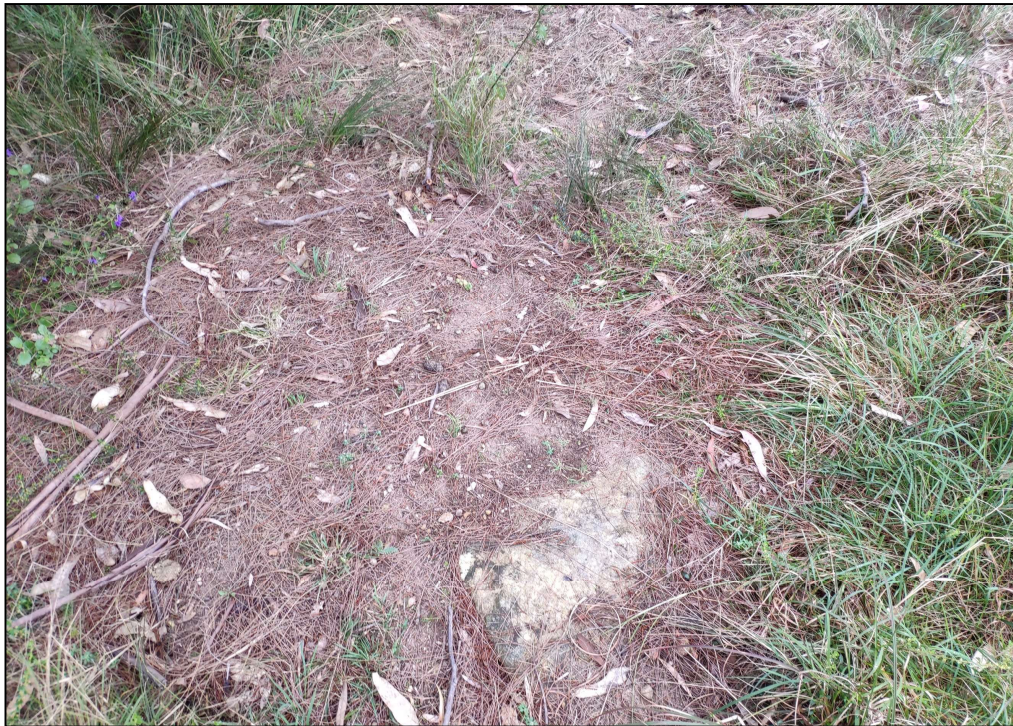
Photo 22: Sandstone outcrop at 25 Wilton Park, close to Nepean River

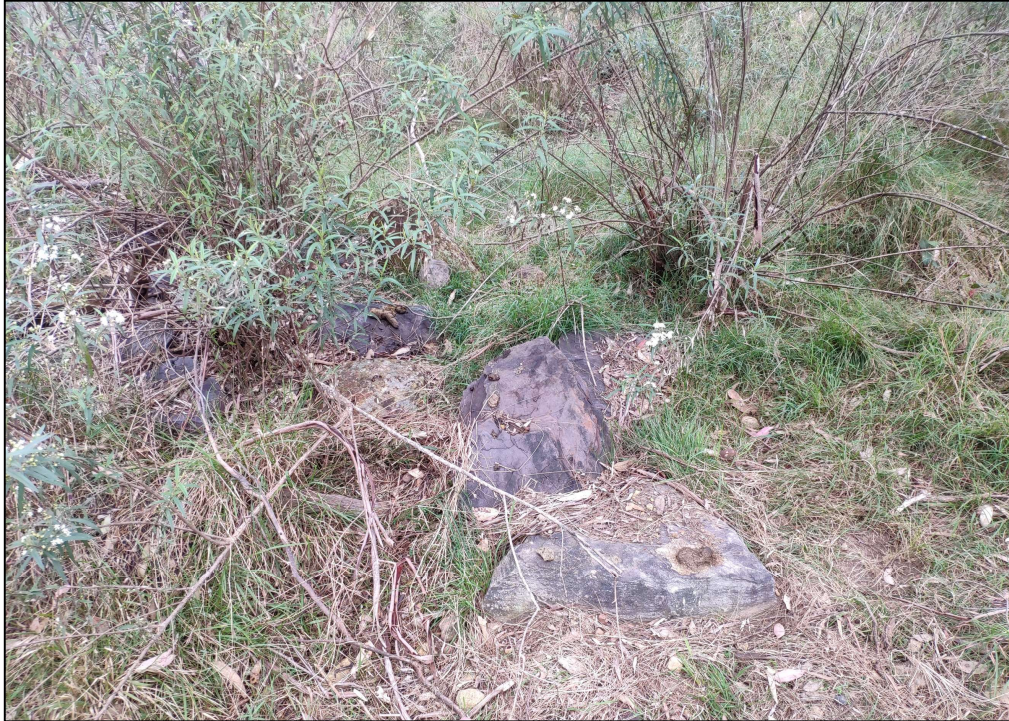
Photo 23: Shale boulder at 25 Wilton Park, close to Nepean River

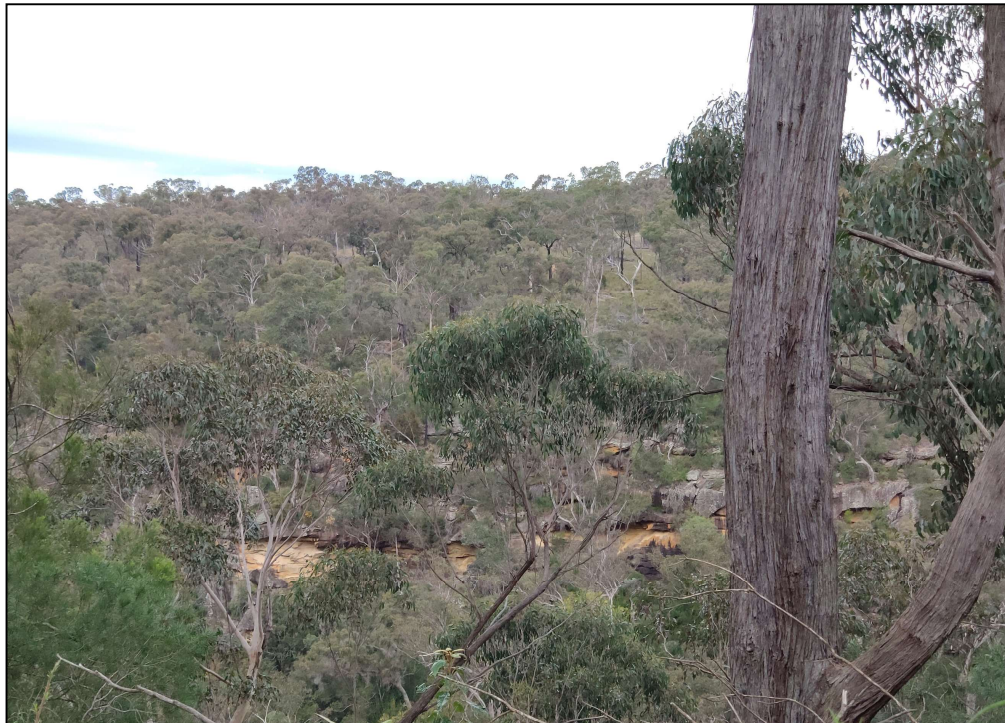
Photo 24: General view of the sandstone cliff across from 25 Wilton Park

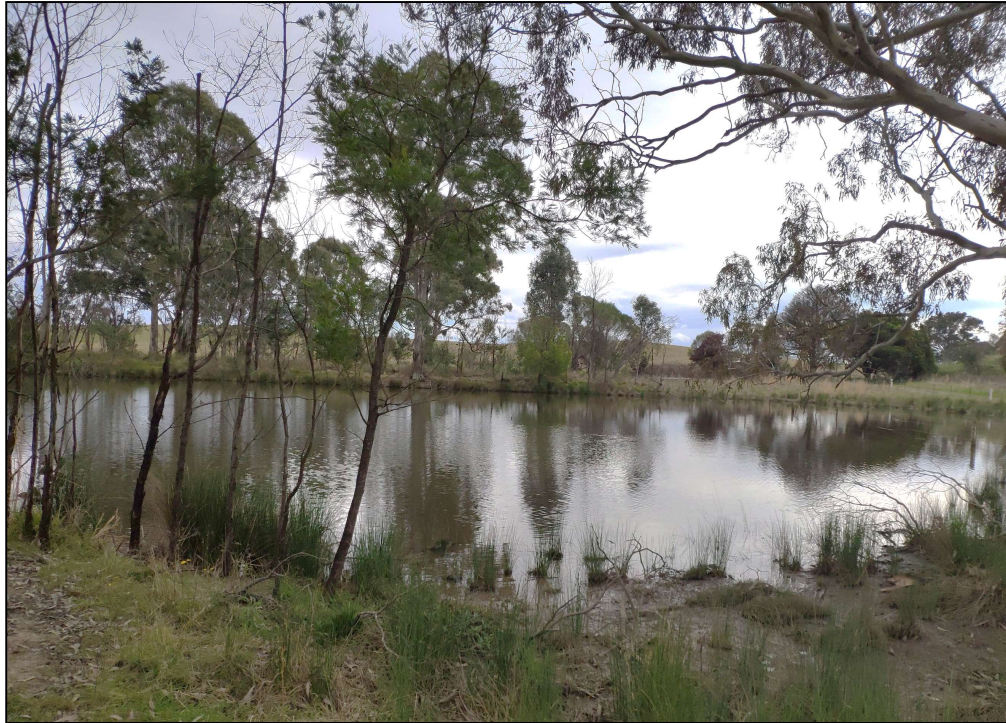
Photo 25: General view of the dam at 25 Wilton Park

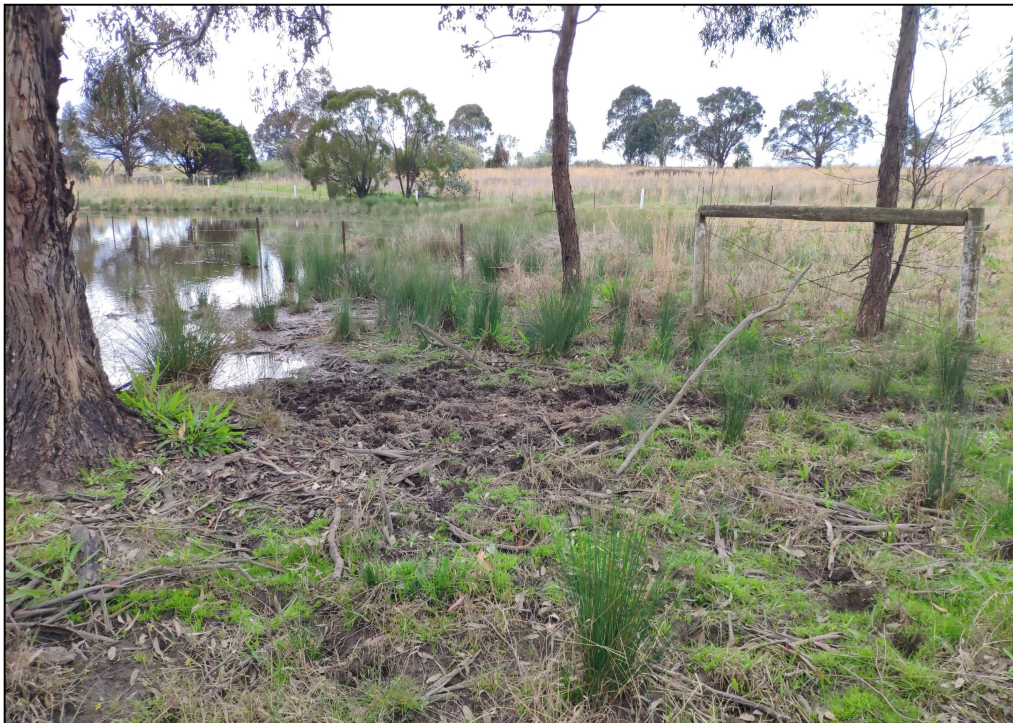
- Soft ground was observed in the vicinity of a number of dams
- Two prominent waterways/ water features were observed within the site; one at 45 Wilton Park Road and another at 30 and 10 Berwick Park Road
- Rock outcrops were observed across the site, in particular closer to the Nepean River and at the creek at 45 Wilton Park Road.

Photo 26: Soft ground near the dam at 25 Wilton Park

- Developments or earthworks on soft ground (i.e., in the vicinity of existing dams and waterbodies shall be designed to allow for predicted settlements within these areas. Else, alternative design (i.e., suspended structures) shall be considered.

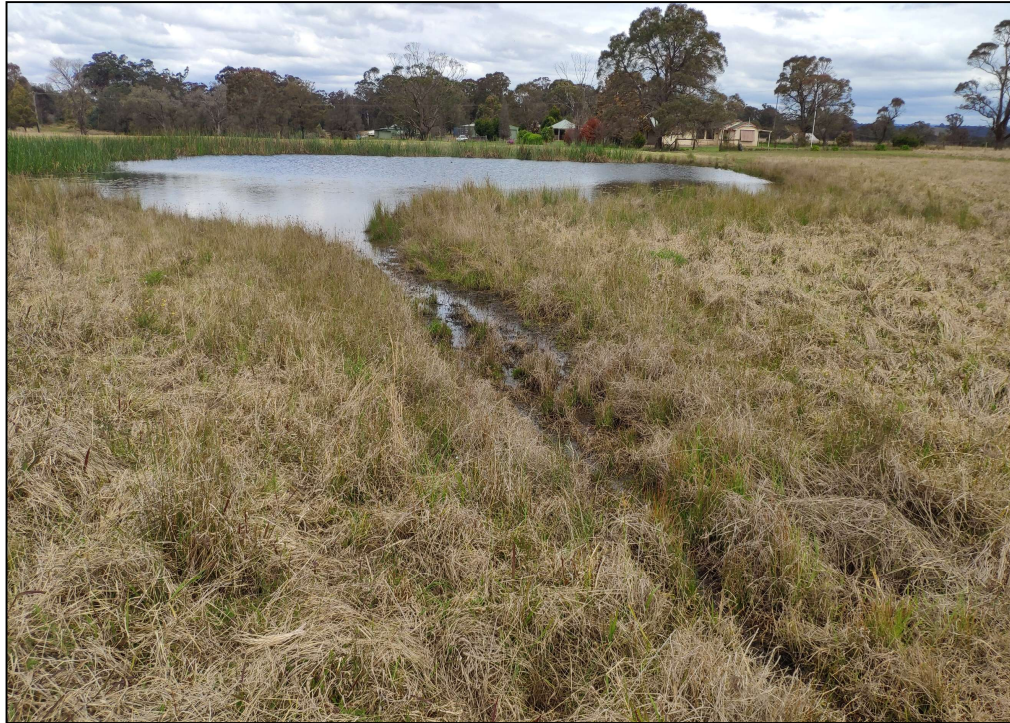
Photo 27: General view of the dam at 45 Wilton Par with a waterway flowing towards the dam

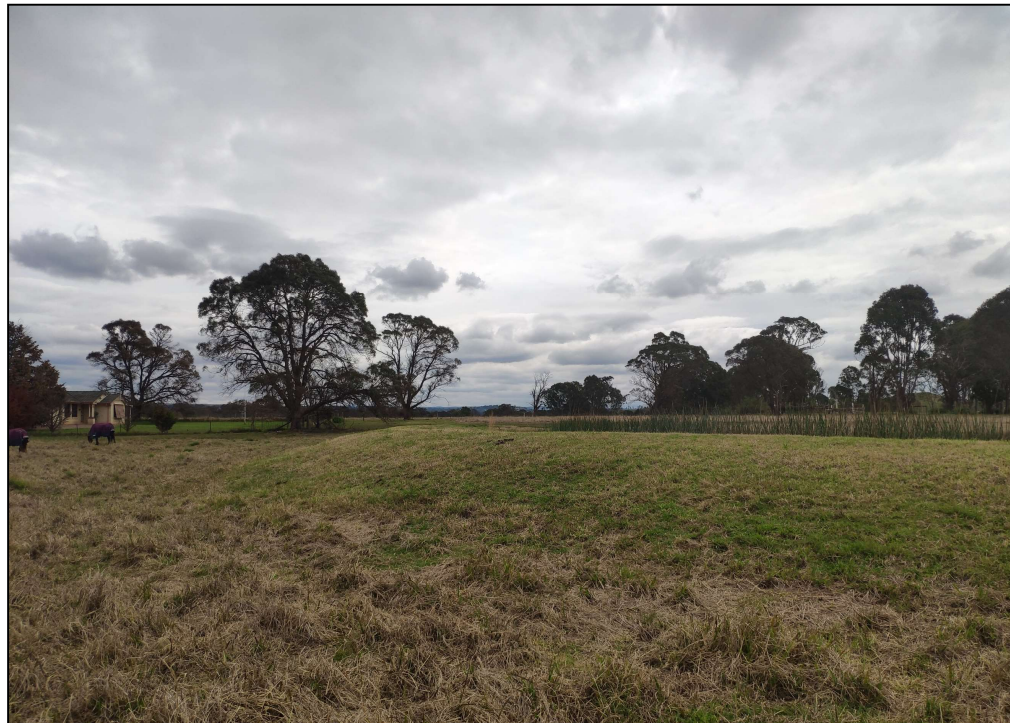
Photo 28: General view of the dam embankment at 45 Wilton Park

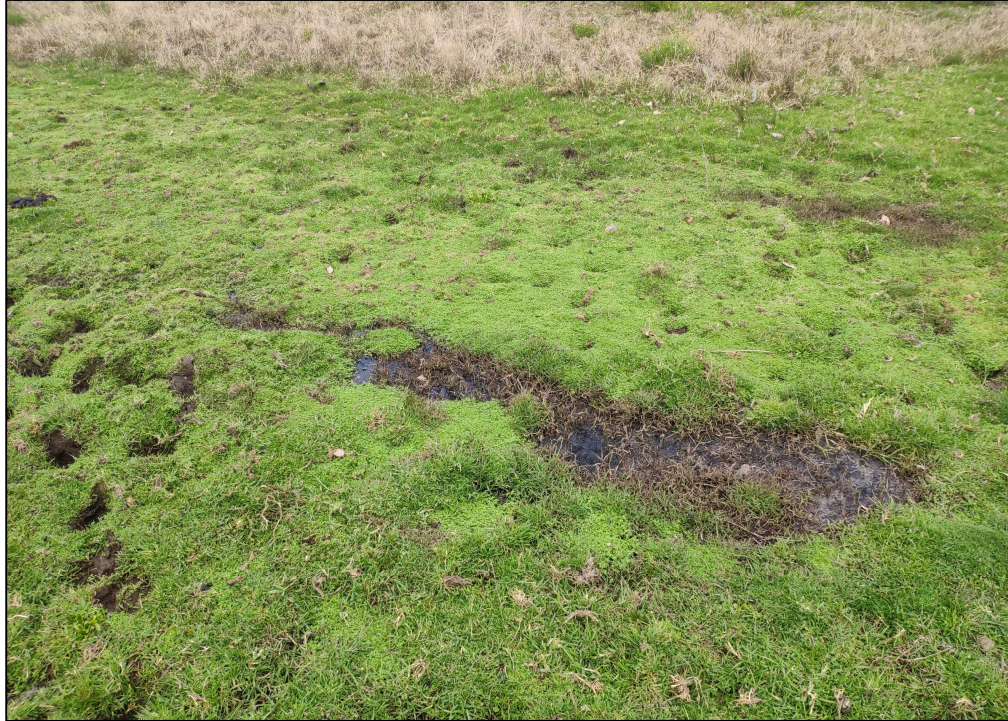
Photo 29: Saturated and soft ground around the waterways at 45 Wilton Park

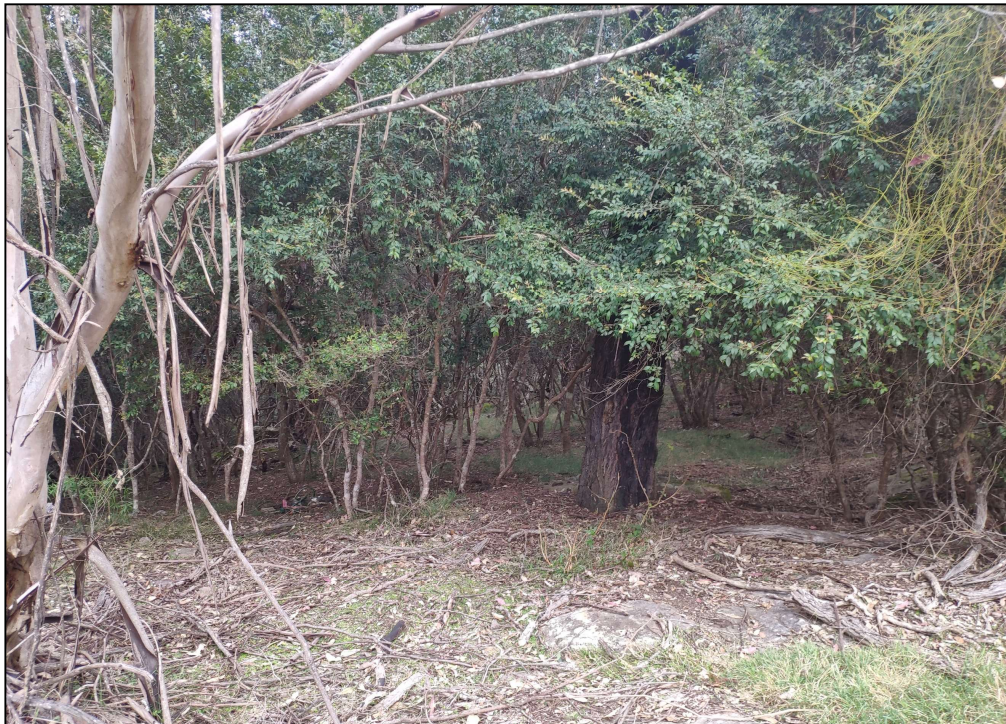
Photo 30: General view of the ground sloping downwards towards the creek at 45 Wilton Park

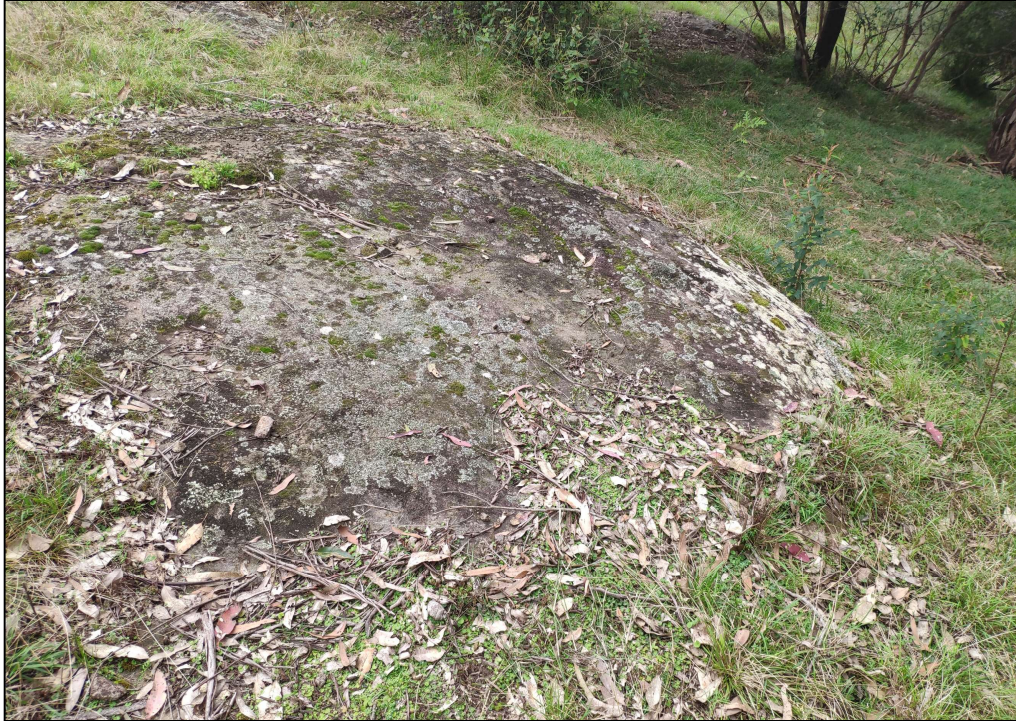
Photo 31: Sandstone outcrop near the creek at 45 Wilton Park
