Our Ref: PSM4854-004L Rev 1

**RE: WILTON PARK ROAD & BERWICK PARK ROAD -  
PLANNING PROPOSAL - REV 1**

**SELECTED SITE PHOTOGRAPHS**

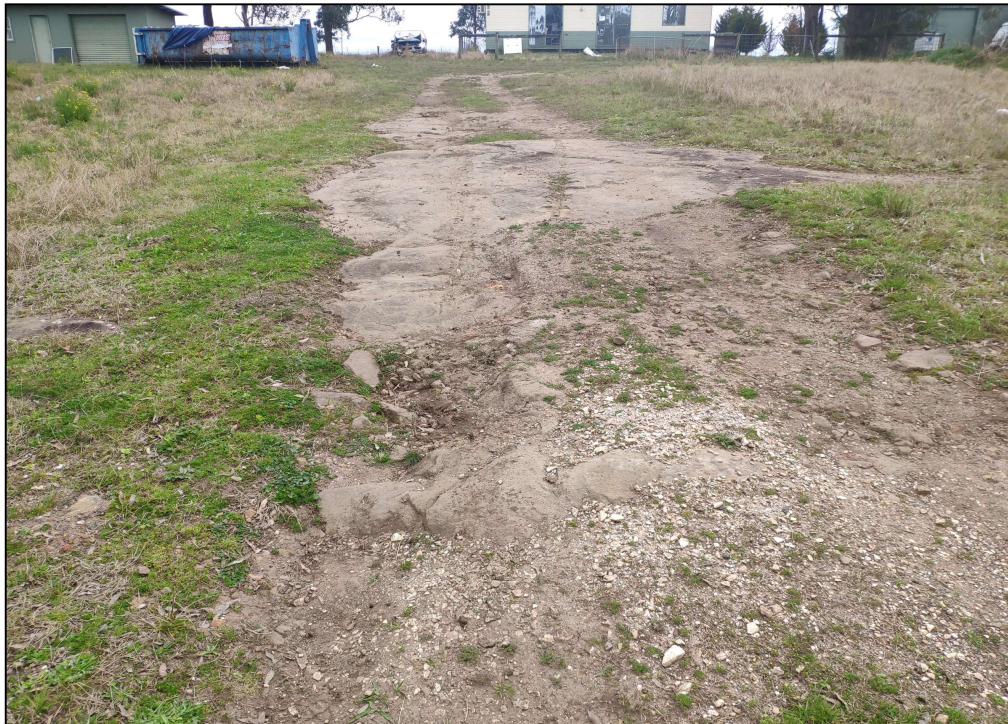
Photo 32: General view of the sandstone outcrop around 45 Wilton Park

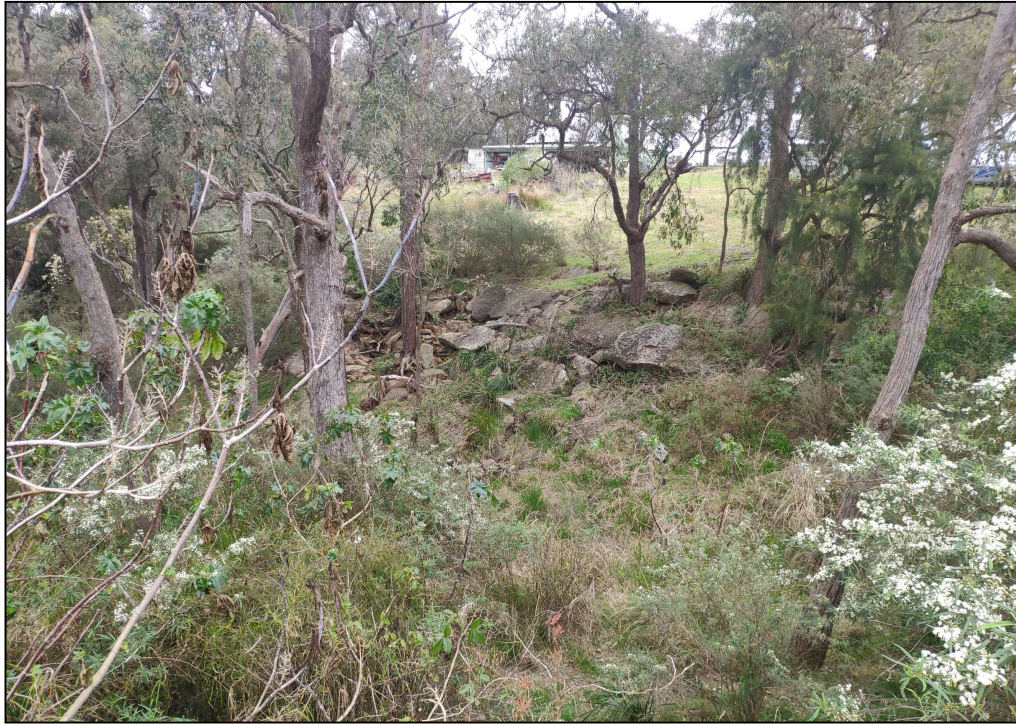
Photo 33: Steep slope with sandstone outcrop at the creek at 45 Wilton Park

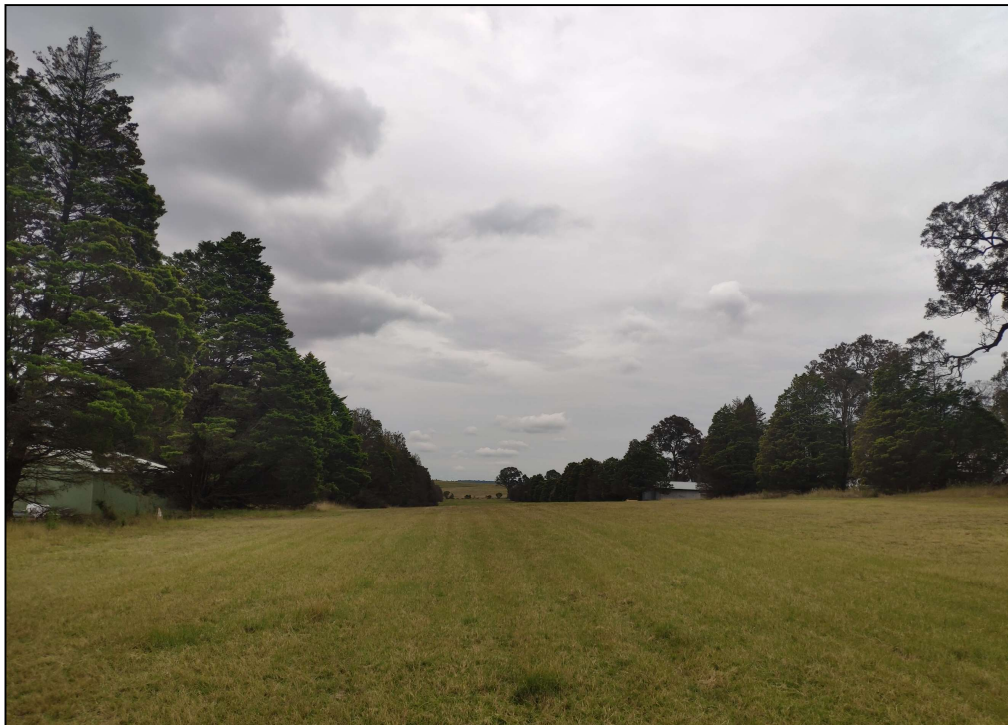
Photo 34: General view of the site at 45 Wilton Park - looking North

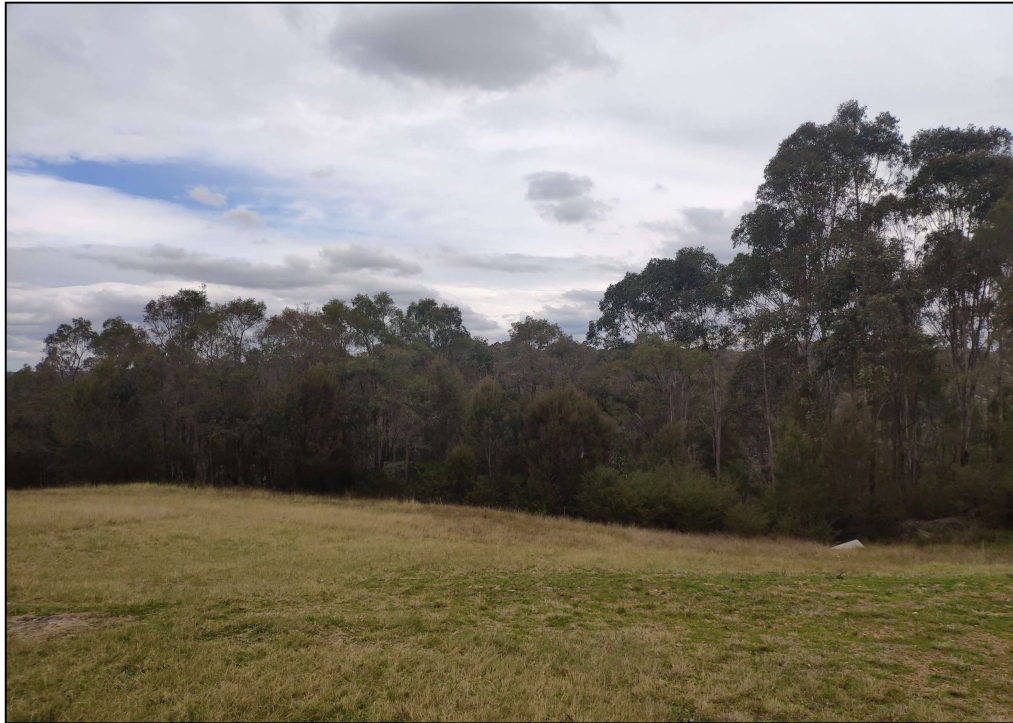
Photo 35: General view of the site at 45 Wilton Park looking south towards Nepean River

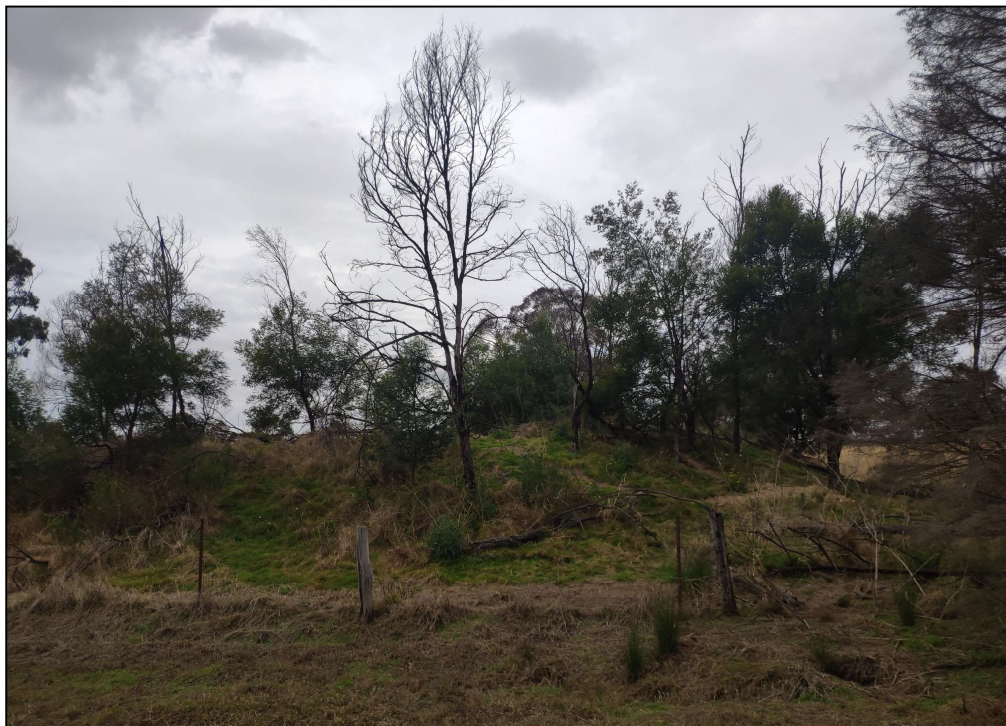
Photo 36: General view of the dam embankment at 25 Wilton Park

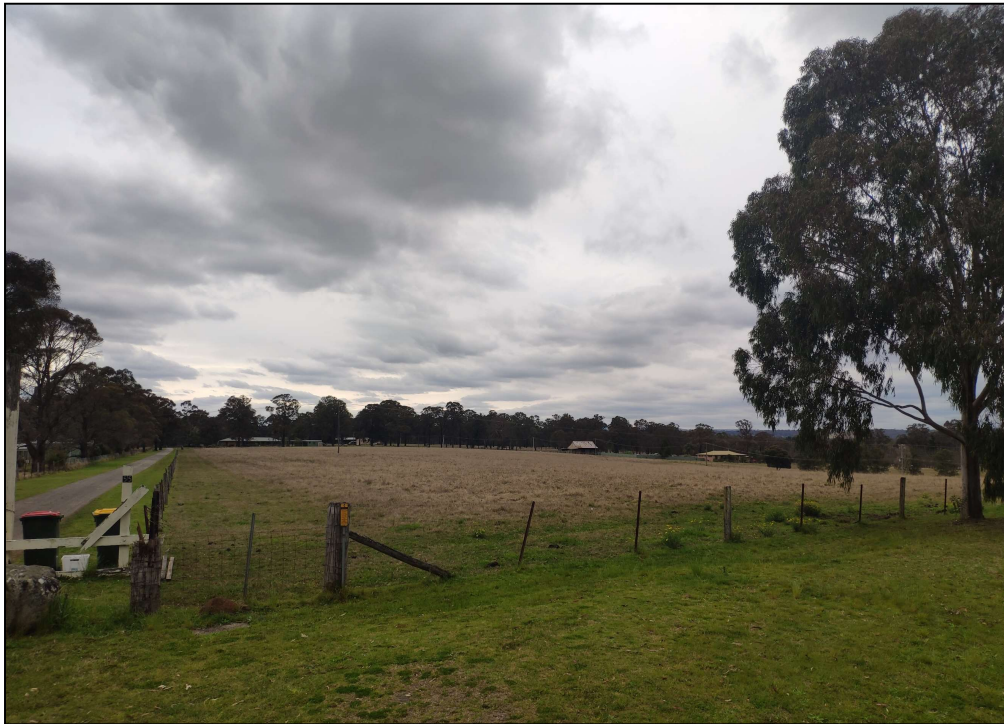
Photo 37: General view of the site at 55 Wilton Park, looking south

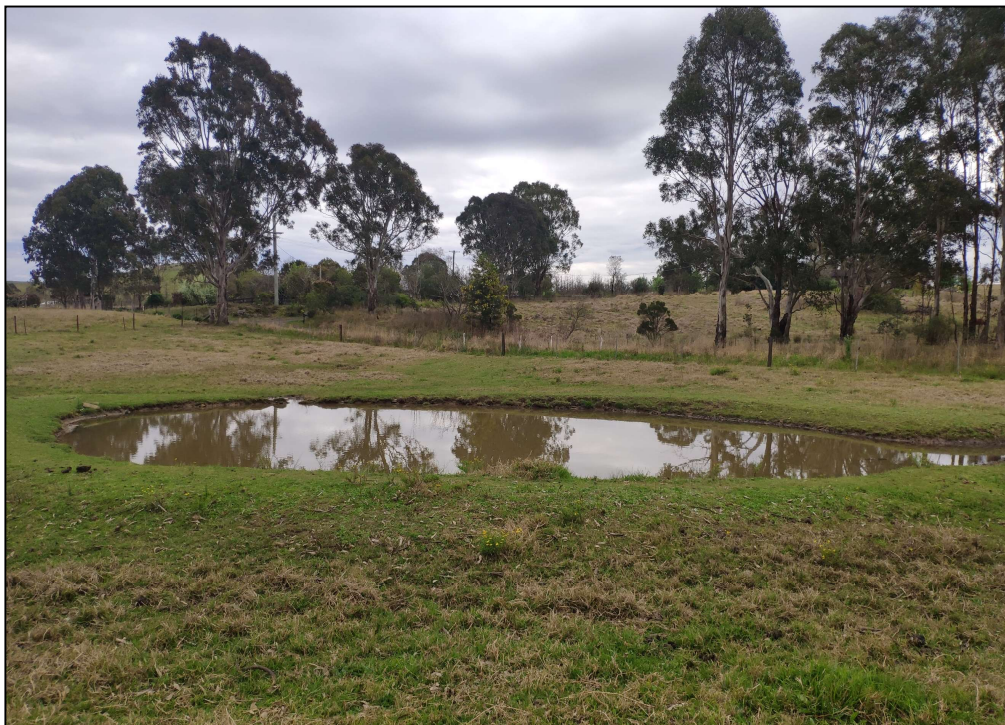
Photo 38: General view of the dam at 75 Wilton Park, near Wilton Park Road

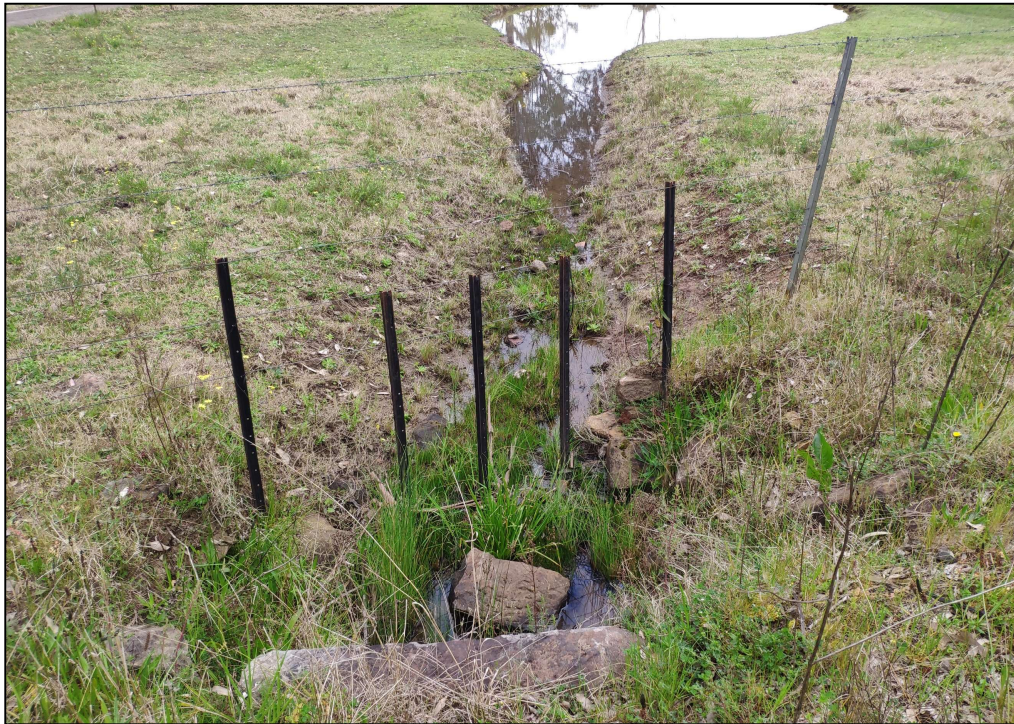
Photo 39: Waterway feeding into the dam at 75 Wilton Park

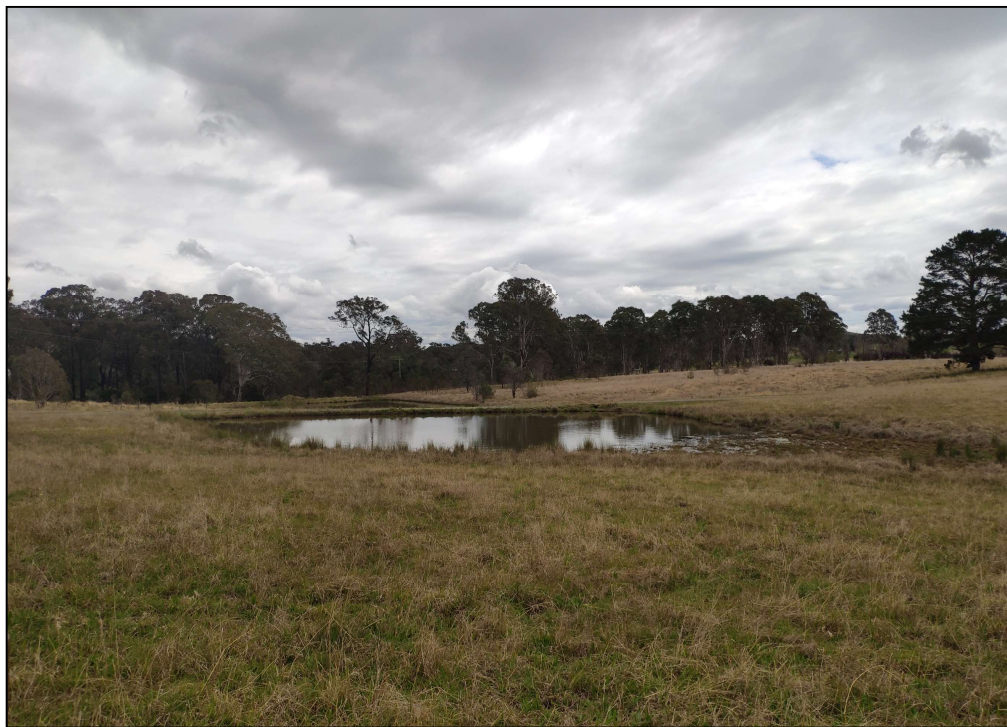
Photo 40: The dam at 85 Wilton Park, viewed from 75 Wilton Park

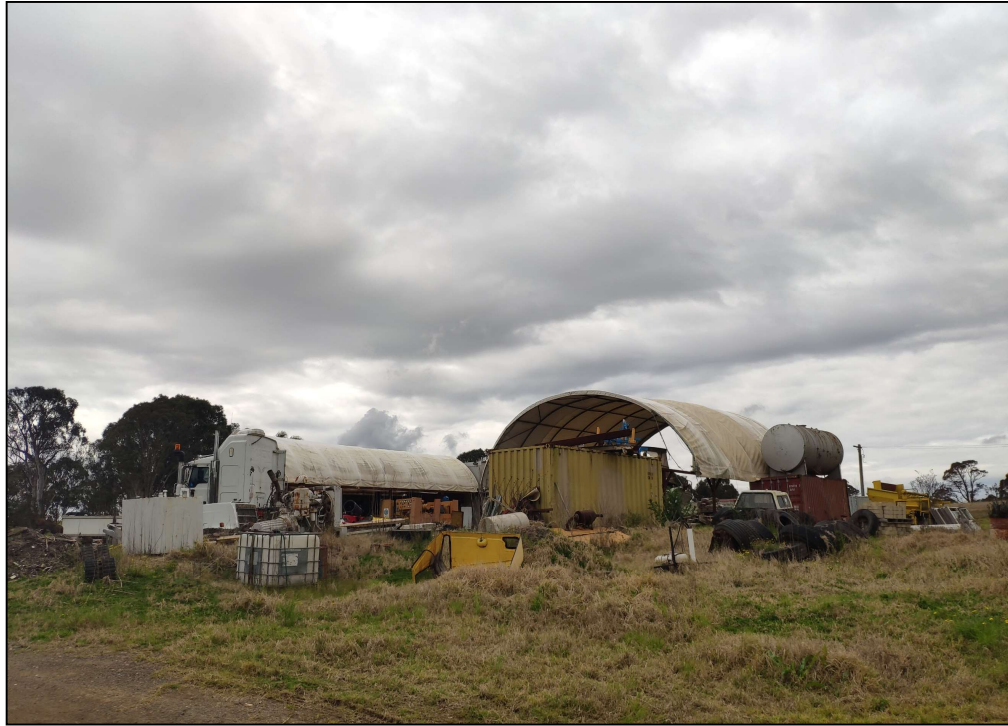
Photo 41: General view of the site at 75 Wilton Park. Stockpile of materials observed

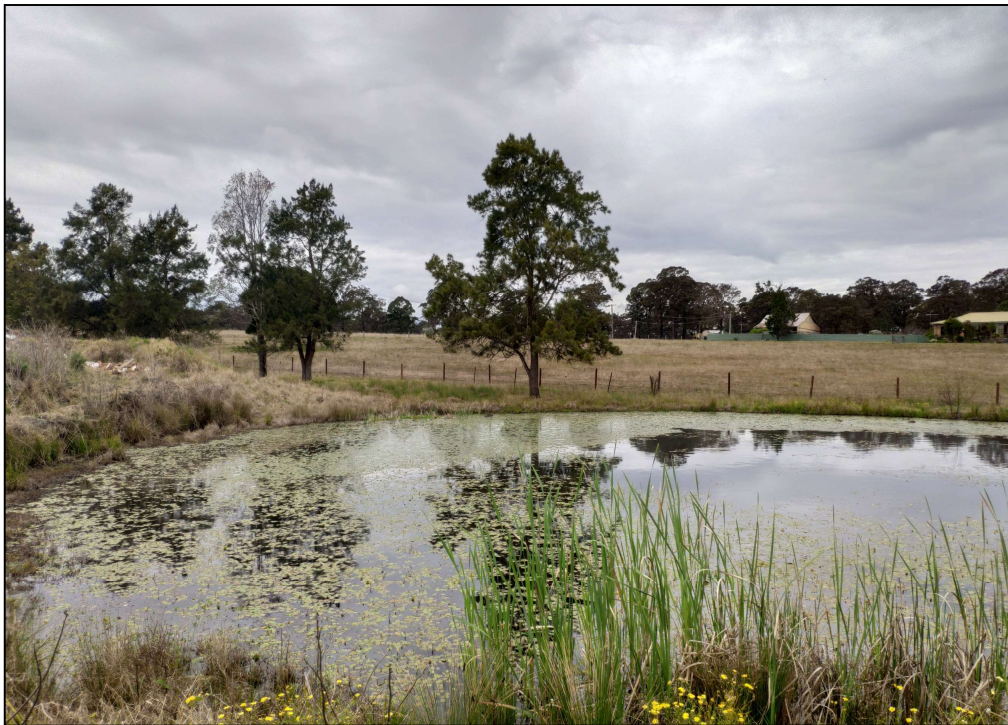
Photo 42: General view of the dam at 75 Wilton Park towards the back of the lot

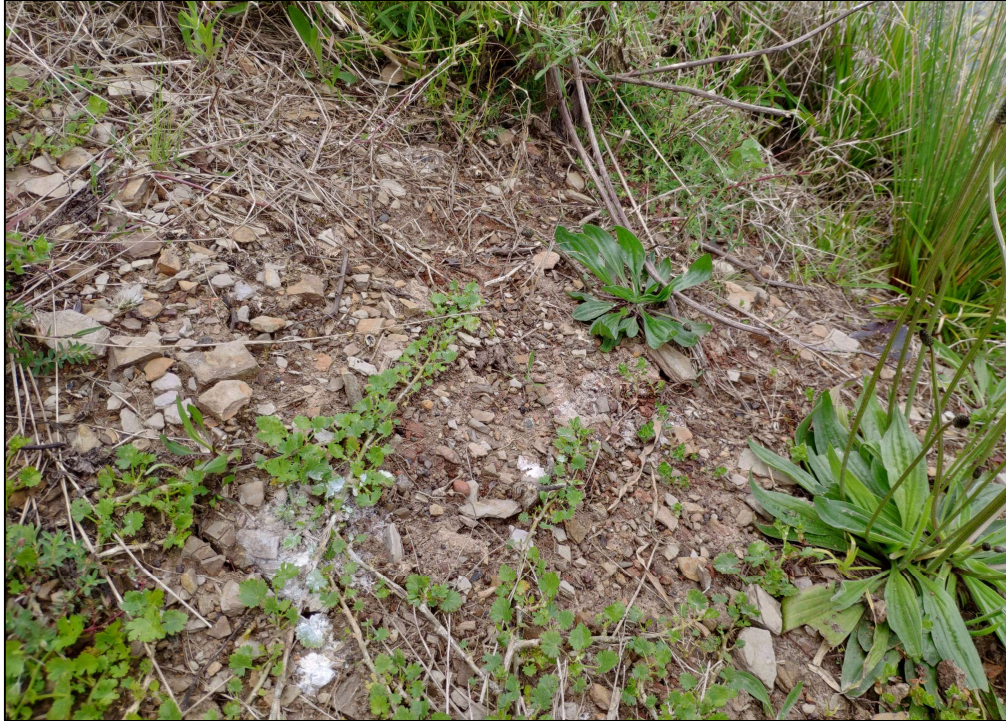
Photo 43: Shale fill at the dam embankment at 75 Wilton Park

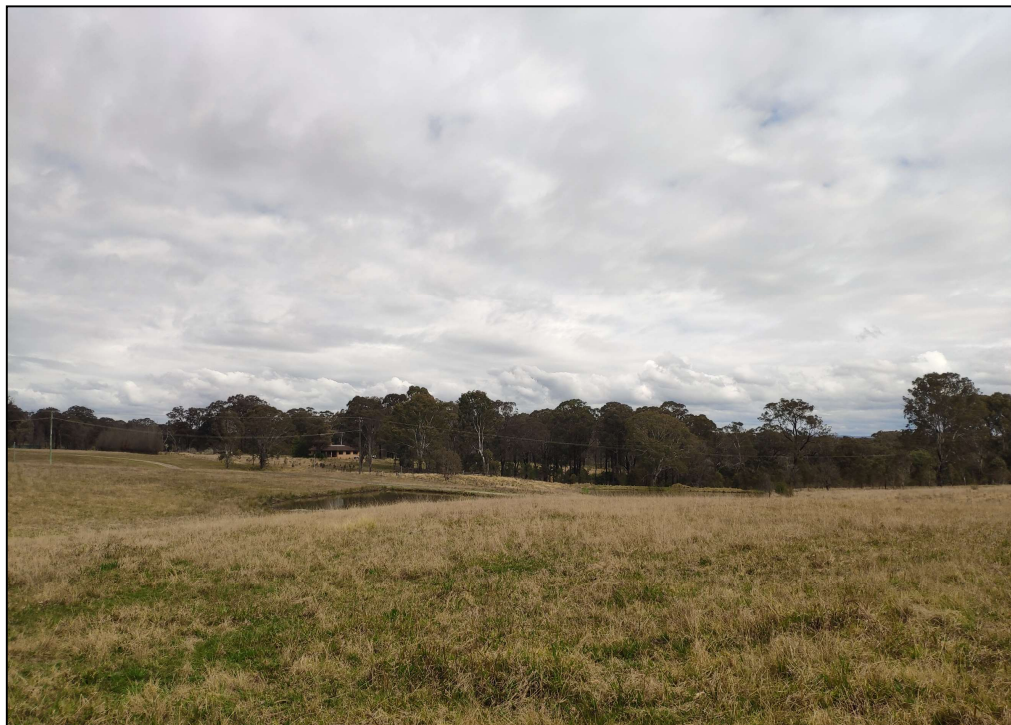
Photo 44: General view of the site at 85 Wilton Park

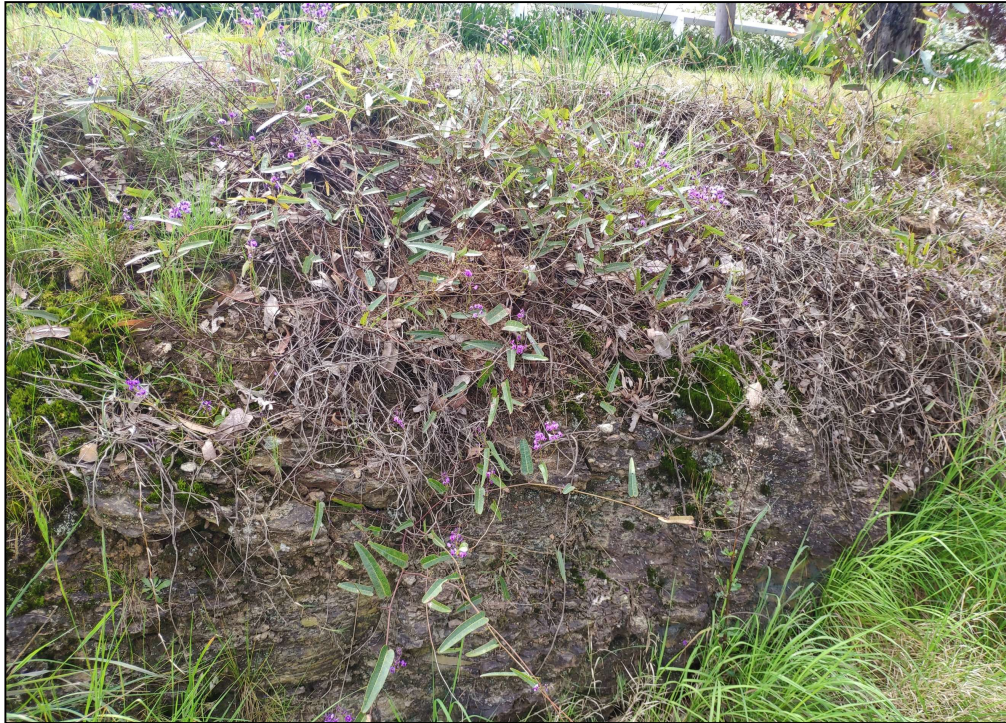
Photo 45: Shale outcrop close to 95 Wilton Park

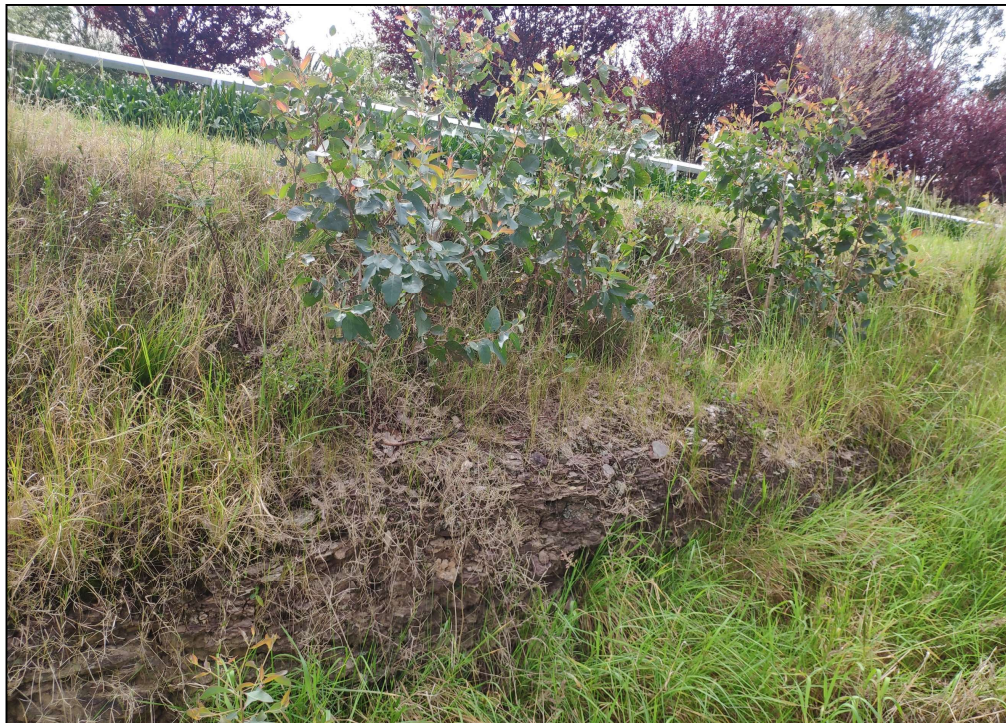
Shale outcrop close to 95 Wilton Park
