## Peer Review

Document number: H-1019

Review of Comprehensive Heritage Study Proposed

Cumberland Heritage List

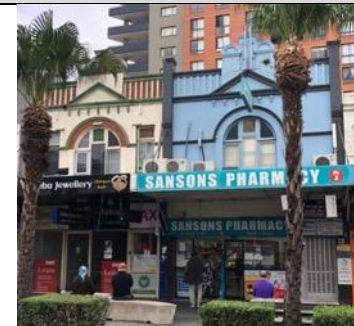
Item	Name	Address	Listing	Comments	Recommendations	Photographic Evidence
HS4	Federation Shopfronts	23 and 25 Auburn Road	Local	<p>The proposed heritage item is located within the proposed South Parade Conservation Area.</p> <p>The Federation Shopfronts are intact, representative example of Federation Free Style commercial buildings that stand out due to their prominent, detailed design to the upper level, despite the alterations to the ground floor.</p> <p>Condition: Fair</p> <p>Integrity: Moderate</p>	<p>The exterior of the Federation Building <b>should be considered for a group listing</b>. While the item is within the proposed HCA, it is a differentiation in architectural form and styling to the other shopfronts along Auburn Road, and has a historical significance that differs to the remainder of the HCA.</p>

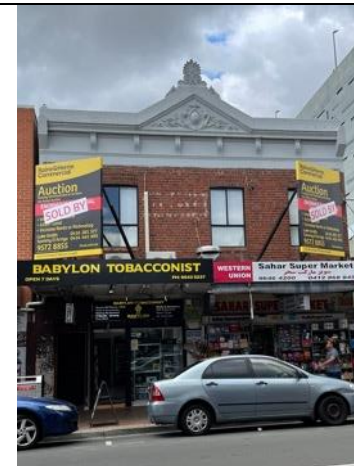
<p>HS5</p>

<p>HS141_Auburn Road_23-25</p>
HS5	Late Victorian Shopfront	60-62 Auburn Road	Local	<p>The heritage inventory sheet notes that 60-62 Auburn Road are recommended for listing and 64 Auburn Road is not recommended.</p> <p>The ground floor of 60-62 Auburn Road has been considerably altered for use as contemporary commercial building, however the upper level is intact and displays late Victorian detailing in the moulding to the parapet. There is evidence of masonry infill below the aluminium window frames, suggesting an earlier doorway.</p> <p>While 64 Auburn Road exhibits historical details and is reflective of the late Victorian commercial architecture, it has been considerably altered and its</p>	<p>The Late Victorian Building at 60-62 Auburn Road. The parapet detailing, corbelling with coping and windows pattern to the first floor are intact, which provides a good example of detailing found on the Later Victorian period shops. <b>The Late Victorian Shopfront should therefore be considered for individual listing at a local level.</b></p> <p>As noted in the heritage inventory sheet, 64 Auburn Road has been considerably altered which has resulted in a low degree of integrity. 64 Auburn Road <b>should not be considered for listing at a local level</b>. There are other</p>

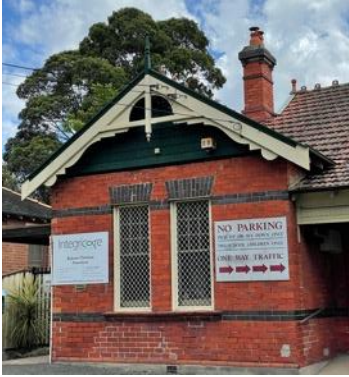
<p>HS11(1)</p>

<p>HS10(1)</p>
HS11	'The Manse' – Federation Residence	21 Harrow Road	Local	<p>'The Manse' presents as a Federation residence that is intact. The polychromatic brickwork to the walls and chimneys introduces contrasting colours to create variations and design elements. There are terracotta finials and chimney pots and detailing to the timber bargeboards.</p> <p>A contemporary shade structure and carport are located to the side. A concrete ramp and steps, with metal handrails, have been added to increase equitable accessibility of the residence.</p> <p>Security grills to the timber double hung windows and doors detract from the aesthetic significance of</p>	'The Manse' Federation Residence <b>should be considered for individual listing at a local level.</b>

Item	Name	Address	Listing	Comments	Recommendations	Photographic Evidence
				<p>the site, as does the signage on the front facade.</p> <p>The single storey addition at the rear does not contribute to the significance of the site.</p> <p>Condition: Moderate</p> <p>Integrity: Fair</p>

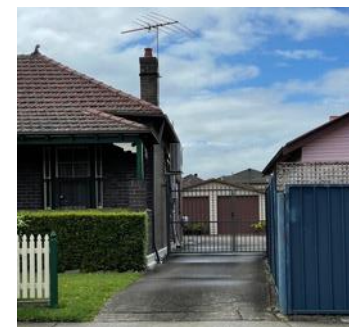
<p>HS12(1)</p>

<p>HS11(2)</p>
HS12	Inter-War Residence	1 Kihilla Road	Local	<p>The Inter-War Residence carries a high degree of integrity and is in a good condition. It displays Federation features, and includes original elements such as terracotta tiled hipped and gabled roof with finials, chimney pots, and timber bracket details to underside of verandah.</p> <p>The tidy garden setting positively contributes to its aesthetic significance.</p> <p>There is a concrete driveway, intrusive metal bars to the front windows and a metal gate to the side with a freestanding garage at the rear. These elements do not contribute to the significance of the site.</p> <p>Condition: Good</p> <p>Integrity: High</p>	The exterior of the Federation Bungalow <b>should be considered for individual listing</b> . It is not known if the interiors are also intact for inclusion in the listing.

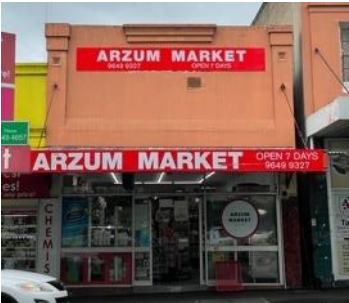
Item	Name	Address	Listing	Comments	Recommendations	Photographic Evidence
				<p>The shop at Nos. 57-59 is freestanding although contributes to the whole.</p> <p>It appears that the parapet form of No. 61 has been infilled although the original form remains evident when viewed in context of Nos. 73-67.</p> <p>Nos. 69-71 appear as a pair and differ in parapet design to the remainder of the shops.</p> <p>Collectively, they present as a moderately intact example of different Inter-War commercial architecture.</p> <p>Condition: Good</p> <p>Integrity: Moderate</p>		<p>HS29(1)</p>

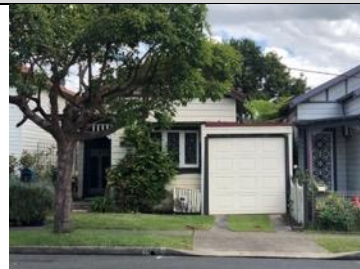
<p>HS140_Northcote_38</p>

Number	Street	Contributory	Non-Contributory	Condition	Integrity	Comments	Photograph and reference number
38	Northcote Street	<input checked="" type="checkbox"/>	<input type="checkbox"/>	<input type="checkbox"/> Poor <input checked="" type="checkbox"/> Fair <input type="checkbox"/> Good	<input type="checkbox"/> Low <input checked="" type="checkbox"/> Moderate <input type="checkbox"/> High	<p>Dwelling conforms to the general form and description of the proposed HCA as a timber clad structure with a corrugated metal, gable ended roof. A timber door is visible behind an aluminium security door. Windows are timber framed and include stained glass. An intrusive garage addition has been constructed to the front of the dwelling, however <b>This item contributes to the conservation area.</b></p>

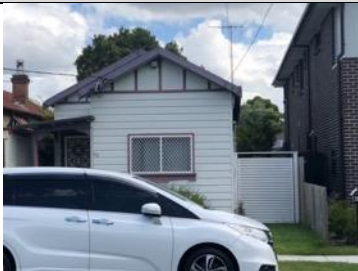
Number	Street	Contributory	Non-Contributory	Condition	Integrity	Comments	Photograph and reference number
40	Northcote Street	<input checked="" type="checkbox"/>	<input type="checkbox"/>	<input type="checkbox"/> Poor <input checked="" type="checkbox"/> Fair <input type="checkbox"/> Good	<input type="checkbox"/> Low <input checked="" type="checkbox"/> Moderate <input type="checkbox"/> High	Dwelling conforms to the general form and description of the proposed HCA as a timber clad structure with a corrugated metal, gable ended roof. An aluminium security door has been installed, and security grills are placed on the windows. Original windows may be in place. An intrusive gate is located to one side. <b>This item contributes to the conservation area.</b>

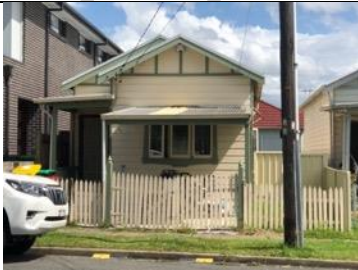
HS140_Northcote_44

44	Northcote Street	<input checked="" type="checkbox"/>	<input type="checkbox"/>	<input type="checkbox"/> Poor <input checked="" type="checkbox"/> Fair <input type="checkbox"/> Good	<input type="checkbox"/> Low <input checked="" type="checkbox"/> Moderate <input type="checkbox"/> High	Dwelling conforms to the general form and description of the proposed HCA as a timber clad structure with a corrugated metal, gable ended roof. An aluminium security door has been installed. Timber window frames and some original window panes are retained. <b>This item contributes to the conservation area.</b>

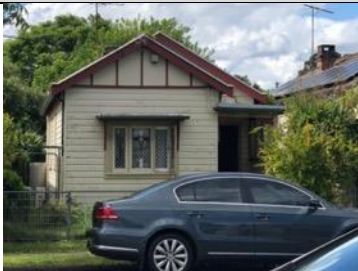
Number	Street	Contributory	Non-Contributory	Condition	Integrity	Comments	Photograph and reference number
55	Northcote Street	<input checked="" type="checkbox"/>	<input type="checkbox"/>	<input type="checkbox"/> Poor <input checked="" type="checkbox"/> Fair <input type="checkbox"/> Good	<input type="checkbox"/> Low <input checked="" type="checkbox"/> Moderate <input type="checkbox"/> High	Dwelling conforms to the general form and description of the proposed HCA as a timber clad structure with a corrugated metal, gable ended roof. The recessed gable end is clad in timber shingles. A security door has been installed. Timber window frames and stained glass windows are intact. <b>This item contributes to the conservation area.</b>

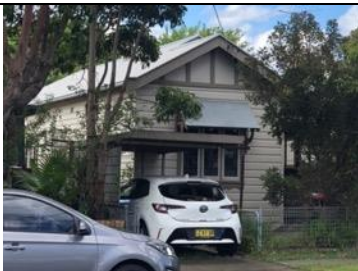
HS140_Northcote_57

HS140_Northcote_55
57	Northcote Street	<input checked="" type="checkbox"/>	<input type="checkbox"/>	<input type="checkbox"/> Poor <input checked="" type="checkbox"/> Fair <input type="checkbox"/> Good	<input type="checkbox"/> Low <input checked="" type="checkbox"/> Moderate <input type="checkbox"/> High	Dwelling conforms to the general form and description of the proposed HCA as a timber clad structure with a corrugated metal, gable ended roof. Timber window frames with stained glass windows are retained. An intrusive carport cover is located to the side. <b>This item contributes to the conservation area.</b>

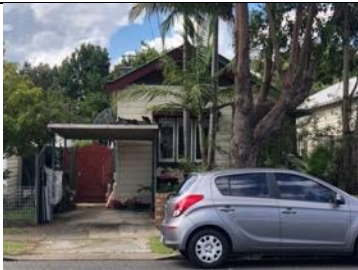
HS140_Northcote_57A

57A	Northcote Street	<input checked="" type="checkbox"/>	<input type="checkbox"/>	<input type="checkbox"/> Poor <input checked="" type="checkbox"/> Fair <input type="checkbox"/> Good	<input type="checkbox"/> Low <input checked="" type="checkbox"/> Moderate <input type="checkbox"/> High	Dwelling conforms to the general form and description of the proposed HCA as a timber clad structure with a corrugated metal, gable ended roof. Timber window frames with stained glass windows are retained. An intrusive carport is located to the site. <b>This item contributes to the conservation area.</b>

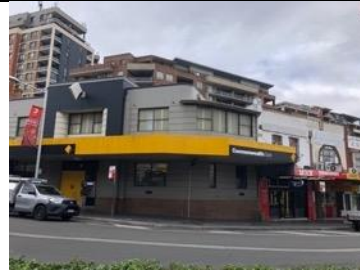
Number	Street	Contributory	Non-Contributory	Condition	Integrity	Comments	Photograph and reference number
1-3	Auburn Road	<input checked="" type="checkbox"/>	<input type="checkbox"/>	<input type="checkbox"/> Poor <input type="checkbox"/> Fair <input checked="" type="checkbox"/> Good	<input type="checkbox"/> Low <input checked="" type="checkbox"/> Moderate <input type="checkbox"/> High	<p>Art deco style, large building curving around the street corner. The ground floor has been altered with new entrances and stone finish to the base. All windows are aluminium frames. Original form and design intent remains visible.</p> <p><b>The building contributes to the character of the HCA.</b></p>

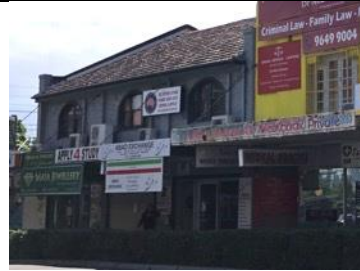
HS141 Auburn Road 2-2E

HS141 Auburn Road 1-3
2	Auburn Road	<input checked="" type="checkbox"/>	<input type="checkbox"/>	<input type="checkbox"/> Poor <input type="checkbox"/> Fair <input checked="" type="checkbox"/> Good	<input type="checkbox"/> Low <input checked="" type="checkbox"/> Moderate <input type="checkbox"/> High	<p>Federation-style building, with terracotta tiled, transverse gabled roof form. The rendered first floor incorporates original timber, arched windows. The ground floor has been altered with contemporary openings. <b>The building contributes to the character of the HCA.</b></p>

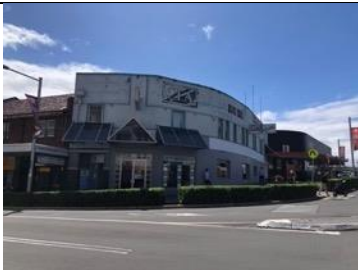
HS141_Auburn Road_2G

2G	Auburn Road	<input checked="" type="checkbox"/>	<input type="checkbox"/>	<input type="checkbox"/> Poor <input checked="" type="checkbox"/> Fair <input type="checkbox"/> Good	<input type="checkbox"/> Low <input checked="" type="checkbox"/> Moderate <input type="checkbox"/> High	Large retail building that curves around the street corner. Parapet façade is higher than the neighbouring 2E Auburn Road. Rendered and painted brick shows signs of minor cracking and plant growth to top course. All windows have been replaced with aluminium frames. Ground floor entrance has been altered and glazed awnings have been added. <b>The building contributes to the character of the HCA.</b>

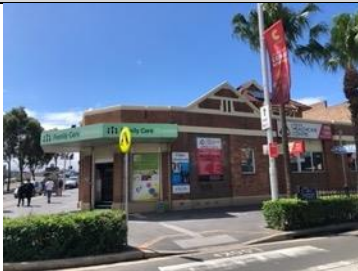
Number	Street	Contributory	Non-Contributory	Condition	Integrity	Comments	Photograph and reference number
4A	Auburn Road	<input checked="" type="checkbox"/>	<input type="checkbox"/>	<input type="checkbox"/> Poor <input type="checkbox"/> Fair <input checked="" type="checkbox"/> Good	<input type="checkbox"/> Low <input checked="" type="checkbox"/> Moderate <input type="checkbox"/> High	Noted as a proposed heritage item (HS2). The ground floor has been significantly altered, although the Federation style remains visible in the upper portion of the building, with some original timber windows and other features on the upper level and parapet. <b>The building contributes to the character of the HCA.</b>

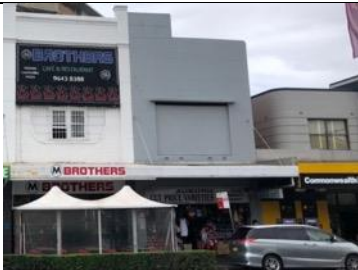
HS141_Auburn Road_5-9

5	Auburn Road	<input type="checkbox"/>	<input checked="" type="checkbox"/>	<input type="checkbox"/> Poor <input checked="" type="checkbox"/> Fair <input type="checkbox"/> Good	<input checked="" type="checkbox"/> Low <input type="checkbox"/> Moderate <input type="checkbox"/> High	Ground floor is significantly altered. The upper level appears to have been altered with a single large window infilled. The parapet also appears to have been altered. Despite the alterations, the original pressed metal ceiling to the awning remains intact. <b>Due to the loss of fabric and low Integrity, the building does not contribute to the character of the HCA.</b>

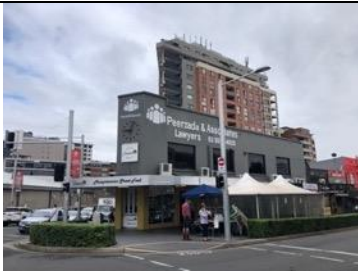
HS141_Auburn Road_35-39(1)

HS141_Auburn Road_31-33
35-39	Auburn Road	<input checked="" type="checkbox"/>	<input type="checkbox"/>	<input type="checkbox"/> Poor <input checked="" type="checkbox"/> Fair <input type="checkbox"/> Good	<input type="checkbox"/> Low <input checked="" type="checkbox"/> Moderate <input type="checkbox"/> High	The large format shop incorporates three shops and is on a prominent corner block. The ground floor has been significantly altered, and the windows to the upper level have been replaced with fixed aluminium windows. The original form and design remain evident. <b>The building contributes to the character of the HCA.</b>

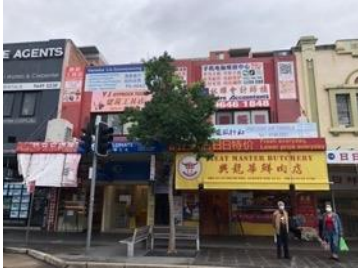
HS141 South Parade 114-116

HS141 South Parade 110-112
114-116	South Parade	<input type="checkbox"/>	<input checked="" type="checkbox"/>	<input type="checkbox"/> Poor <input checked="" type="checkbox"/> Fair <input type="checkbox"/> Good	<input checked="" type="checkbox"/> Low <input type="checkbox"/> Moderate <input type="checkbox"/> High	Pair of shops that present as a whole. The ground floor has been altered, with signage to the upper level and replacement aluminium windows detract from the façade. <b>The building is not contributory to the character of the HCA.</b>

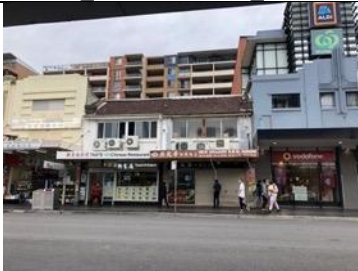
HS141_South Parade_124-126

HS141_South Parade_122
124-126	South Parade	<input type="checkbox"/>	<input checked="" type="checkbox"/>	<input checked="" type="checkbox"/> Poor <input type="checkbox"/> Fair <input type="checkbox"/> Good	<input checked="" type="checkbox"/> Low <input type="checkbox"/> Moderate <input type="checkbox"/> High	Pair of earlier shops, with terracotta tiled, transverse gabled roof form. Original windows have been replaced with aluminium sliders and air conditioner condenser units below the windows/on the awnings detract from the façade. <b>Due to significant change to original fabric, the pair of shops do not contribute to the HCA.</b>

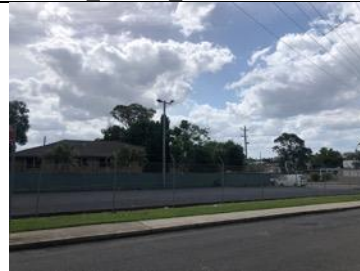
<p>HS144 Bursill 86</p>

<p>HS144 Bursill 84</p>
86	Bursill Street	<input type="checkbox"/>	<input checked="" type="checkbox"/>	N/A	N/A	Heritage Inventory Sheet notes this item as non-contributory and not recommended for listing within the HCA boundaries. The site is currently vacant and <b>does not contribute to the character of the HCA.</b>

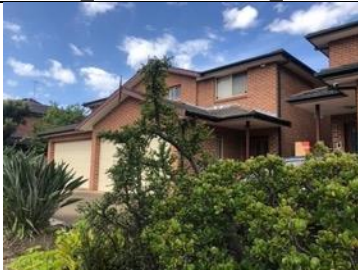
HS144_Mountford_66-68

HS144_Guildford Road_271
66-68	Mountford Avenue	<input type="checkbox"/>	<input checked="" type="checkbox"/>	N/A	N/A	<p>Heritage Inventory Sheet notes this item as non-contributory and not recommended for listing within the HCA boundaries.</p> <p>It is a ca. 21<sup>st</sup> century construction that presents as six residences across three semi-detached dwellings.</p> <p><b>It does not contribute to the character of the HCA.</b></p>

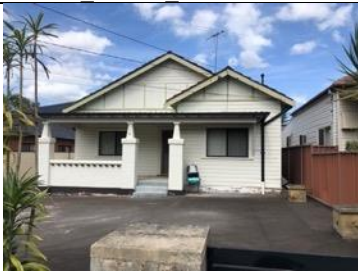
HS144_Talbot_6

HS144 Talbot_4
6	Talbot Road	<input checked="" type="checkbox"/>	<input type="checkbox"/>	<input type="checkbox"/> Poor <input type="checkbox"/> Fair <input checked="" type="checkbox"/> Good	<input type="checkbox"/> Low <input checked="" type="checkbox"/> Moderate <input type="checkbox"/> High	Heritage Inventory Sheet notes this item as non-contributory and not recommended for listing within the HCA boundaries.  It is of a similar era of construction to the contributory items in the HCA and is reflective of the form and scale of the contributory dwellings. However, as it is located further north of the contributory buildings, the boundary would have to be increased significantly, with multiple non-contributory buildings in between.

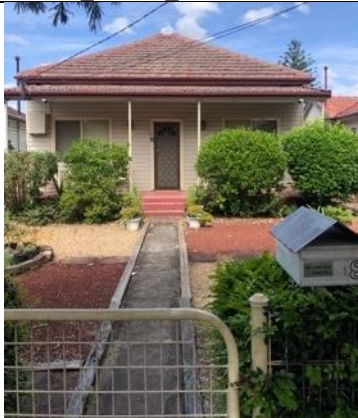
<p>HS144_Talbot_8</p>

<p>HS144_Talbot_7</p>
8	Talbot Road	<input checked="" type="checkbox"/>	<input type="checkbox"/>	<input type="checkbox"/> Poor <input type="checkbox"/> Fair <input checked="" type="checkbox"/> Good	<input type="checkbox"/> Low <input checked="" type="checkbox"/> Moderate <input type="checkbox"/> High	<p>Heritage Inventory Sheet notes as non-contributory and not recommended for listing within the HCA boundaries.</p> <p>It is of a similar era of construction to the contributory items in the HCA and is reflective of the form and scale of the contributory dwellings. However, as it is located further north of the contributory buildings, the boundary would have to be increased significantly, with multiple non-contributory buildings in between. <b>No. 8 Talbot Road contributes to the character of the HCA.</b></p>

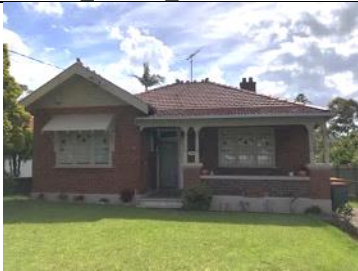
HS144_Talbot_11

HS144_Talbot_10
11	Talbot Road	<input checked="" type="checkbox"/>	<input type="checkbox"/>	<input type="checkbox"/> Poor <input type="checkbox"/> Fair <input checked="" type="checkbox"/> Good	<input type="checkbox"/> Low <input type="checkbox"/> Moderate <input checked="" type="checkbox"/> High	Heritage Inventory Sheet notes this item as a listed heritage item. It is part of the existing listing, 'Talbot Road Precinct,' item I164 (11-23 and 12-24 Talbot Road). It is a red brick, single storey dwelling that retains original features such as finials to the terracotta tiled, hipped and gabled roof, chimney pots and stained glass window details. <b>It contributes to the character of the HCA and should be considered for Individual heritage listing</b> as it provides a good example of its type.

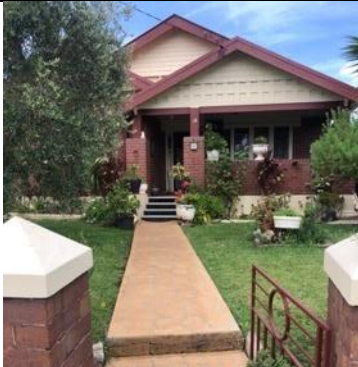
HS144_Talbot_14

HS144_Talbot_13
14	Talbot Road	<input checked="" type="checkbox"/>	<input type="checkbox"/>	<input type="checkbox"/> Poor <input type="checkbox"/> Fair <input checked="" type="checkbox"/> Good	<input type="checkbox"/> Low <input type="checkbox"/> Moderate <input checked="" type="checkbox"/> High	Heritage Inventory Sheet notes this item as a listed heritage item. It is part of the existing listing, item I164. It is a red brick, single storey dwelling with three shingle clad gables on the front façade. It retains original windows, and timber elements. <b>It contributes to the character of the HCA and should be considered for Individual heritage listing</b> as it provides a good example of its type.

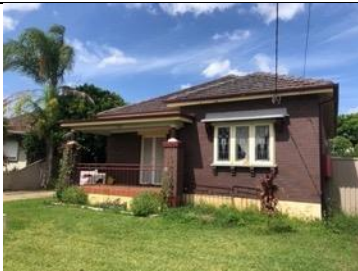
HS144_Talbot_20

HS144_Talbot_19
20	Talbot Road	<input checked="" type="checkbox"/>	<input type="checkbox"/>	<input type="checkbox"/> Poor <input type="checkbox"/> Fair <input checked="" type="checkbox"/> Good	<input type="checkbox"/> Low <input type="checkbox"/> Moderate <input checked="" type="checkbox"/> High	Heritage Inventory Sheet notes this item as a listed heritage item. It is part of the existing listing, item I164. It is a single storey, brick dwelling with original stained glass windows. <b>It is contributory to the character of the HCA.</b>

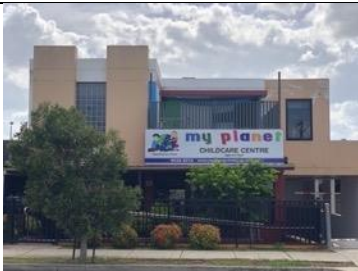
HS144_Talbot_25

HS144_Talbot_24
25	Talbot Road	<input type="checkbox"/>	<input checked="" type="checkbox"/>	N/A	N/A	Heritage Inventory Sheet notes this item as non-contributory and not recommended for listing within the HCA boundaries. It is a contemporary, two-storey structure in use as a childcare centre. It <b>does not contribute towards the character of the HCA.</b>
