REPORT: **Arboricultural Impact Assessment**

Billbergia Group Pty Ltd

Lot 101, DP 791908
1 King Street
Concord West NSW 2138

22nd of January, 2024

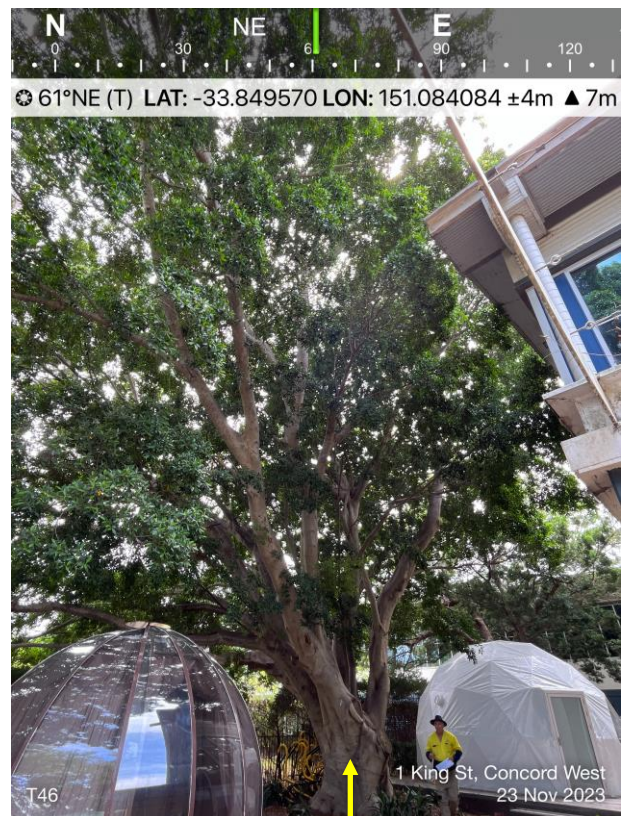
Plate 8: Tree 46.

46	Adjacent George Street.	<u>Ficus microcarpa</u> var. 'hillii' Hill's Weeping Fig	24	25	51 60	6.1 2.7	Mature, good condition, previously pruned at 30cm and 50cm height.	3a A2	High	Retain and protect.
47	Adjacent George Street.	<u>Podocarpus elatus</u> Plum Pine	NS 18 EW 15	18	86 85	10.3 3.1	Mature, good condition but poor development, with a lean and an unbalanced canopy to the north-east, and decay to the east at 50cm height.	3a A2	High	Retain and protect.
48	Western boundary.	<u>Celtis spp.</u> Hackberry	6	8	10/10/13 25	2.3 1.9	Immature, good condition but poor development, with damaged roots.	2a Z3	Very Low	Remove (Exempt plant species).
49	Tree removed prior to this report.									
50	Western boundary.	<u>Celtis spp.</u> Hackberry	6	7	10 (x 5)/13 25	3.1 1.9	Immature, good condition, with a lean to the north-west.	2a Z3	Very Low	Remove (Exempt plant species).
51	Western boundary.	<u>Cupressocyparis leylandii</u> Leighton Green	5	12	18 22	2.2 1.8	Semi-mature, moderate condition, with an unbalanced canopy to the west.	3d Z10	Low	Remove and replenish.

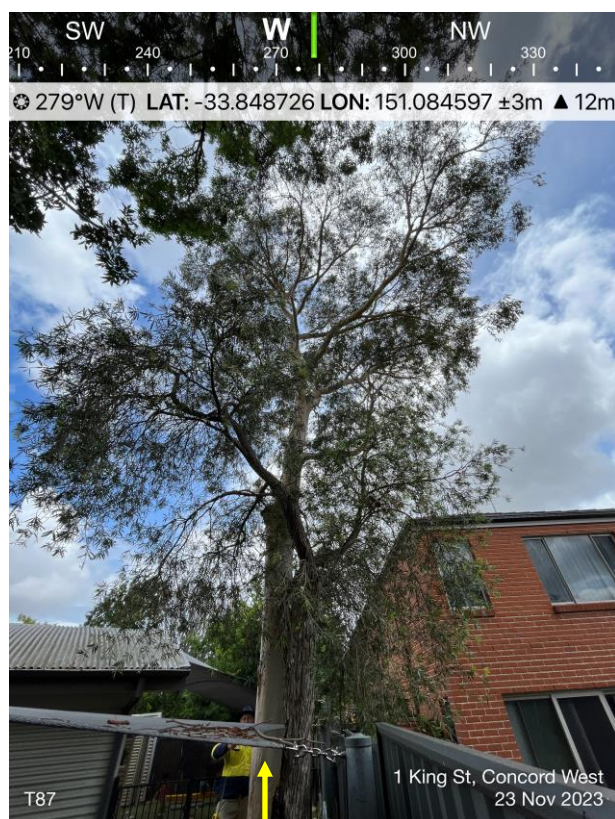
Plate 11: Tree 87.

87	Childcare.	<i>Eucalyptus haemastoma</i> Scribbly Gum	12	18	45 55	5.4 2.6	Immature, good condition but poor development, previously pruned, with a cavity at the base of the tree.	2d A2	Moderate	Retain and protect.
88	Childcare.	<i>Callistemon viminalis</i> Weeping Bottlebrush	6	7	15 20	2.0 1.7	Immature, good condition but poor development, previously pruned.	2a A1	Low-Moderate	Retain and protect.
89	Adjacent King Street access.	<i>Melaleuca quinquenervia</i> Broad-Leaved Paperbark	8	12	40 45	4.8 2.4	Semi-mature, good condition but poor development, with a lean to the west.	2a Z10	Moderate	Remove and replenish.
90	Western boundary.	<i>Gleditsia triacanthos</i> Honey Locust	8	7	28 30	3.4 2.0	Semi-mature, with an unbalanced canopy to the west, decay at 1m height, and physical damage from concrete at the base of the tree.	3d Z10	Low-Moderate	Remove and replenish.
91	Western boundary.	<i>Casuarina glauca</i> Swamp She-Oak	12	24	70 90	8.4 3.2	Mature, good condition but poor development.	2a A1	High	Retain and protect.

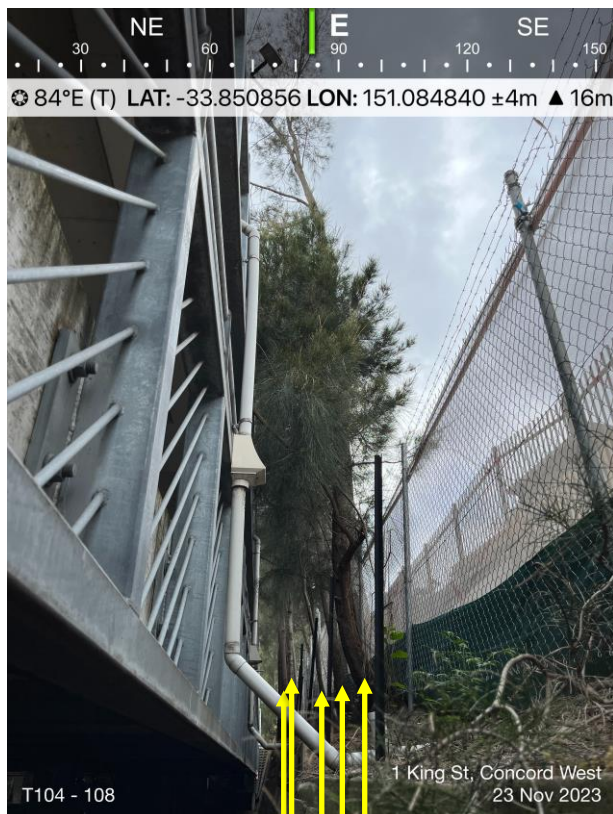
104	Southern boundary.	<i>Casuarina glauca</i> Swamp She-Oak	4	6	20 22	2.4 1.8	Immature, with an unbalanced canopy to the north.	2d A1	Low	Retain and protect.
105	Southern boundary.	<i>Casuarina glauca</i> Swamp She-Oak	6	18	10/20 30	2.6 2.0	Immature, growing through the fence.	2a A1	Low	Retain and protect.
106 (x 2)	Southern boundary.	<i>Casuarina glauca</i> Swamp She-Oak	6	22	10/20 22	2.6 1.8	Immature, good condition but poor development, with physical damage.	2a Z10	Low	Remove and replenish.
107	Southern boundary.	<i>Casuarina glauca</i> Swamp She-Oak	3	8	14/15 20	2.5 1.7	Immature, poor condition, with physical damage.	2d Z10	Low	Remove and replenish.
108	Southern boundary.	<i>Casuarina glauca</i> Swamp She-Oak	6	13	43 51	5.2 2.5	Semi-mature, moderate condition.	3d Z10	Low-Moderate	Remove and replenish.
108a	Southern boundary.	<i>Casuarina glauca</i> Swamp She-Oak	3	8	10-15 10-15	2.0 1.5	Juvenile, excellent condition.	1a A1	Low	Retain and protect.

Plate 15: Trees 104 to 108 (from right to left) area very inaccessible due to fence and structure on bank.

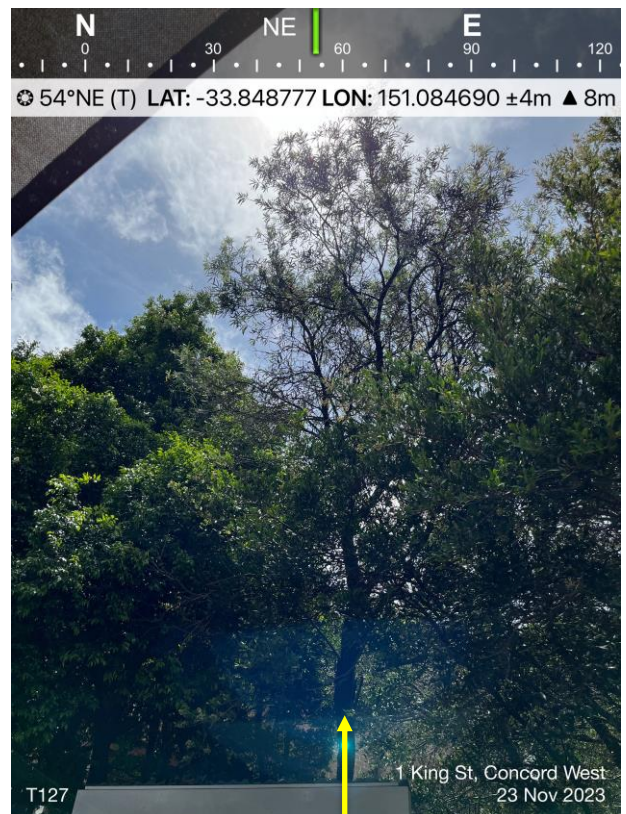
Plate 16: Tree 127.

127	Childcare.	<i>Callistemon viminalis</i> Weeping Bottlebrush	6	8	15 20	2.0 1.7	Immature, good condition but poor development, with an unbalanced canopy to the south.	2a Z10	Low	Remove and replenish.
128	Childcare.	<i>Syzygium spp.</i> Lilly Pilly	6	9	11/17 20	2.4 1.7	Immature, good condition but poor development.	2a A1	Low	Retain and protect.
129 (x 24)	20m from c-care access.	<i>Cupressocyparis leylandii</i> Leighton Green (hedge)	2	4	10 10	2.0 1.5	Immature, one (1) dead.	2a Z10	Low	Remove and replenish.

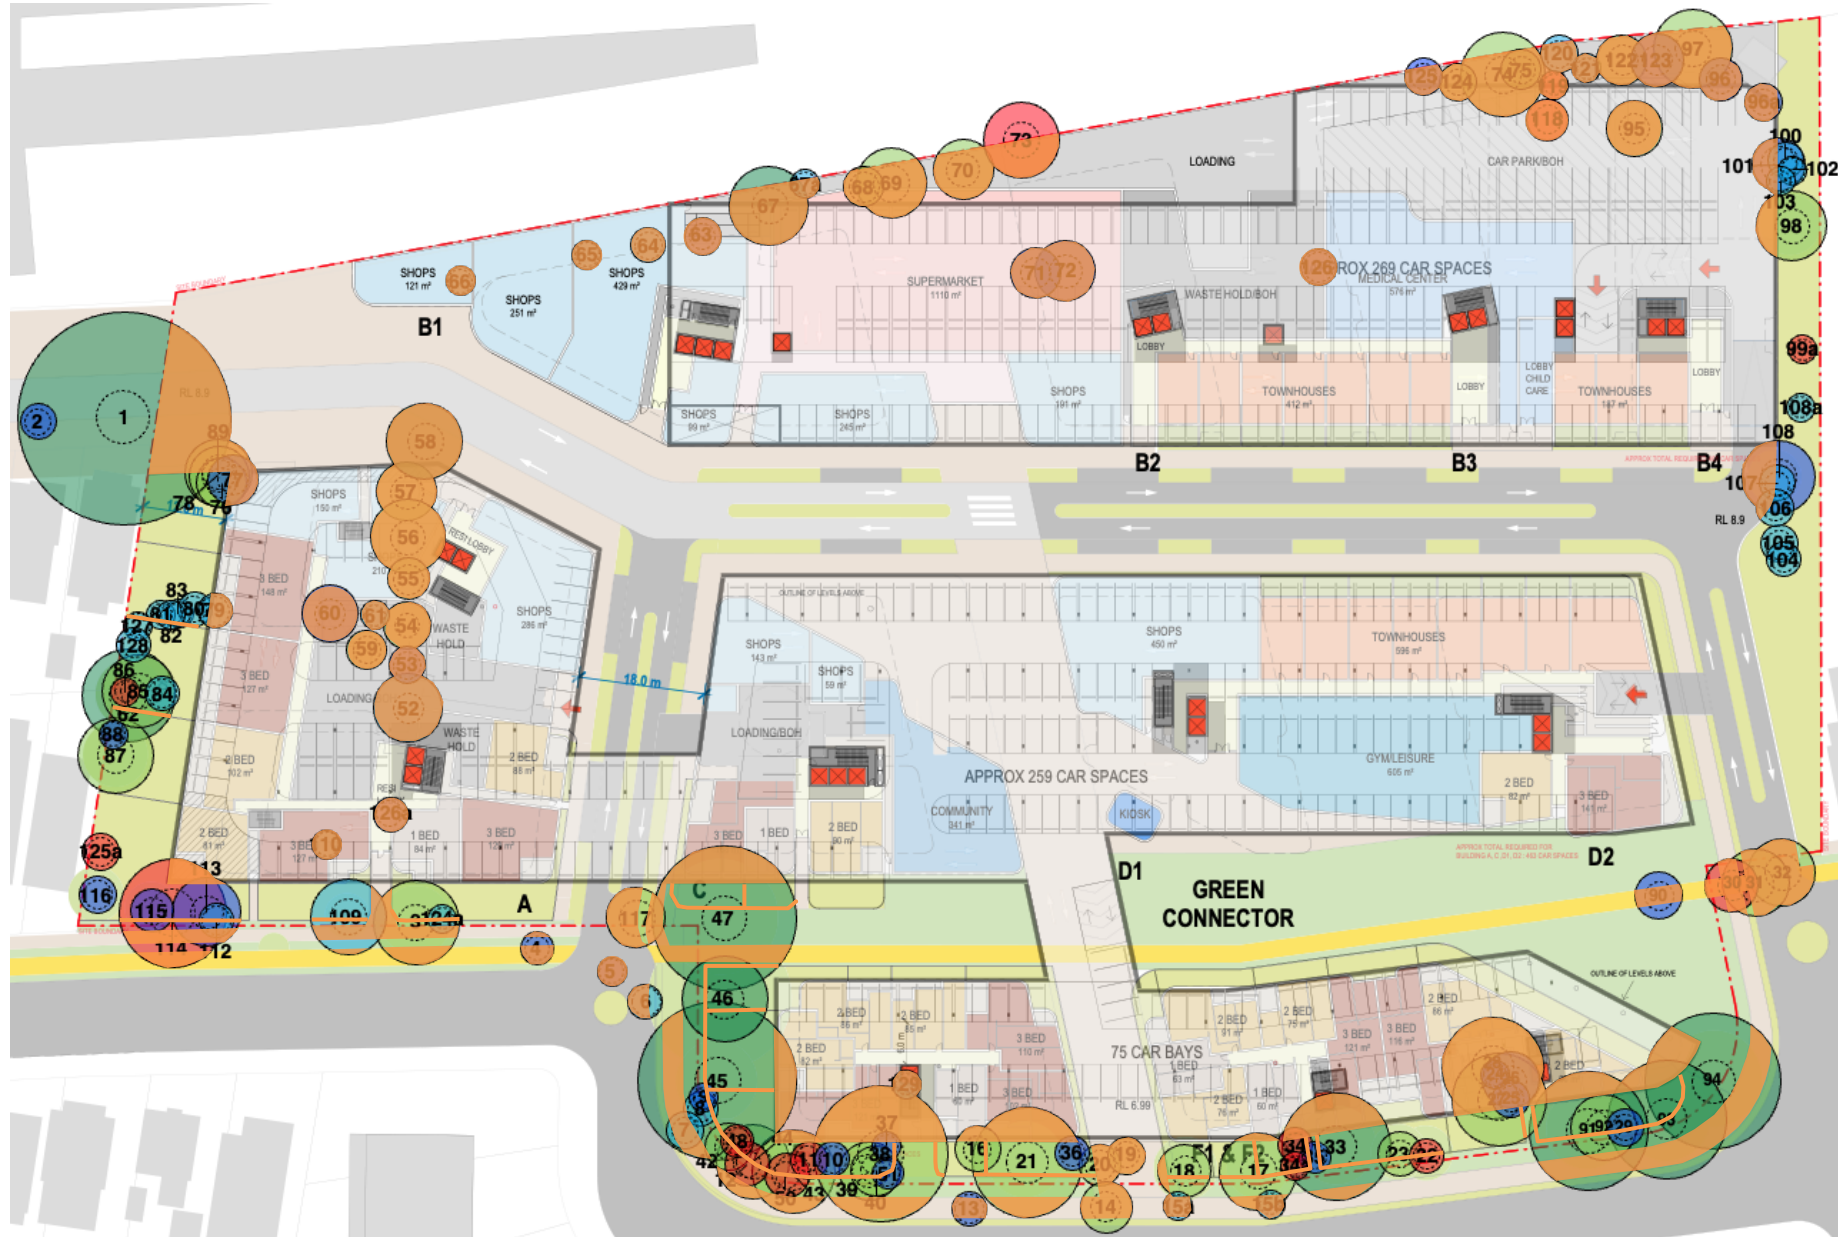
4.3.2 One hundred and seventeen (117) trees/tree groups will have major anticipated impacts from encroachments of greater than 10%. Twelve (12) trees numbered 1, 18, 45, 46, 47, 62, 91, 92, 93, 94, 98 and 115 are to be retained with tree-sensitive construction measures and root mapping investigations; and one hundred and five (105) trees/tree groups numbered 3, 4, 5, 6, 7, 8, 9, 11, 12, 13, 14, 15a, 15b, 16, 17, 19, 20, 21, 22, 23, 24, 25, 26, 27, 28, 29, 30, 31, 32, 33, 34, 34a, 35, 36, 37, 38, 39, 40, 42, 43, 44, 48, 50, 51, 52, 53, 54, 55, 56, 57, 58, 59, 60, 61, 63, 64, 65, 66, 67, 67a, 68, 69, 70, 71, 72, 73, 74, 75, 76, 77, 78, 79, 81, 82, 89, 90, 95, 96, 96a, 97, 100, 101, 103, 106, 107, 108, 109, 110, 112, 113, 114, 117, 118, 119, 120, 121, 122, 123, 124, 124a, 125, 126, 126a, 127 and 129 are proposed for removal to support the proposed works.

Figure 5: TPZ Encroachments. Encroachments are highlighted in orange.
