Subject: 345 Appin Road, Appin Planning Proposal – Riparian Assessment

Thank you for the opportunity to prepare this riparian assessment of the watercourses at 345 Appin Road, Appin (the subject site) to support the planning proposal for the North Appin (Part) Precinct.

Attachment B – Riparian Assessment Matrix

345 Appin Road, Appin Riparian Assessment

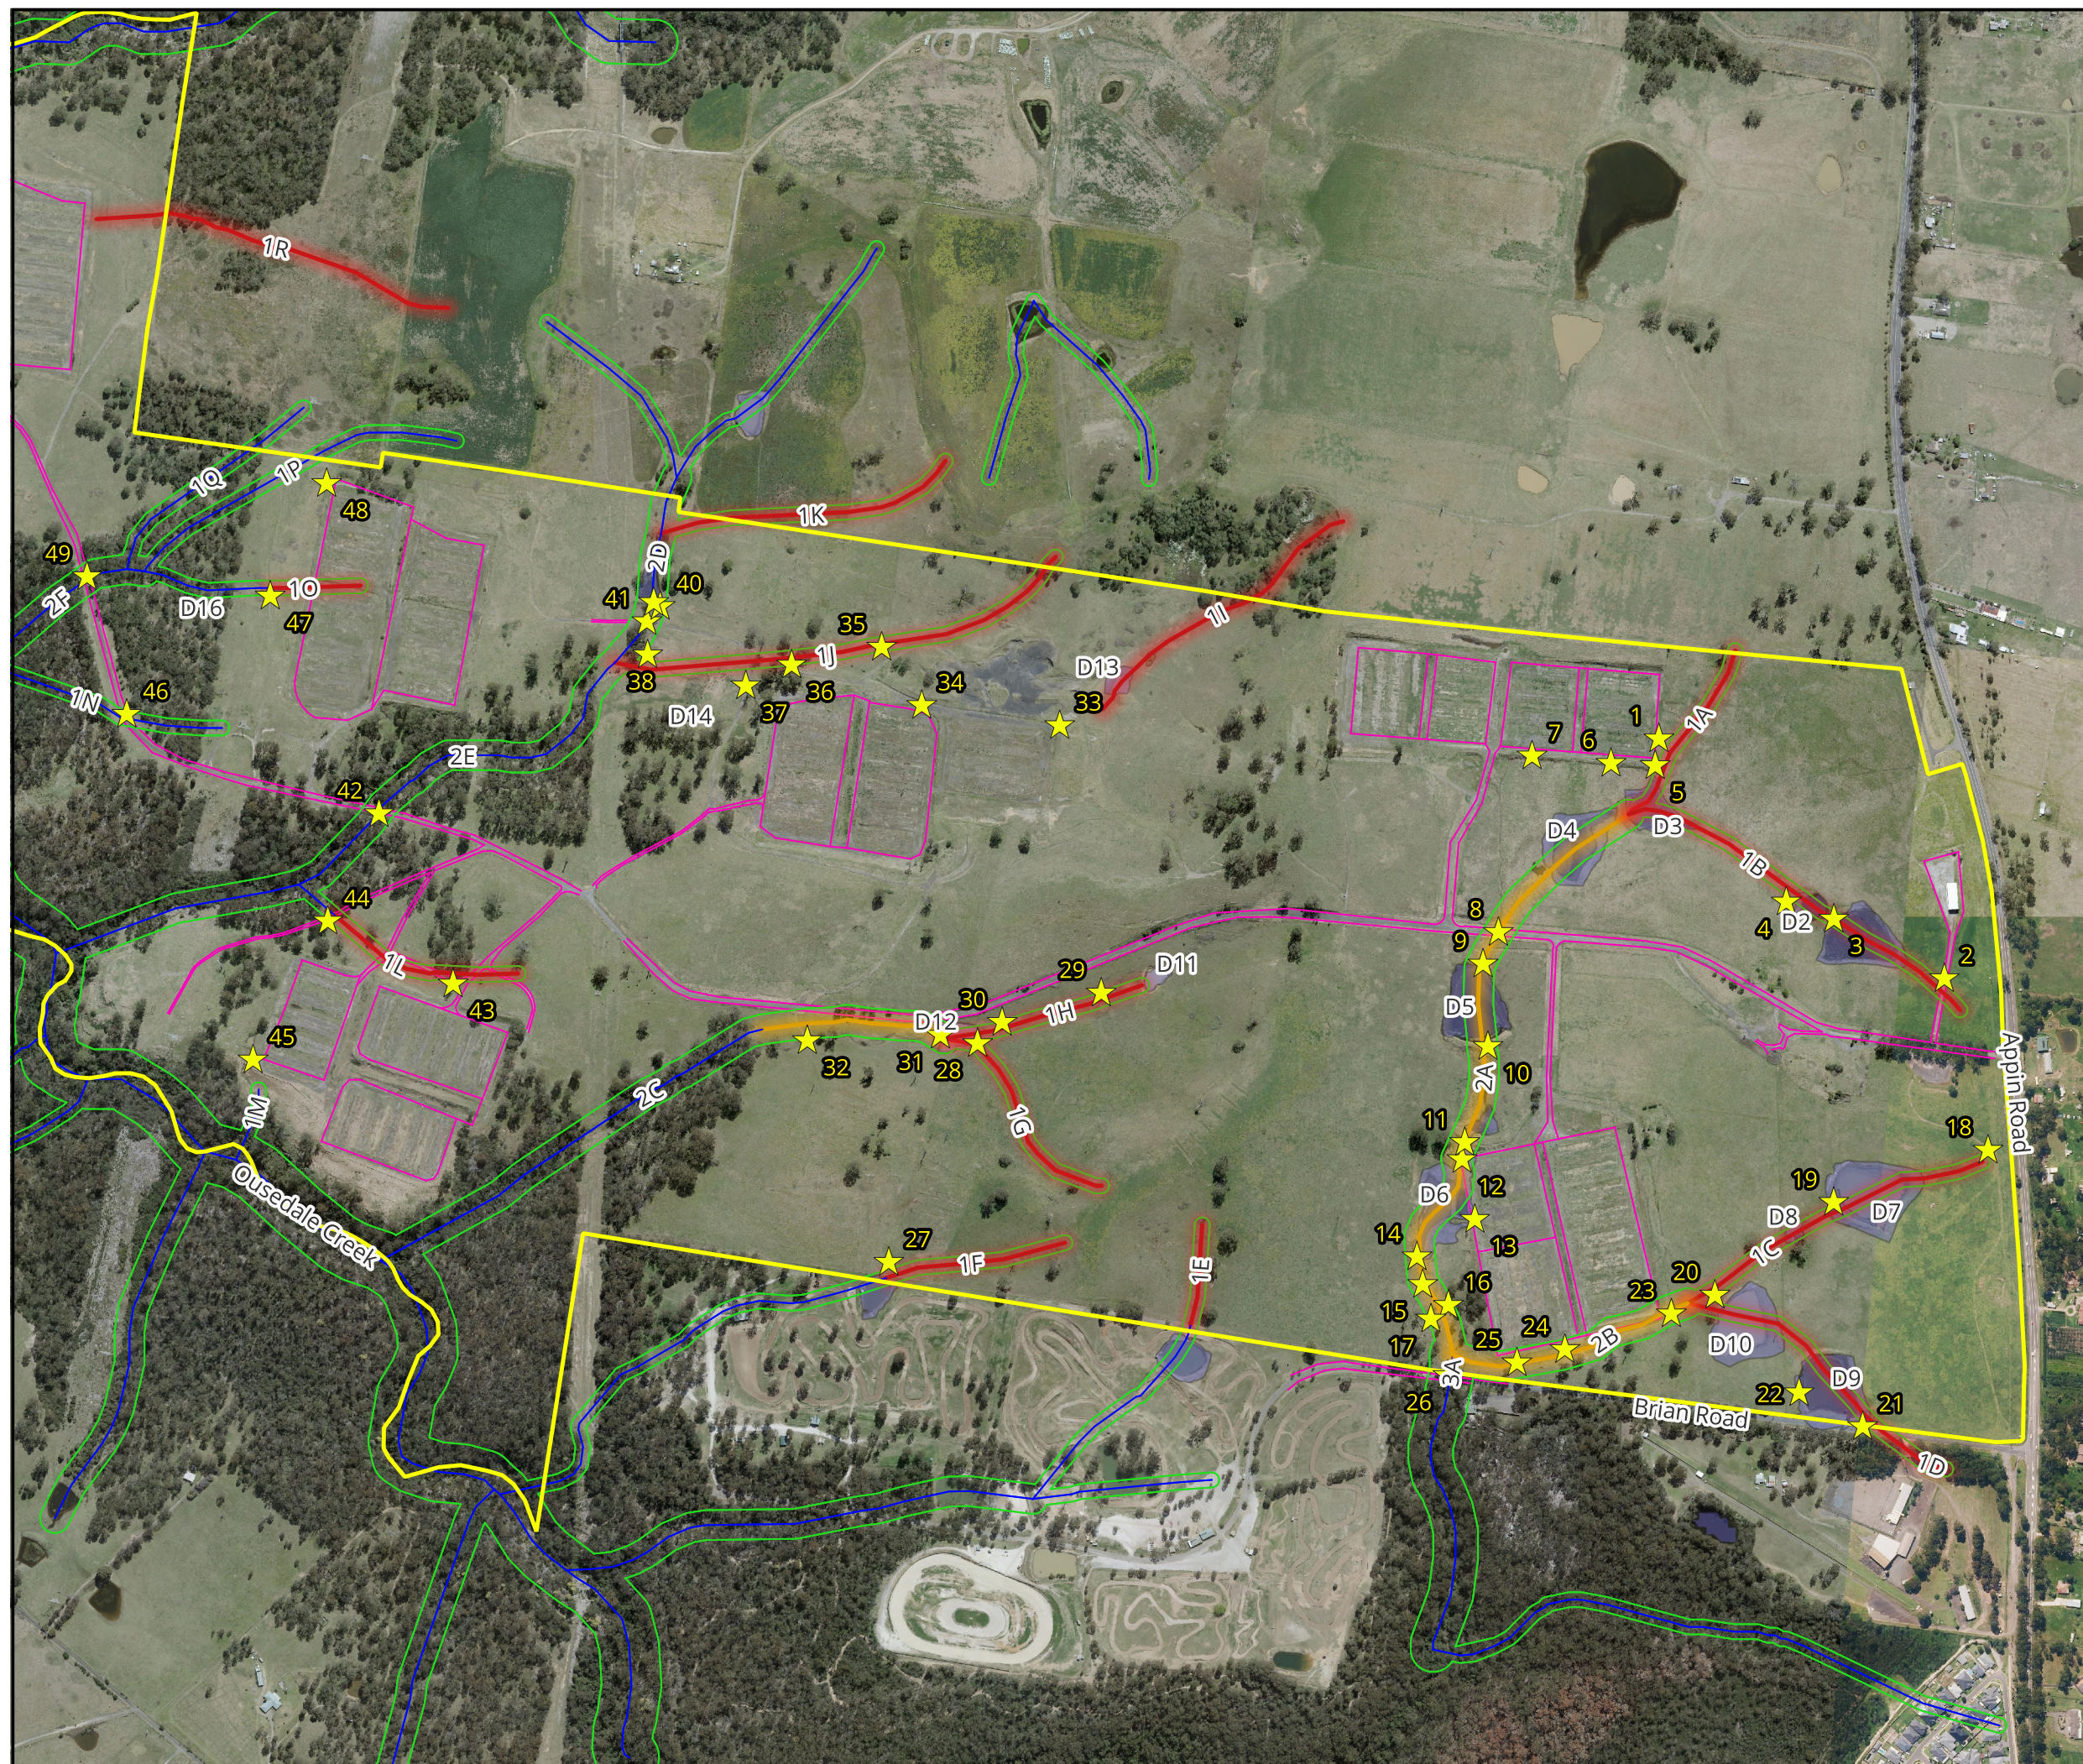
The riparian assessment concludes that some of the mapped watercourses across the site are not what would be classified as "rivers" under the WM Act. These watercourses do not display riparian characteristics and there is no defined creek bed / banks or preservable vegetation with biodiversity value. It is proposed that these watercourses will be replaced by traditional street minor/major drainage systems (where they are first order watercourses). Other second order watercourses are proposed to be realigned as overland flow paths to allow drainage to occur as it does under current conditions. In particular, the north-south watercourse 2A will be rejuvenated to provide riparian value to the waterway. The watercourses that are proposed to be retained are primarily situated in the conservation lands.

Refer to Figure 1 (Attachment A) for an illustration of the photo locations across the site and the watercourses proposed for removal, retention, and realignment. Refer to Attachment B for the riparian assessment matrix of all visited watercourses which have been tested against the Waterfront land tool.

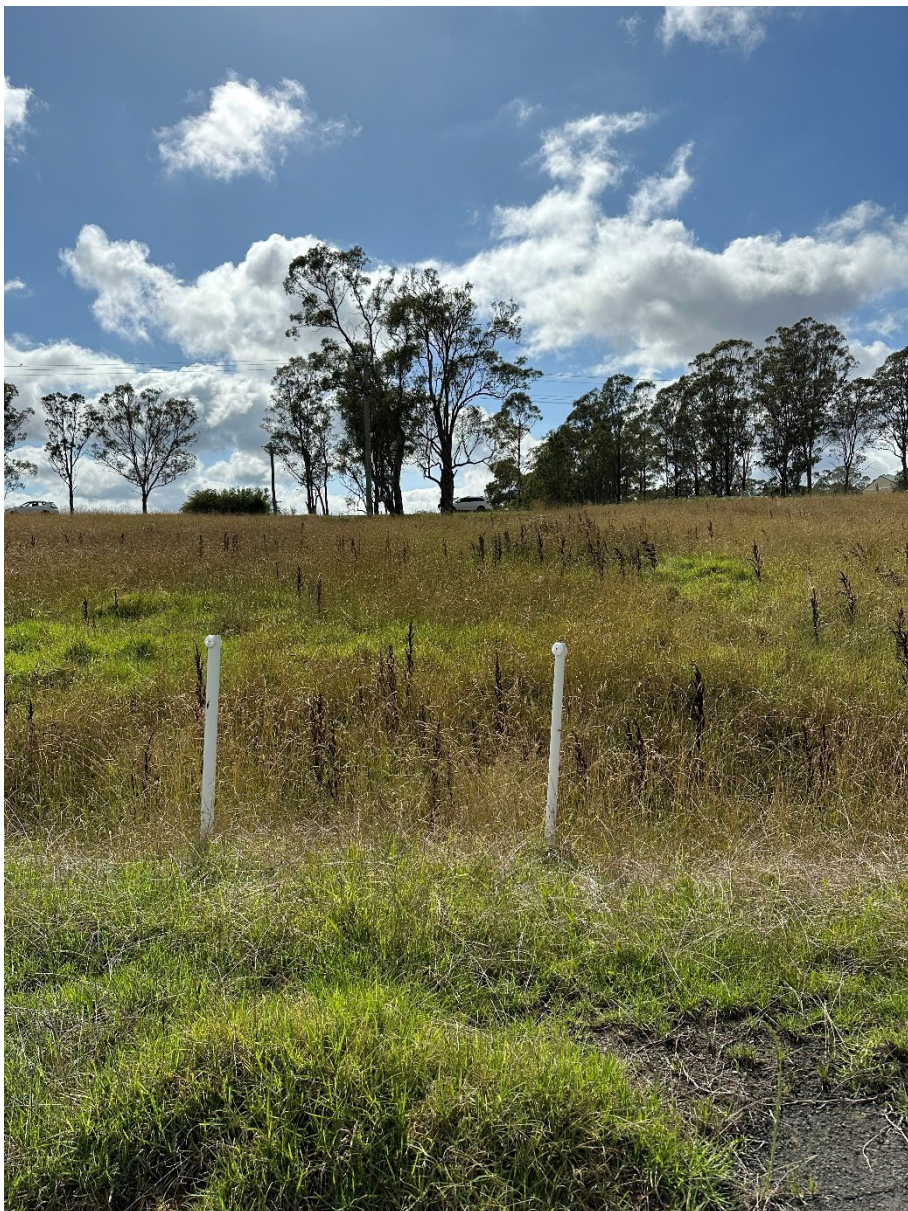
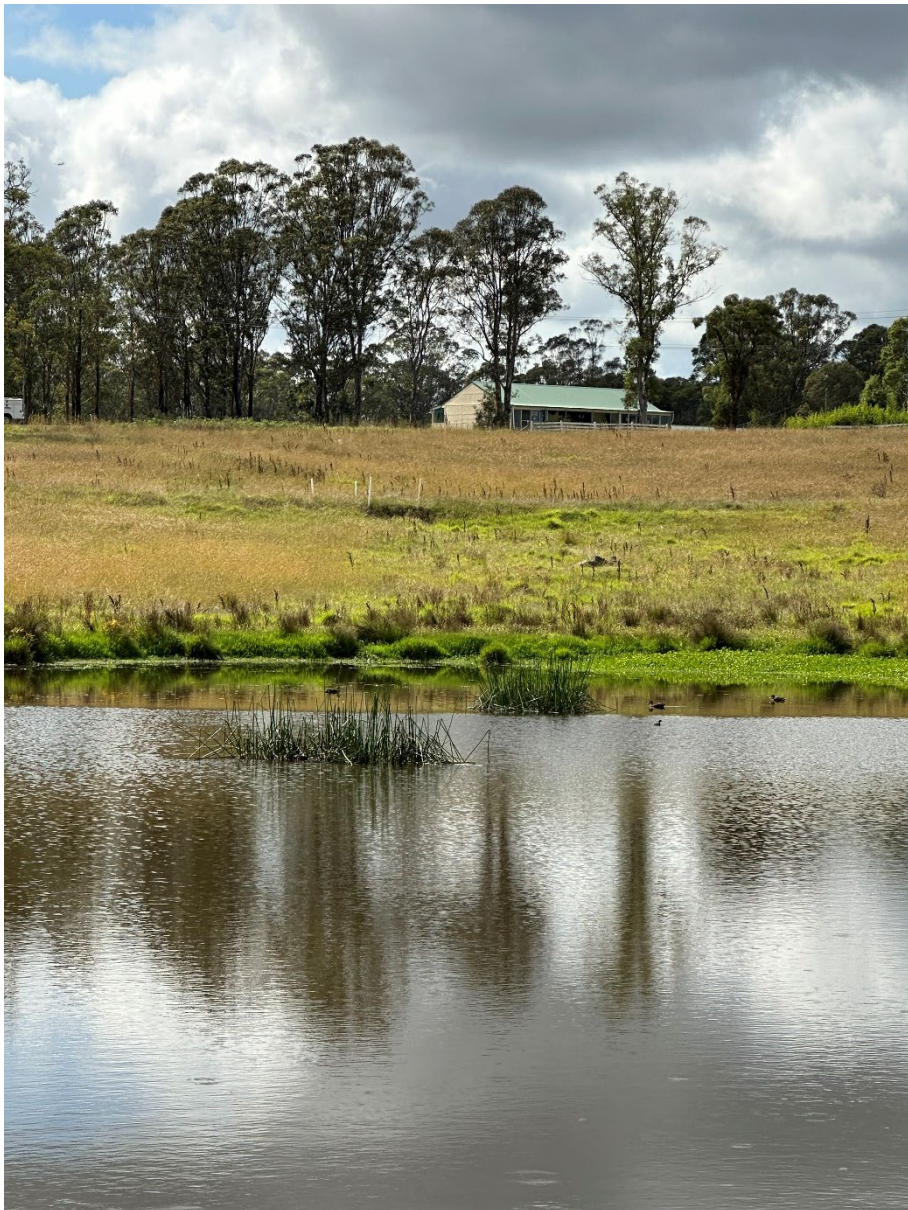
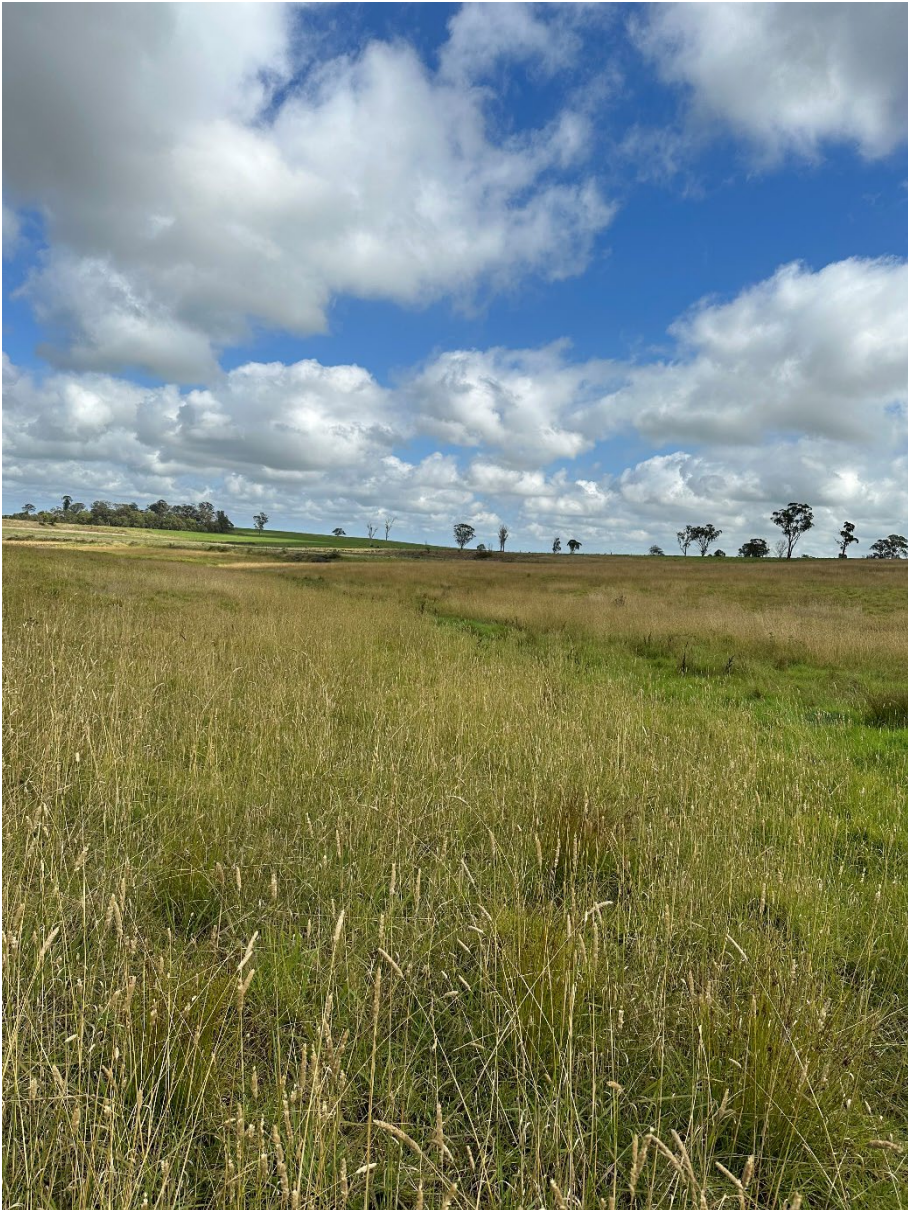
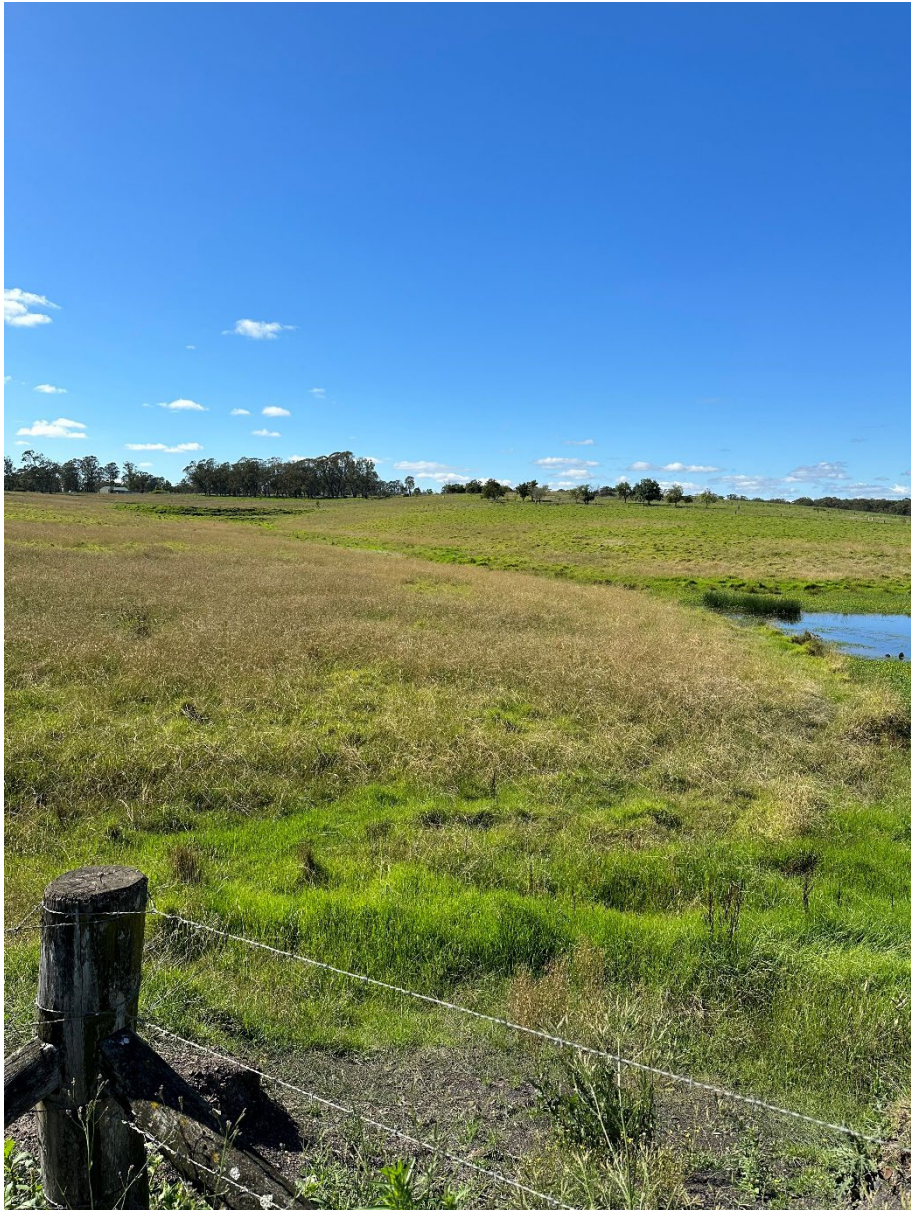
WATERCOURSE 1B

Description	The photos of watercourse 1B show a local depression connecting a series of man-made farm dams. The area consists of tall pasture grass (no trees) with no defined creek bed or banks. No riparian function evident.
Watercourse order	1 st order
Does the watercourse have a defined bed or bank?	No
Watercourse Features (NRAR Waterfront Land Tool – Appendix 6)	None

Result: Controlled activity approval not required–No watercourse

- There is no bed or bank
- There are no watercourse features

Outcome: Watercourse 1B is proposed to be removed in the proposed development and will be replaced by traditional road drainage networks
