Subject: 345 Appin Road, Appin Planning Proposal – Riparian Assessment

Thank you for the opportunity to prepare this riparian assessment of the watercourses at 345 Appin Road, Appin (the subject site) to support the planning proposal for the North Appin (Part) Precinct.

Attachment B – Riparian Assessment Matrix

345 Appin Road, Appin Riparian Assessment

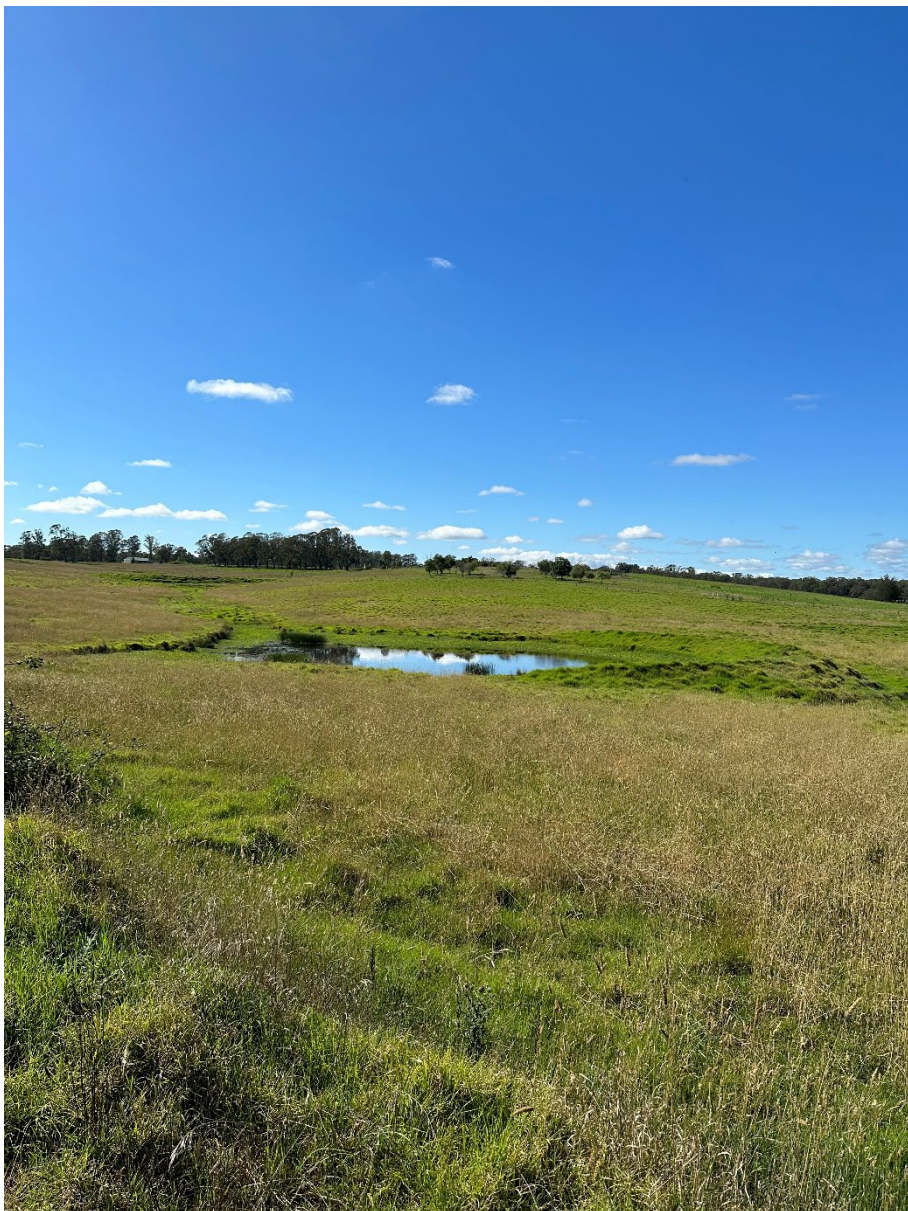
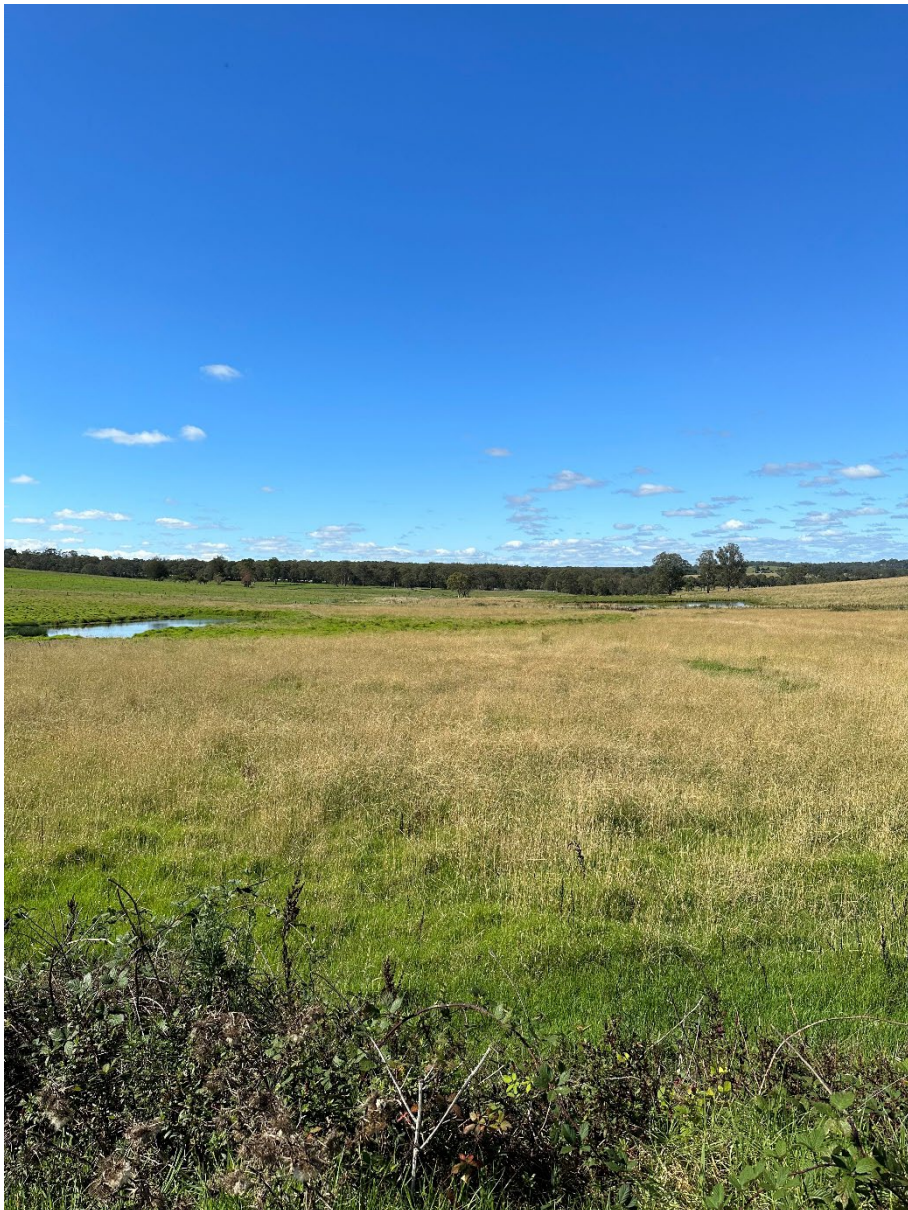
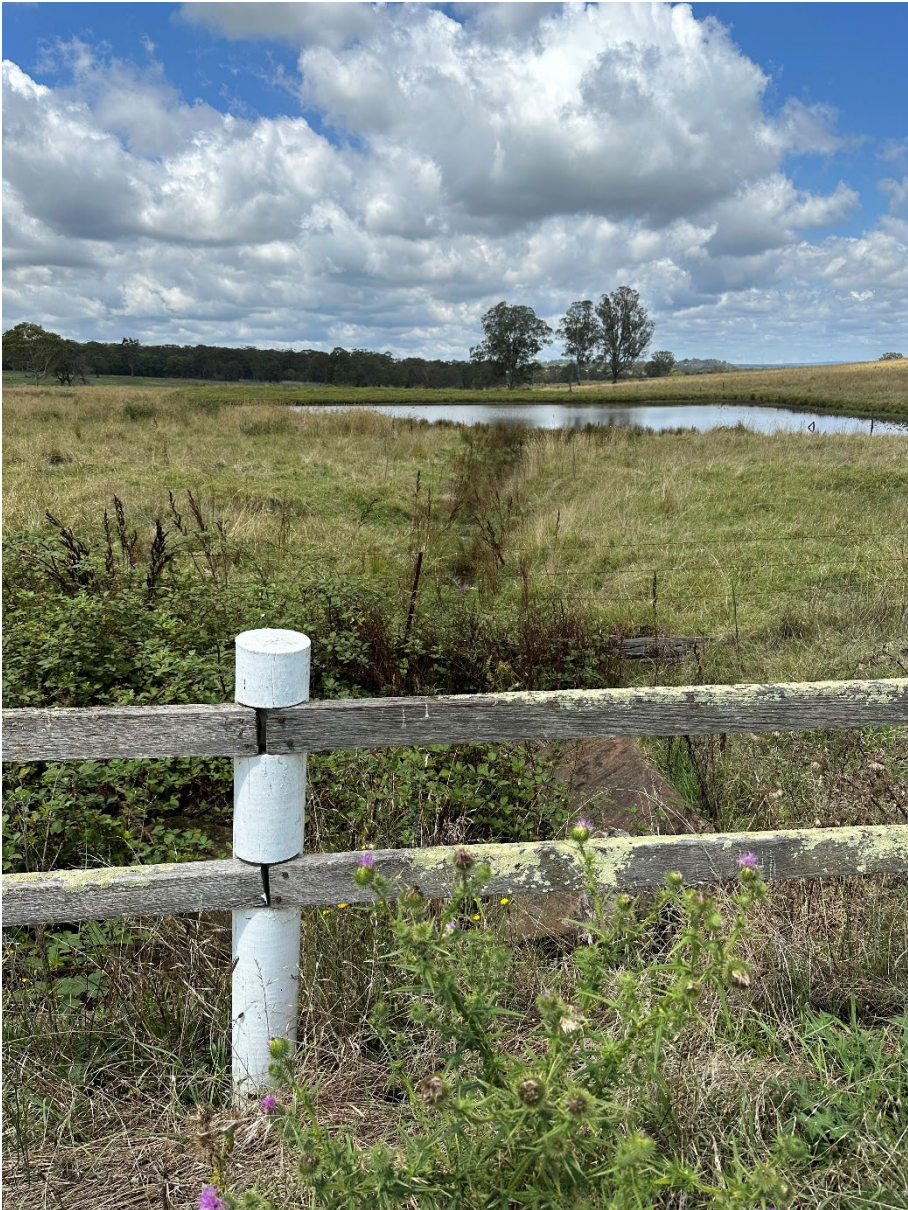
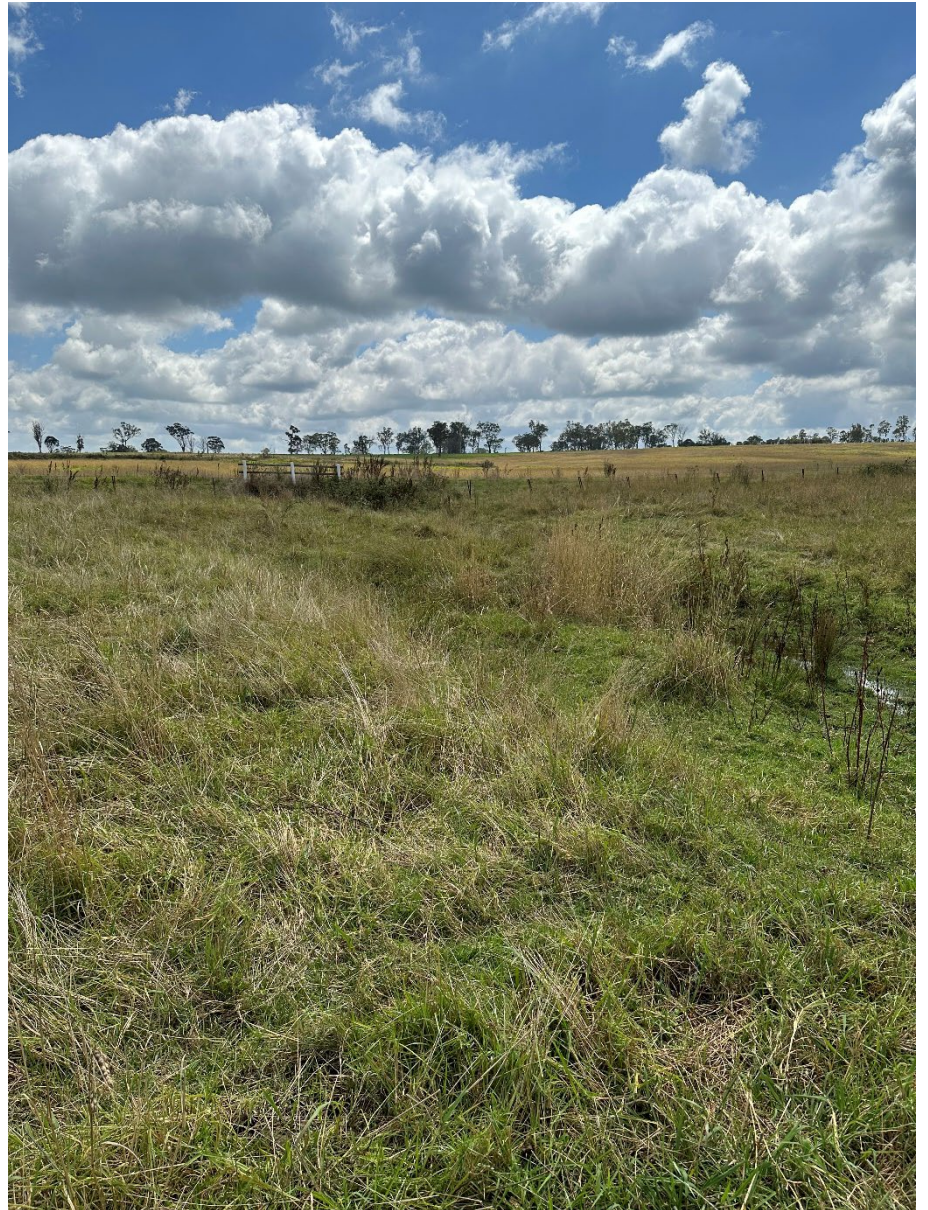
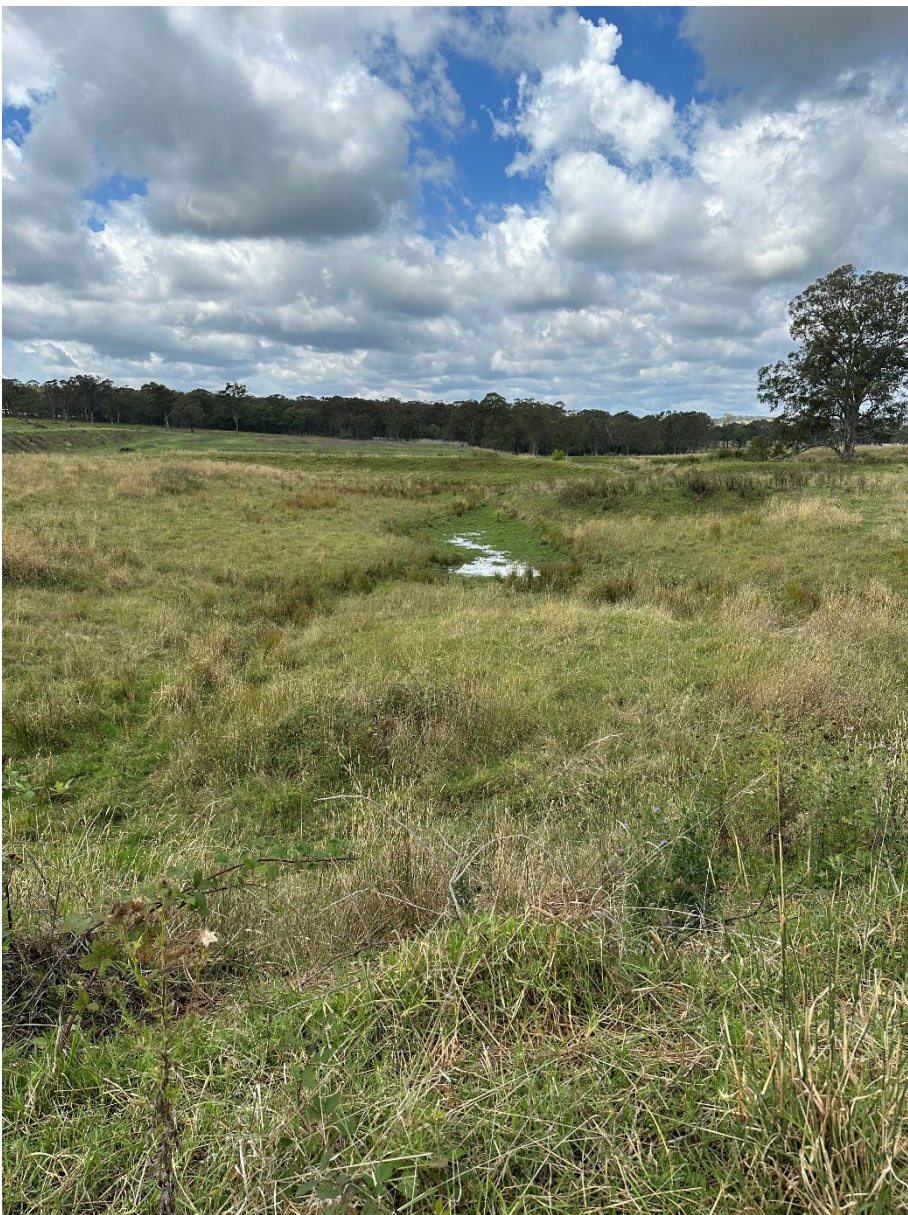
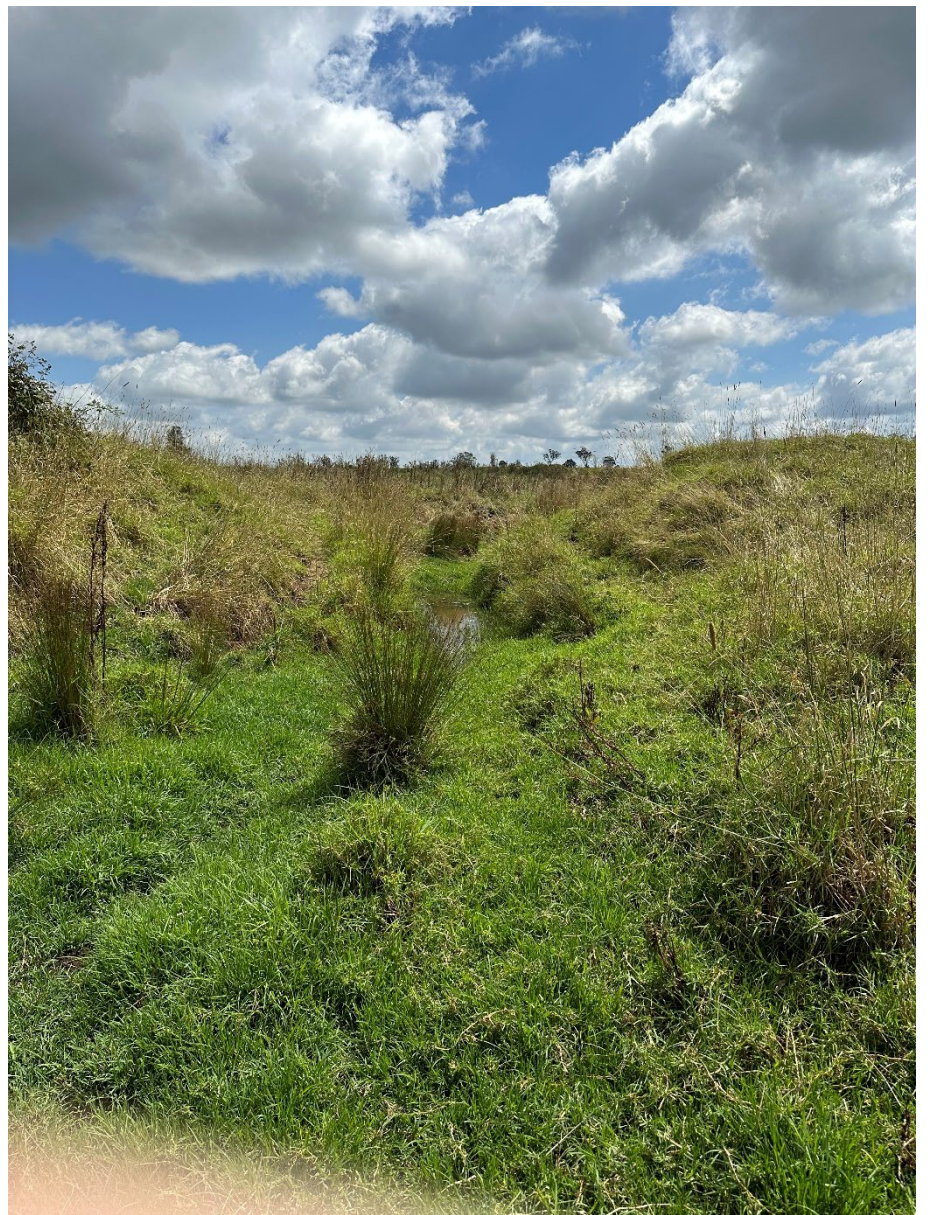
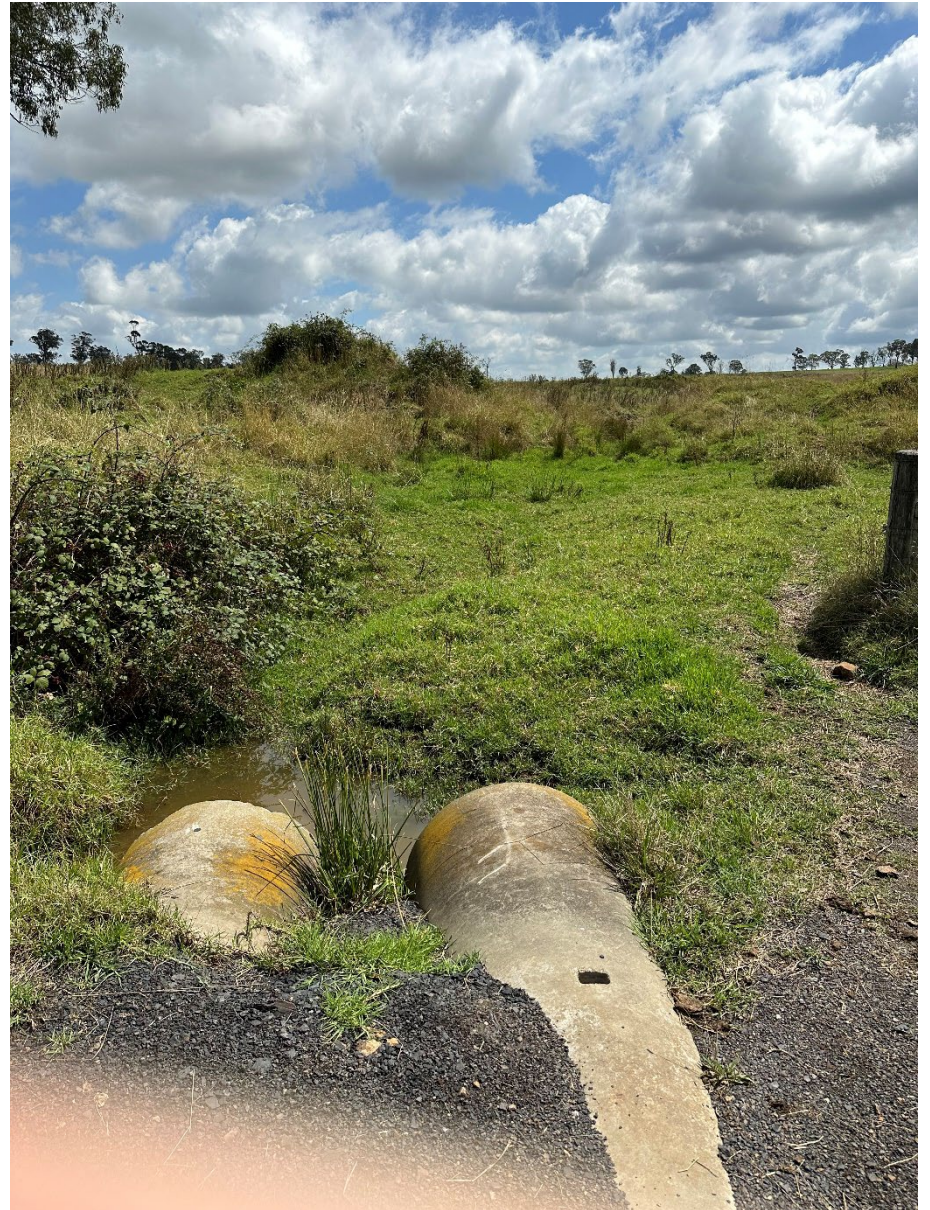
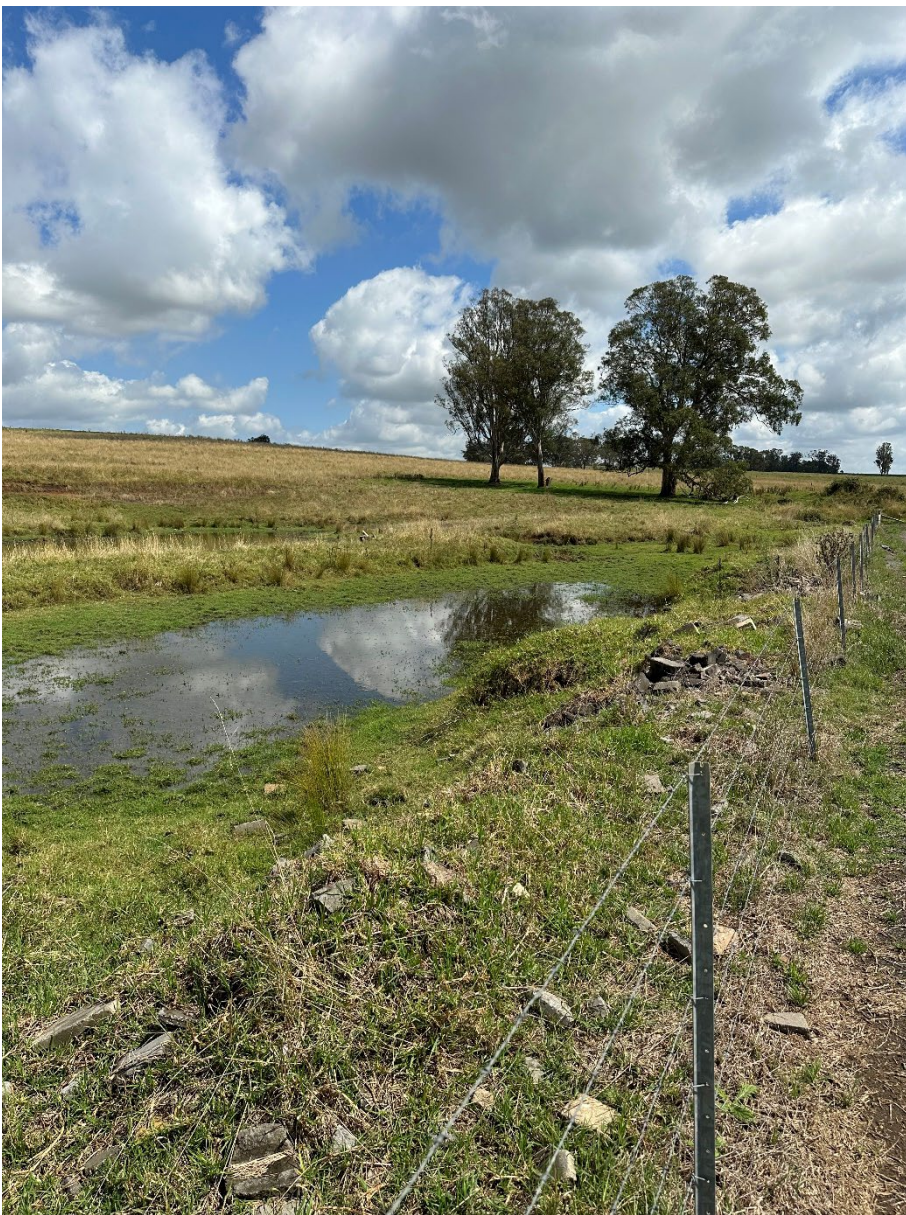
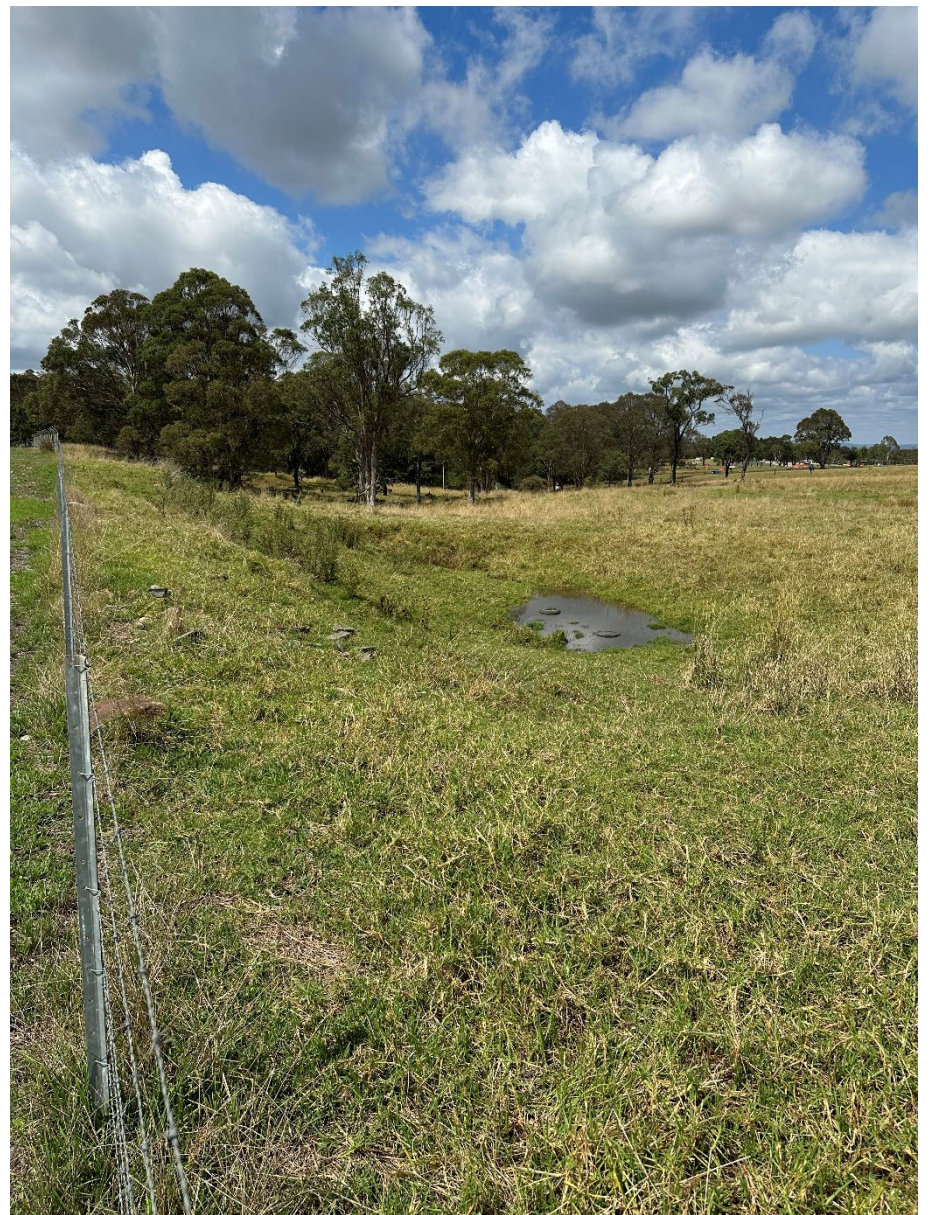
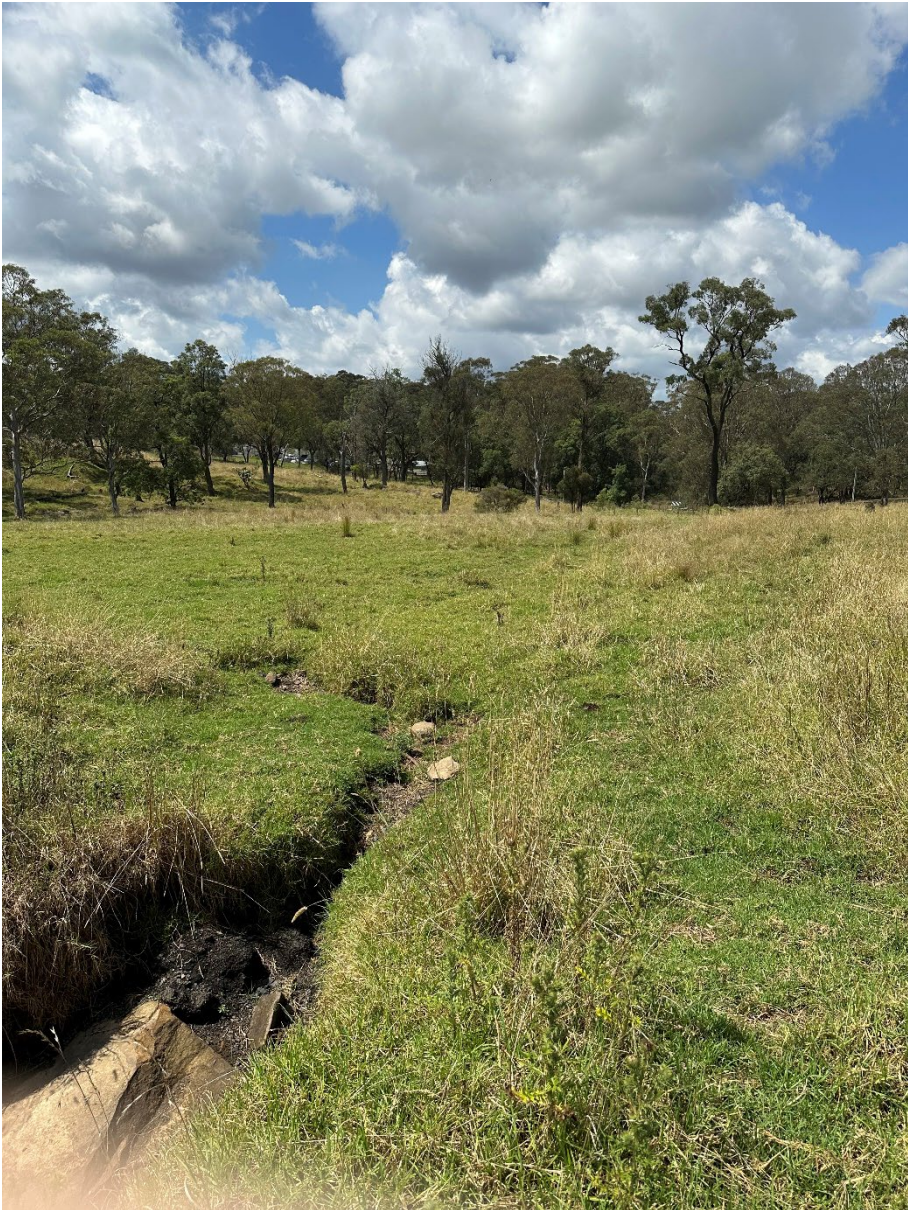
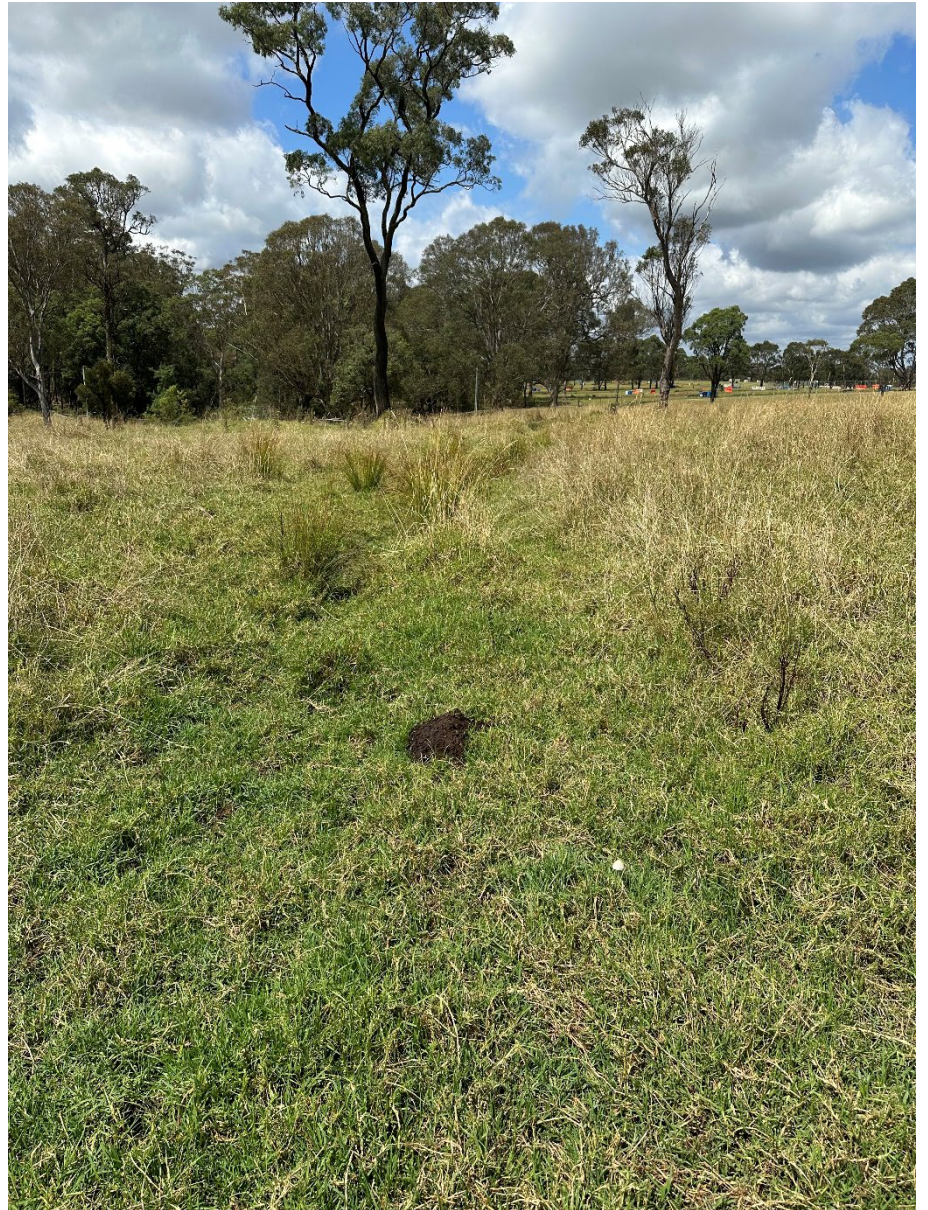
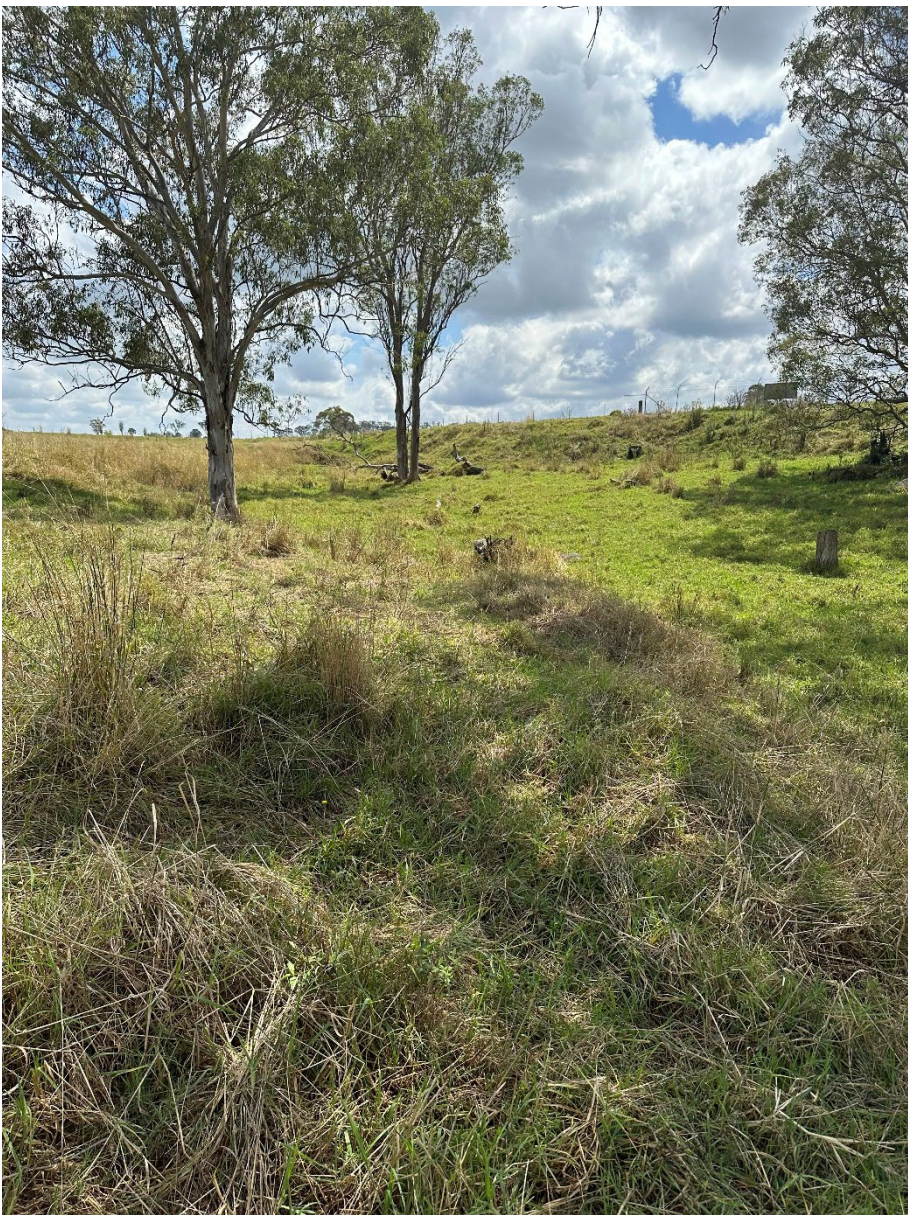
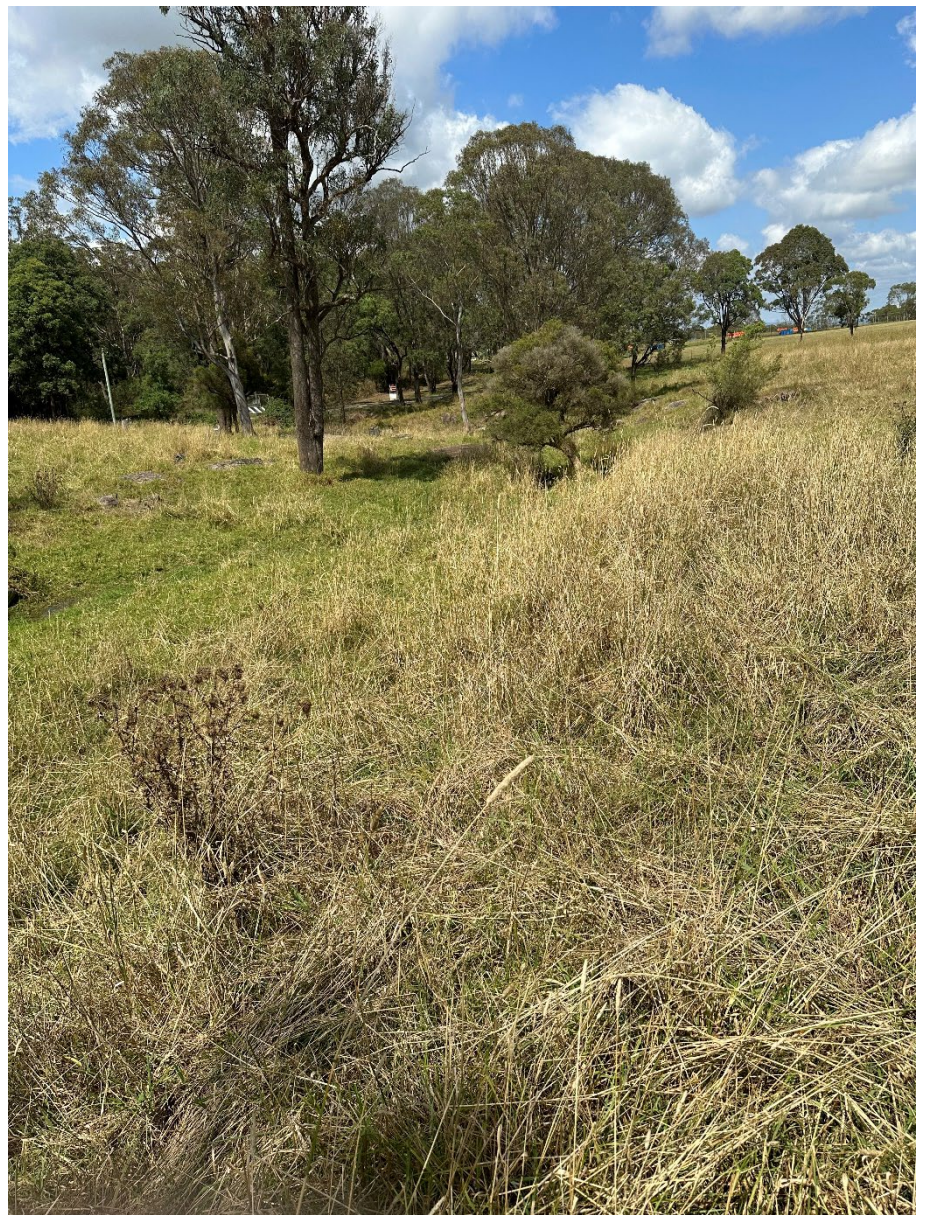
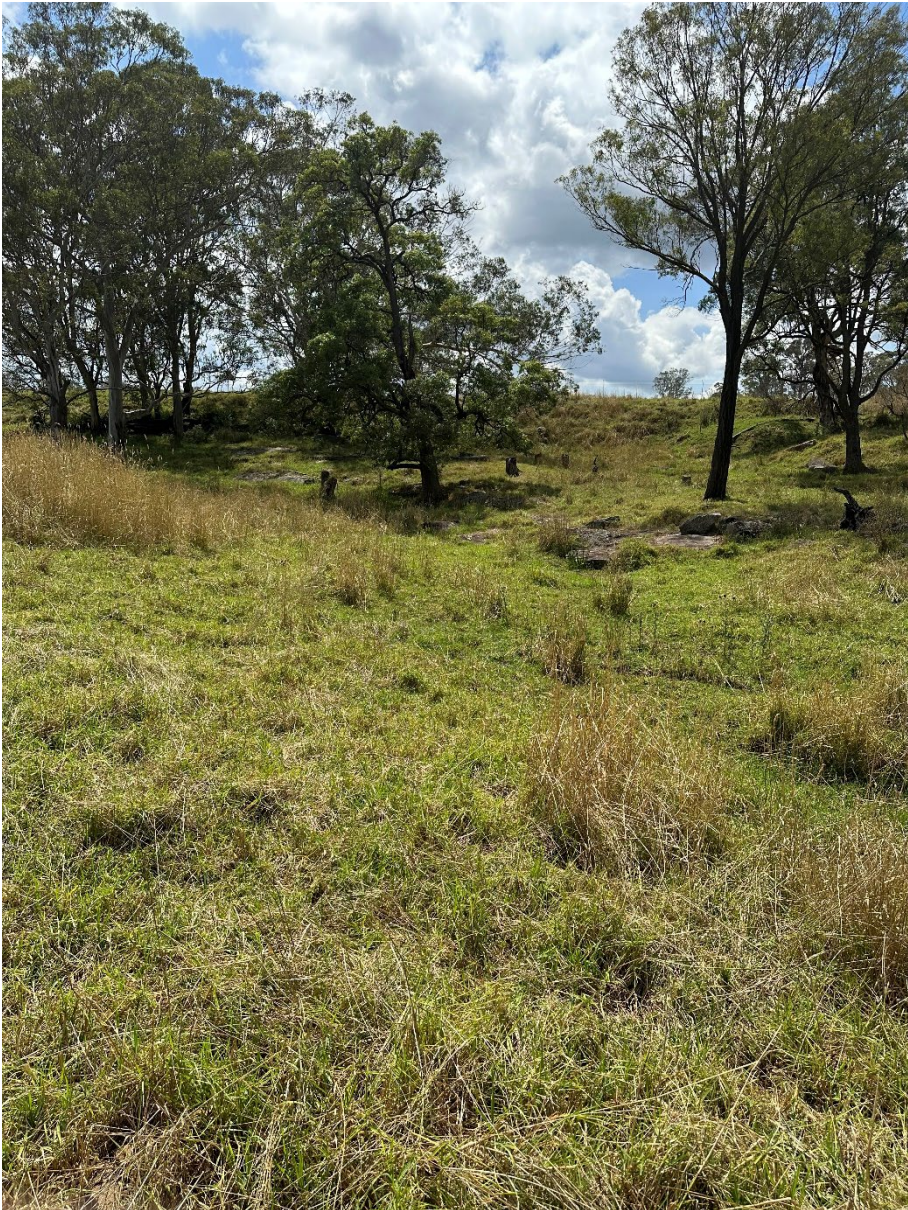
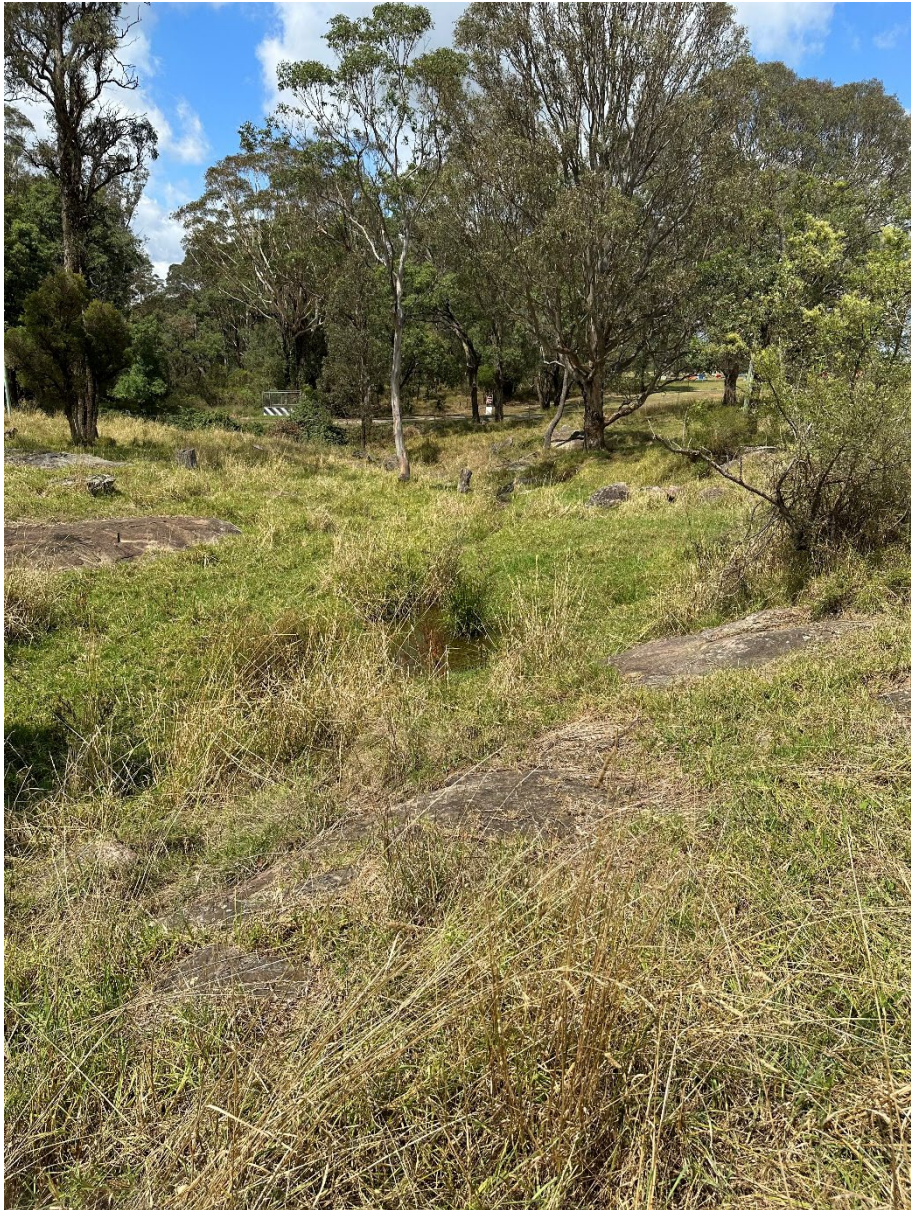
WATERCOURSE 2A

Description	The photos of watercourse 2A generally show limited signs of riparian function. Majority of the watercourse consists of natural depressions (no creek bed or banks) which in a lot of cases do not align with the mapped hydrolines.
Watercourse order	2 nd order
Does the watercourse have a defined bed or bank?	No
Watercourse Features (NRAR Waterfront Land Tool – Appendix 6)	None

Result: Controlled activity approval not required–No watercourse

- There is no bed or bank
- There are no watercourse features

Outcome: Watercourse 2A is proposed to be realigned and rejuvenated to provide an improved ecological value to the waterway

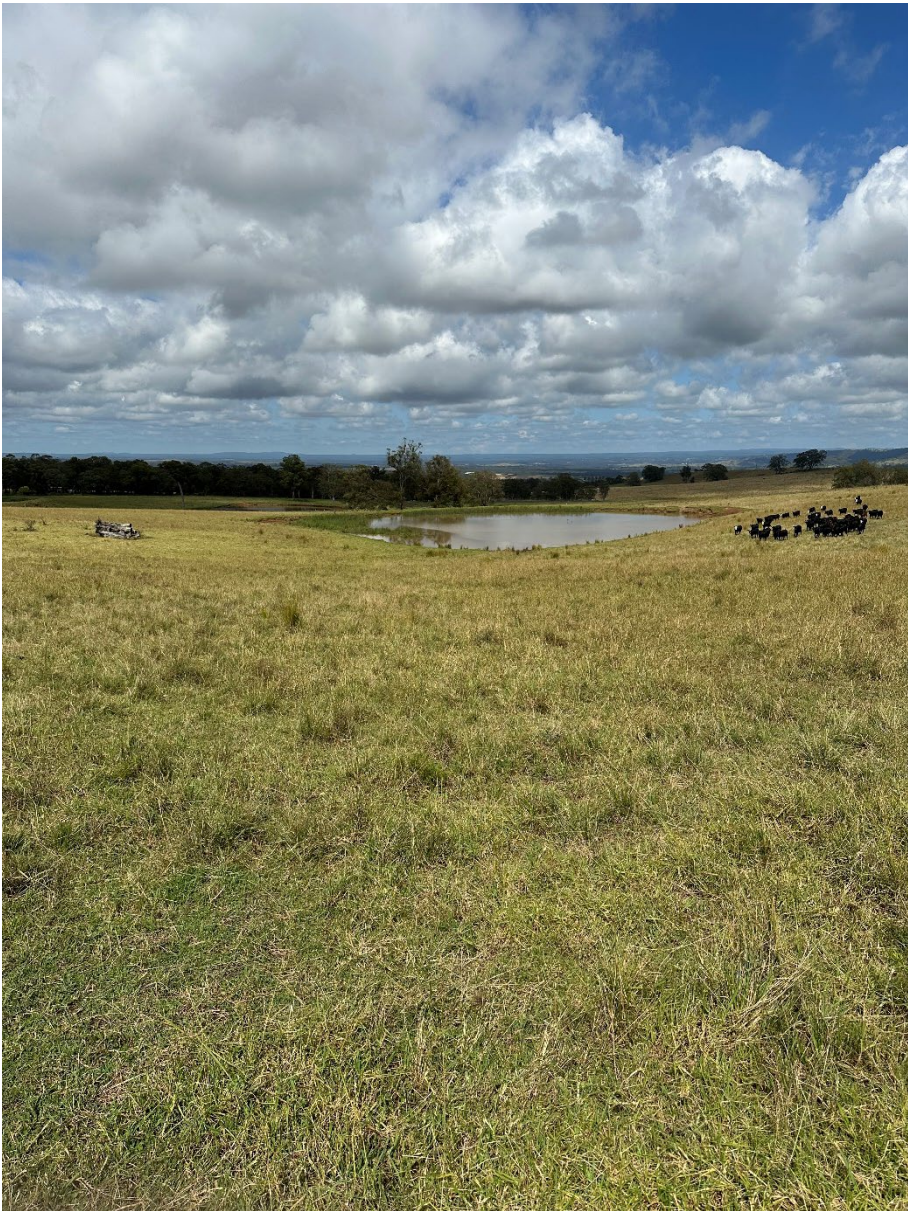
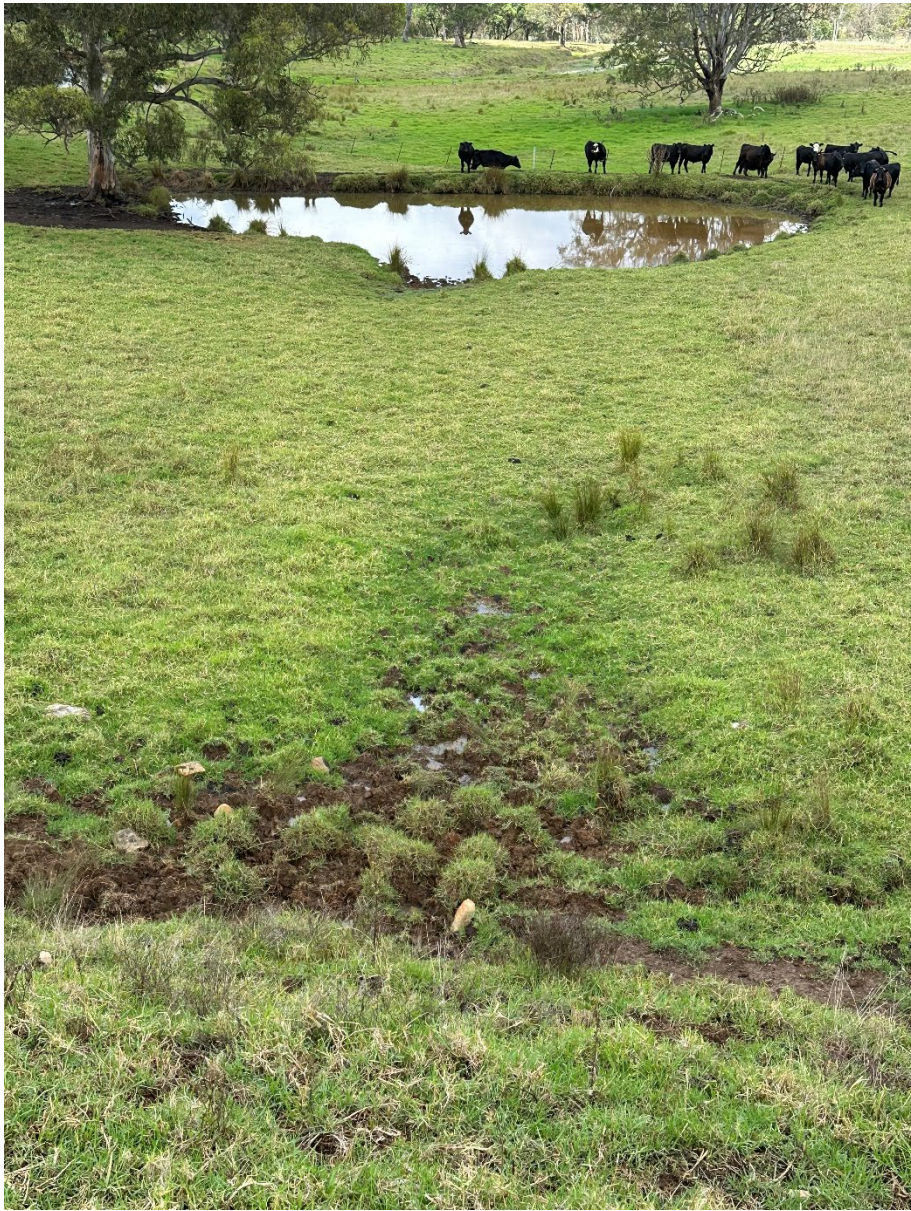
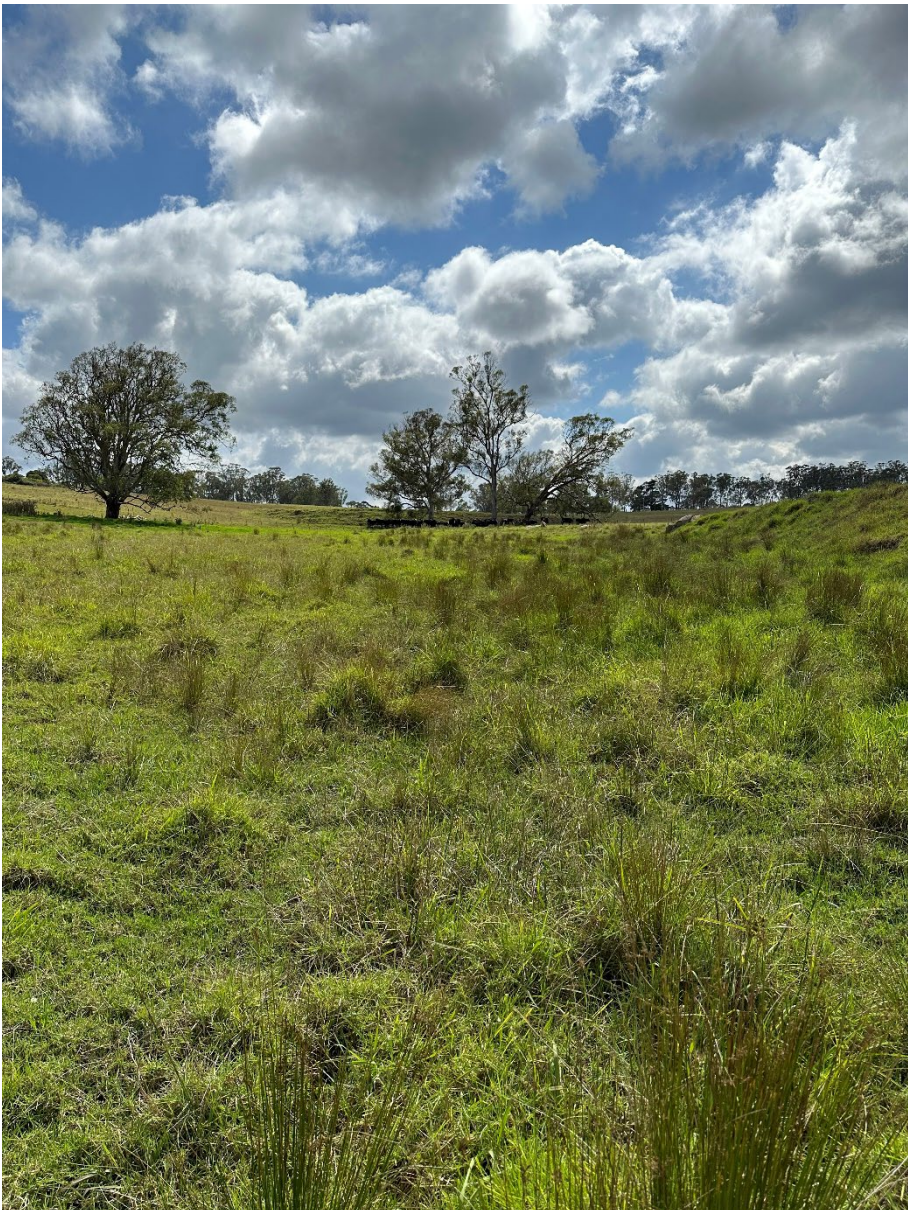
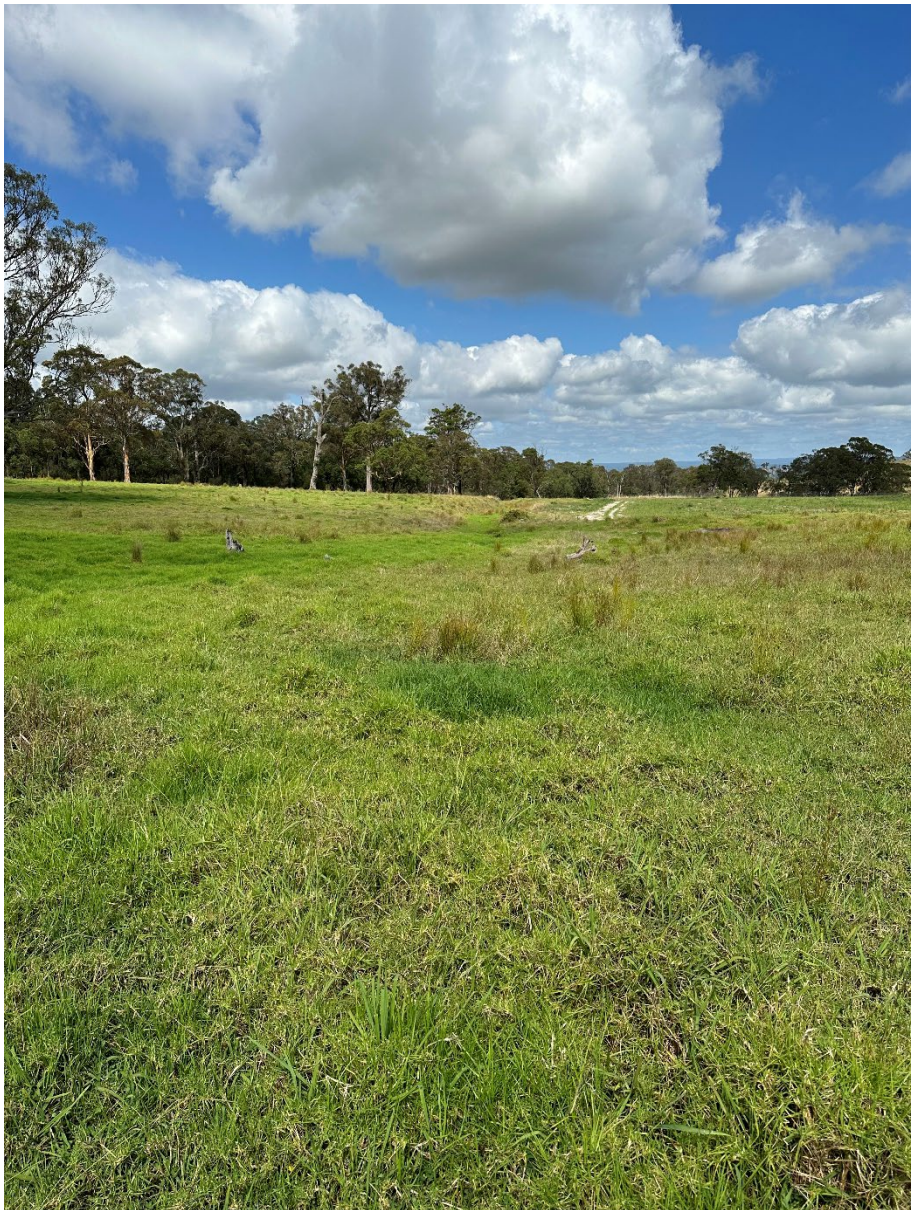
WATERCOURSE 1C

The photos of watercourse 1C show an open clearing with tall pasture grass (no tree). Local depression in terrain with no defined

creek bed or banks. A series of farm dams are online to the watercourse. No riparian function evident.
Watercourse order	1 st order
Does the watercourse have a defined bed or bank?	No
Watercourse Features (NRAR Waterfront Land Tool – Appendix 6)	None

Result: Controlled activity approval not required–No watercourse

Outcome: Watercourse 1C is proposed to be removed in the proposed development and will be replaced by traditional road drainage networks
