Subject: 345 Appin Road, Appin Planning Proposal – Riparian Assessment

Thank you for the opportunity to prepare this riparian assessment of the watercourses at 345 Appin Road, Appin (the subject site) to support the planning proposal for the North Appin (Part) Precinct.

Attachment B – Riparian Assessment Matrix

345 Appin Road, Appin Riparian Assessment

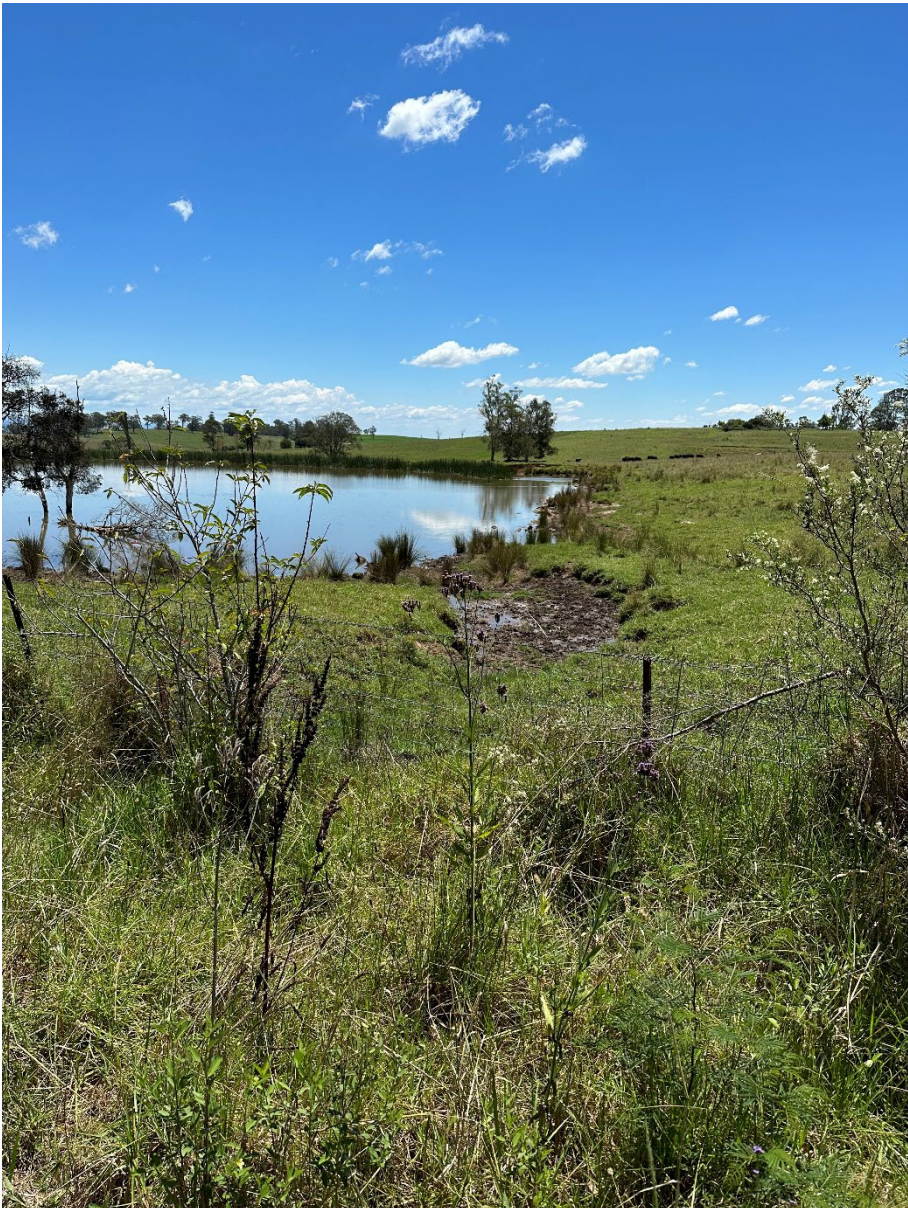
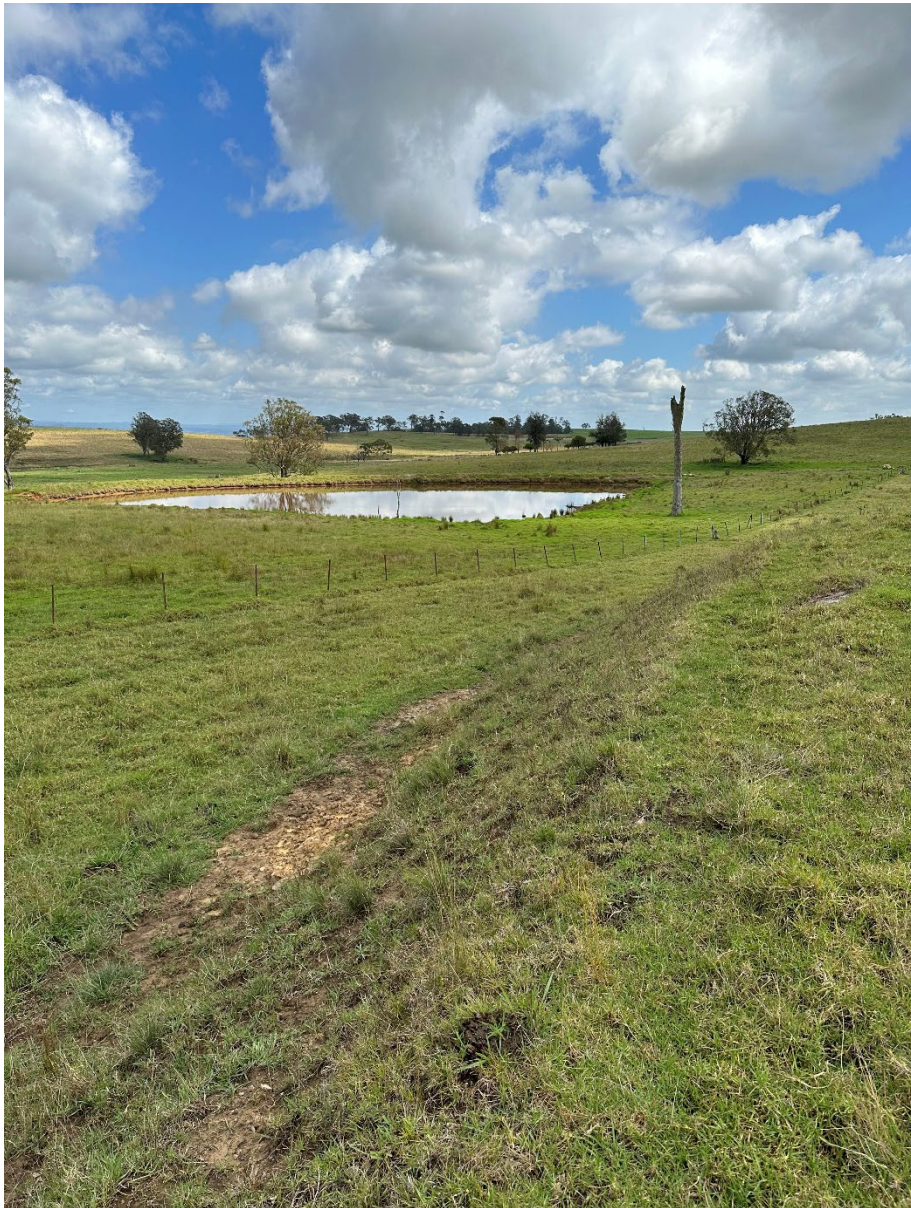
WATERCOURSE 1D

Description	The photos of watercourse 1D show cascading farm dams D9 and D10 with minimal riparian connectivity in between. No defined creek bed or banks. No riparian function evident.
Watercourse order	1 st order
Does the watercourse have a defined bed or bank?	No
Watercourse Features (NRAR Waterfront Land Tool – Appendix 6)	None

Result: Controlled activity approval not required–No watercourse

Outcome: Watercourse 1D is proposed to be removed in the proposed development and will be replaced by traditional road drainage networks

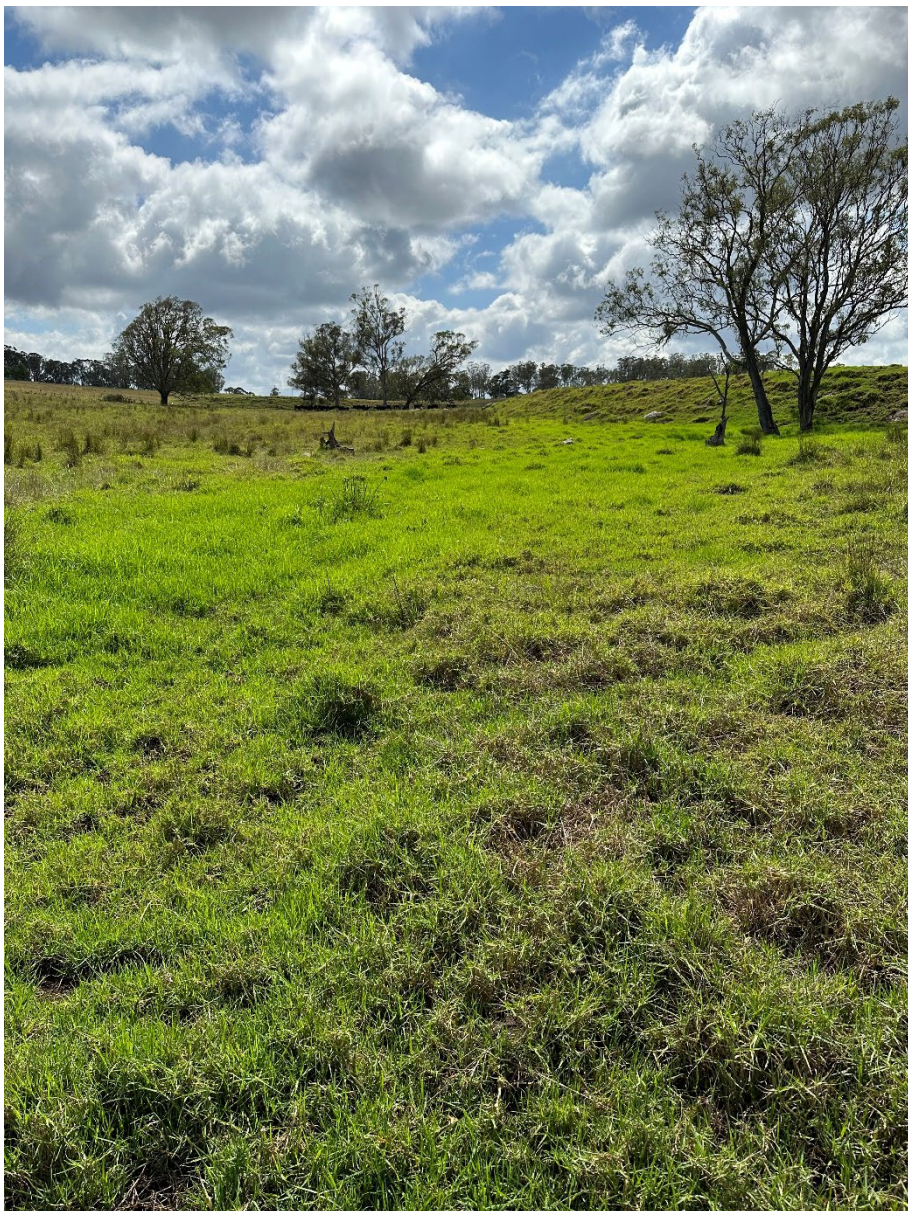
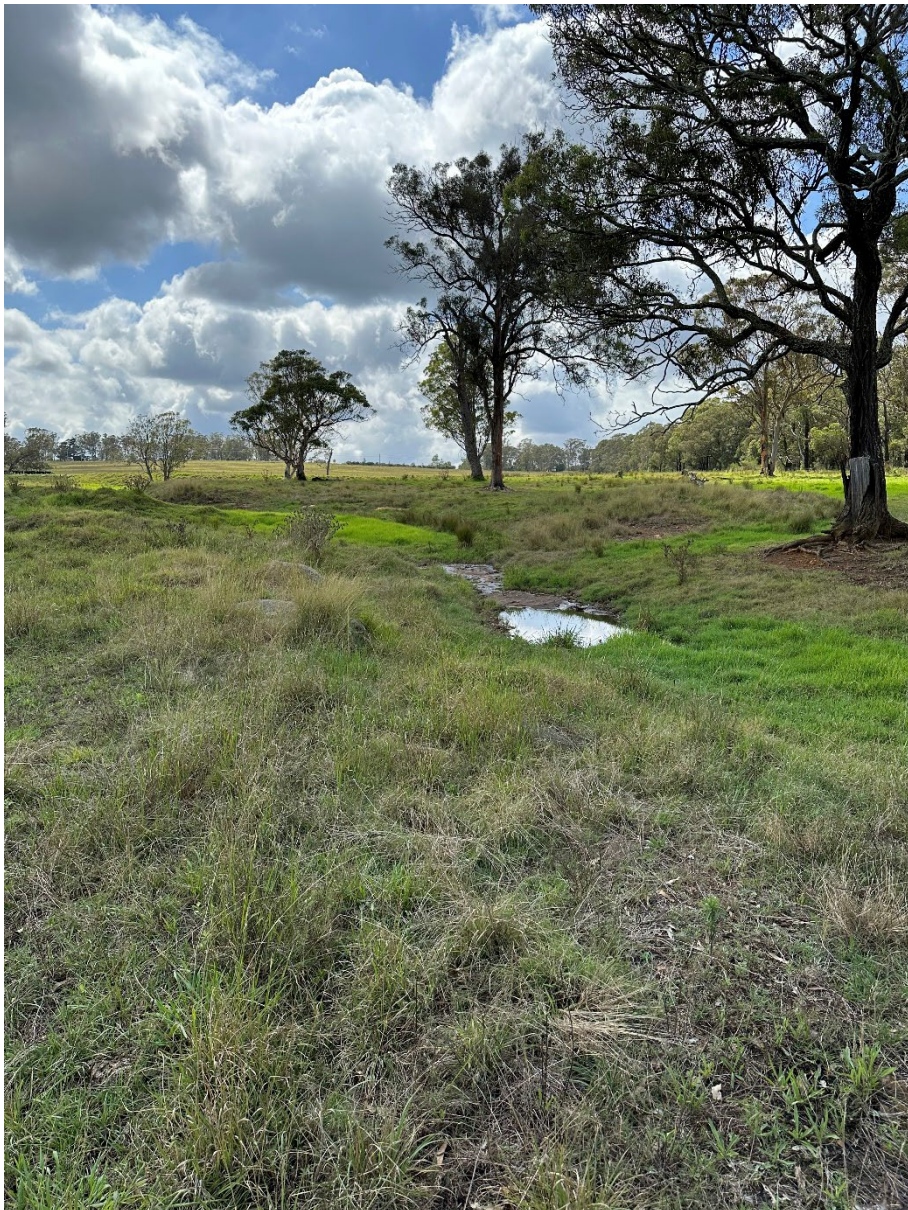
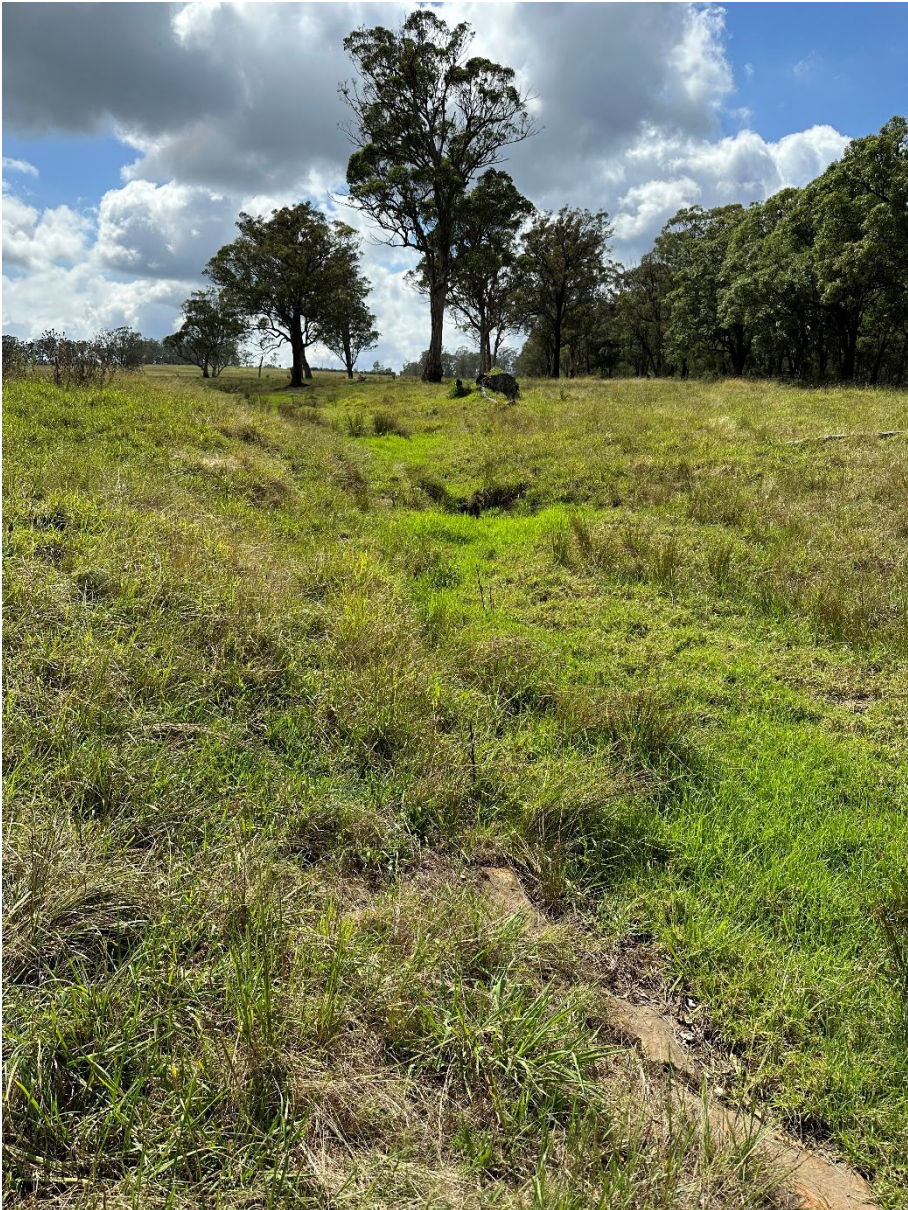
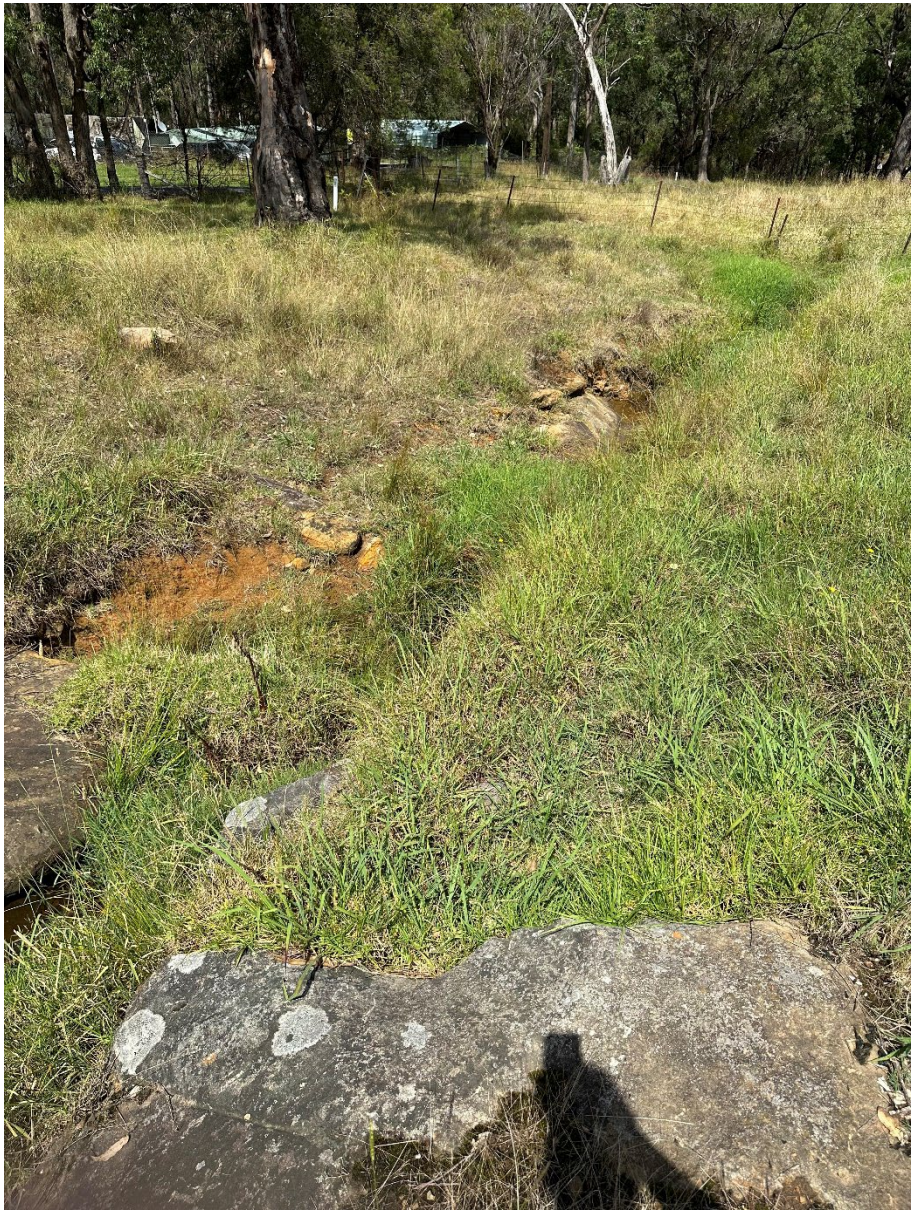
WATERCOURSE 2B

Description	The photos of watercourse 2B show signs of a watercourse with evidence of erosion in the creek bed and pools of stagnant water. It should be noted that rainfall occurred in the days prior to the site visit. There is minimal riparian vegetation in the creek bed.
Watercourse order	2 nd order
Does the watercourse have a defined bed or bank?	No
Watercourse Features (NRAR Waterfront Land Tool – Appendix 6)	Yes – Pools and erosion
High bank of the watercourse (NRAR Waterfront Land Tool – Appendix 8)	Type 4 – Laterally Unconfined Discontinuous
Are the proposed works located within 40 metres of the high bank?	Yes

Result: Controlled activity approval is required
One or more of the following features are on this property or a neighbouring property:

The proposed works are located within 40 metres of the high bank of the watercourse

Outcome: Watercourse 2B is proposed to be realigned in the proposed development and will be replaced by a linear open space alongside Brian Road which will include an overland flowpath. Given the limited ecological value in the location of the existing watercourse, this realignment is considered to be a suitable outcome.

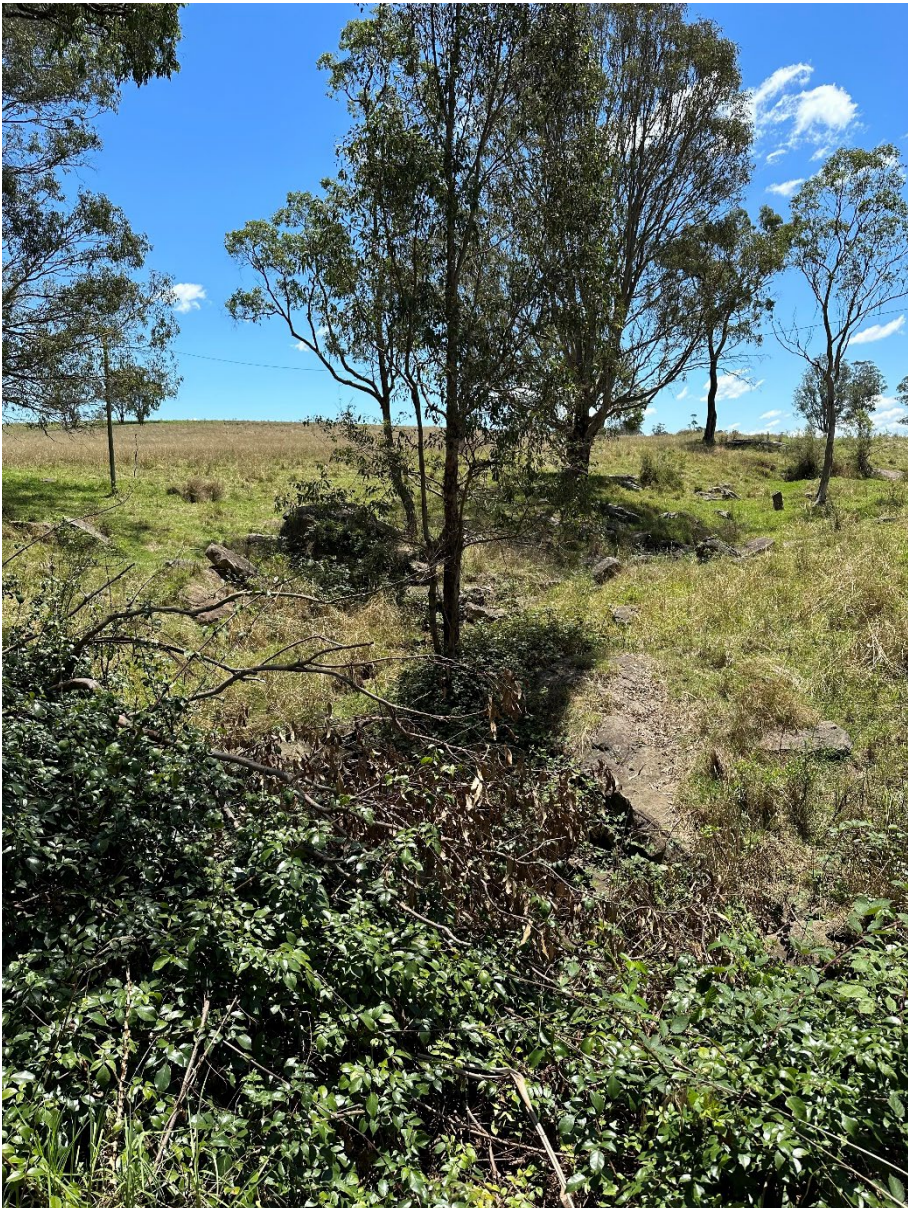
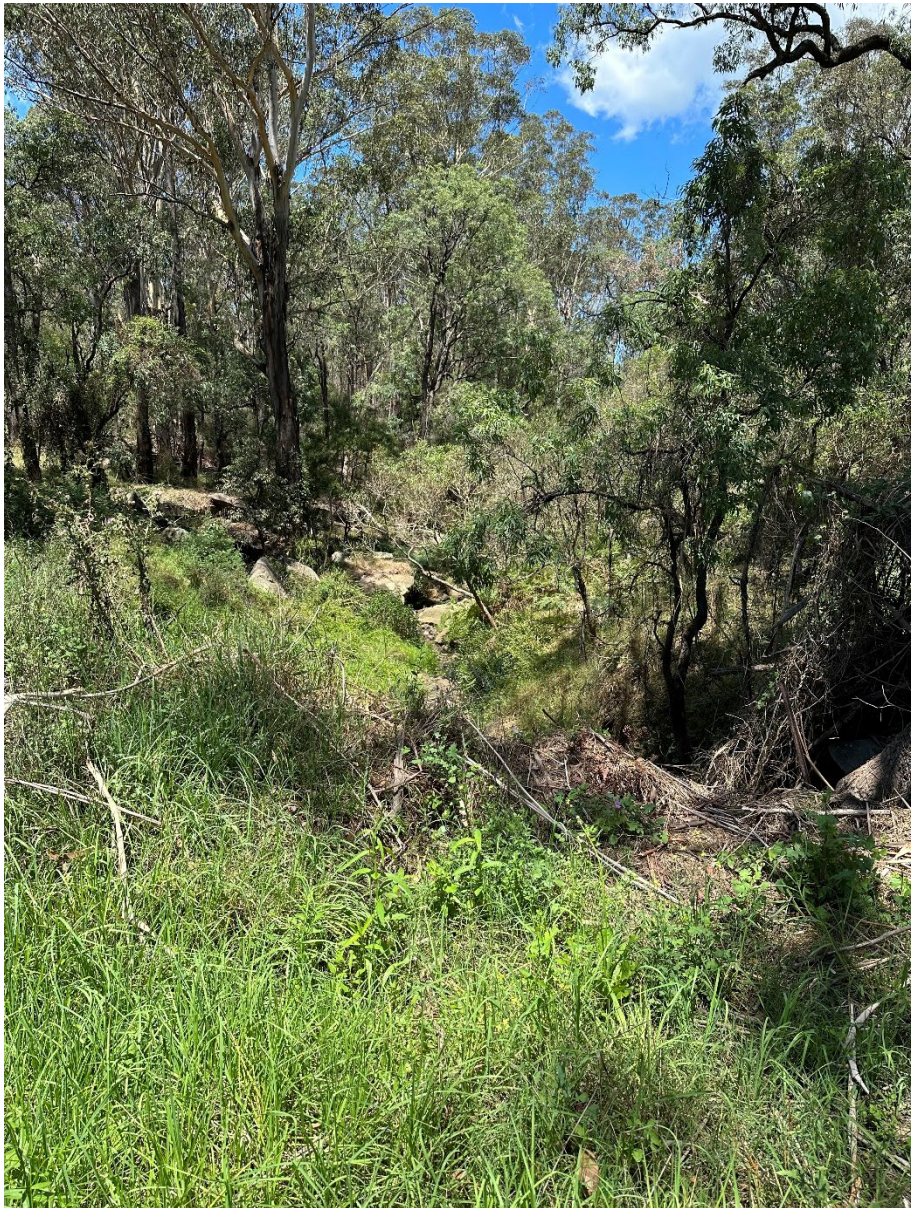
WATERCOURSE 3A

Description	The photos of watercourse 3A show clear signs of a watercourse with evidence of erosion in the creek bed with exposed rock outcrops. The watercourse has clear bed and banks.
Watercourse order	3 rd order
High bank of the watercourse (NRAR Waterfront Land Tool – Appendix 8)	Type 4 – Laterally Unconfined Discontinuous
Are the proposed works located within 40 metres of the high bank?	Yes

Result: Controlled activity approval is required
One or more of the following features are on this property or a neighbouring property:

The proposed works are located within 40 metres of the high bank of the watercourse

Outcome: Watercourse 3A is proposed to be retained in the proposed development

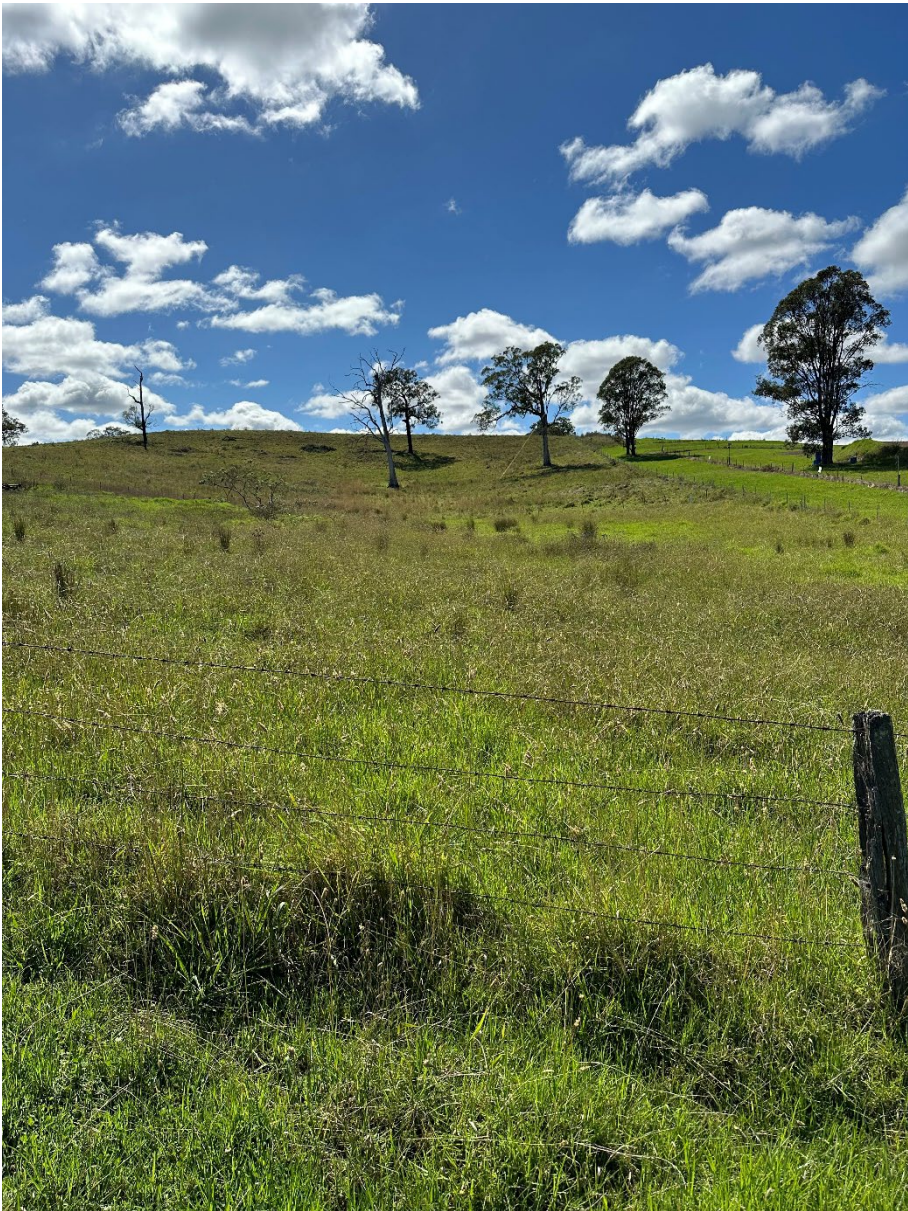
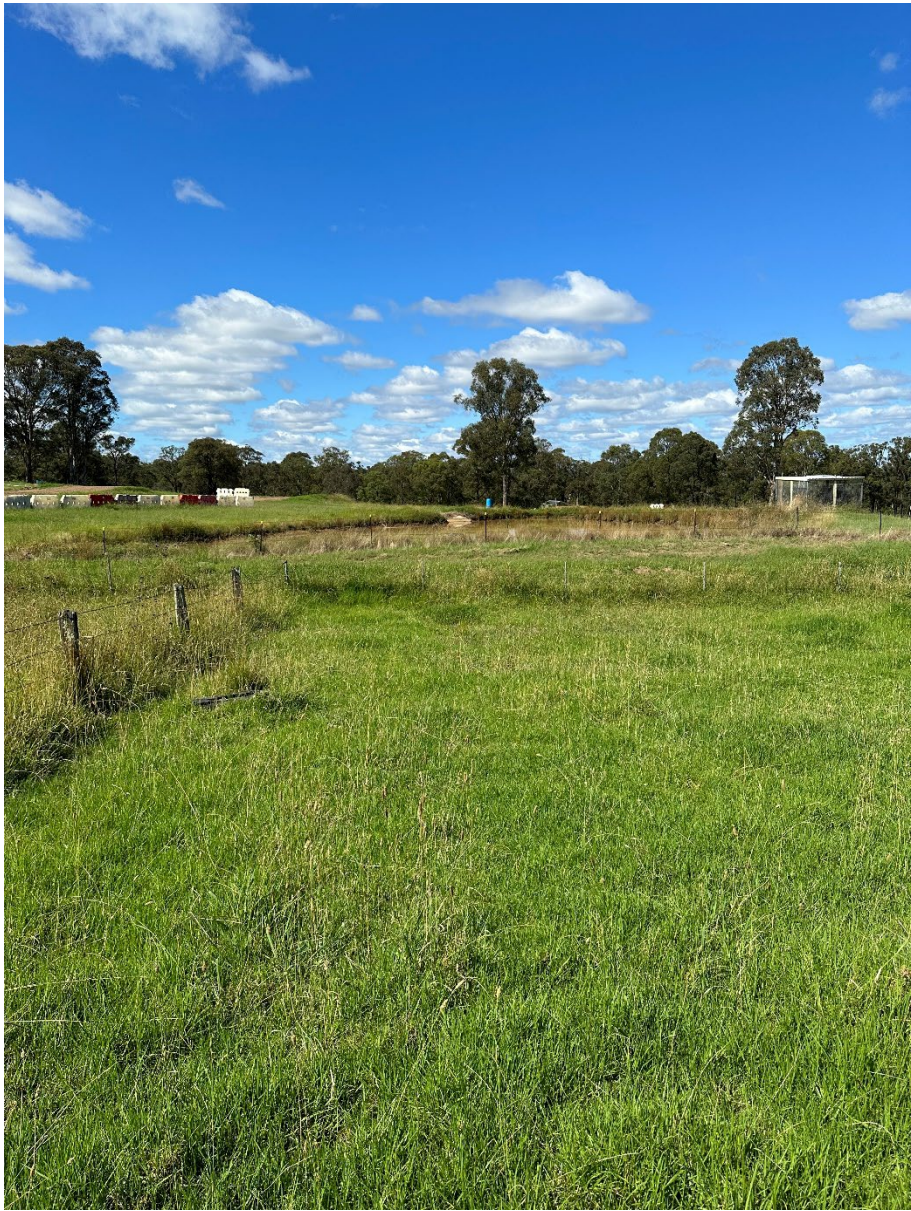
WATERCOURSE 1F

Description	The photos of watercourse 1F show an open clearing with tall pasture grass (no trees). Local depression in terrain with no defined creek bed or banks. No riparian function evident.
Watercourse order	1 st order
Does the watercourse have a defined bed or bank?	No
Watercourse Features (NRAR Waterfront Land Tool – Appendix 6)	None

Result: Controlled activity approval not required–No watercourse

Outcome: Watercourse 1F is proposed to be removed in the proposed development and will be replaced by traditional road drainage networks

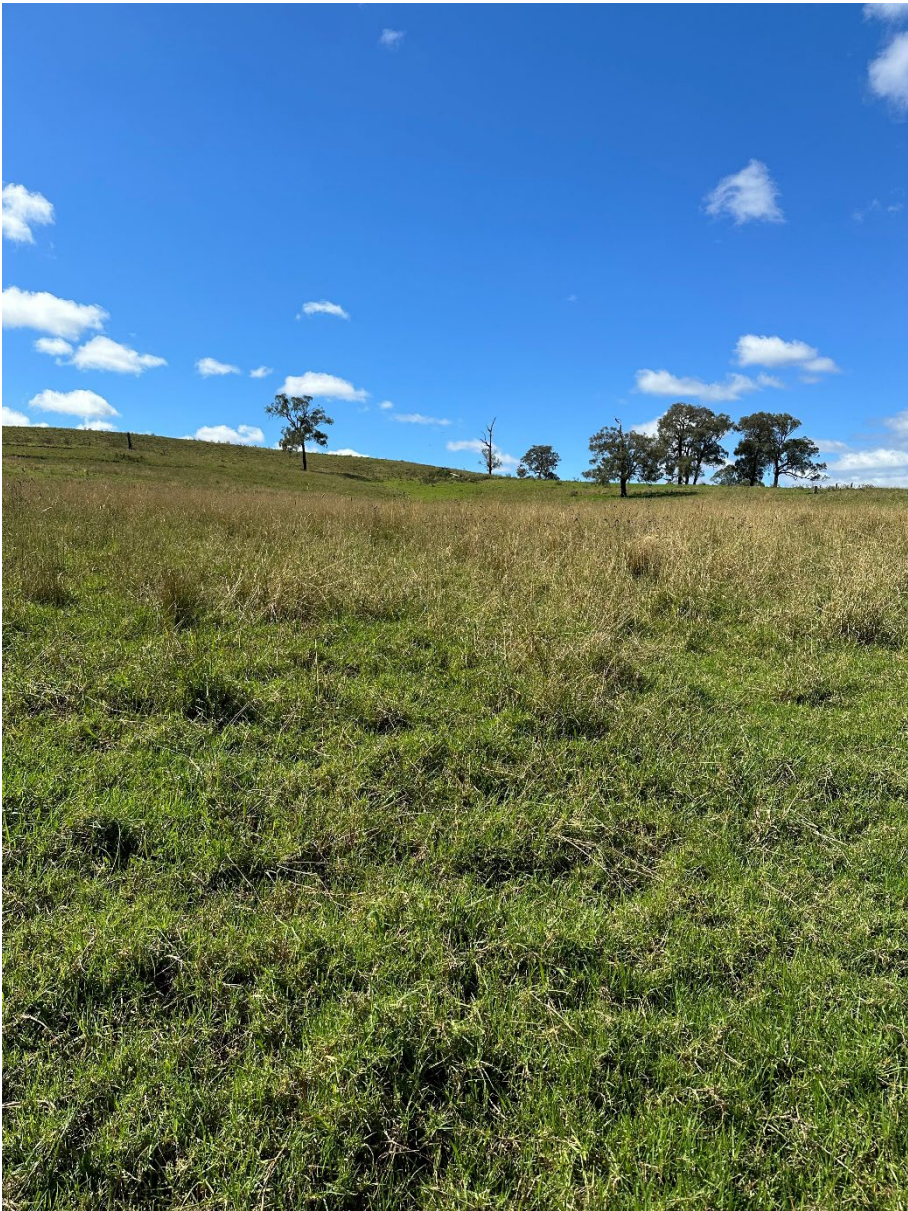
Location 28 (Looking Upstream)

Description	The photos of watercourse 1G show an open clearing with tall pasture grass (no trees). Local depression in terrain with no defined creek bed or banks. No riparian function evident.
Watercourse order	1 st order
Does the watercourse have a defined bed or bank?	No
Watercourse Features (NRAR Waterfront Land Tool – Appendix 6)	None

Result: Controlled activity approval not required–No watercourse

Outcome: Watercourse 1G is proposed to be removed in the proposed development and will be replaced by traditional road drainage networks

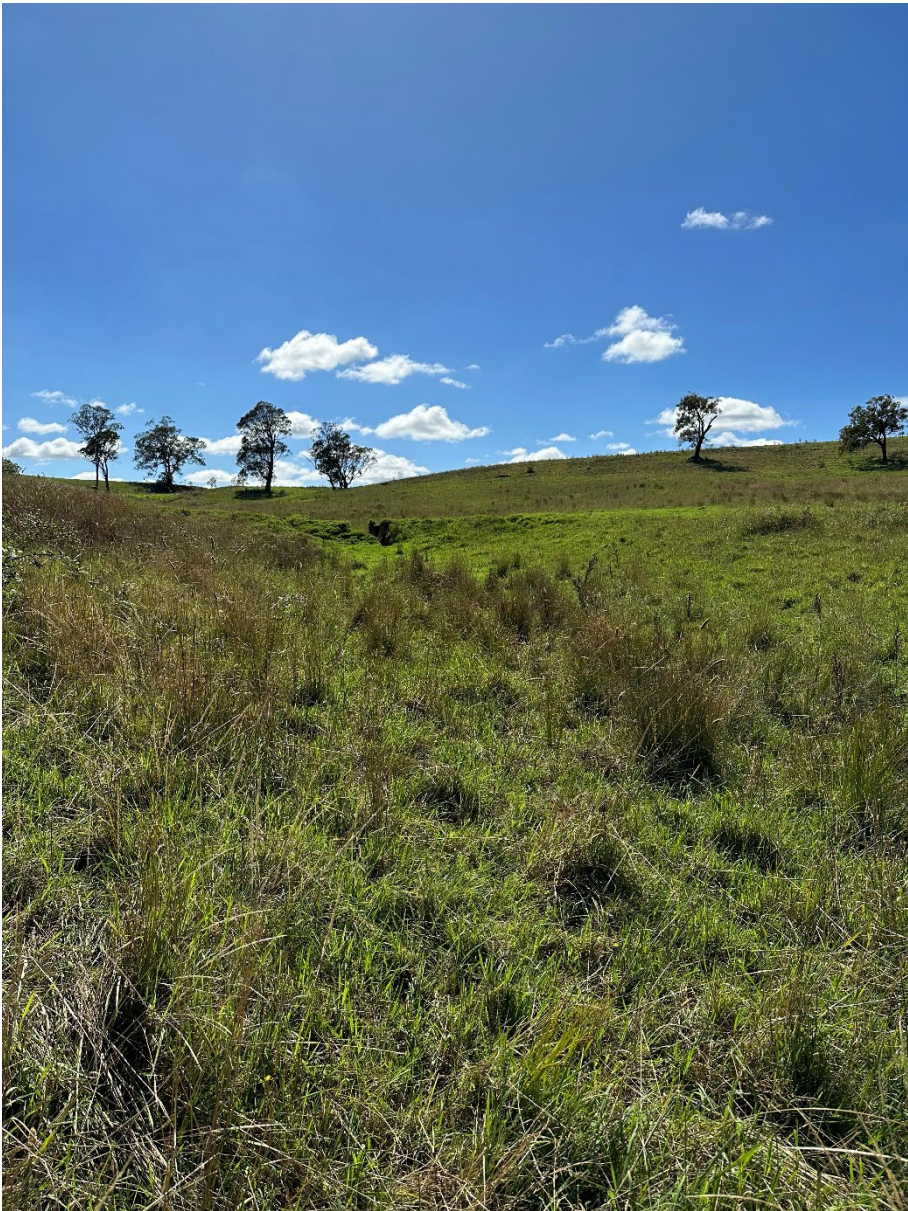
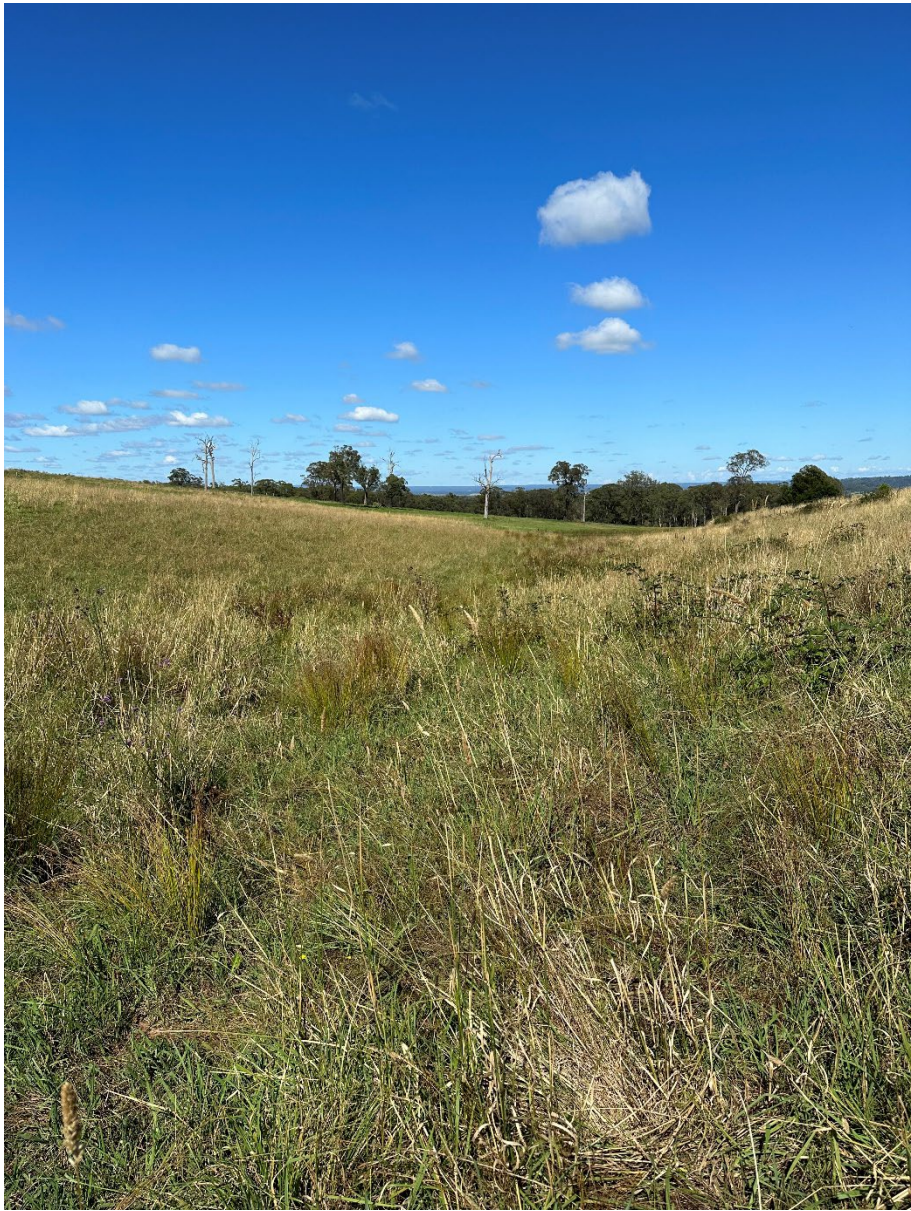
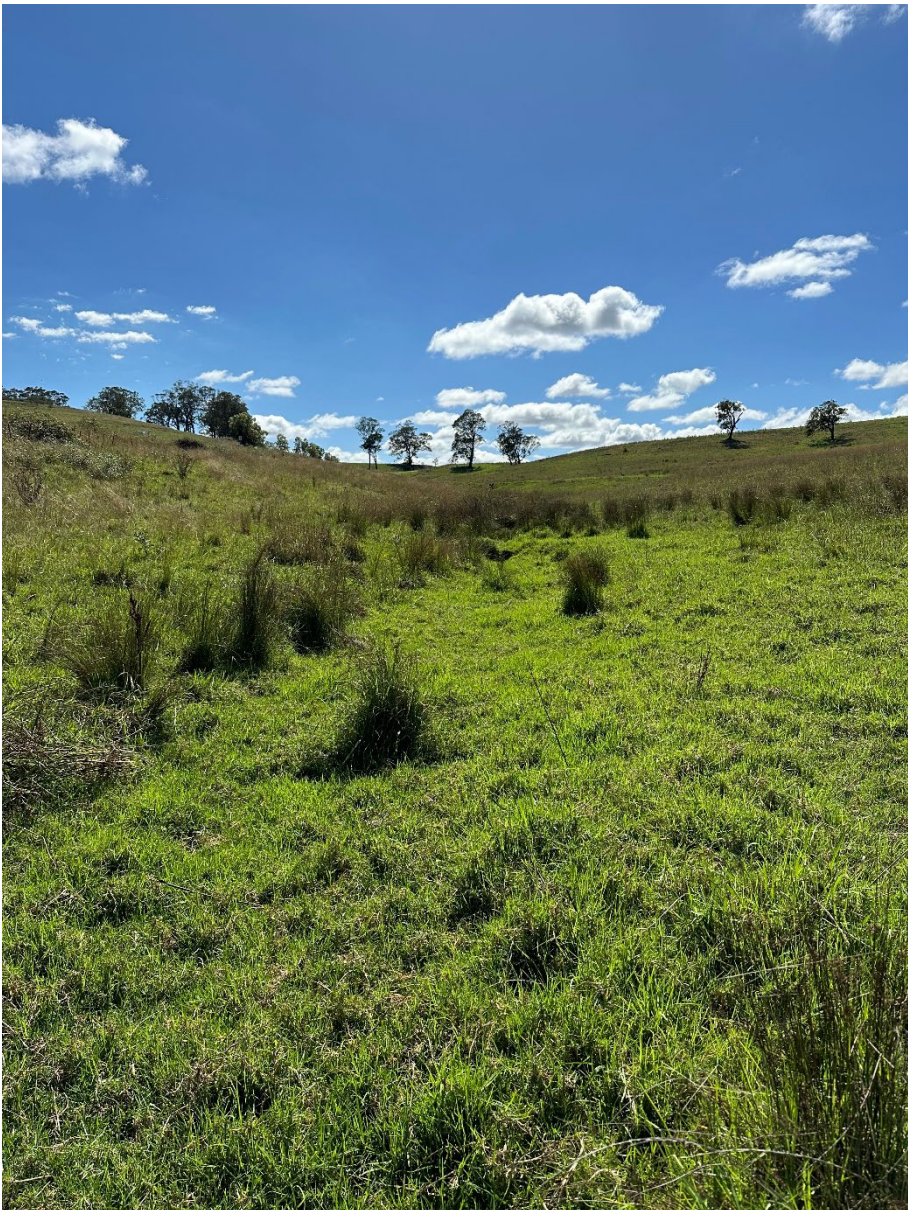
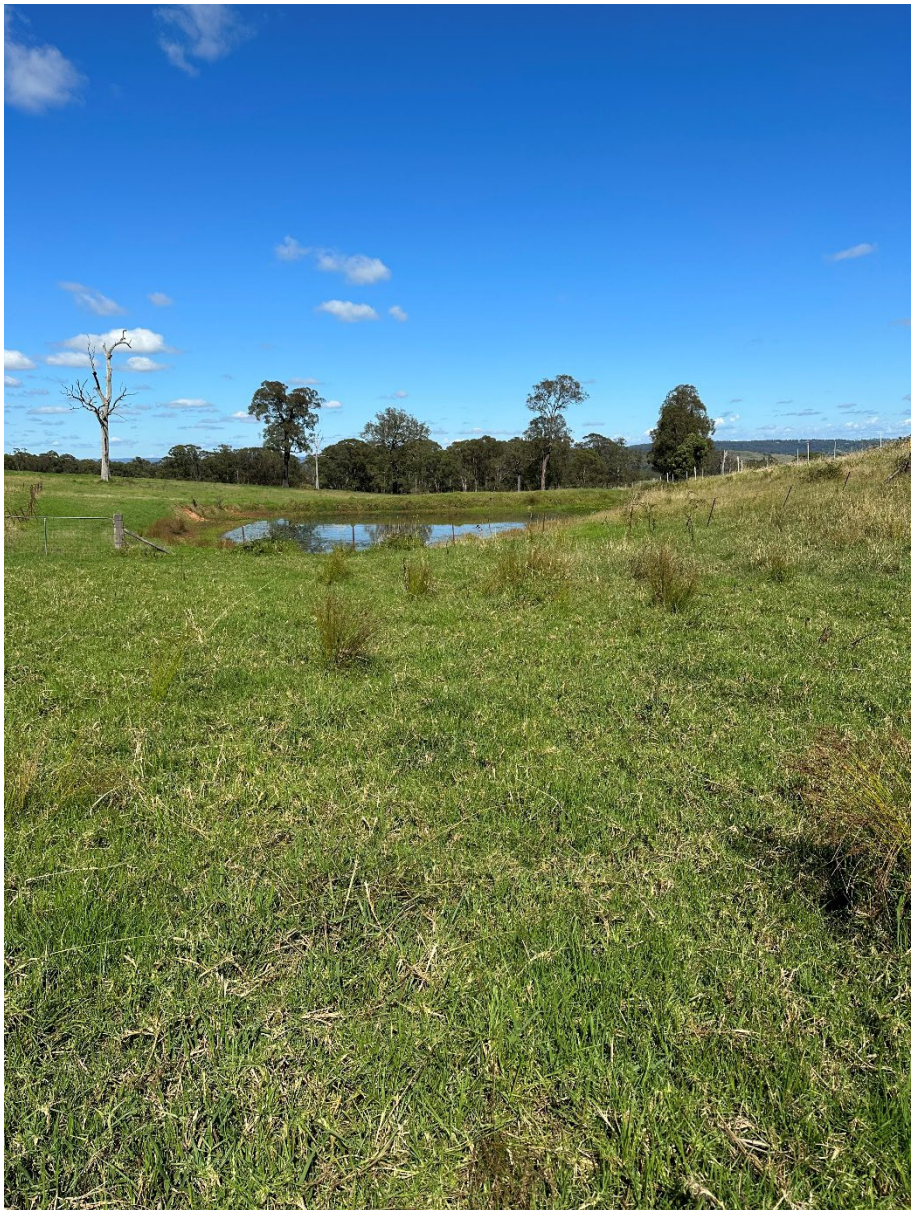
WATERCOURSE 1H

The photos of watercourse 1H show an open clearing with tall pasture grass (no trees). Local depression in terrain with no defined

creek bed or banks. Minimal riparian connectivity between farm dams.
Watercourse order	1 st order
Does the watercourse have a defined bed or bank?	No
Watercourse Features (NRAR Waterfront Land Tool – Appendix 6)	None

Result: Controlled activity approval not required–No watercourse

Outcome: Watercourse 1H is proposed to be removed in the proposed development and will be replaced by traditional road drainage networks

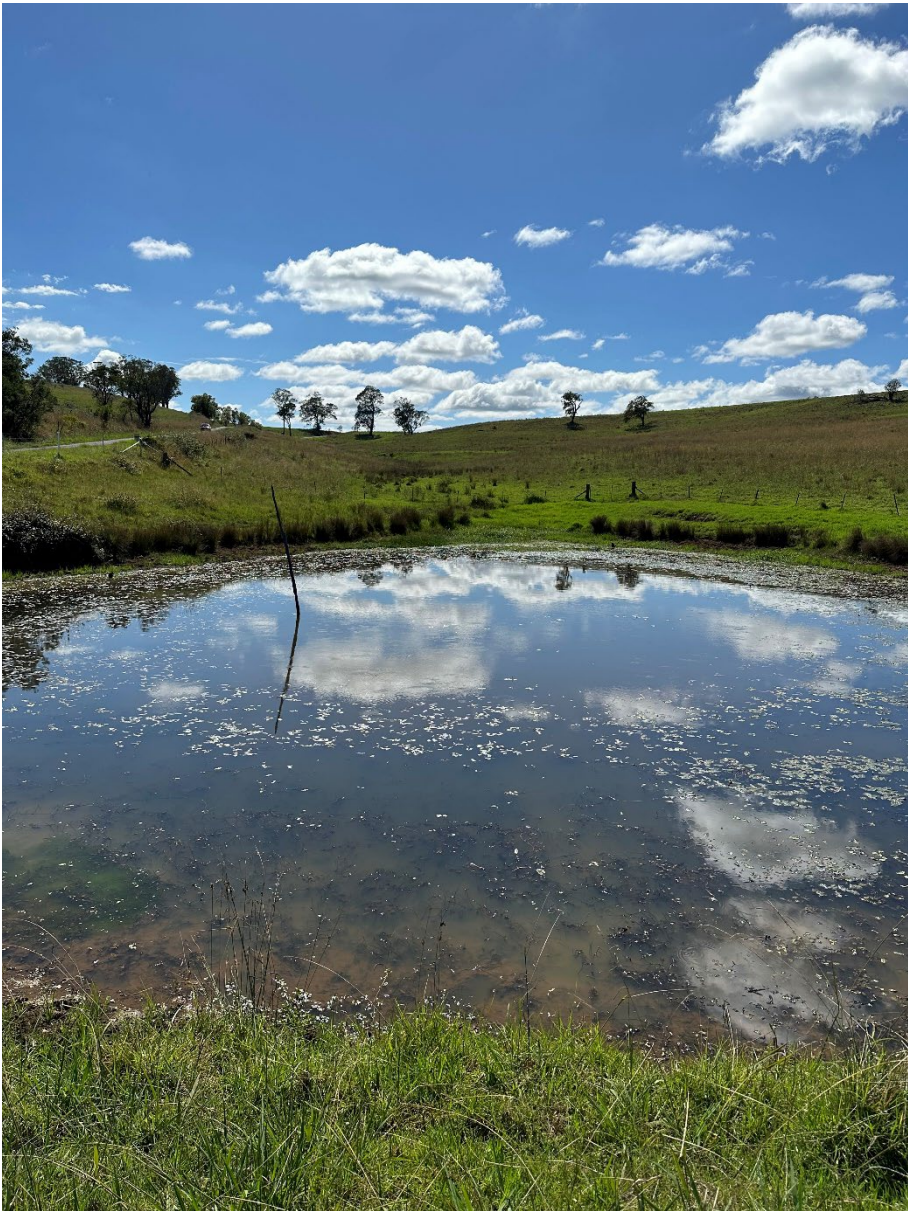
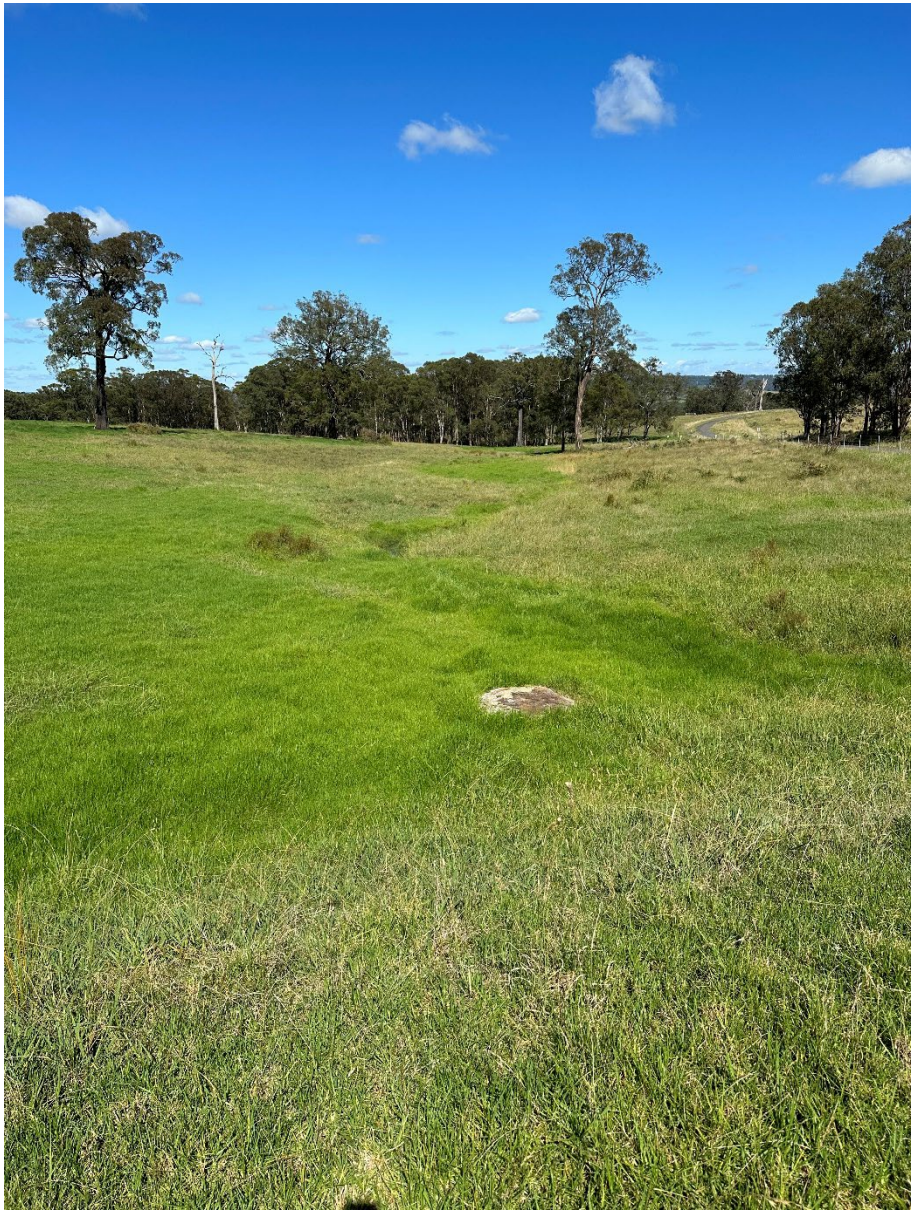
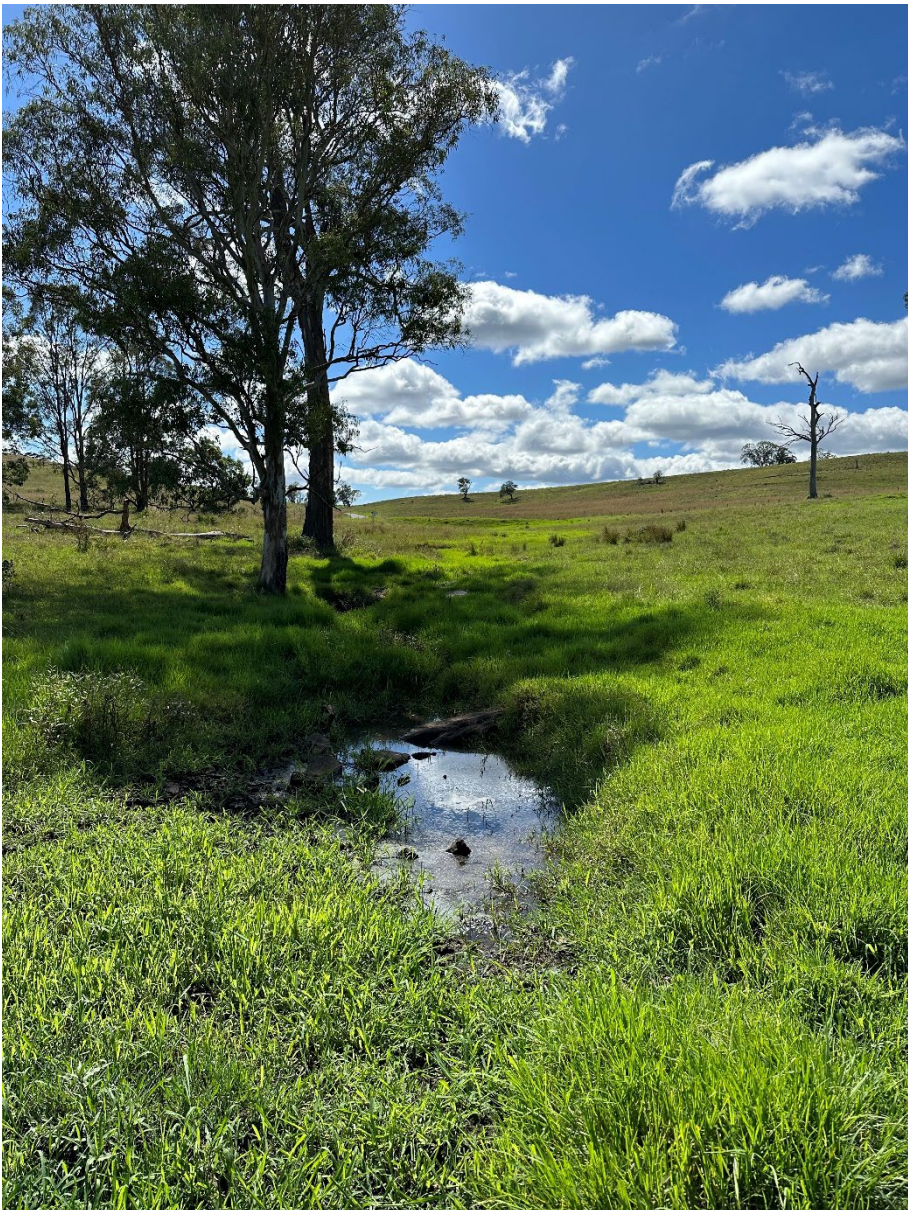
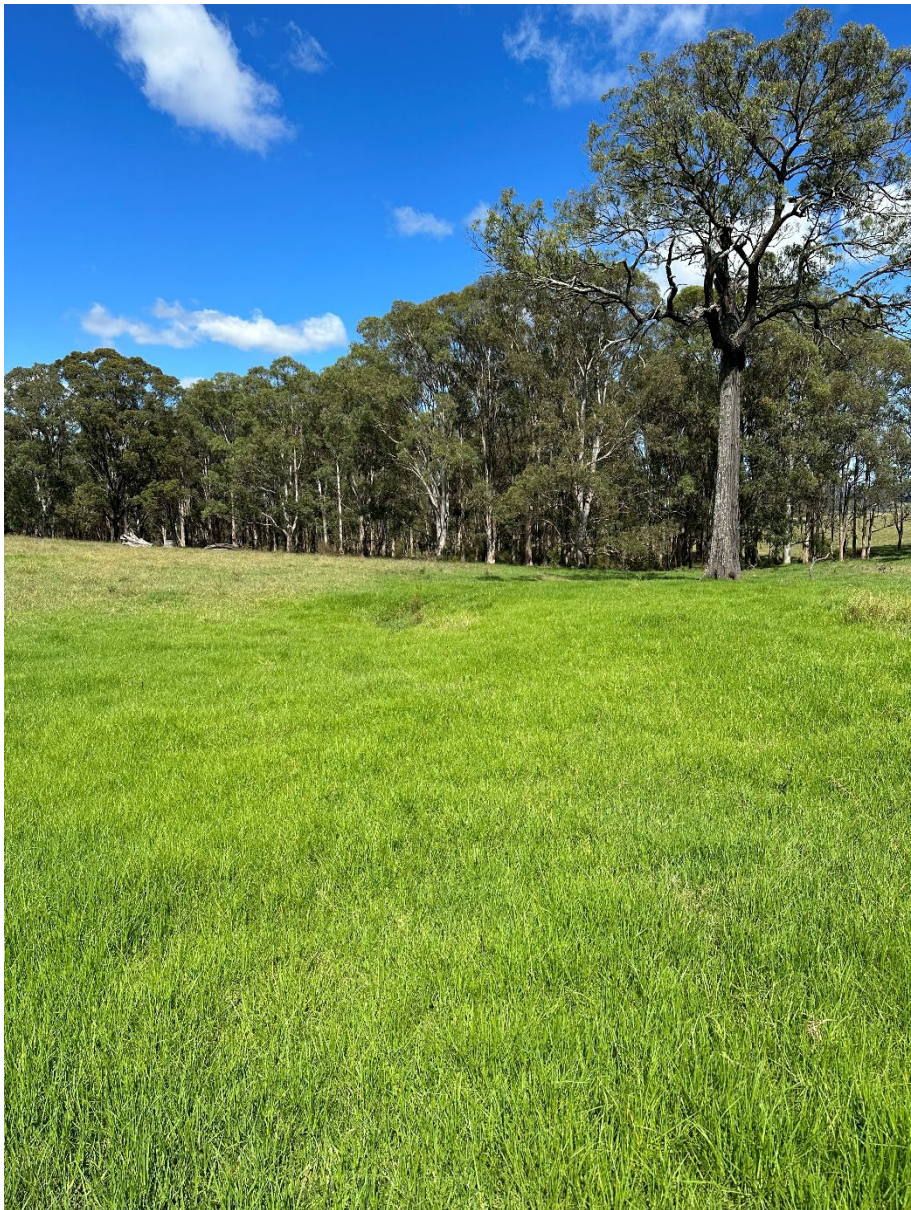
WATERCOURSE 2C

The photos of watercourse 2C show an open clearing with tall pasture grass (no trees). Local depression in terrain with no defined creek bed or banks. Minor pool of water evident at location 32,

though it is noted that rainfall had occurred in the days prior to the site visit. No riparian function evident.
Watercourse order	2 nd order
Does the watercourse have a defined bed or bank?	No
Watercourse Features (NRAR Waterfront Land Tool – Appendix 6)	None

Result: Controlled activity approval not required–No watercourse

Outcome: Watercourse 2C is proposed to be removed in the proposed development and will be replaced by traditional road drainage networks
