Subject: 345 Appin Road, Appin Planning Proposal – Riparian Assessment

Thank you for the opportunity to prepare this riparian assessment of the watercourses at 345 Appin Road, Appin (the subject site) to support the planning proposal for the North Appin (Part) Precinct.

Attachment B – Riparian Assessment Matrix

345 Appin Road, Appin Riparian Assessment

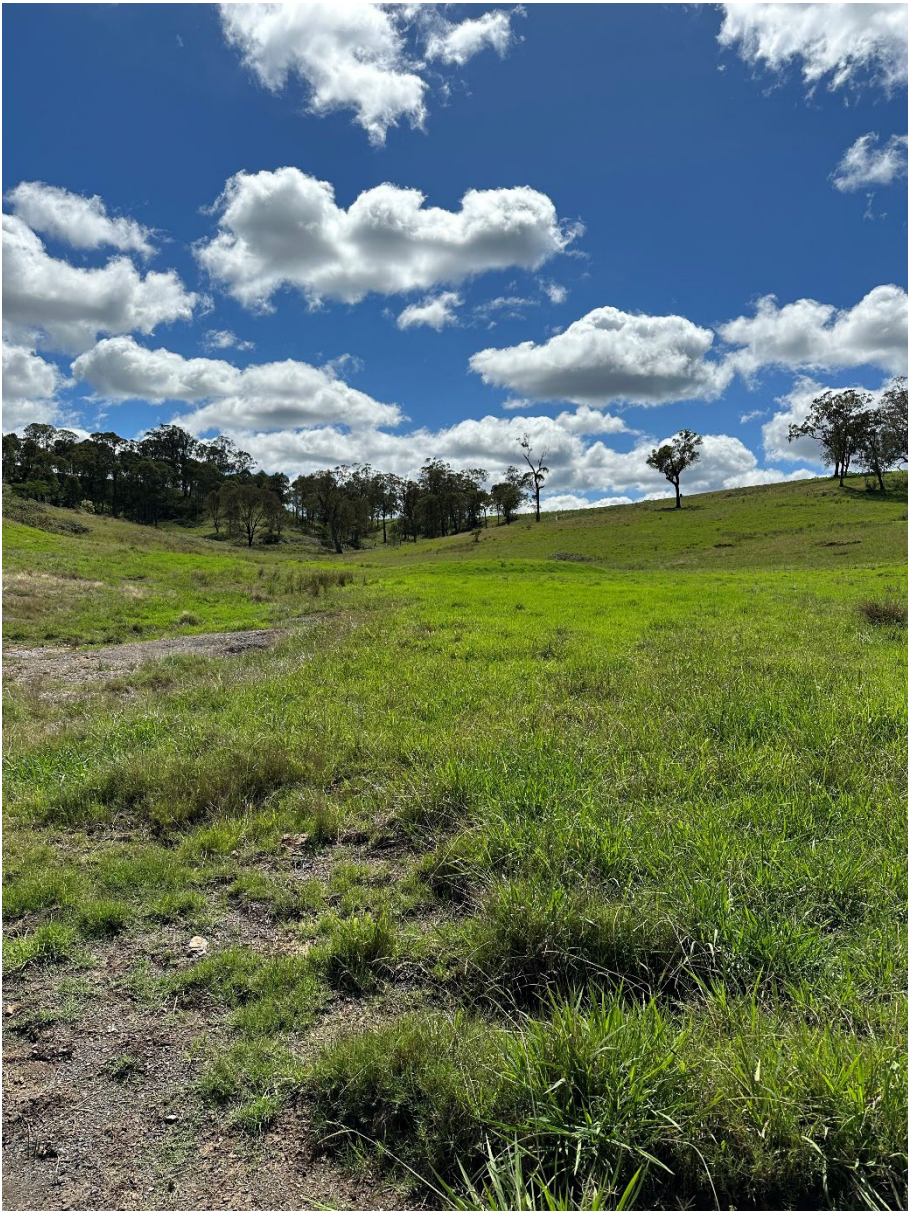
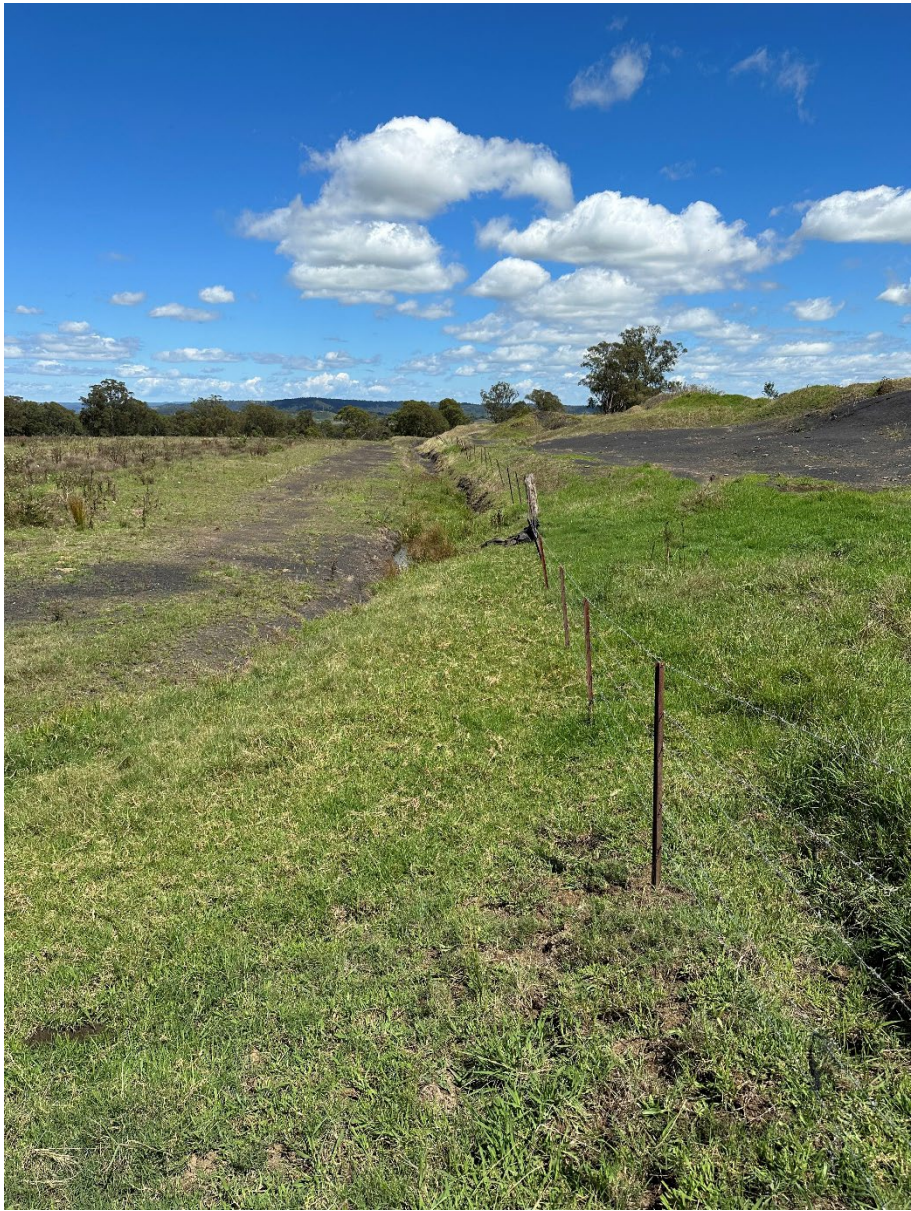
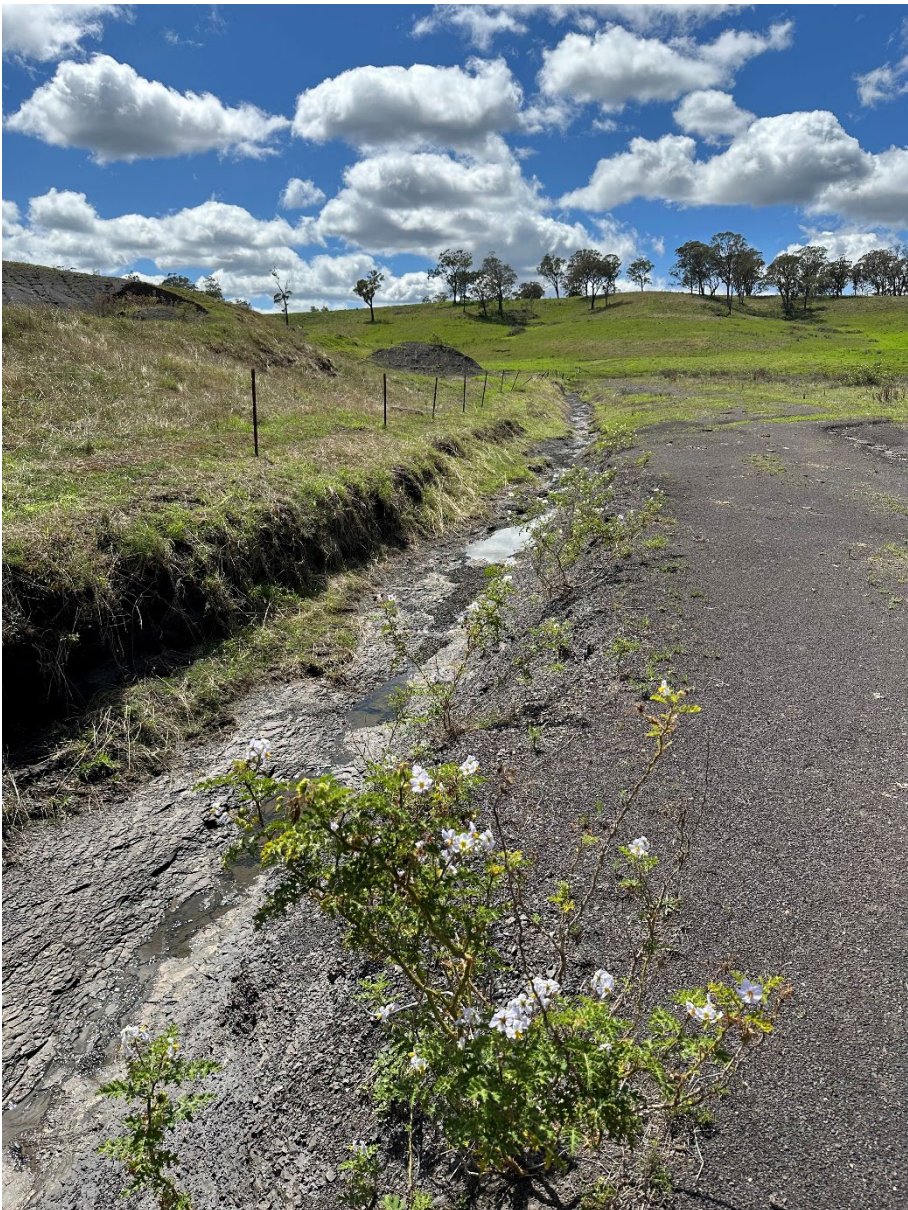
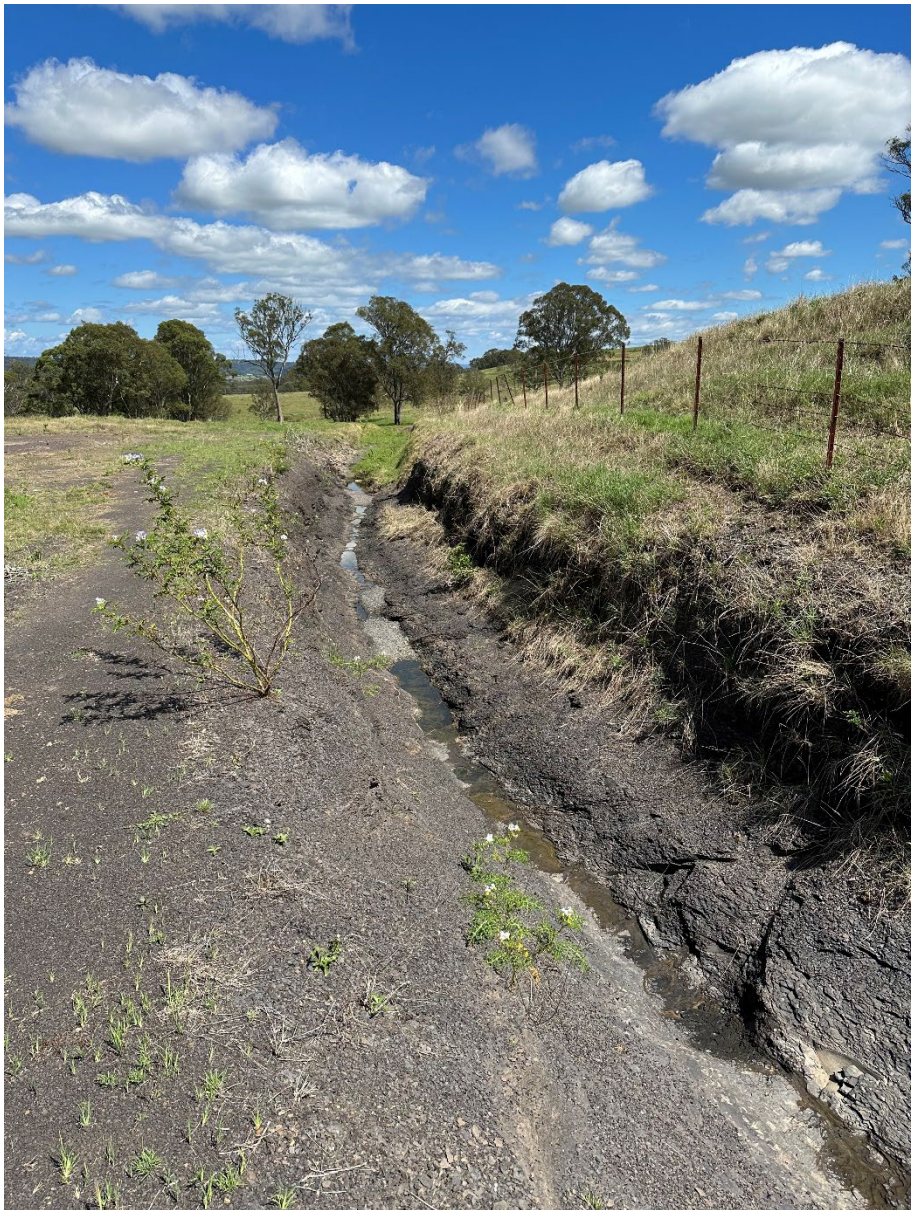
WATERCOURSE 1I

The photos of watercourse 1I show an open clearing with tall pasture grass (no trees) upstream of photo location 33. Local depression in terrain with no defined creek bed or banks. No riparian function

evident. The natural watercourse appears to have been disconnected by the chicken farm pads and replaced by a channel as pictured at location 34. This is an unmapped channel with no signs of riparian function.
Watercourse order	1 st order
Does the watercourse have a defined bed or bank?	No
Watercourse Features (NRAR Waterfront Land Tool – Appendix 6)	None

Result: Controlled activity approval not required–No watercourse

Outcome: Watercourse 1l is proposed to be removed in the proposed development and will be replaced by traditional road drainage networks

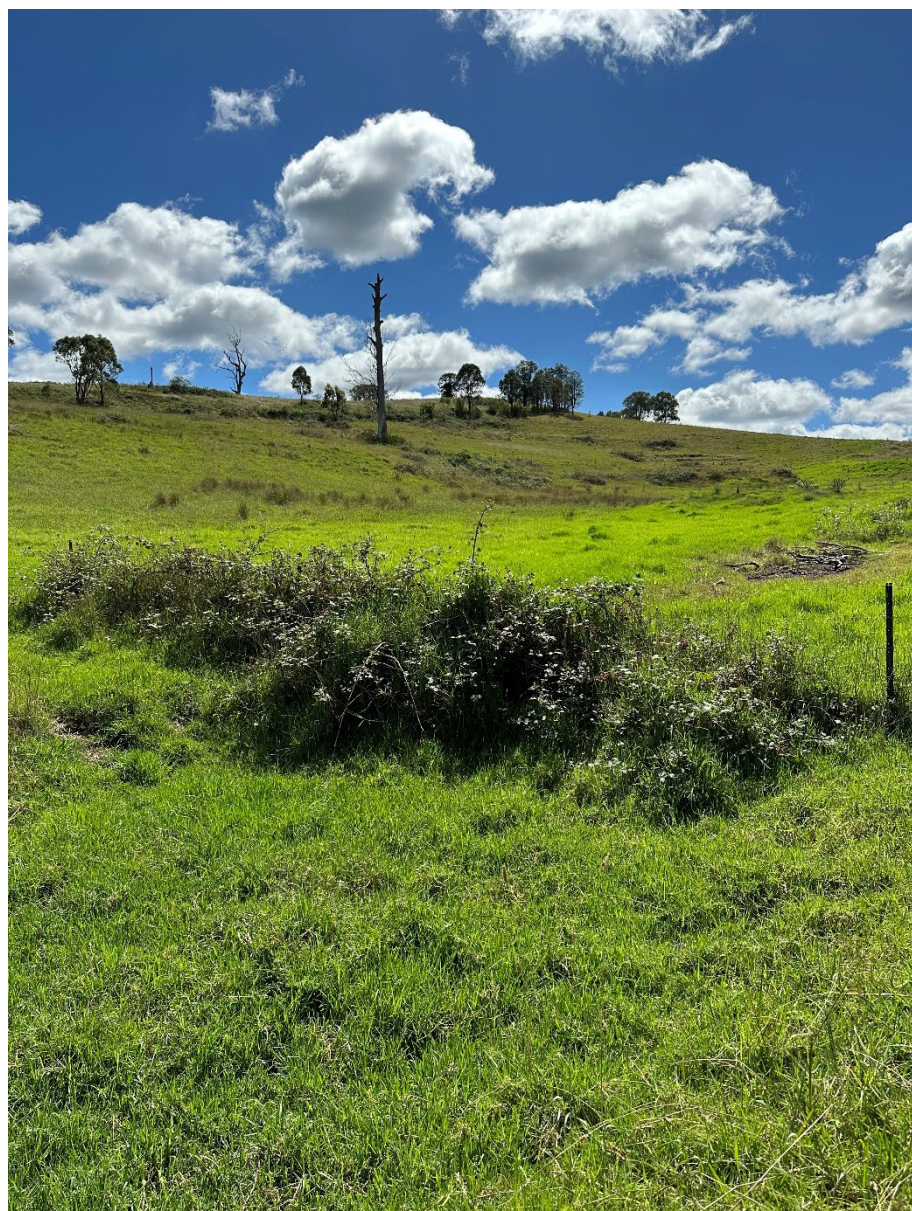
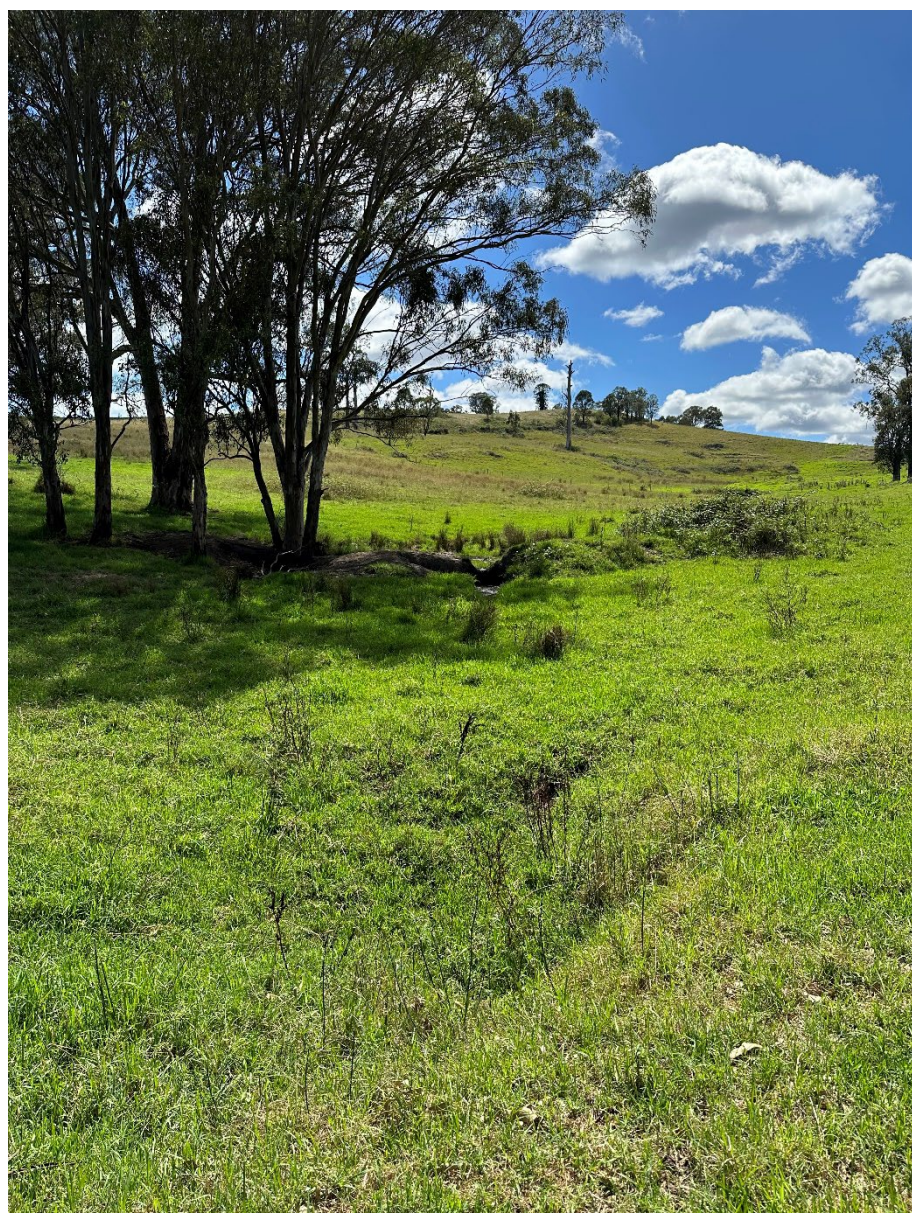
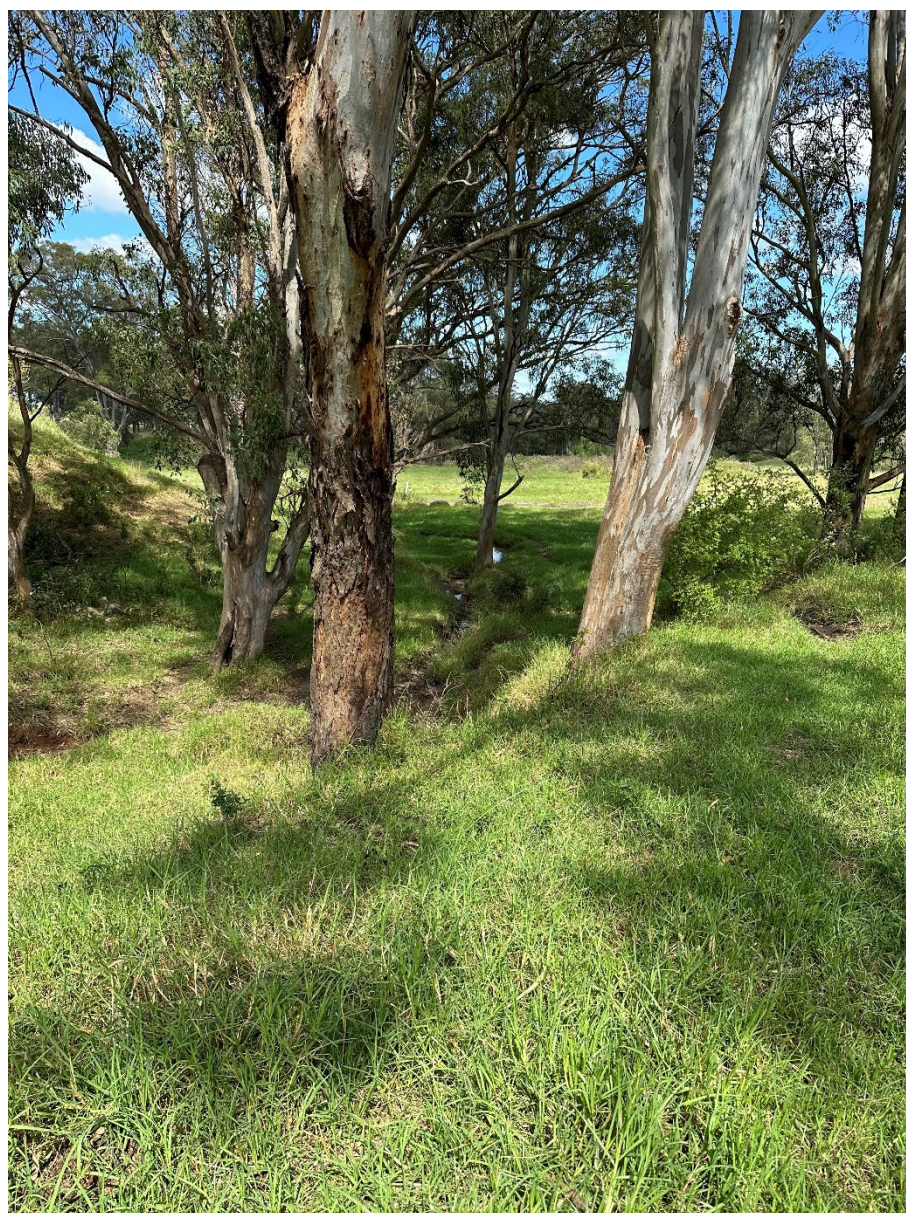
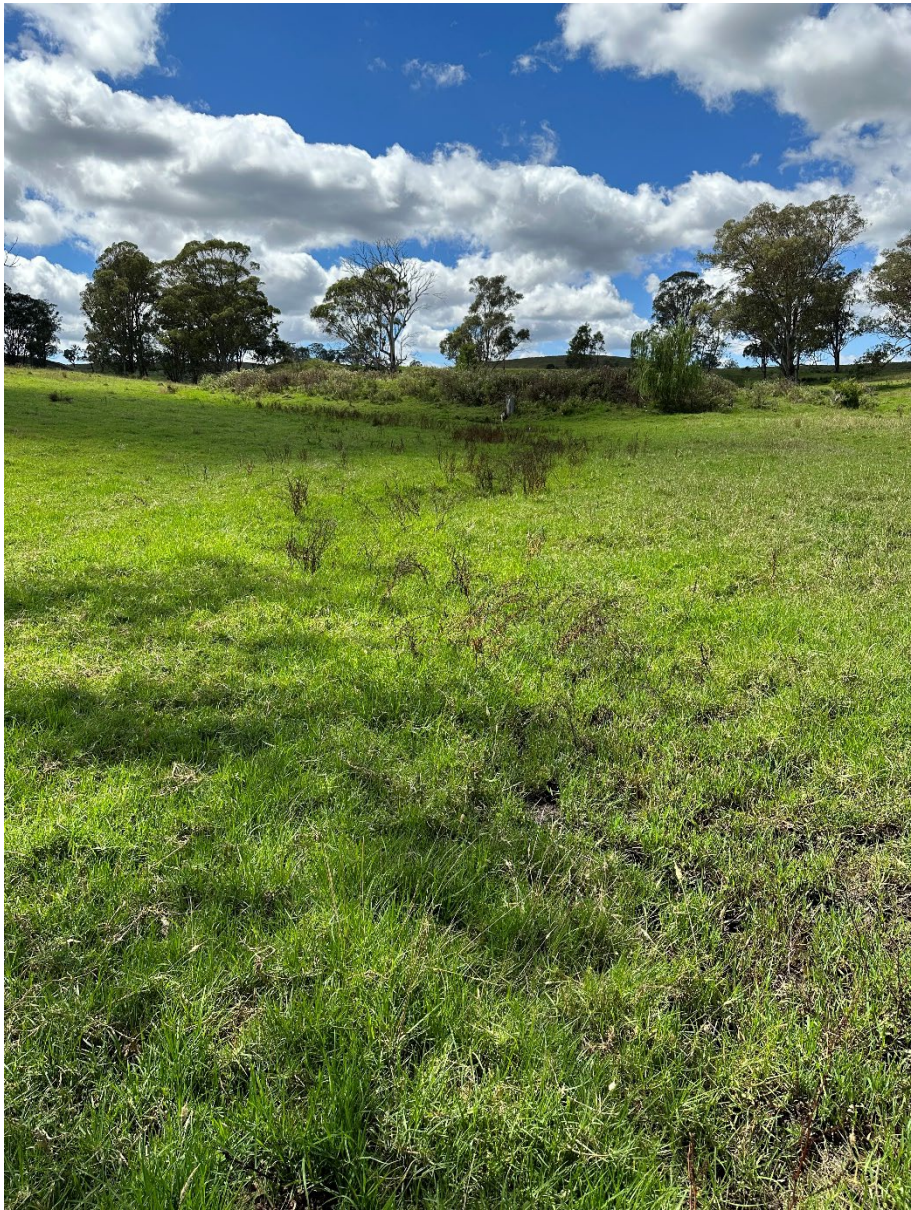
WATERCOURSE 1J

Description	The photos of watercourse 1J show an open clearing with tall pasture grass (no trees). Local depression in terrain with no defined creek bed or banks. No riparian function evident.
Watercourse order	1 st order
Does the watercourse have a defined bed or bank?	No
Watercourse Features (NRAR Waterfront Land Tool – Appendix 6)	None

Result: Controlled activity approval not required–No watercourse

Outcome: Watercourse 1J is proposed to be removed in the proposed development and will be replaced by traditional road drainage networks

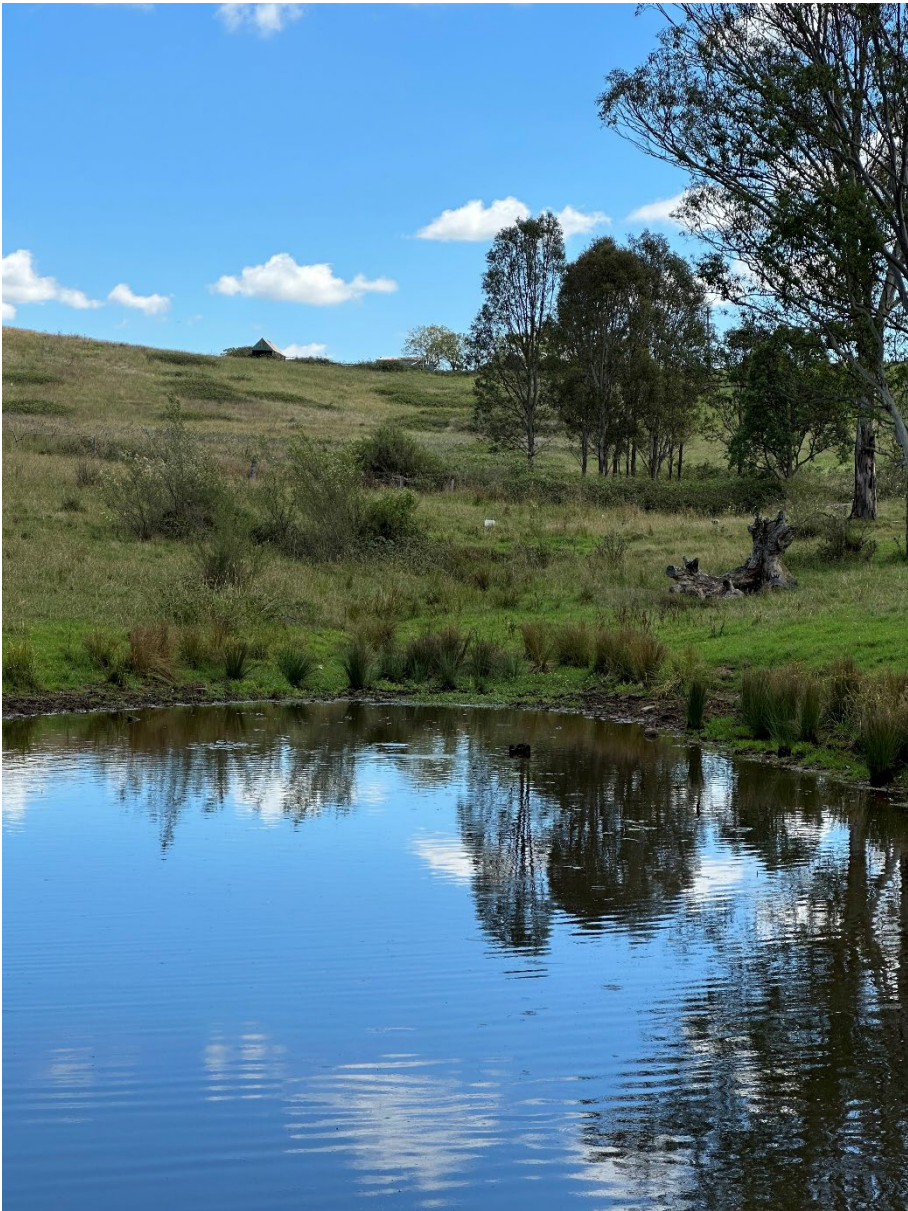
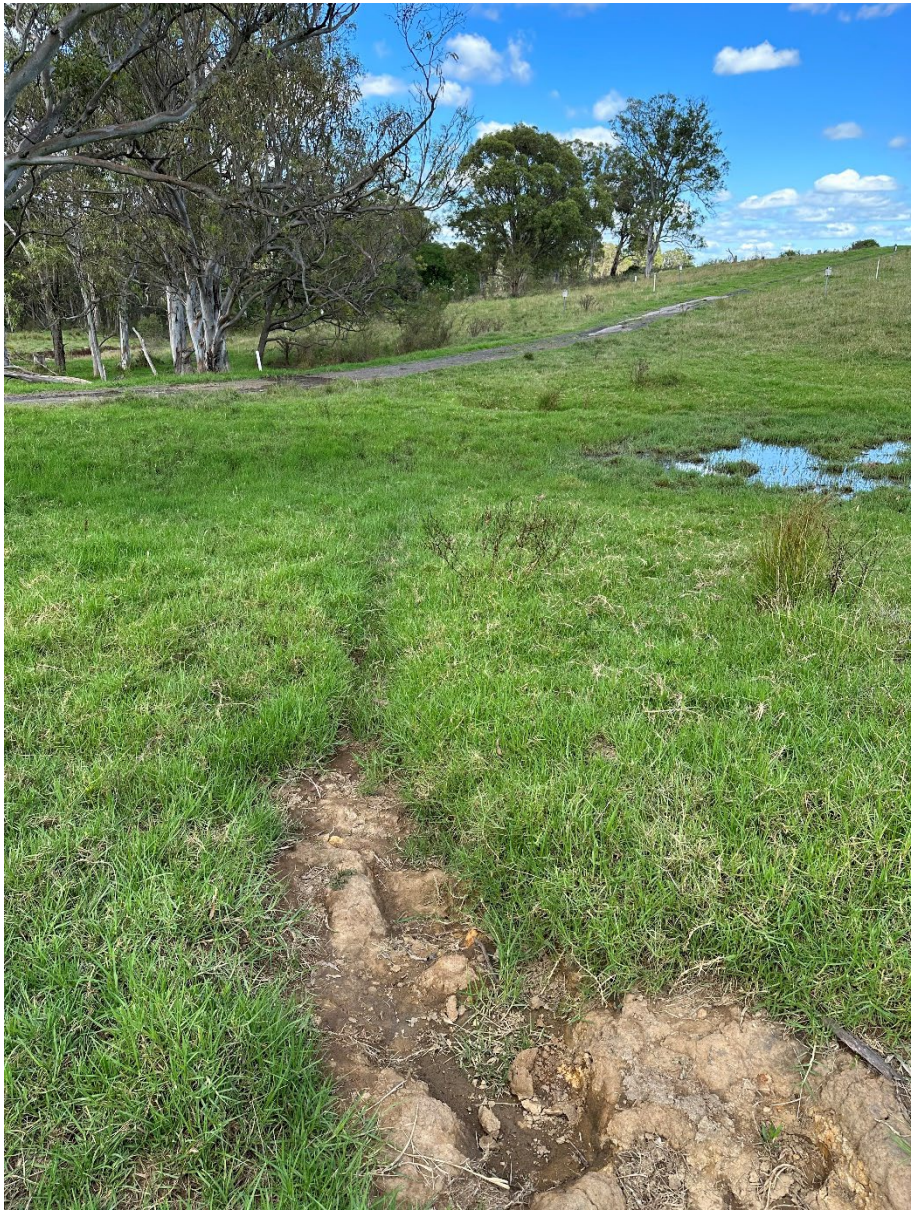
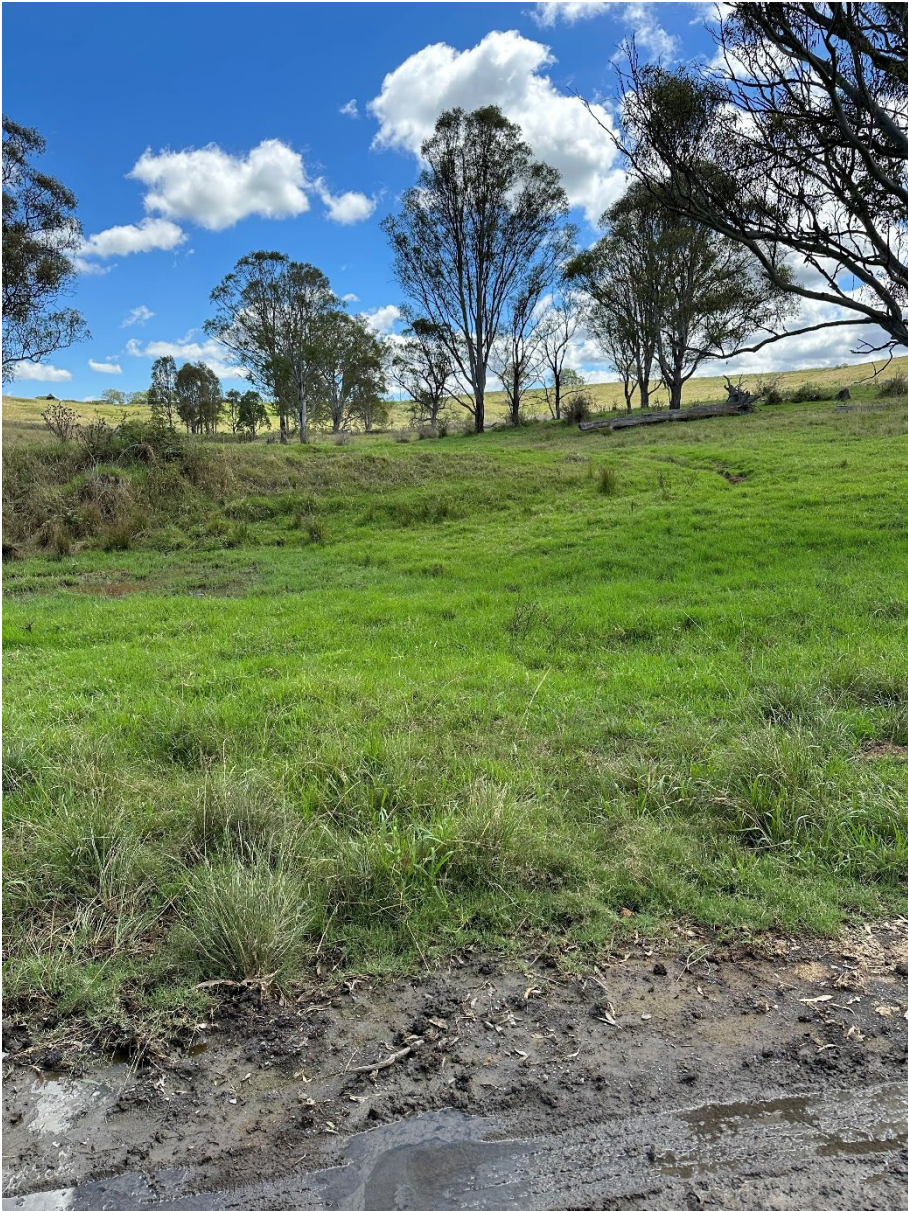
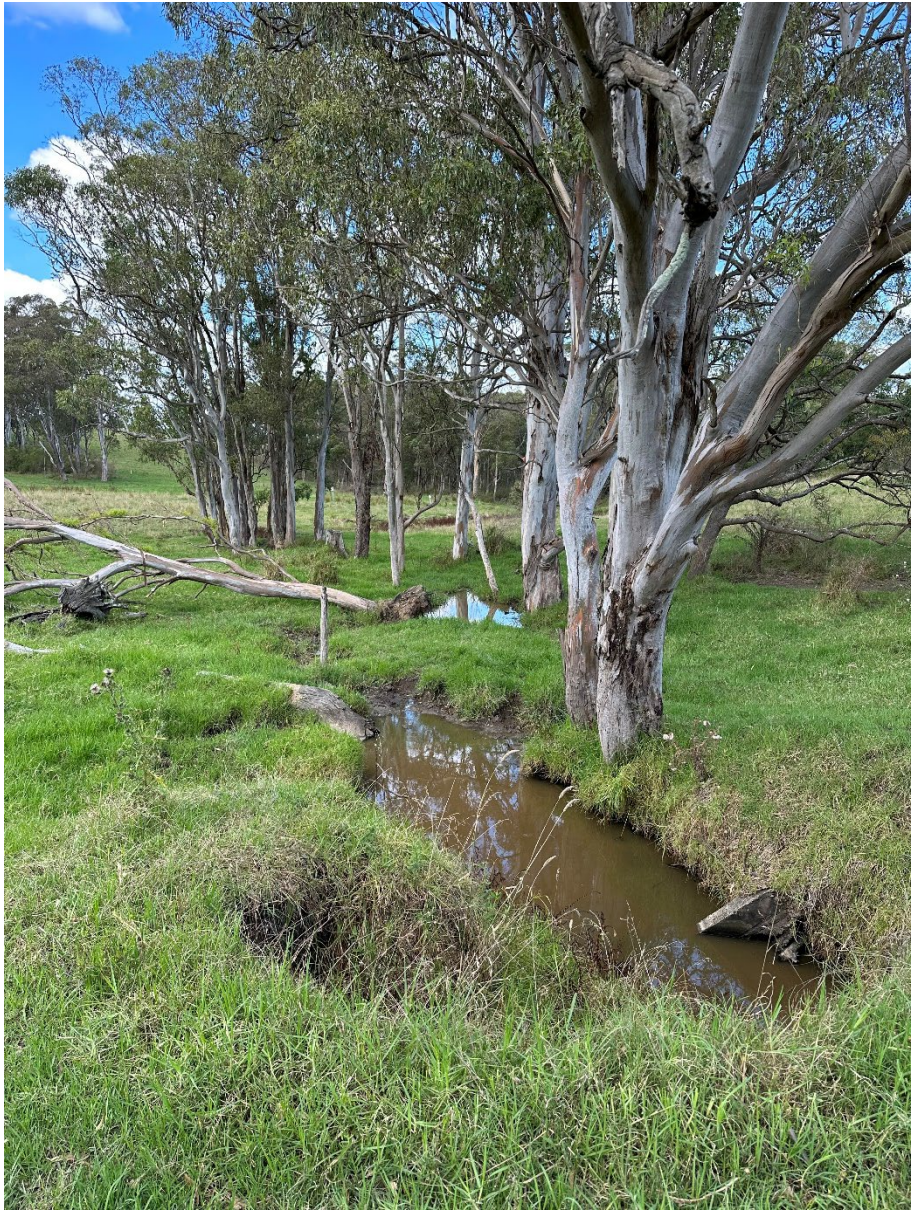
WATERCOURSE 2D

The photos of watercourse 2D some evidence of riparian vegetation upstream of Dam 15. Signs of scouring at the dam outlet. Clear

evidence of bed and bank downstream of location 41 with permanent water pools.
Watercourse order	2nd order
Does the watercourse have a defined bed or bank?	Upstream of 41 – No Downstream of 41 - Yes
Watercourse Features (NRAR Waterfront Land Tool – Appendix 6)	Yes – Pools and erosion
High bank of the watercourse (NRAR Waterfront Land Tool – Appendix 8)	Type 4 – Laterally Unconfined Discontinuous
Are the proposed works located within 40 metres of the high bank?	Yes

Result: Controlled activity approval is required

The proposed works are located within 40 metres of the high bank of the watercourse

Outcome: Watercourse 2D is proposed to be retained in its existing alignment and rejuvenated to provide an improved ecological value to the waterway

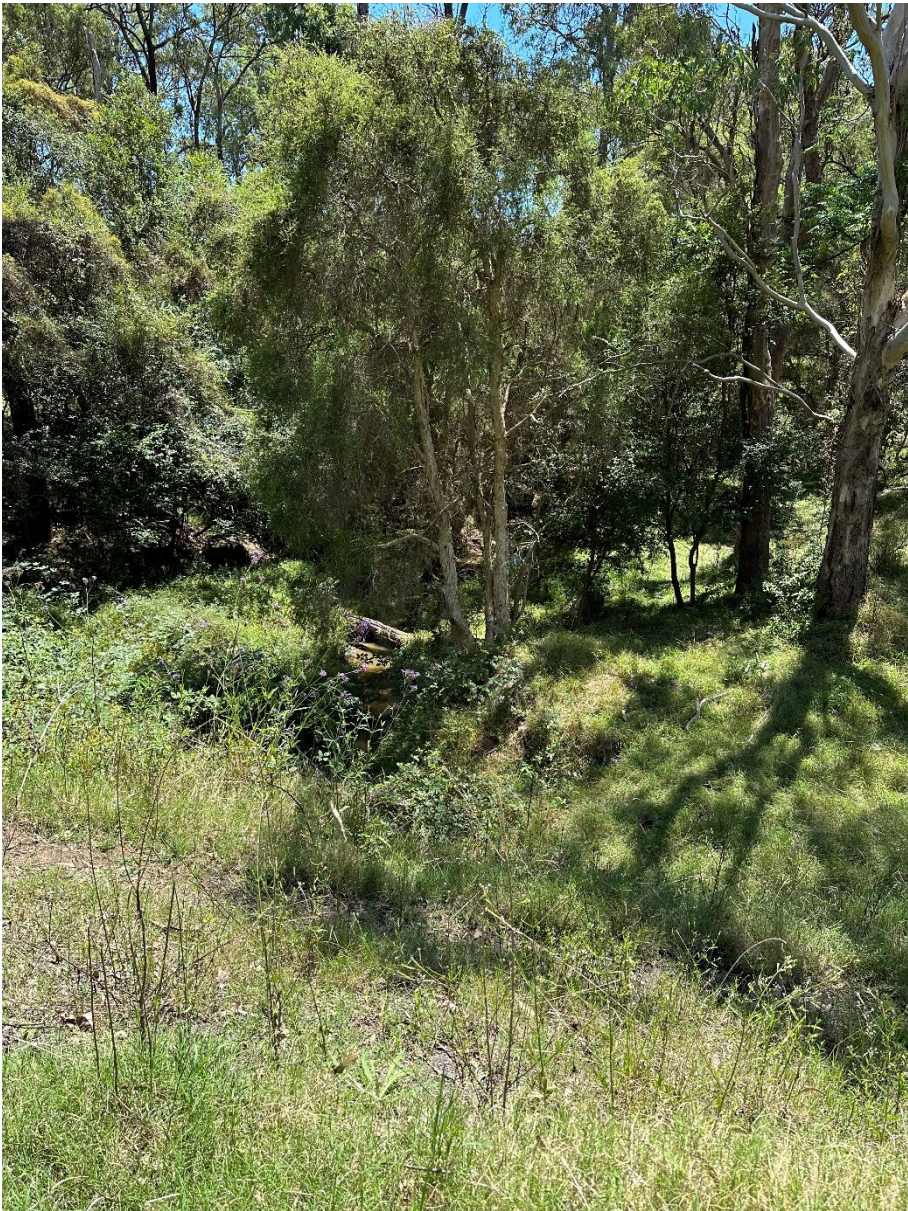
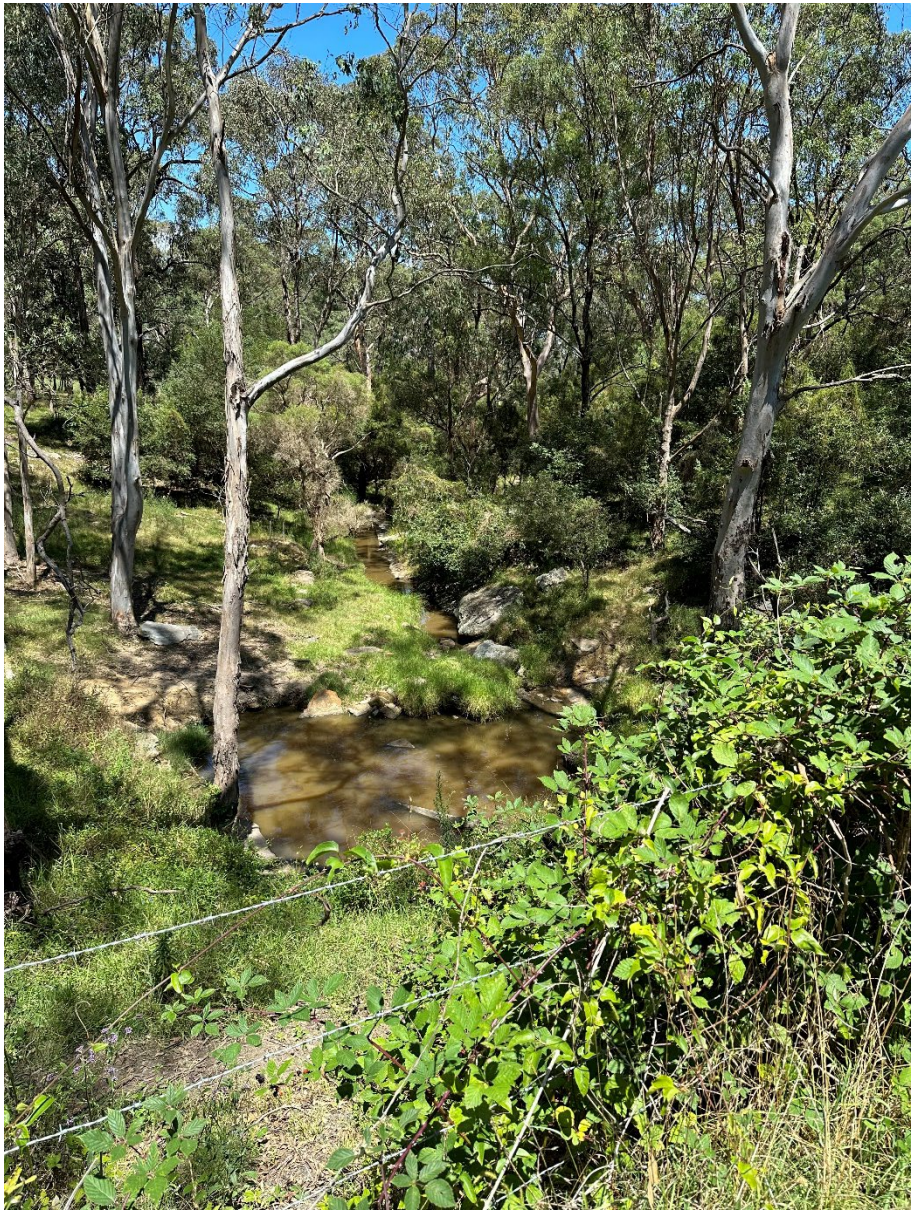
WATERCOURSE 2E

Description	The photos of watercourse 2E show a defined creek with bed and banks. Riparian vegetation of overbanks and permanent pools and exposed rocks in creek bed.
Watercourse order	2 nd order
Does the watercourse have a defined bed or bank?	Yes
Watercourse Types (NRAR Waterfront Land Tool – Appendix 5)	Type 1 – Confined Valley Headwater
Watercourse Features (NRAR Waterfront Land Tool – Appendix 6)	Yes – Pools and erosion
High bank of the watercourse (NRAR Waterfront Land Tool – Appendix 8)	Type 1 – Confined Valley Headwater
Are the proposed works located within 40 metres of the high bank?	Yes

Result: Controlled activity approval is required
One or more of the following features are on this property or a neighbouring property:

The proposed works are located within 40 metres of the high bank of the watercourse

Outcome: Watercourse 2E is proposed to be retained within the conservation zone

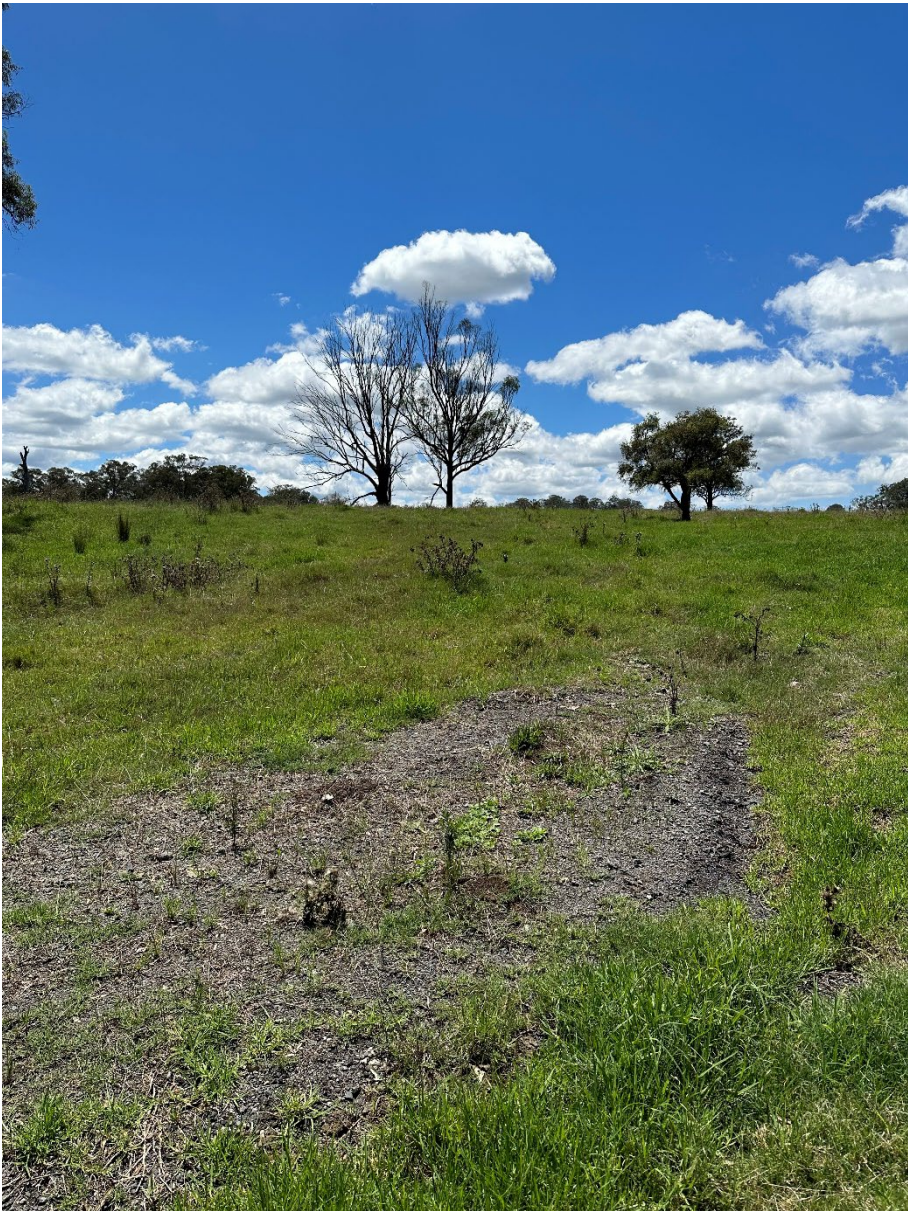
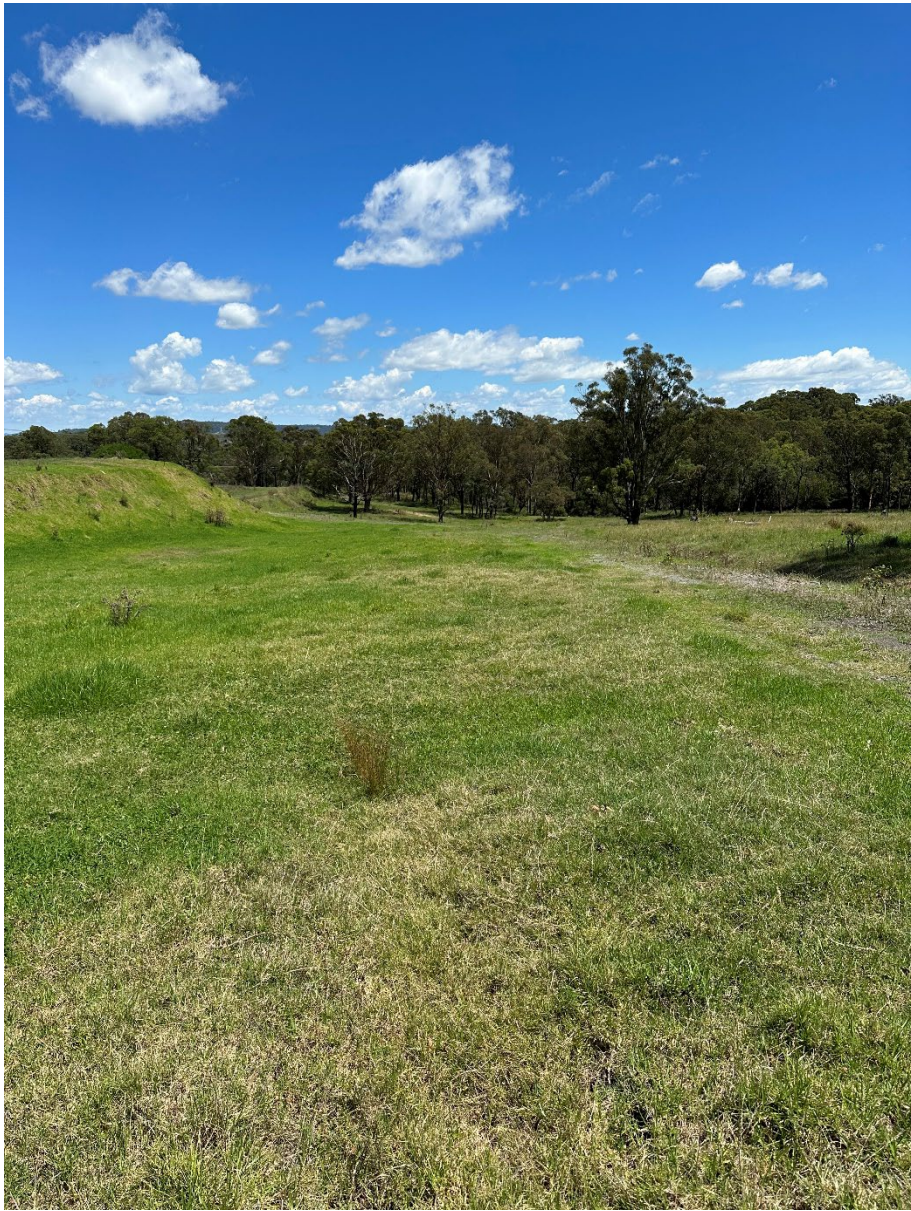
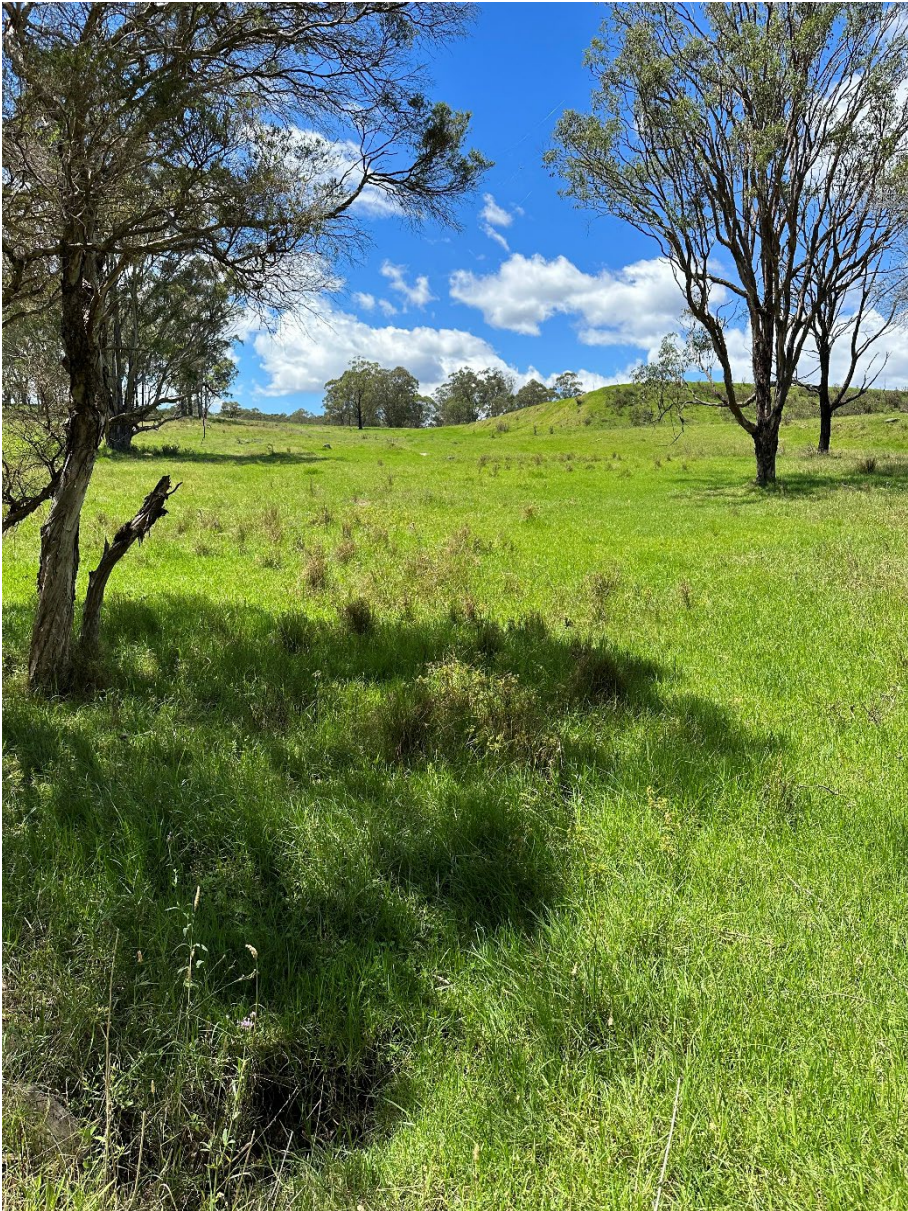
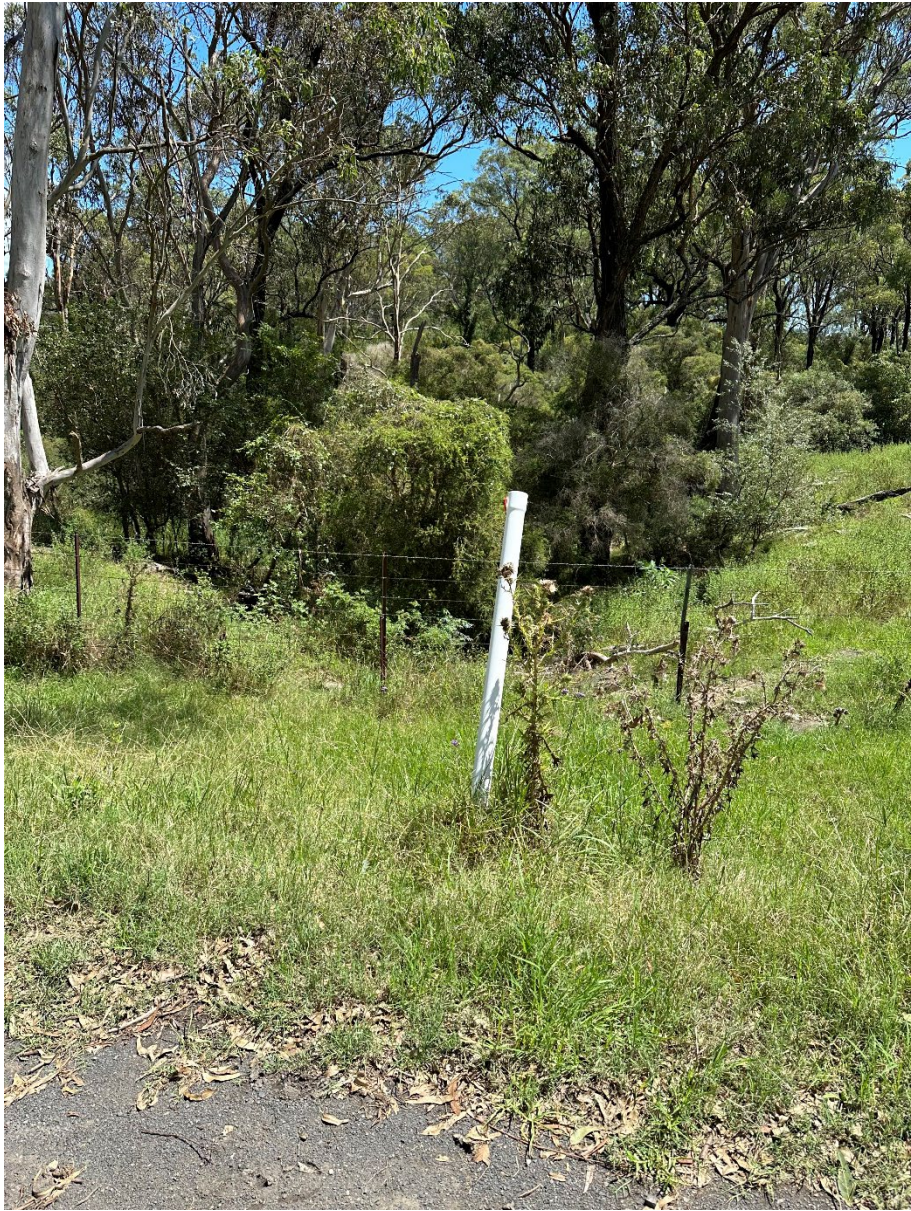
WATERCOURSE 1L

The photos of watercourse 1L show an open clearing with tall pasture grass (sparse trees). Local depression in terrain with no defined creek bed or banks. No riparian function evident.

Watercourse order	1 st order
Does the watercourse have a defined bed or bank?	No
Watercourse Features (NRAR Waterfront Land Tool – Appendix 6)	None

Result: Controlled activity approval not required–No watercourse

Outcome: Watercourse 1L is proposed to be removed in the proposed development and will be replaced by traditional road drainage networks

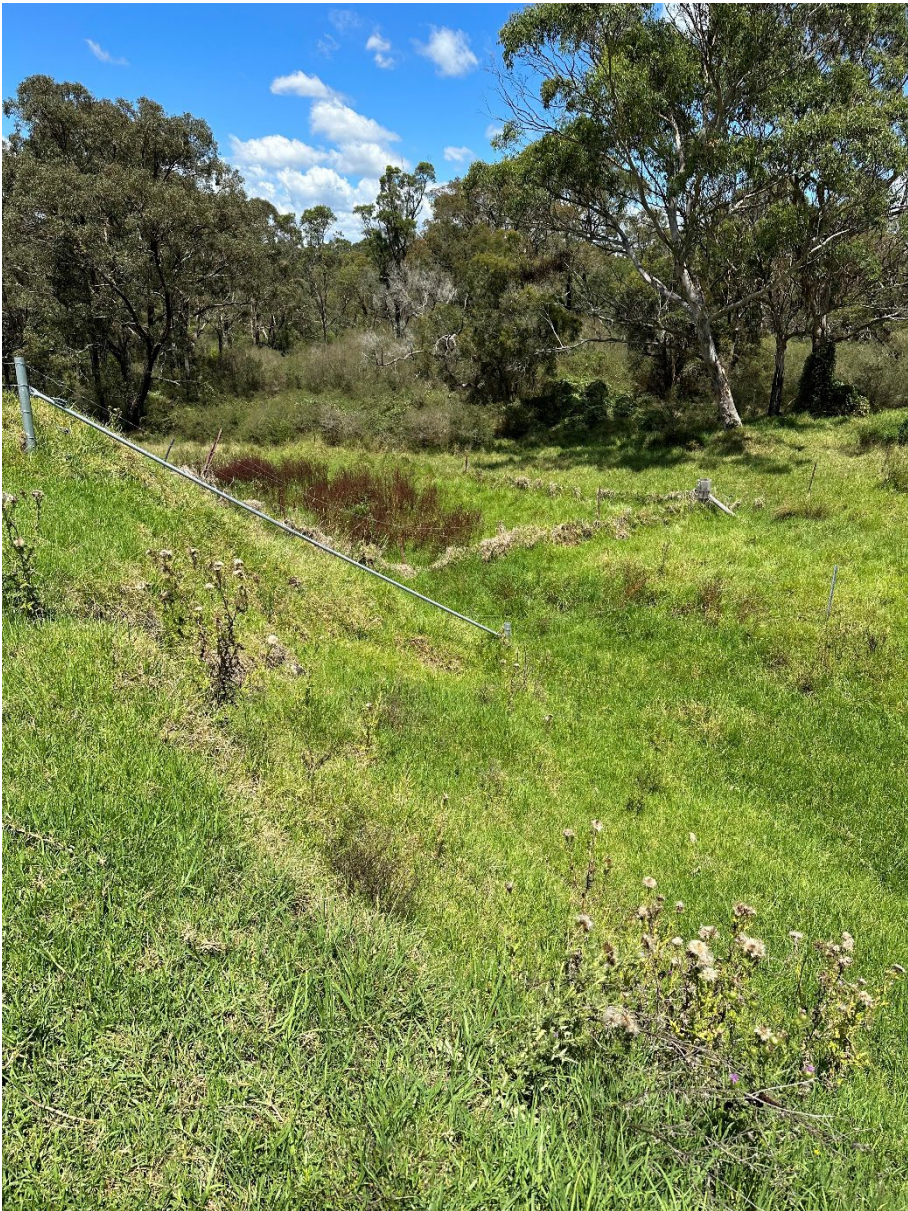
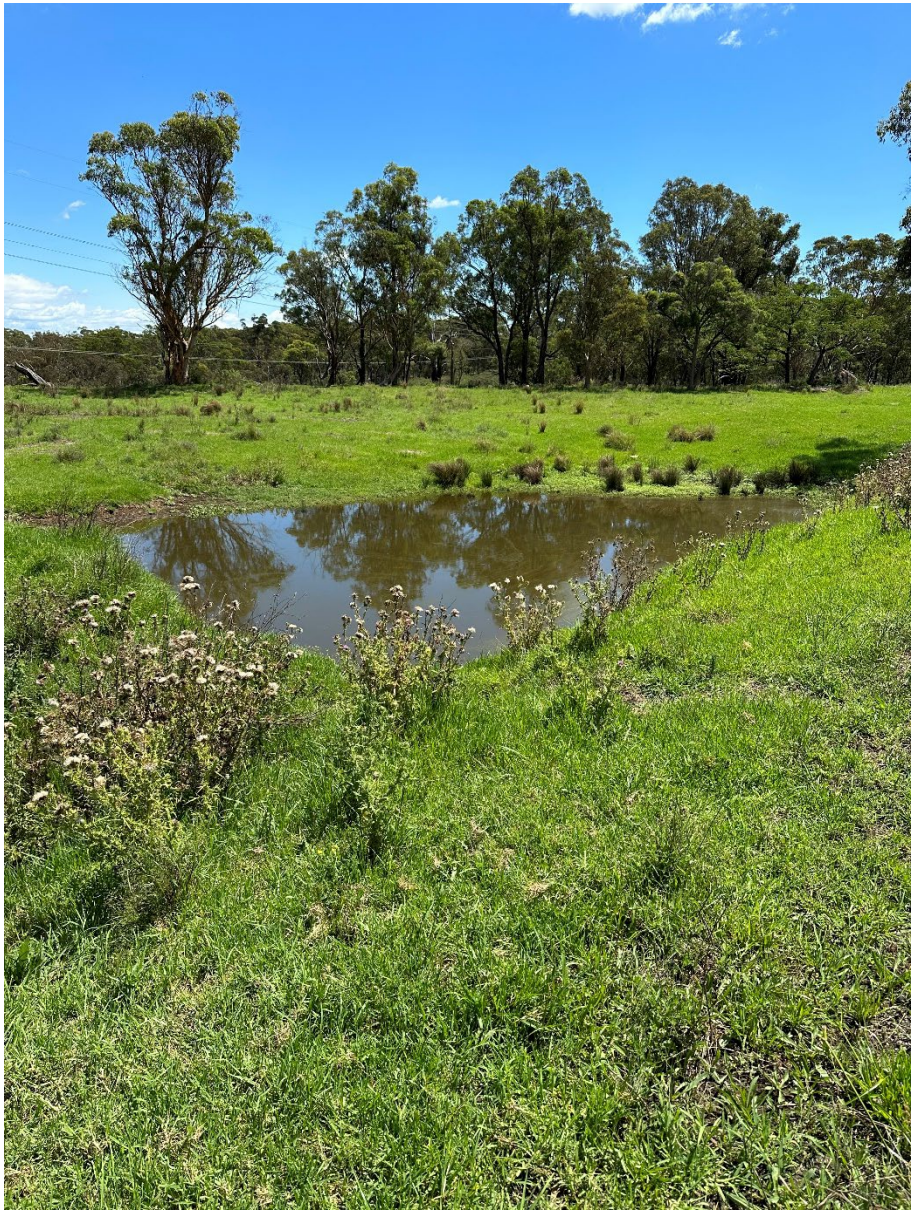
WATERCOURSE 1M

Description	The photos of watercourse 1M shows a clear transition in vegetation looking downstream where the watercourse begins. The existing farm dam is disconnected from the downstream watercourse.
Watercourse order	1 st order
Does the watercourse have a defined bed or bank?	No
Watercourse Features (NRAR Waterfront Land Tool – Appendix 6)	None

Result: Controlled activity approval not required–No watercourse

Outcome: Watercourse 1J is proposed to be removed in the proposed development
