Subject: 345 Appin Road, Appin Planning Proposal – Riparian Assessment

Thank you for the opportunity to prepare this riparian assessment of the watercourses at 345 Appin Road, Appin (the subject site) to support the planning proposal for the North Appin (Part) Precinct.

Attachment B – Riparian Assessment Matrix

345 Appin Road, Appin Riparian Assessment

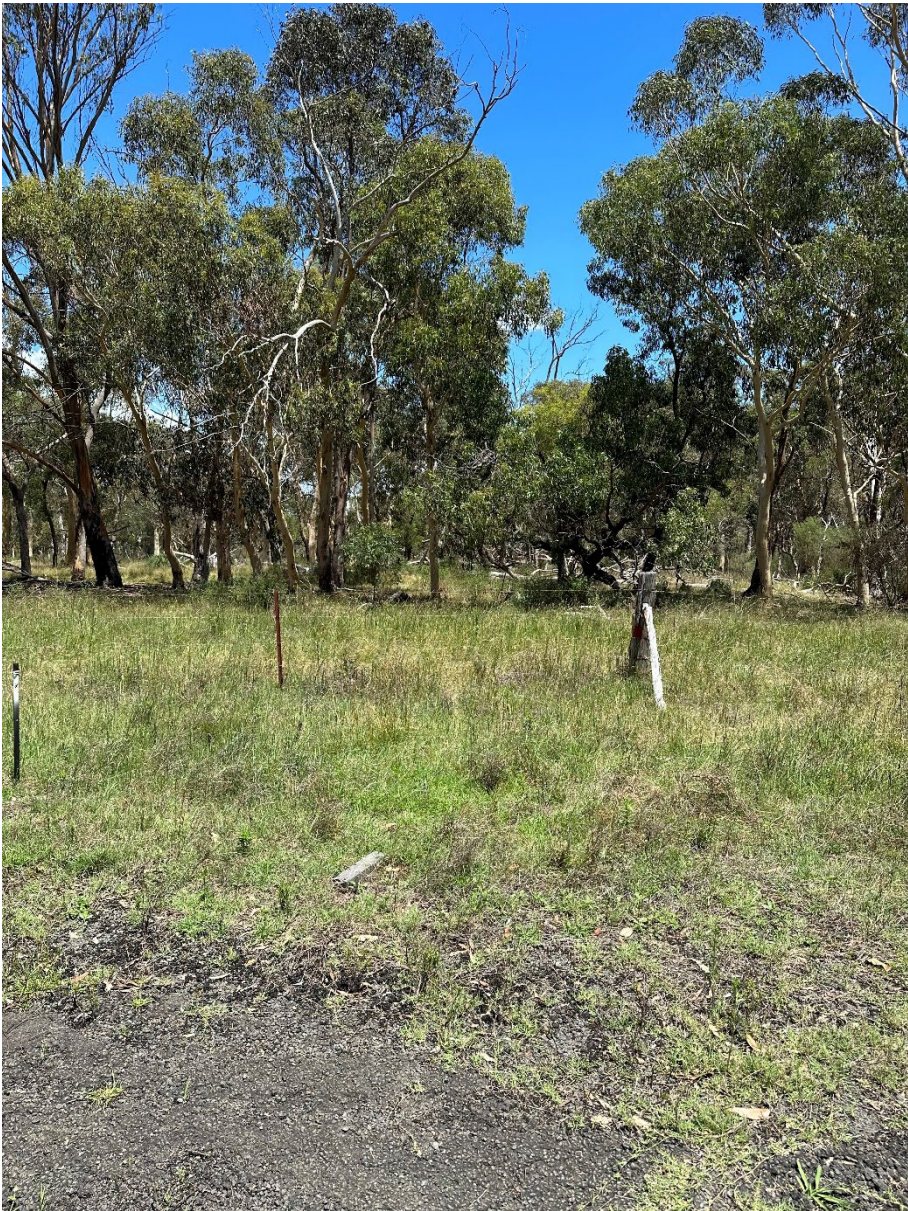
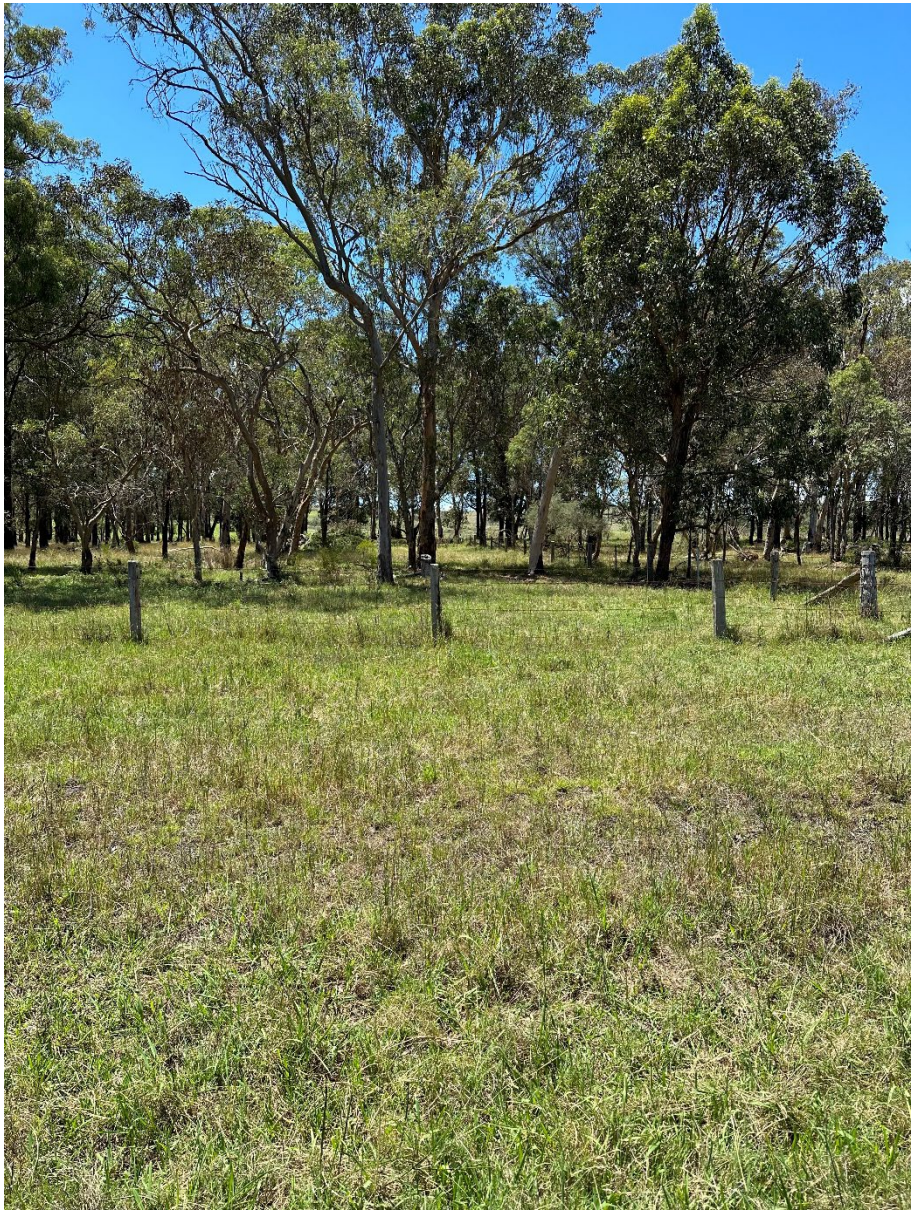
WATERCOURSE 1N

Description	The photos of watercourse 1N shows no sign of a watercourse (no creek bed or banks). Dense vegetation with trees.
Watercourse order	1 st order
Does the watercourse have a defined bed or bank?	No
Watercourse Features (NRAR Waterfront Land Tool – Appendix 6)	None

Result: Controlled activity approval not required–No watercourse

Outcome: Watercourse 1N is proposed to be retained in the conservation zone

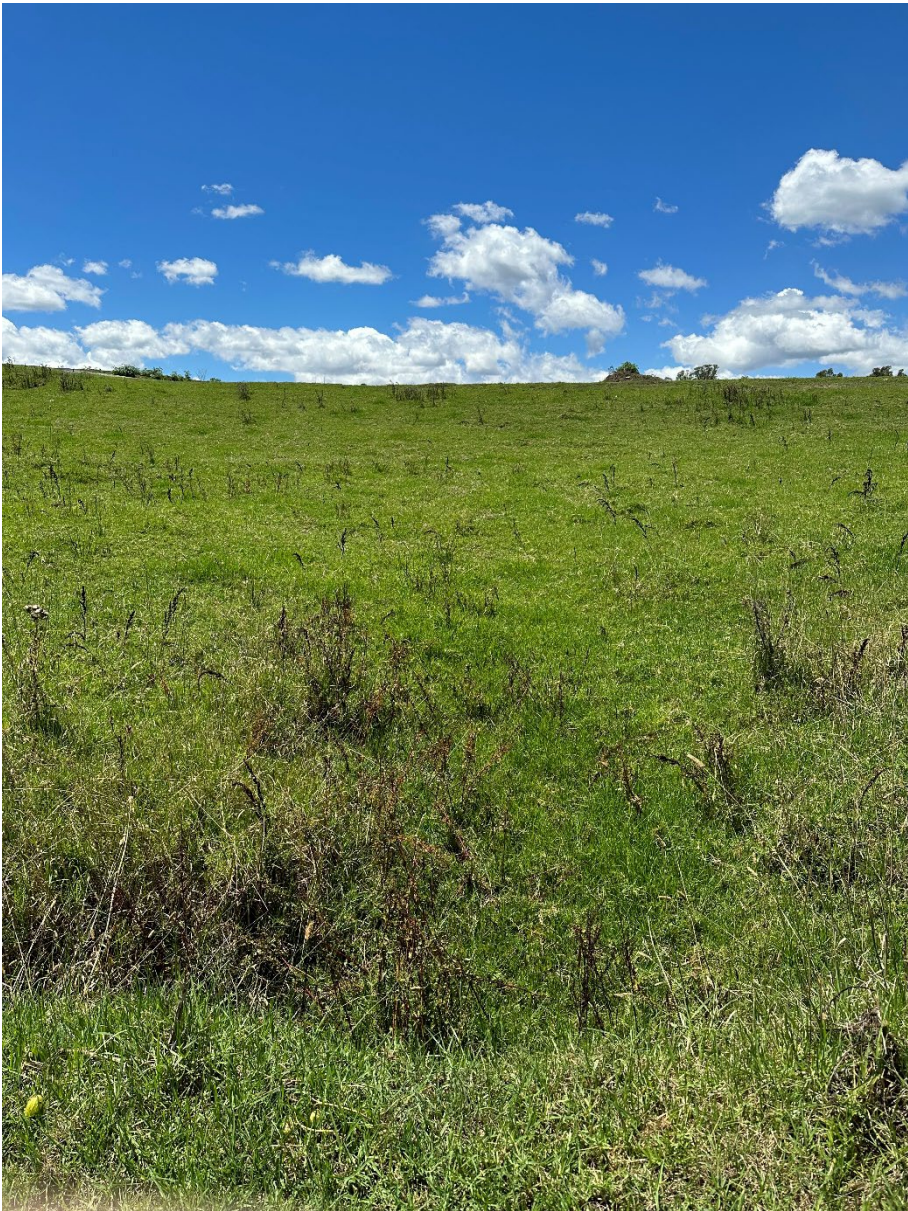
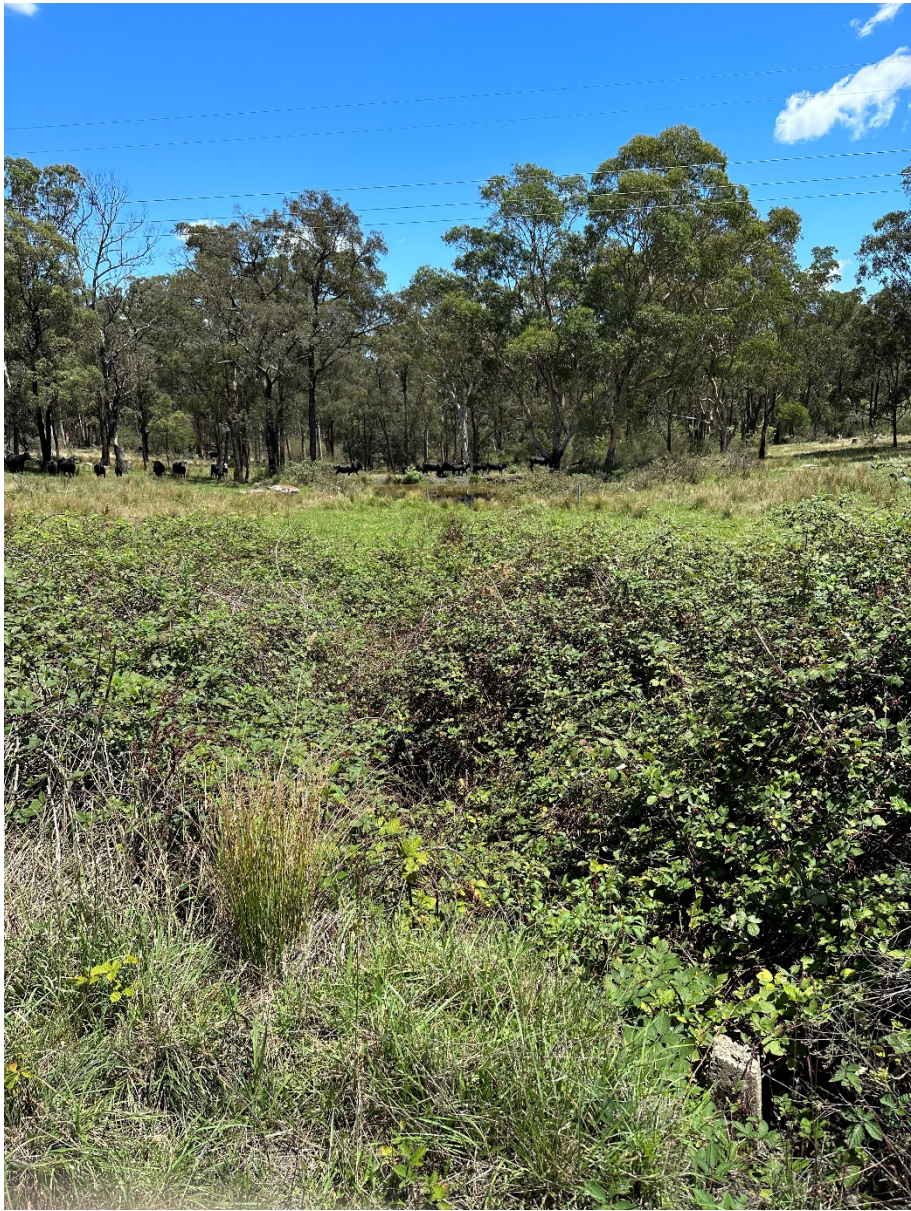
WATERCOURSE 10

Description	The photos of watercourse 1O shows a clear transition in vegetation looking upstream versus downstream. Looking upstream there is tall pasture grass with no riparian vegetation evident and no creek bed or banks. Looking downstream there is clear vegetation change within the existing electrical easement.
Watercourse order	1 st order
Does the watercourse have a defined bed or bank?	No
Watercourse Features (NRAR Waterfront Land Tool – Appendix 6)	None

Result: Controlled activity approval not required–No watercourse

Outcome: Watercourse 1O is proposed to be removed upstream of Location 47 and will be replaced by traditional road drainage networks. Watercourse 1O is proposed to be retained within the electrical easement and conservation zone further downstream.

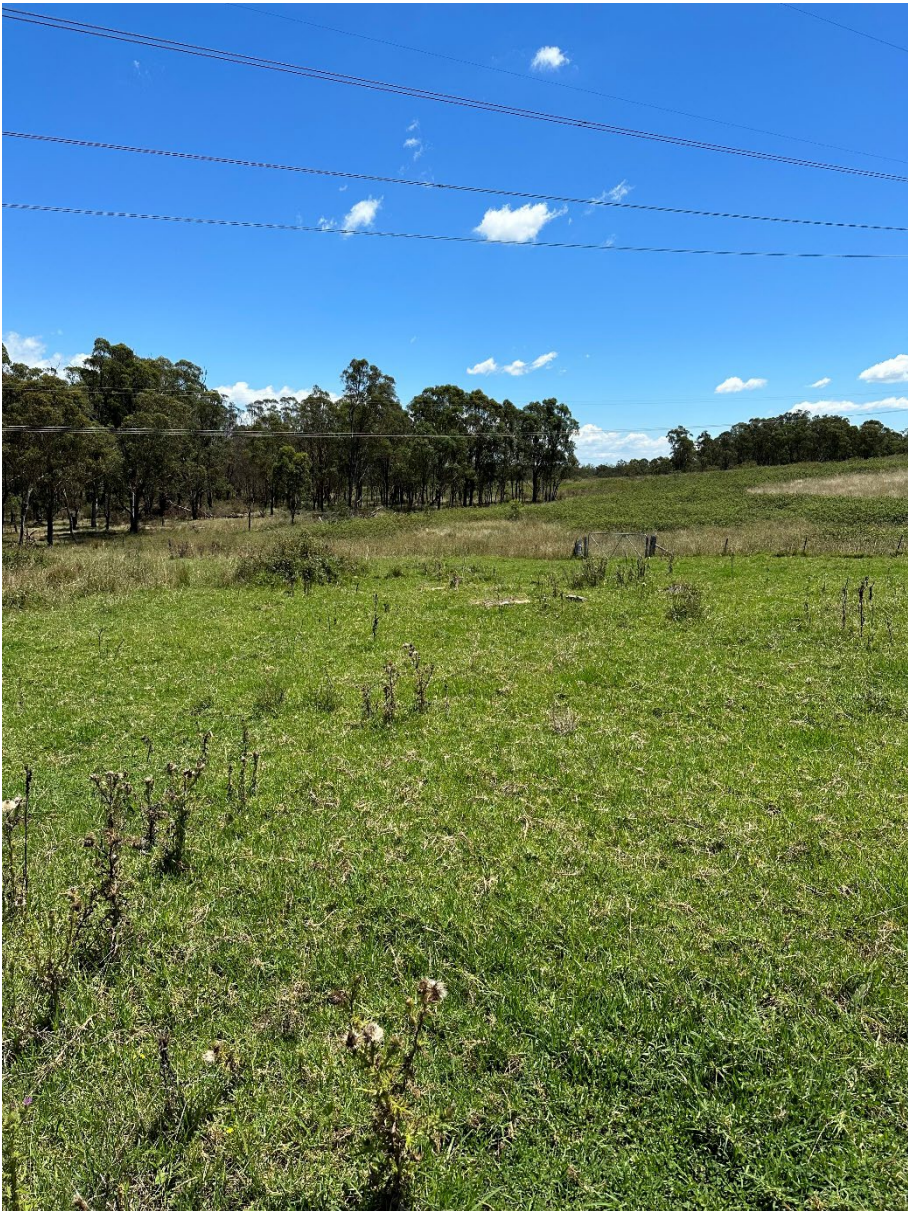
Location 48 (Looking downstream)

Description	The photos of watercourse 1P show an open clearing with tall pasture grass (sparse trees). Local depression in terrain with no defined creek bed or banks. No riparian function evident.
Watercourse order	1 st order
Does the watercourse have a defined bed or bank?	No
Watercourse Features (NRAR Waterfront Land Tool – Appendix 6)	None

Result: Controlled activity approval not required–No watercourse

Outcome: Watercourse 1P is proposed to be retained within the electrical easement and conservation zone further downstream.

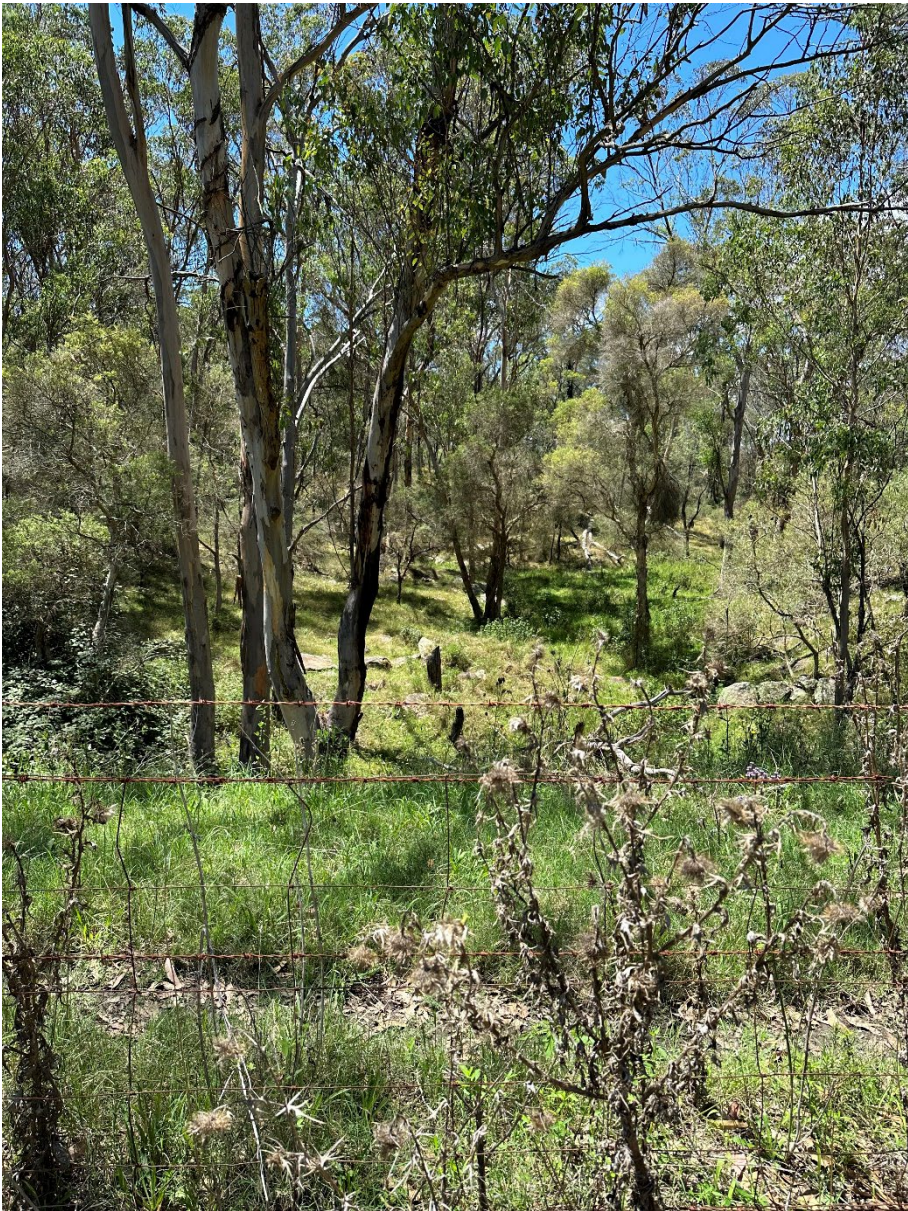
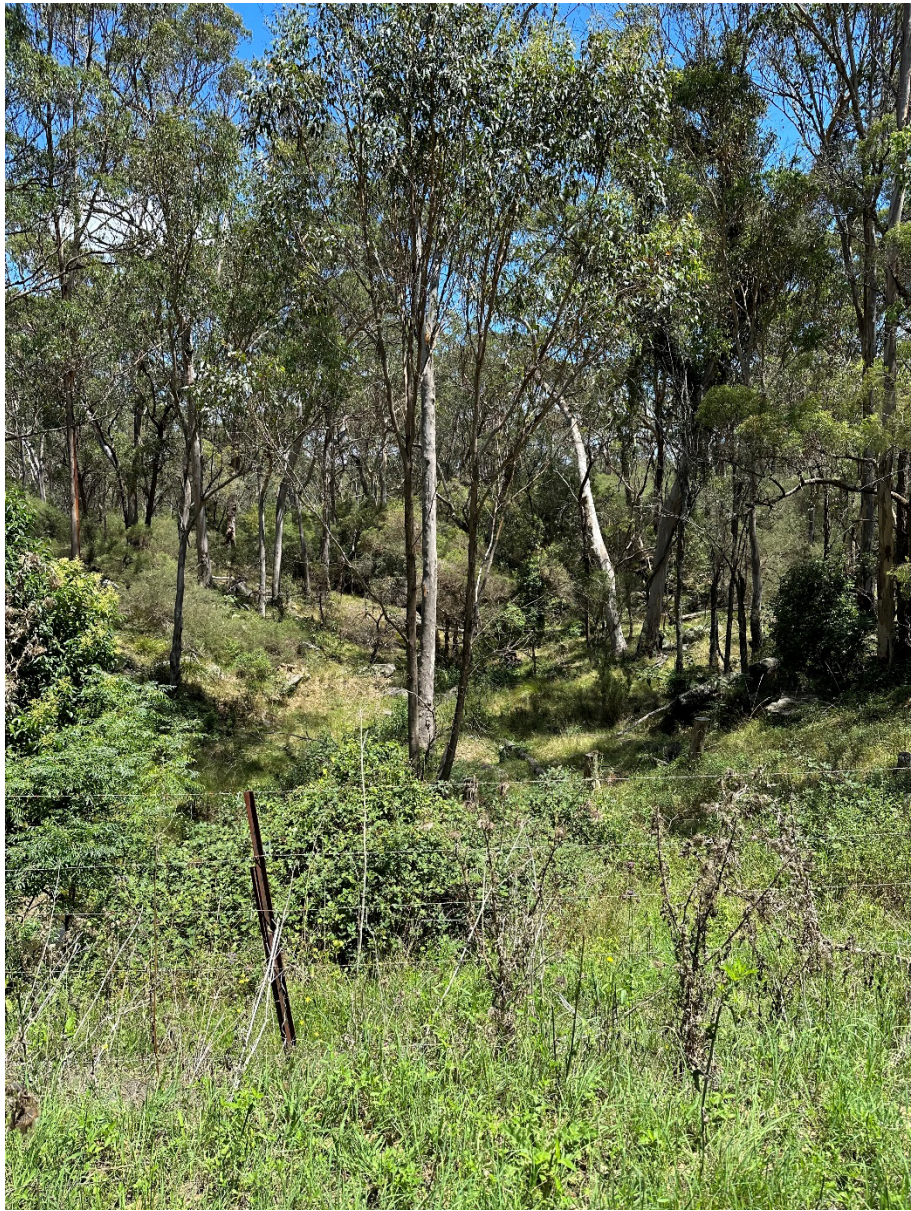
WATERCOURSE 2F

Description	The photos of watercourse 2F show a defined creek with bed and banks. Riparian vegetation on overbanks and within creek bed.
Watercourse order	2 nd order
Does the watercourse have a defined bed or bank?	Yes
Watercourse Types (NRAR Waterfront Land Tool – Appendix 5)	Type 1 – Confined Valley Headwater
Watercourse Features (NRAR Waterfront Land Tool – Appendix 6)	Yes – Pools and erosion
High bank of the watercourse (NRAR Waterfront Land Tool – Appendix 8)	Type 1 – Confined Valley Headwater
Are the proposed works located within 40 metres of the high bank?	Yes

Result: Controlled activity approval is required
One or more of the following features are on this property or a neighbouring property:

The proposed works are located within 40 metres of the high bank of the watercourse

Outcome: Watercourse 2F is proposed to be retained within the conservation zone
