Preliminary Site Investigation for Contamination

Planning Proposal Request Glenlee House, Menangle Park, NSW

> > Project 92425.00 September 2020

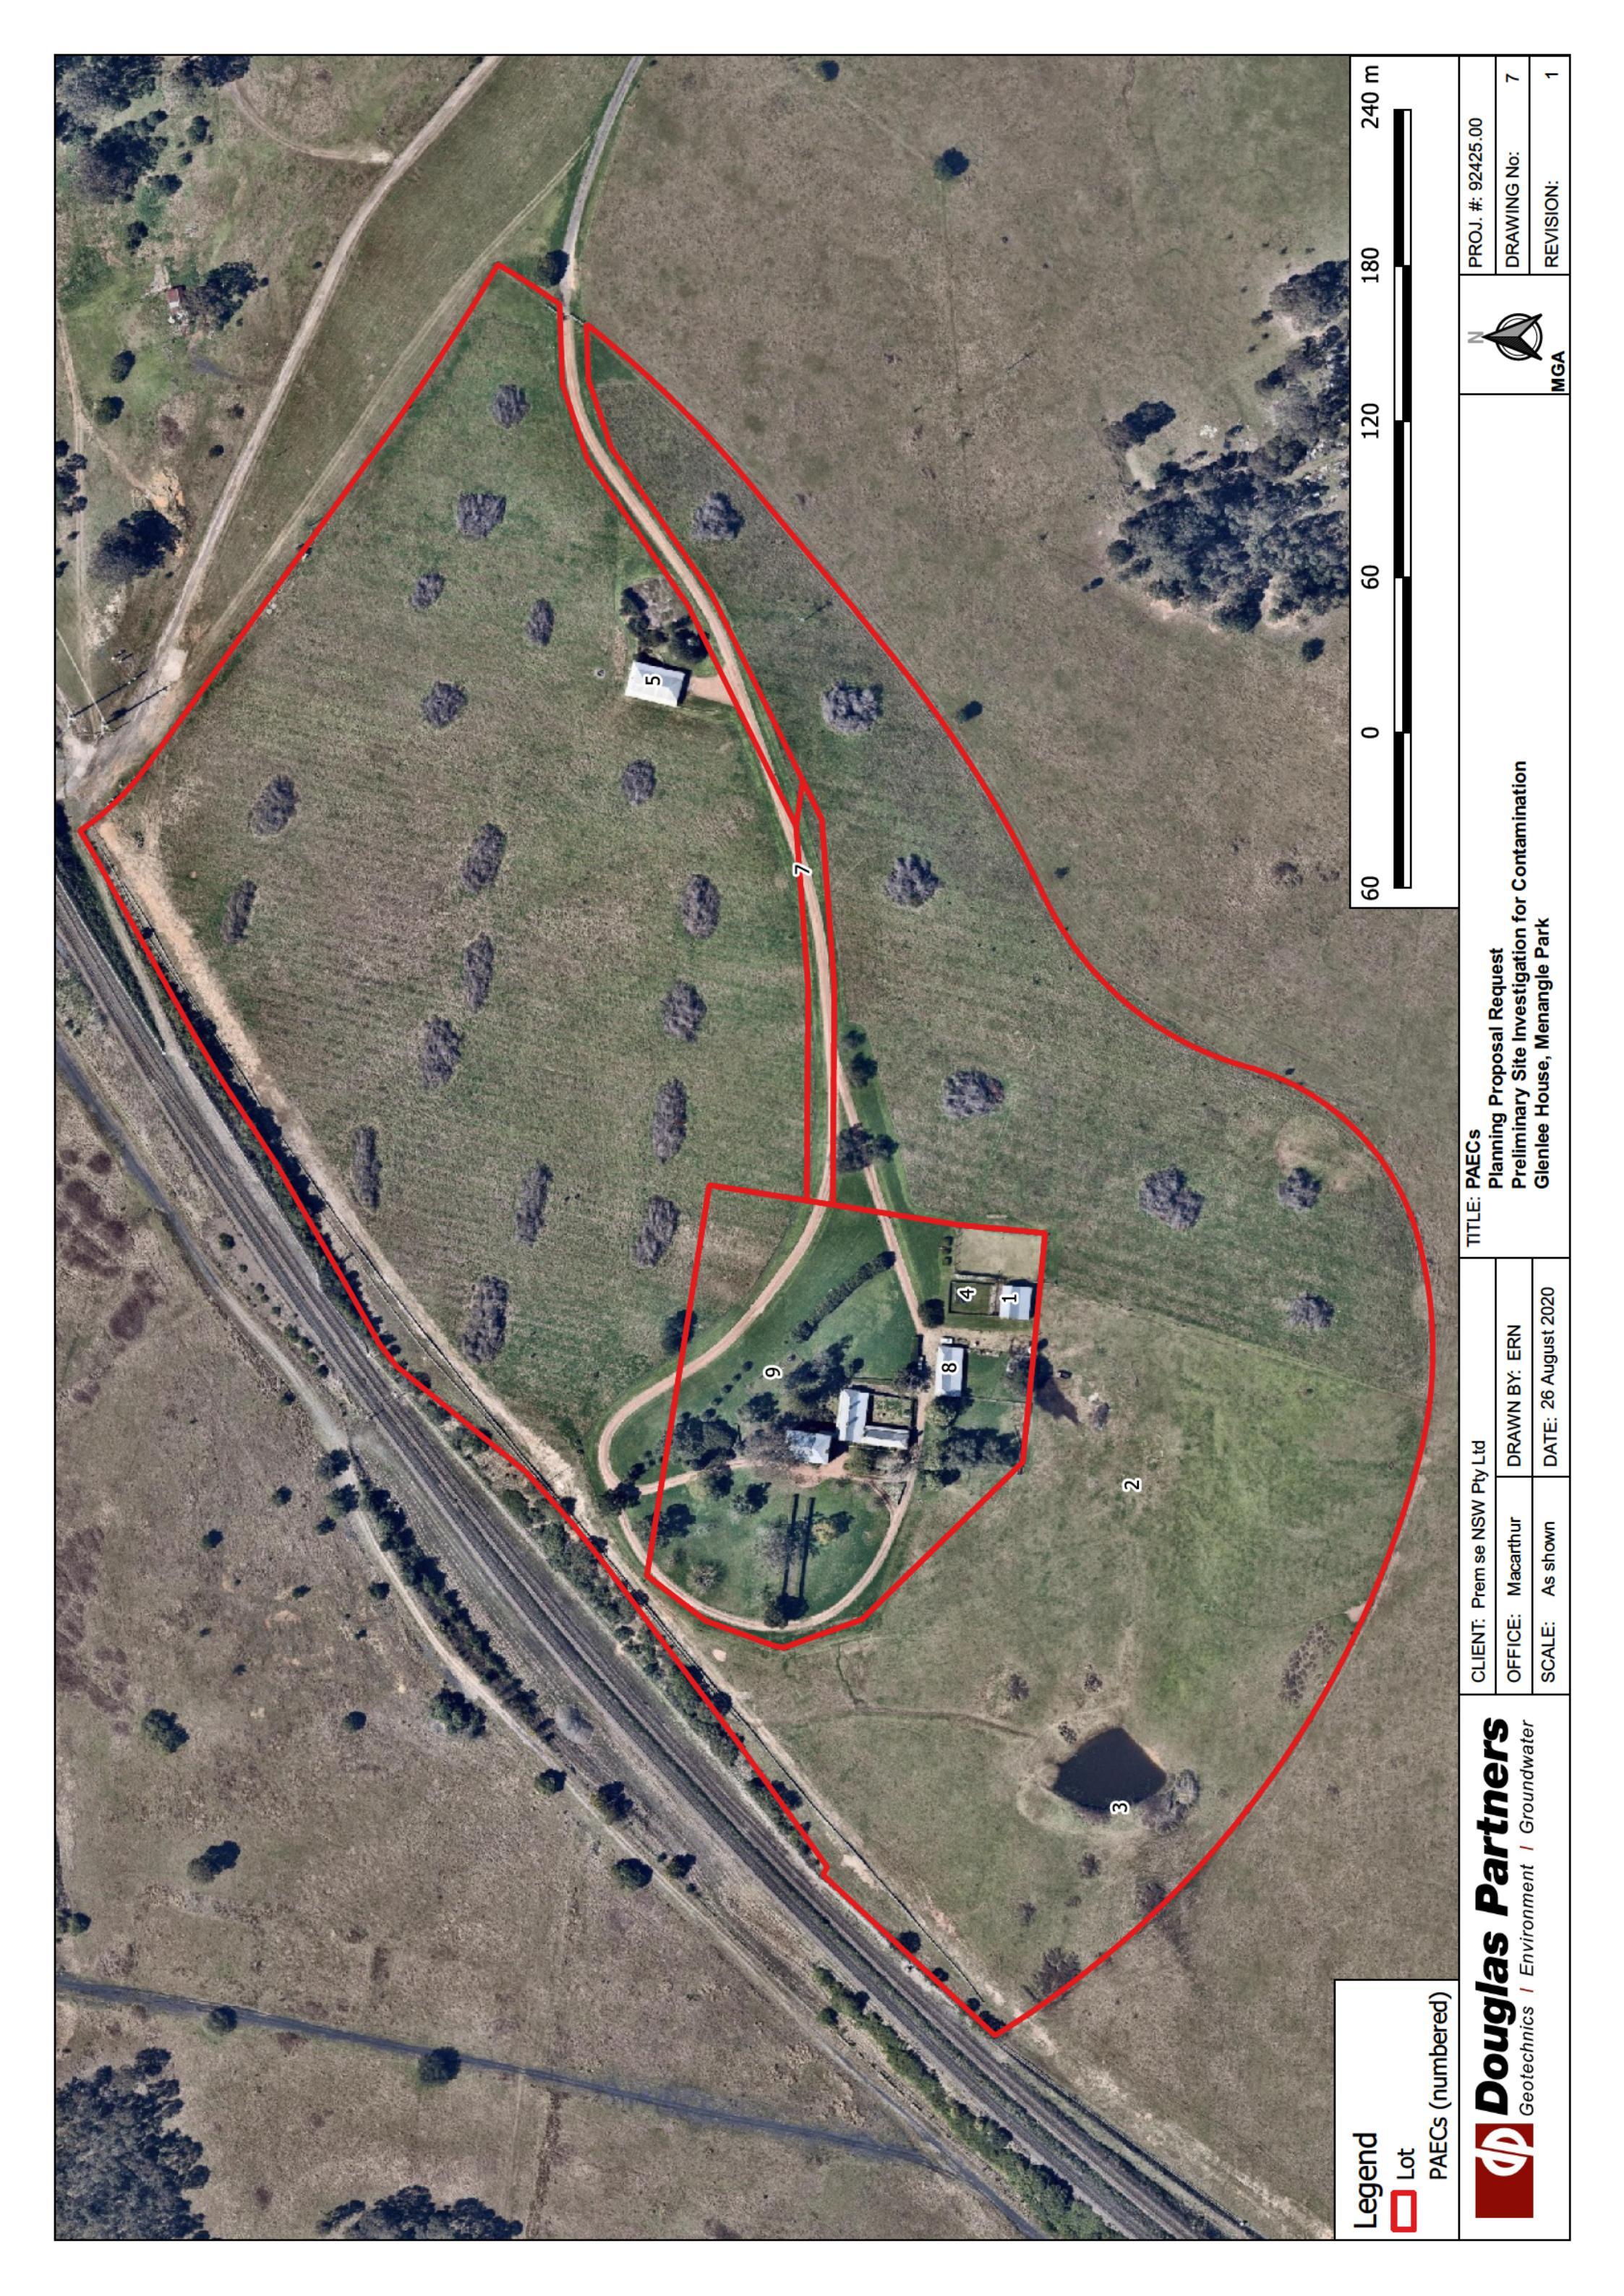
From the site history review and the site inspection, it is considered a potential for contamination exists at the Site. Ten areas were identified as PAEC and are summarised in Table 3. The PAEC locations are shown on Drawing 7.

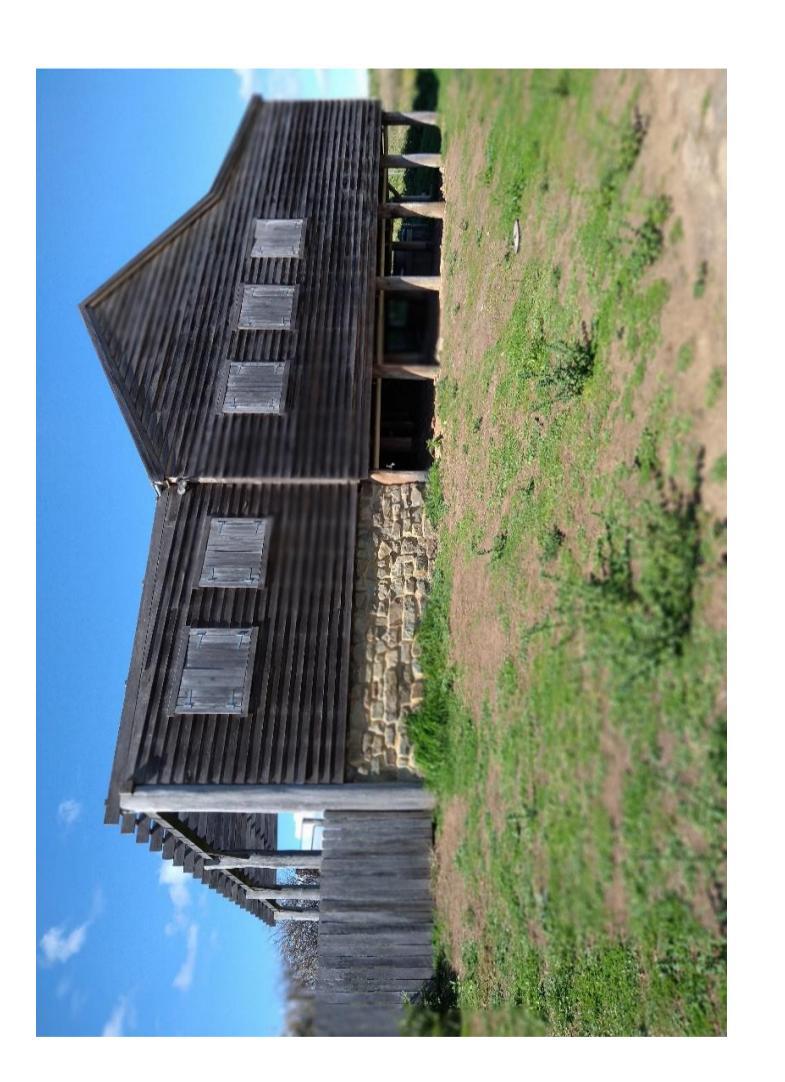
- Cement fragments and occasional demolition rubble underneath the structure where a possible fire was noted in the historical aerial review;
- Hummocky ground to the south of the main house and structures, suggesting possible filling / soil
 mounds below vegetation. Thick vegetation cover prevented closer inspection, however, small
 piles of timber, possible coal wash or bitumen, and occasional plastic were occasionally visible on
 the surface;

Photo 1 - Structure in formerly fire effected area

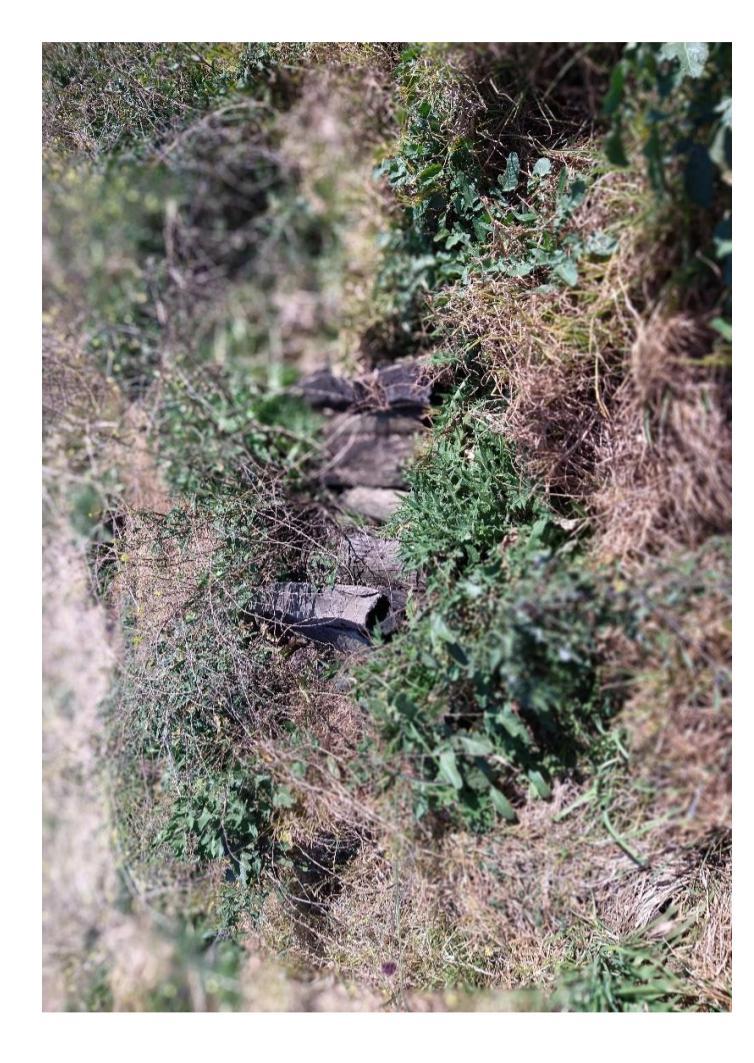
Photo 2 - Rubbish in hummocky area

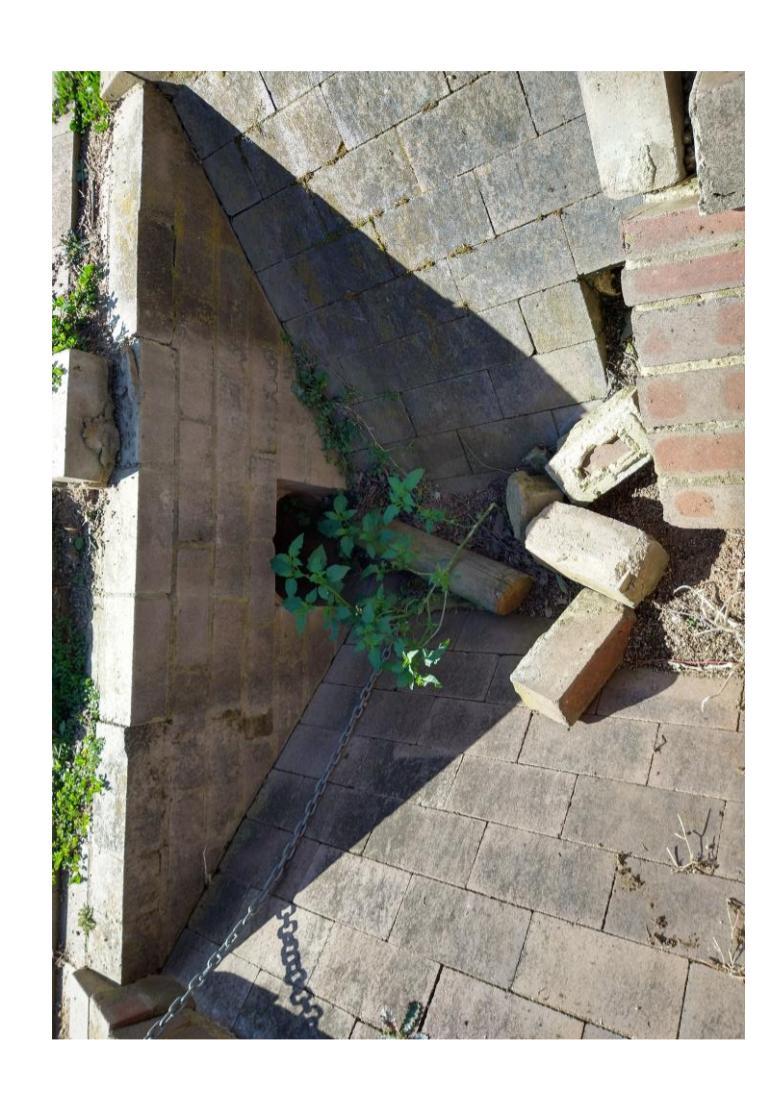
- Below ground drainage lines run perpendicular to the above access road. The drainage pits are constructed of brick, however, a closer inspection of the pipe to determine its construction material was not possible due to the depth and orientation of the pipe;

Photo 4 - Drainage pits

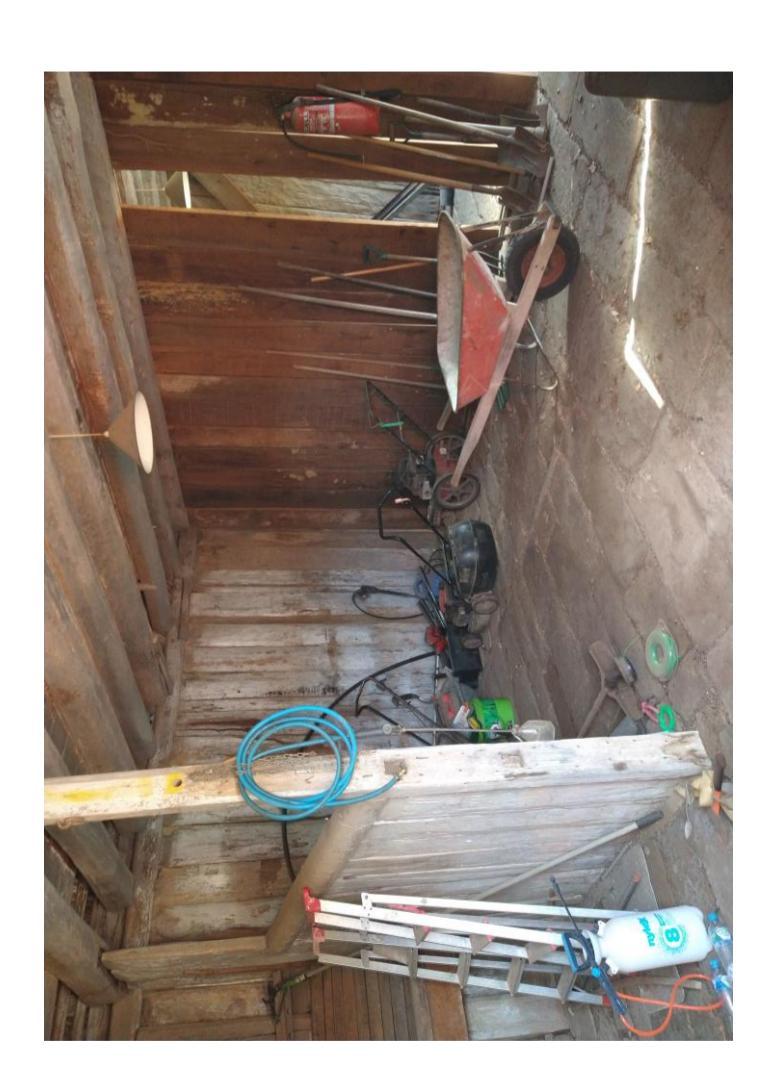
- Timber horse stables located south of the house. These are built up on a cobble/concrete floor and appear to have been used for minor fuel/oil and machinery storage (e.g. lawnmowers sighted in the walkover) only; and

Photo 5 - Horse sheds, showing minor chemical and machinery storage

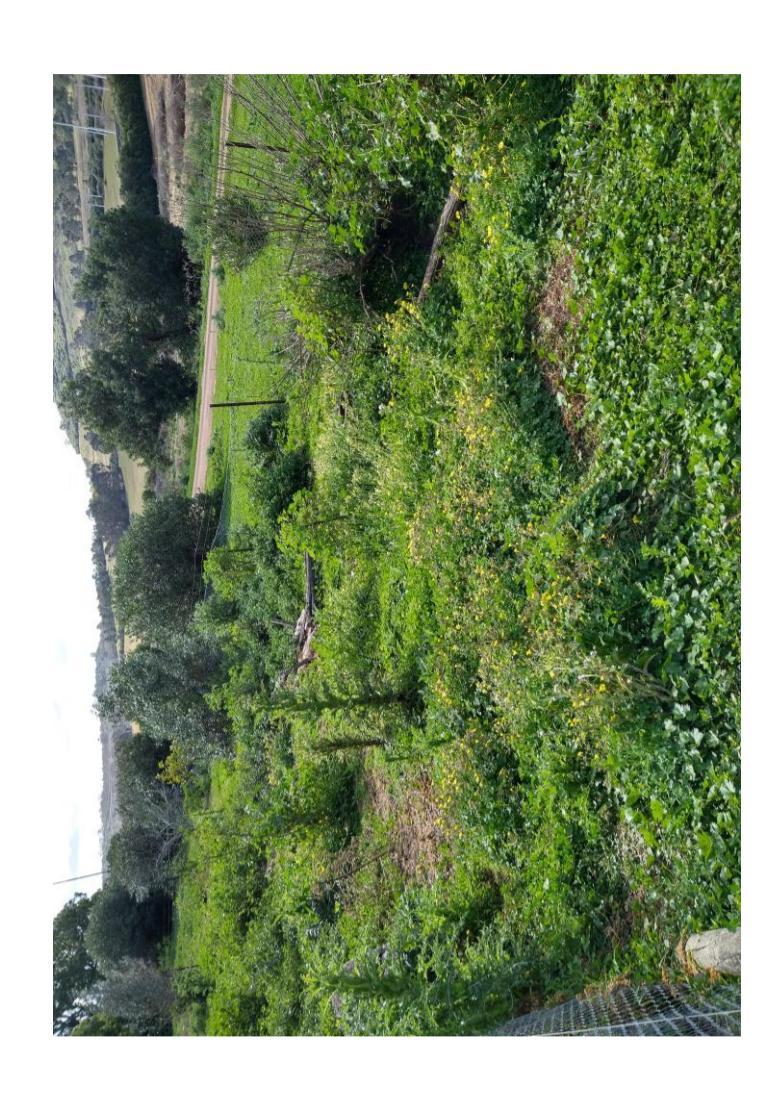
Photo 6 - Garden beds

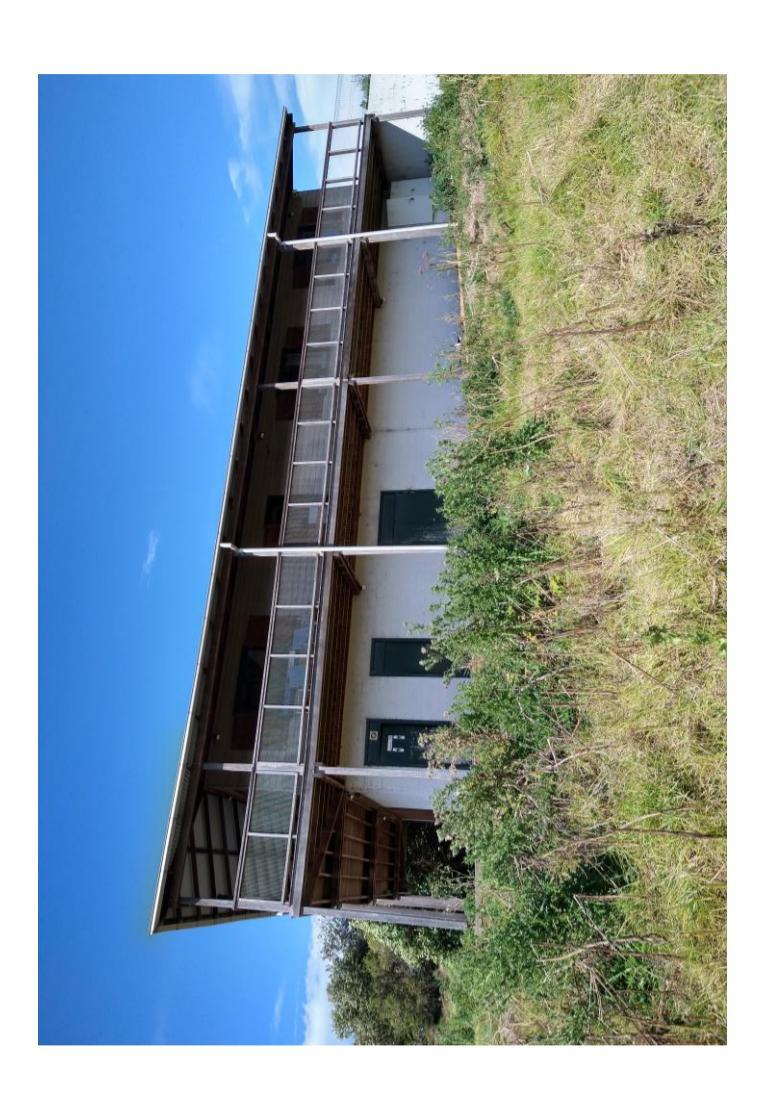
Photo 8 - New structure in Lot 3

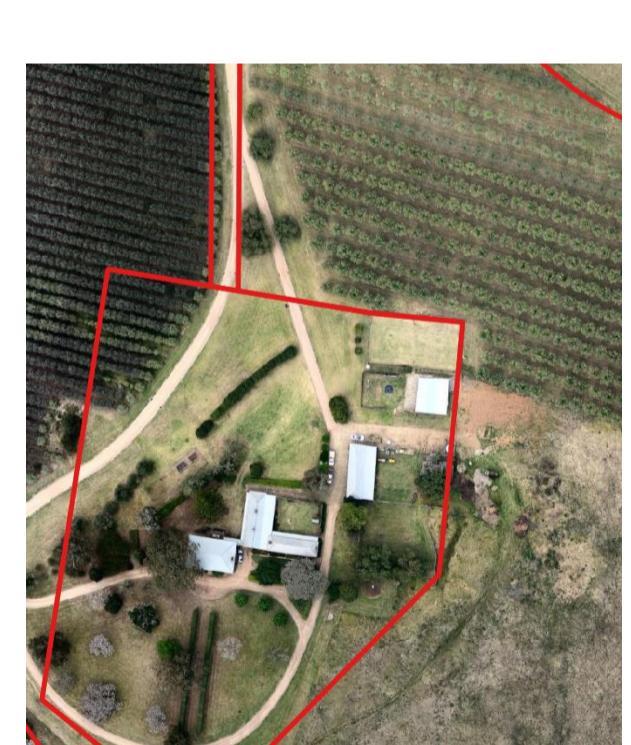
Photo 9 - Early 2012 aerial imagery, showing rebuilt structure

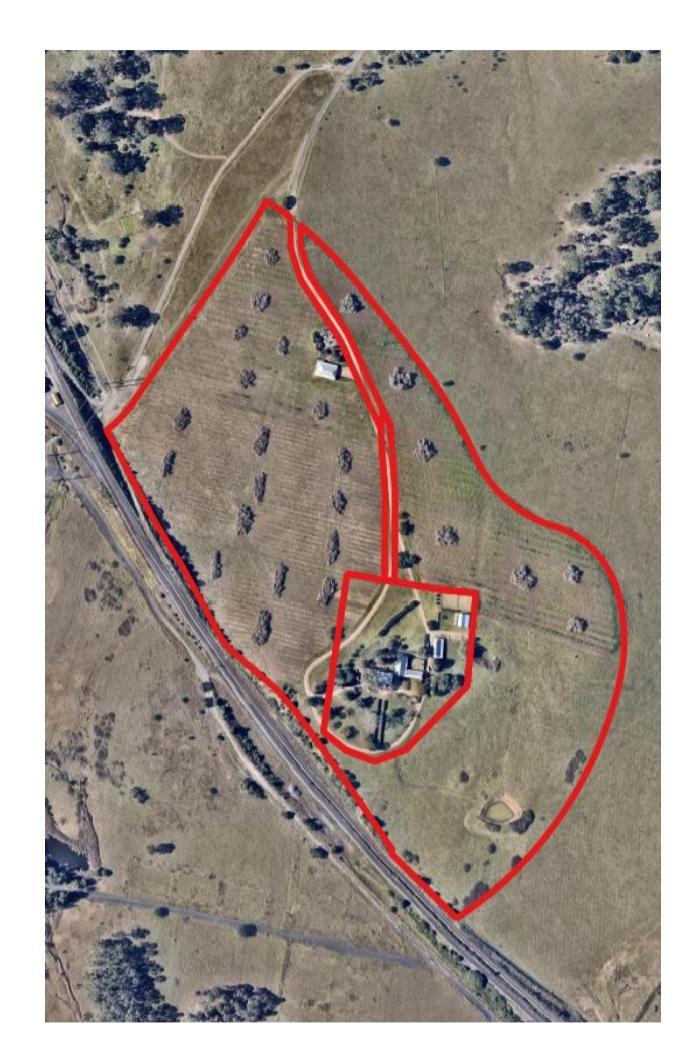
Photo 10 - Mid 2014 aerial imagery, showing large scale vegetation clearing

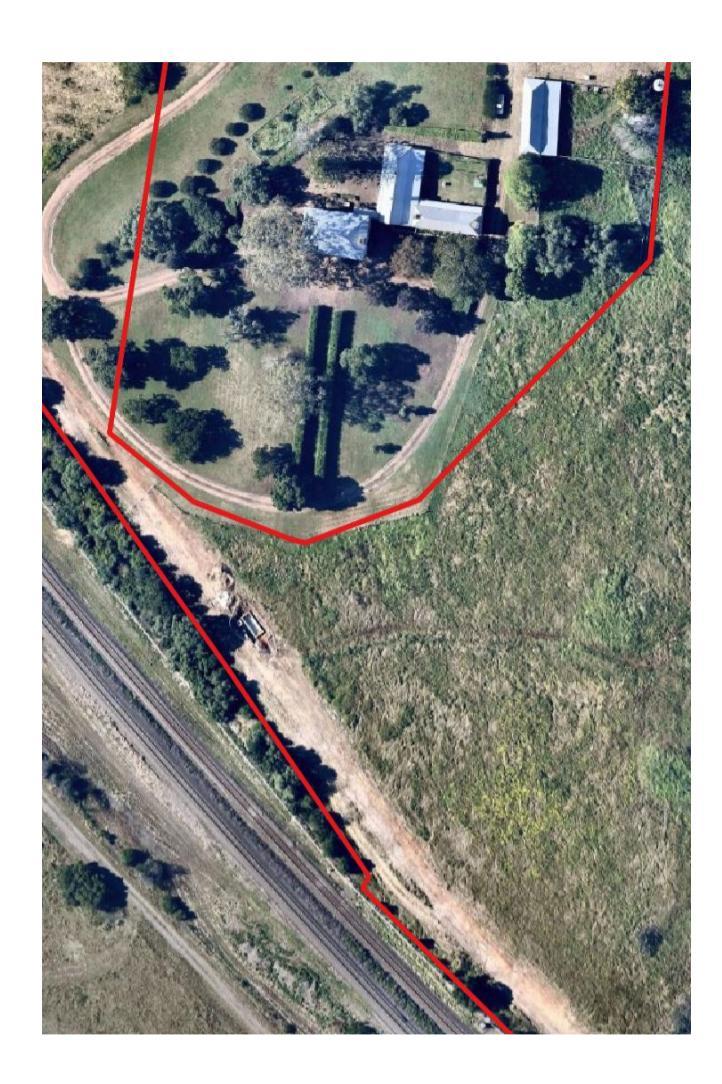
Photo 11 - Mid 2016 imagery, showing former tennis court
