Proposed Seniors Living
Development
Preliminary Geotechnical
Assessment

Lot 2 DP 1145348,
107 Haussman Drive,
Thornton

NEW17P-0074-AA
29 June 2017

**RE: PROPOSED SENIORS LIVING DEVELOPMENT
LOT 2 DP 1145348 (NO. 107) HAUSSMAN DRIVE, THORNTON
PRELIMINARY GEOTECHNICAL ASSESSMENT**

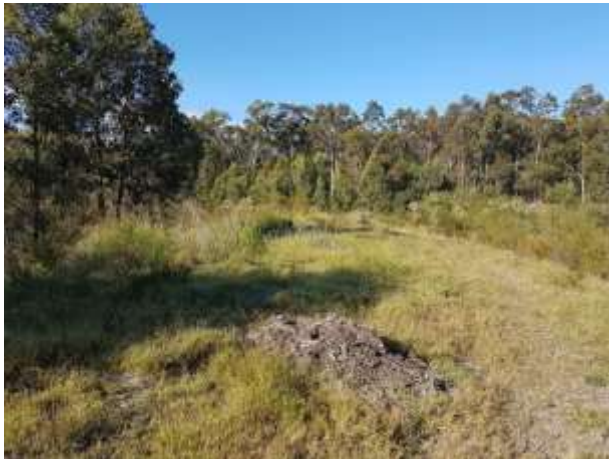
Photograph 5: Possible topsoil /fill mound at location of TP07, facing south.

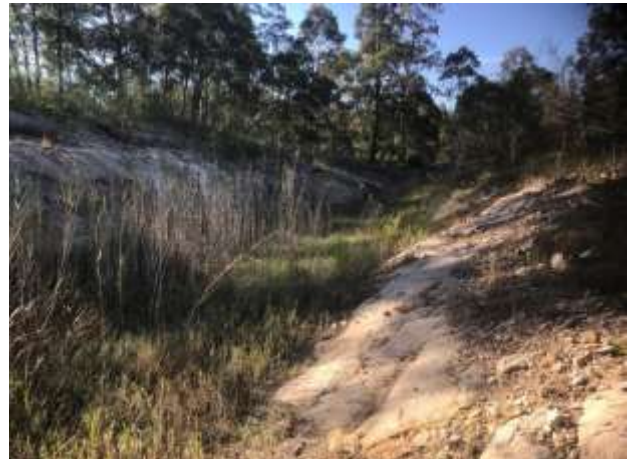
Photograph 6: Drainage channel connecting to northern side of filled area, facing east. Rock outcropping visible in sides.

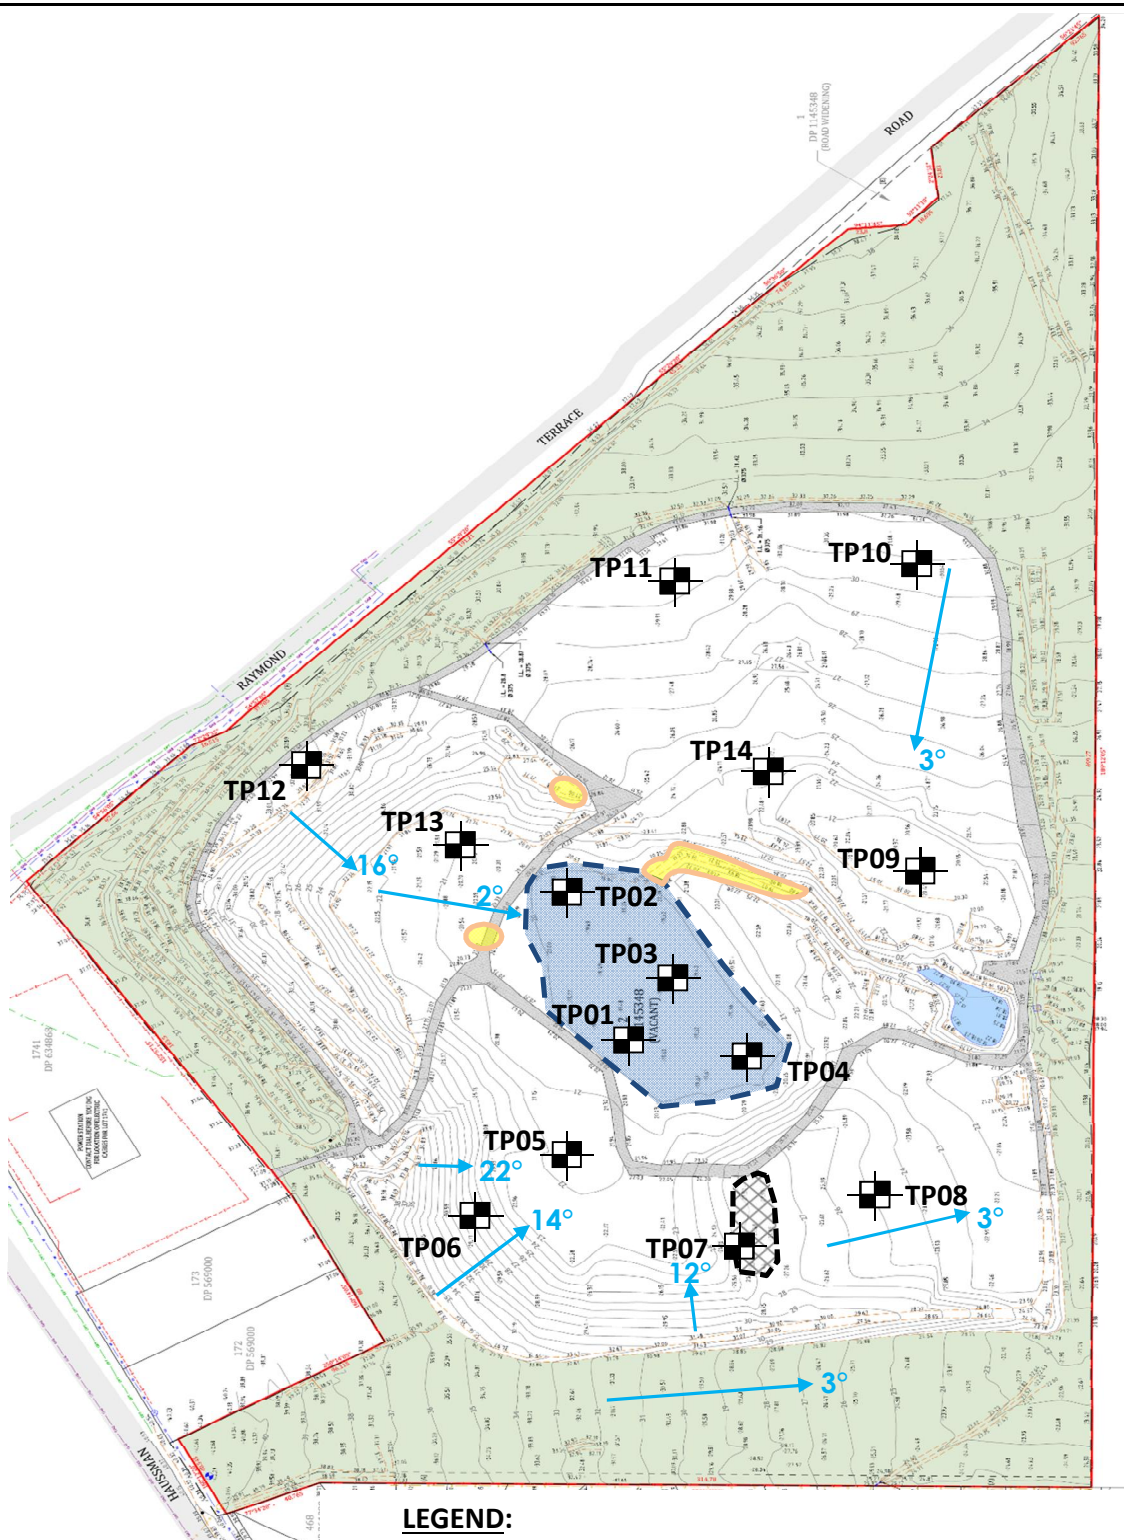
FIGURE AA1:

Based on the results of the field work and laboratory testing, the site of the proposed seniors living development located at Lot 2 DP1145348, No. 107 Haussman Drive, Thornton, as shown on Figure AA1, is preliminary classified in its current condition in accordance with AS2870-2011 'Residential Slabs and Footings', as **Class 'P'**.

Site Layout and Approximate Test Pit Locations
